(12) **United States Patent**
Hong

(10) **Patent No.:** **US 9,770,791 B2**
(45) **Date of Patent:** **Sep. 26, 2017**

(54) **METHOD FOR REPAIRING AN AIRFOIL SURFACE HAVING AN ELASTOMERIC PROTECTIVE COATING**

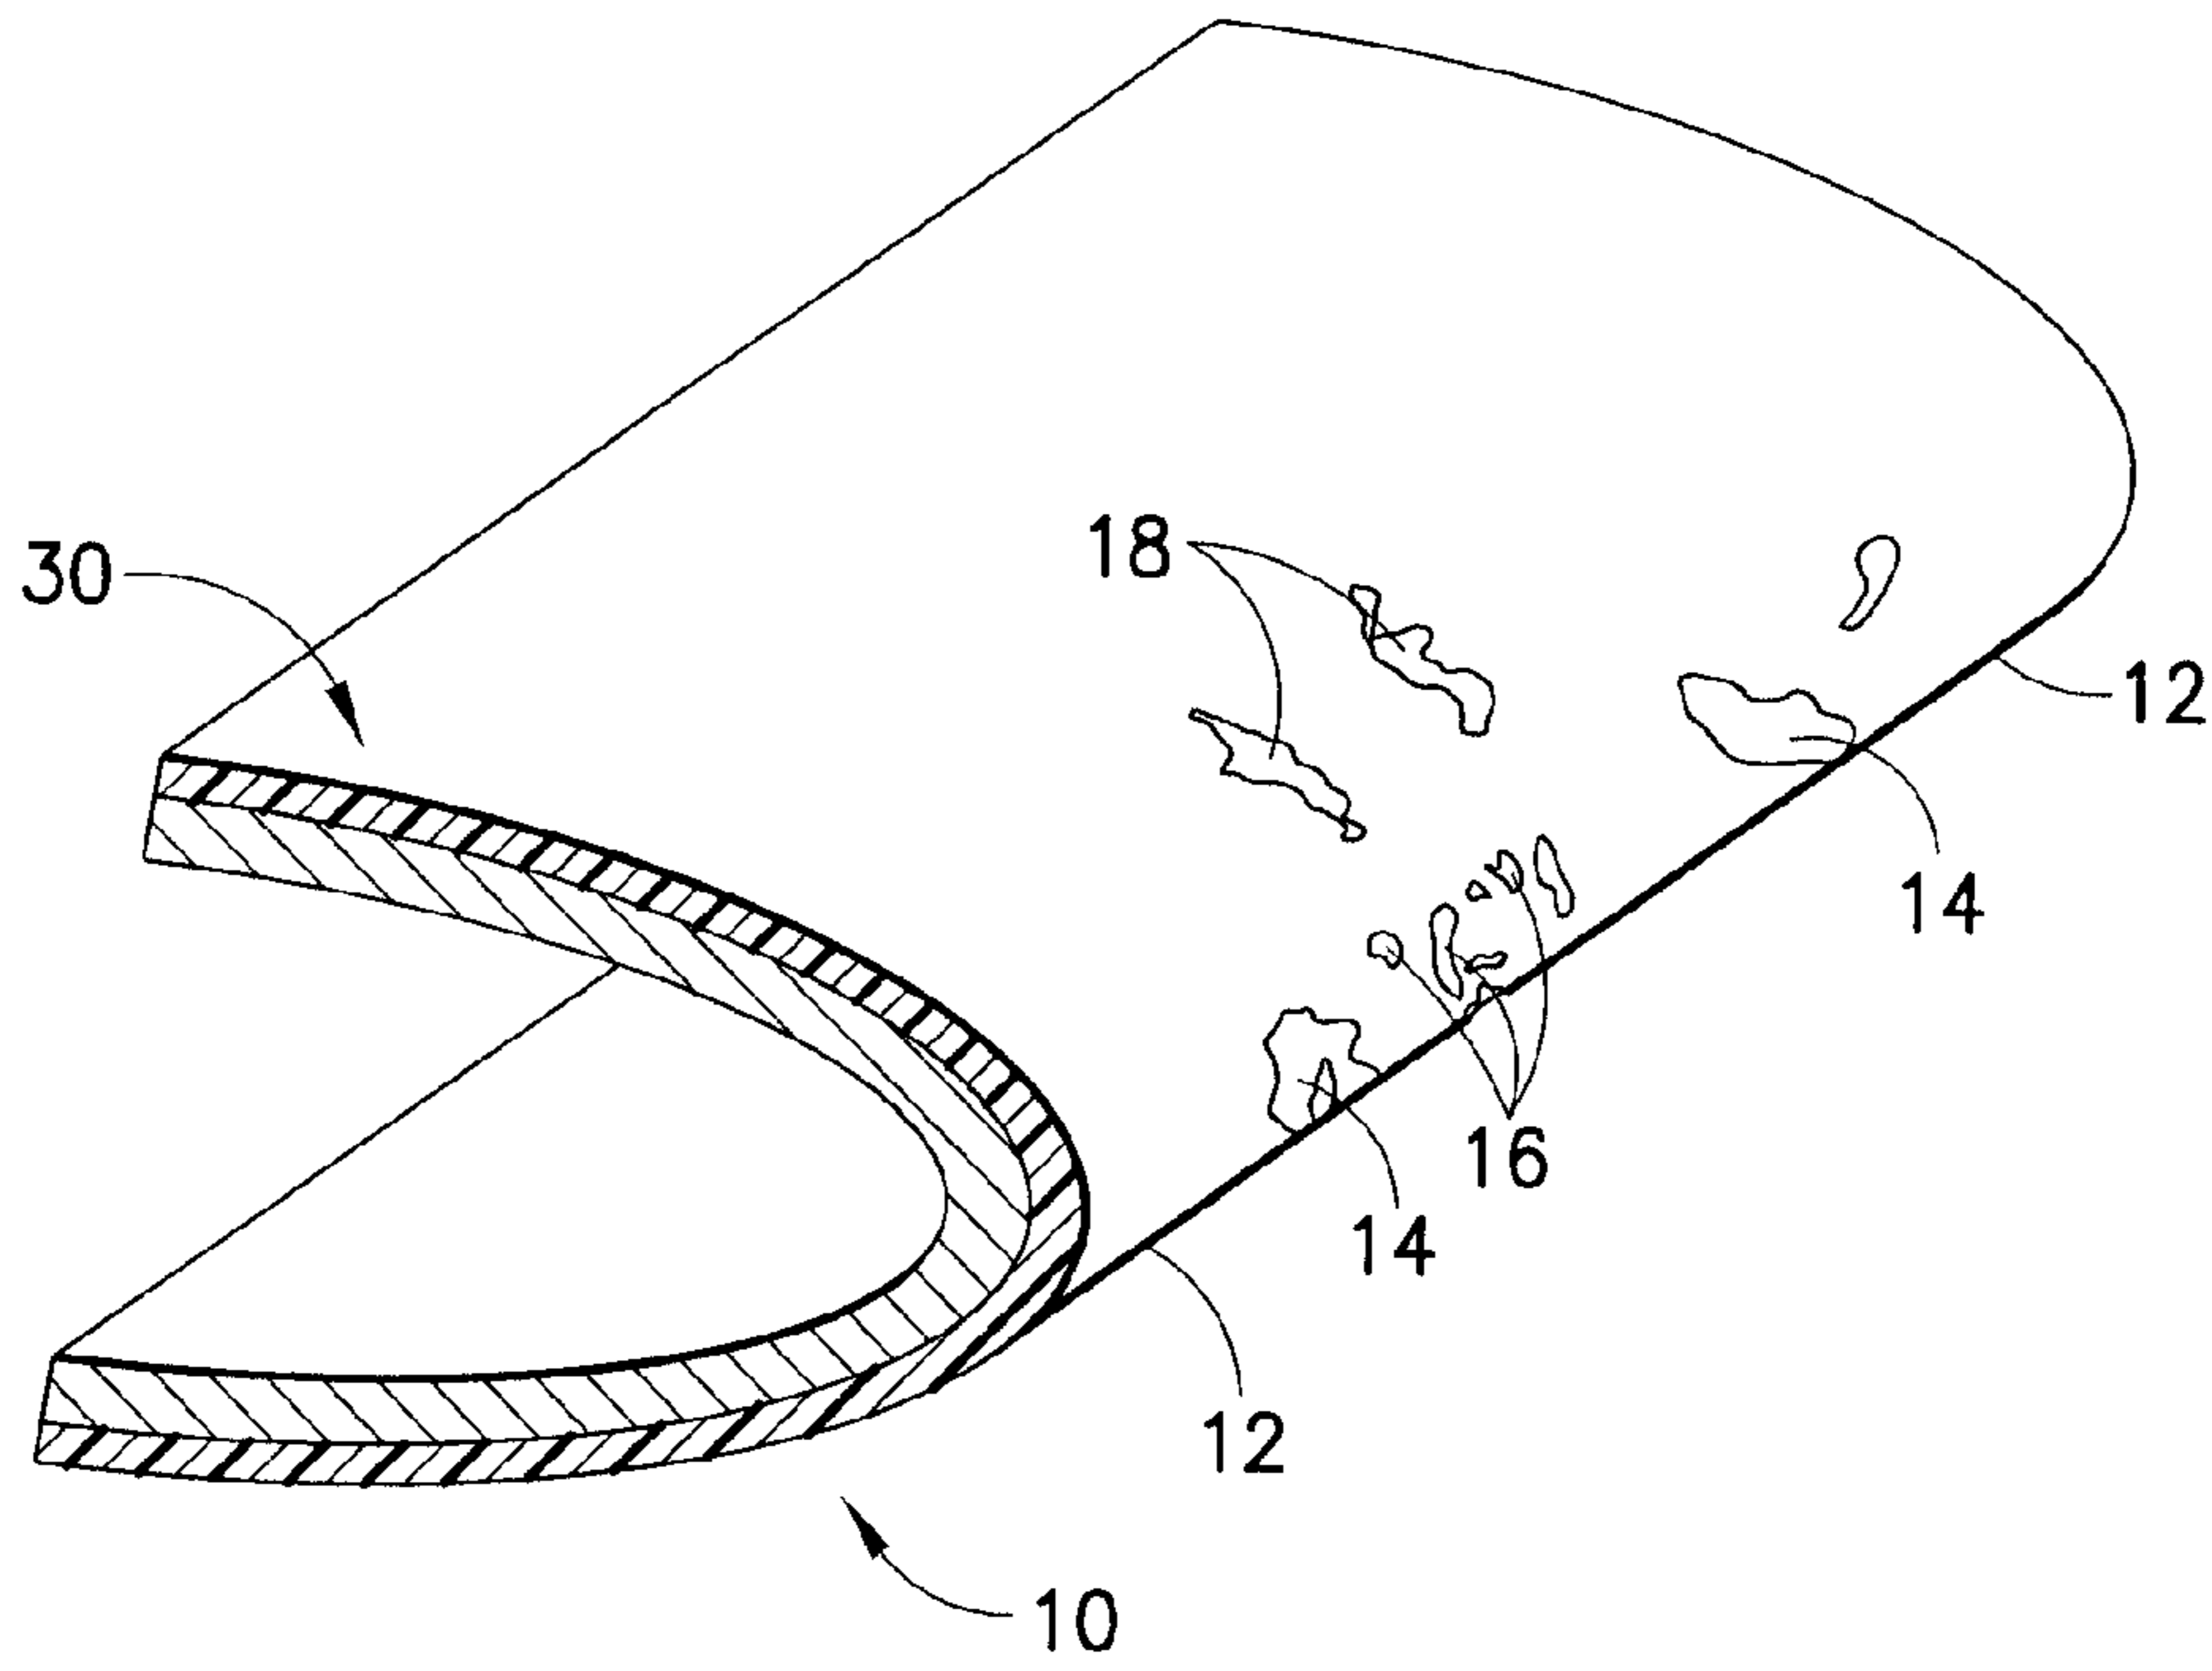
FIG. 1 is partial section of the leading edge portion of an airfoil structure showing sand and water erosion damage.

FIGS. 1 and 2 show a time lapse sequence of the erosion damage progression on an airfoil shaped structure 10, the leading edge portion 12 of which is shown in FIGS. 1 and 2 in sectional view. Rain erosion and impact damage (14 and 16) typically occurs at the front of the leading edge 12, while sand or solid particle erosion tends to focus on the contour surfaces slightly away from the leading edges. Rain erosion typically caused pits, craters, and holes, while sand erosion typically produces uniformly matte surface appearance and very shallow erosion hole patterns. FIG. 2 illustrates a later stage of erosion damage using the same section from FIG. 1. In FIG. 2 the most severe erosion sites 20 and 22 occurs when the surface is first eroded by sand or dust particles, and then followed by rain erosion. Under this mixed sand/rain environment, the side surfaces region 24 surrounding the leading edges are typically eroded into deep pits and craters very quickly.

The wind carries sand and rain and debris into contact with the leading edge 52 and impinges on its contoured surfaces 62' and 64' on either side of the leading edge. These leading edge areas are the test surfaces simulated by the test airfoil of FIG. 3. and are generally where the damage occurs as best shown in the drawing representations in FIGS. 1 and 2.

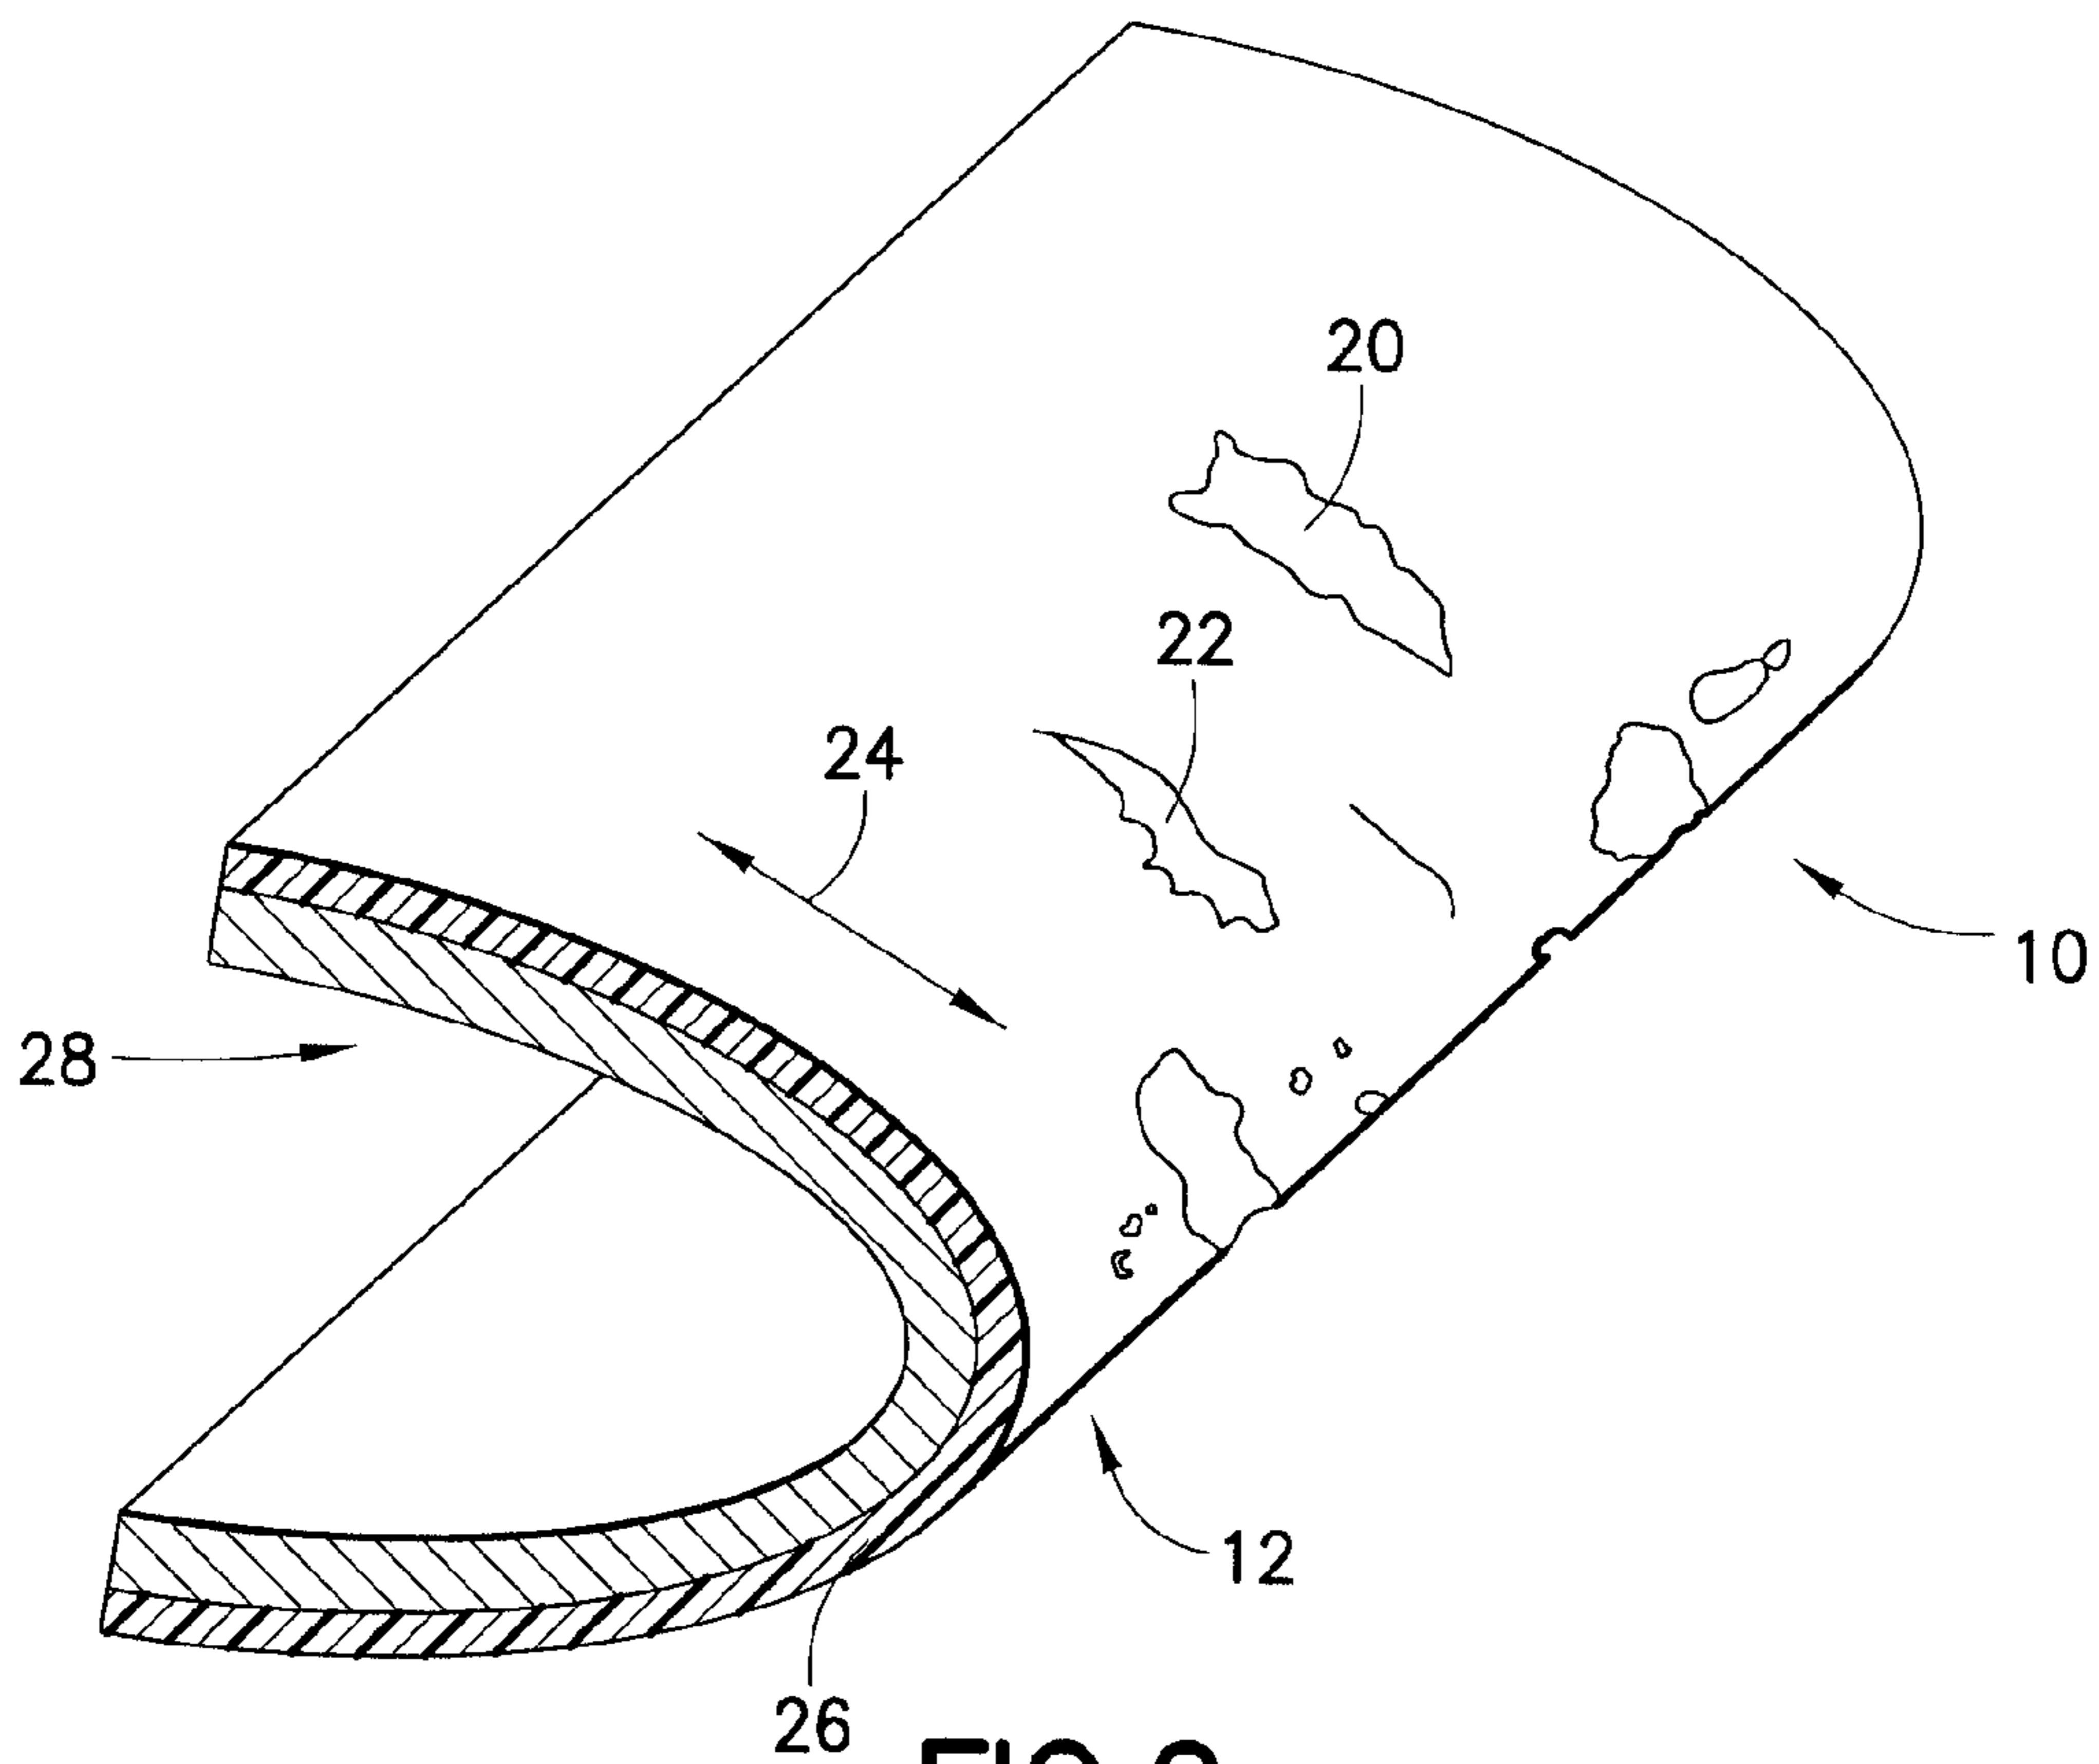
FIG. 2 is a partial section of the leading edge portion of an airfoil structure showing more severe sand and water erosion damage.

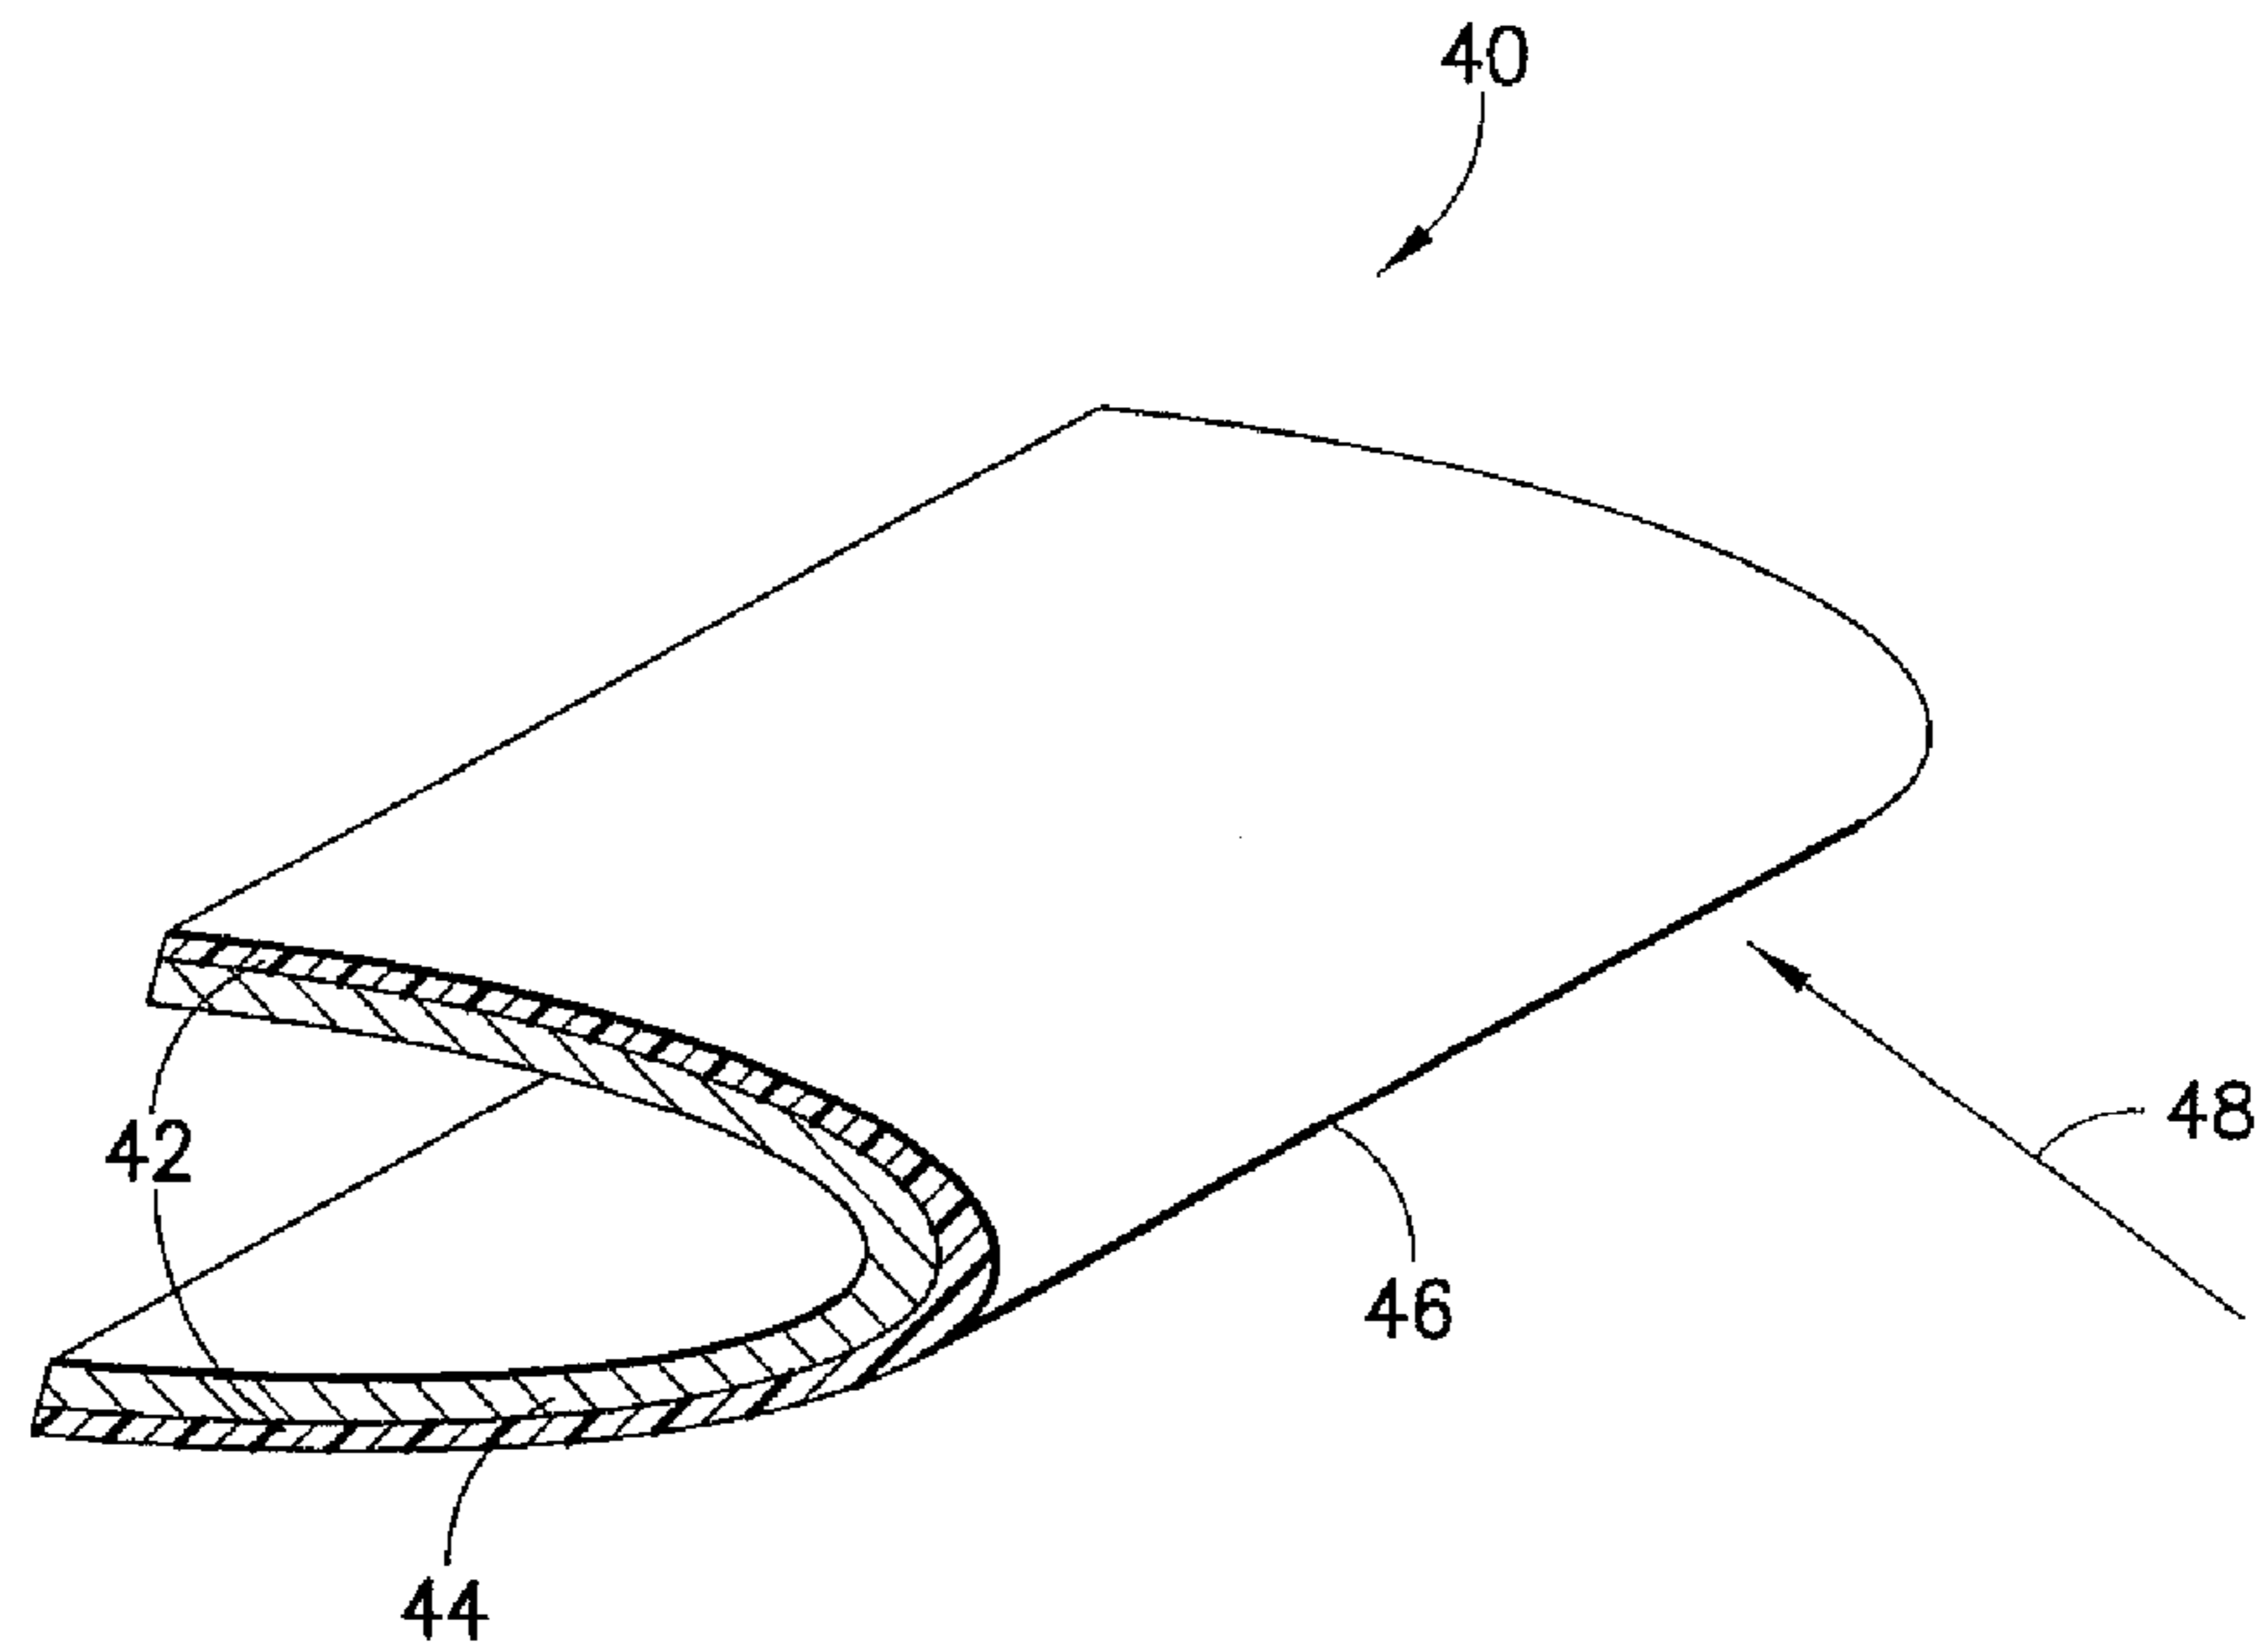
FIG. 3 shows the test airfoil 40 which is a mock-up of the partial airfoil leading edge section of an actual rotor used to simulate actual damage from water and sand impingement in a controlled environment. The elastomeric coating 42 is deposited on the underlying substrate 44 surface area of the whole test airfoil. The leading edge 46 is the focal point for the impingement of water and sand during testing shown by directional arrow 48. All along the leading edge 44 and all the adjacent surfaces represented by this test airfoil damage occurs by the appearance during testing of the erosion damage cavities shown in FIGS. 1 and 2.

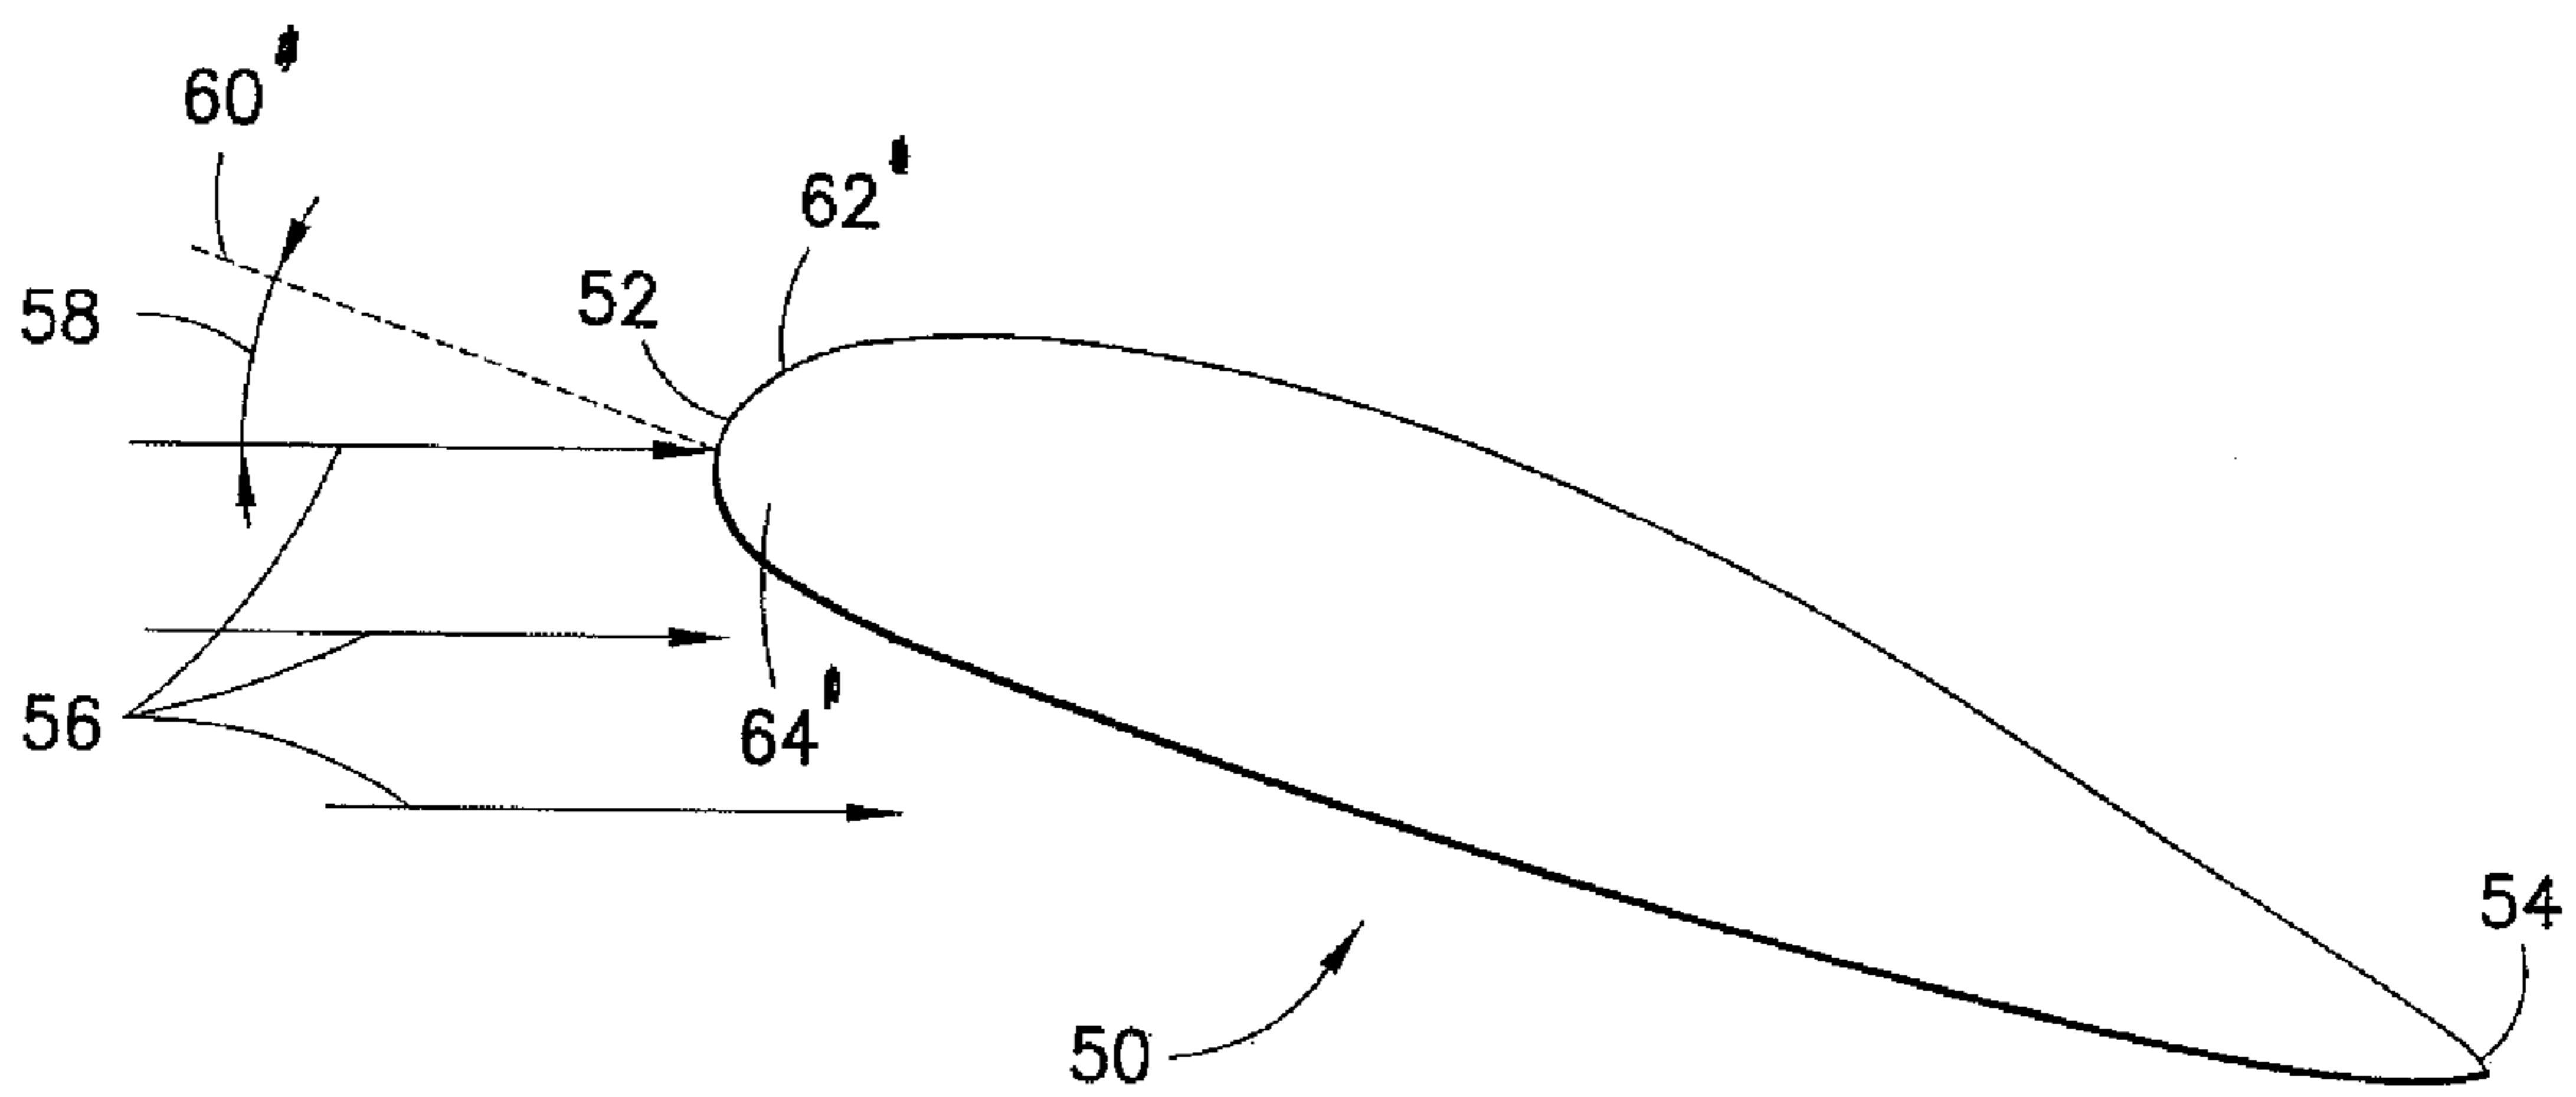
FIG. 4 is a cross sectional schematic view of an airfoil shape with major airfoil or hydrofoil elements identified

FIG. 4 illustrates by a cross-sectional diagrammatic representation of the convention structural portions of a typical airfoil 50 having a leading edge 52 and a trailing edge 54 with the oncoming wind direction shown as arrow 56, the angle of attack 58 is the angle between the wind direction and the chord 60' of the airfoil 50 shown as a dashed line 60'.

The term "airfoil" as used throughout this specification is meant to be more expansive than the conventional airfoil shaped structure in FIG. 4 and will also encompass structures such as hydrofoils which have an aerodynamic shape that is somewhat different than FIG. 4 but are similarly subject to wind or water carried sand and debris. Such included shapes are radomes shape which would have a leading edge in the form of a narrowed point rather than the leading edge which is geometrically a line in FIG. 4 airfoil form. Aircraft antennae are shaped to allow smooth airflow around them and are considered within the term "airfoil" as are other devices benefiting from the advancement of the embodiments such as windmill blades, turbine blades, runner blades, fan blades, compressor blades, propeller blades, vanes, stay vanes, hydroelectric turbines, marine propellers, hydro turbines, gas turbines, tide mills, windmills, compressors, pumps, blower, impellers, propellers, and many kinds of fans all of which have the common feature of having fluid passing by the surfaces which may carry damaging sand and debris.

The term "leading edge" will similarly be understood to have a broader meaning than shown in FIG. 4 and should be defined as a narrowed surface designed to encounter the wind or other fluid such as water. It is may be an elongated narrowed edge in the case of a rotor blade, wing, antenna, windmill blade or a sharper edge surface as in a propeller blade or a forward wind encountering point area as in a radomes (which may have a blunt conical form or other generally rounded shape).

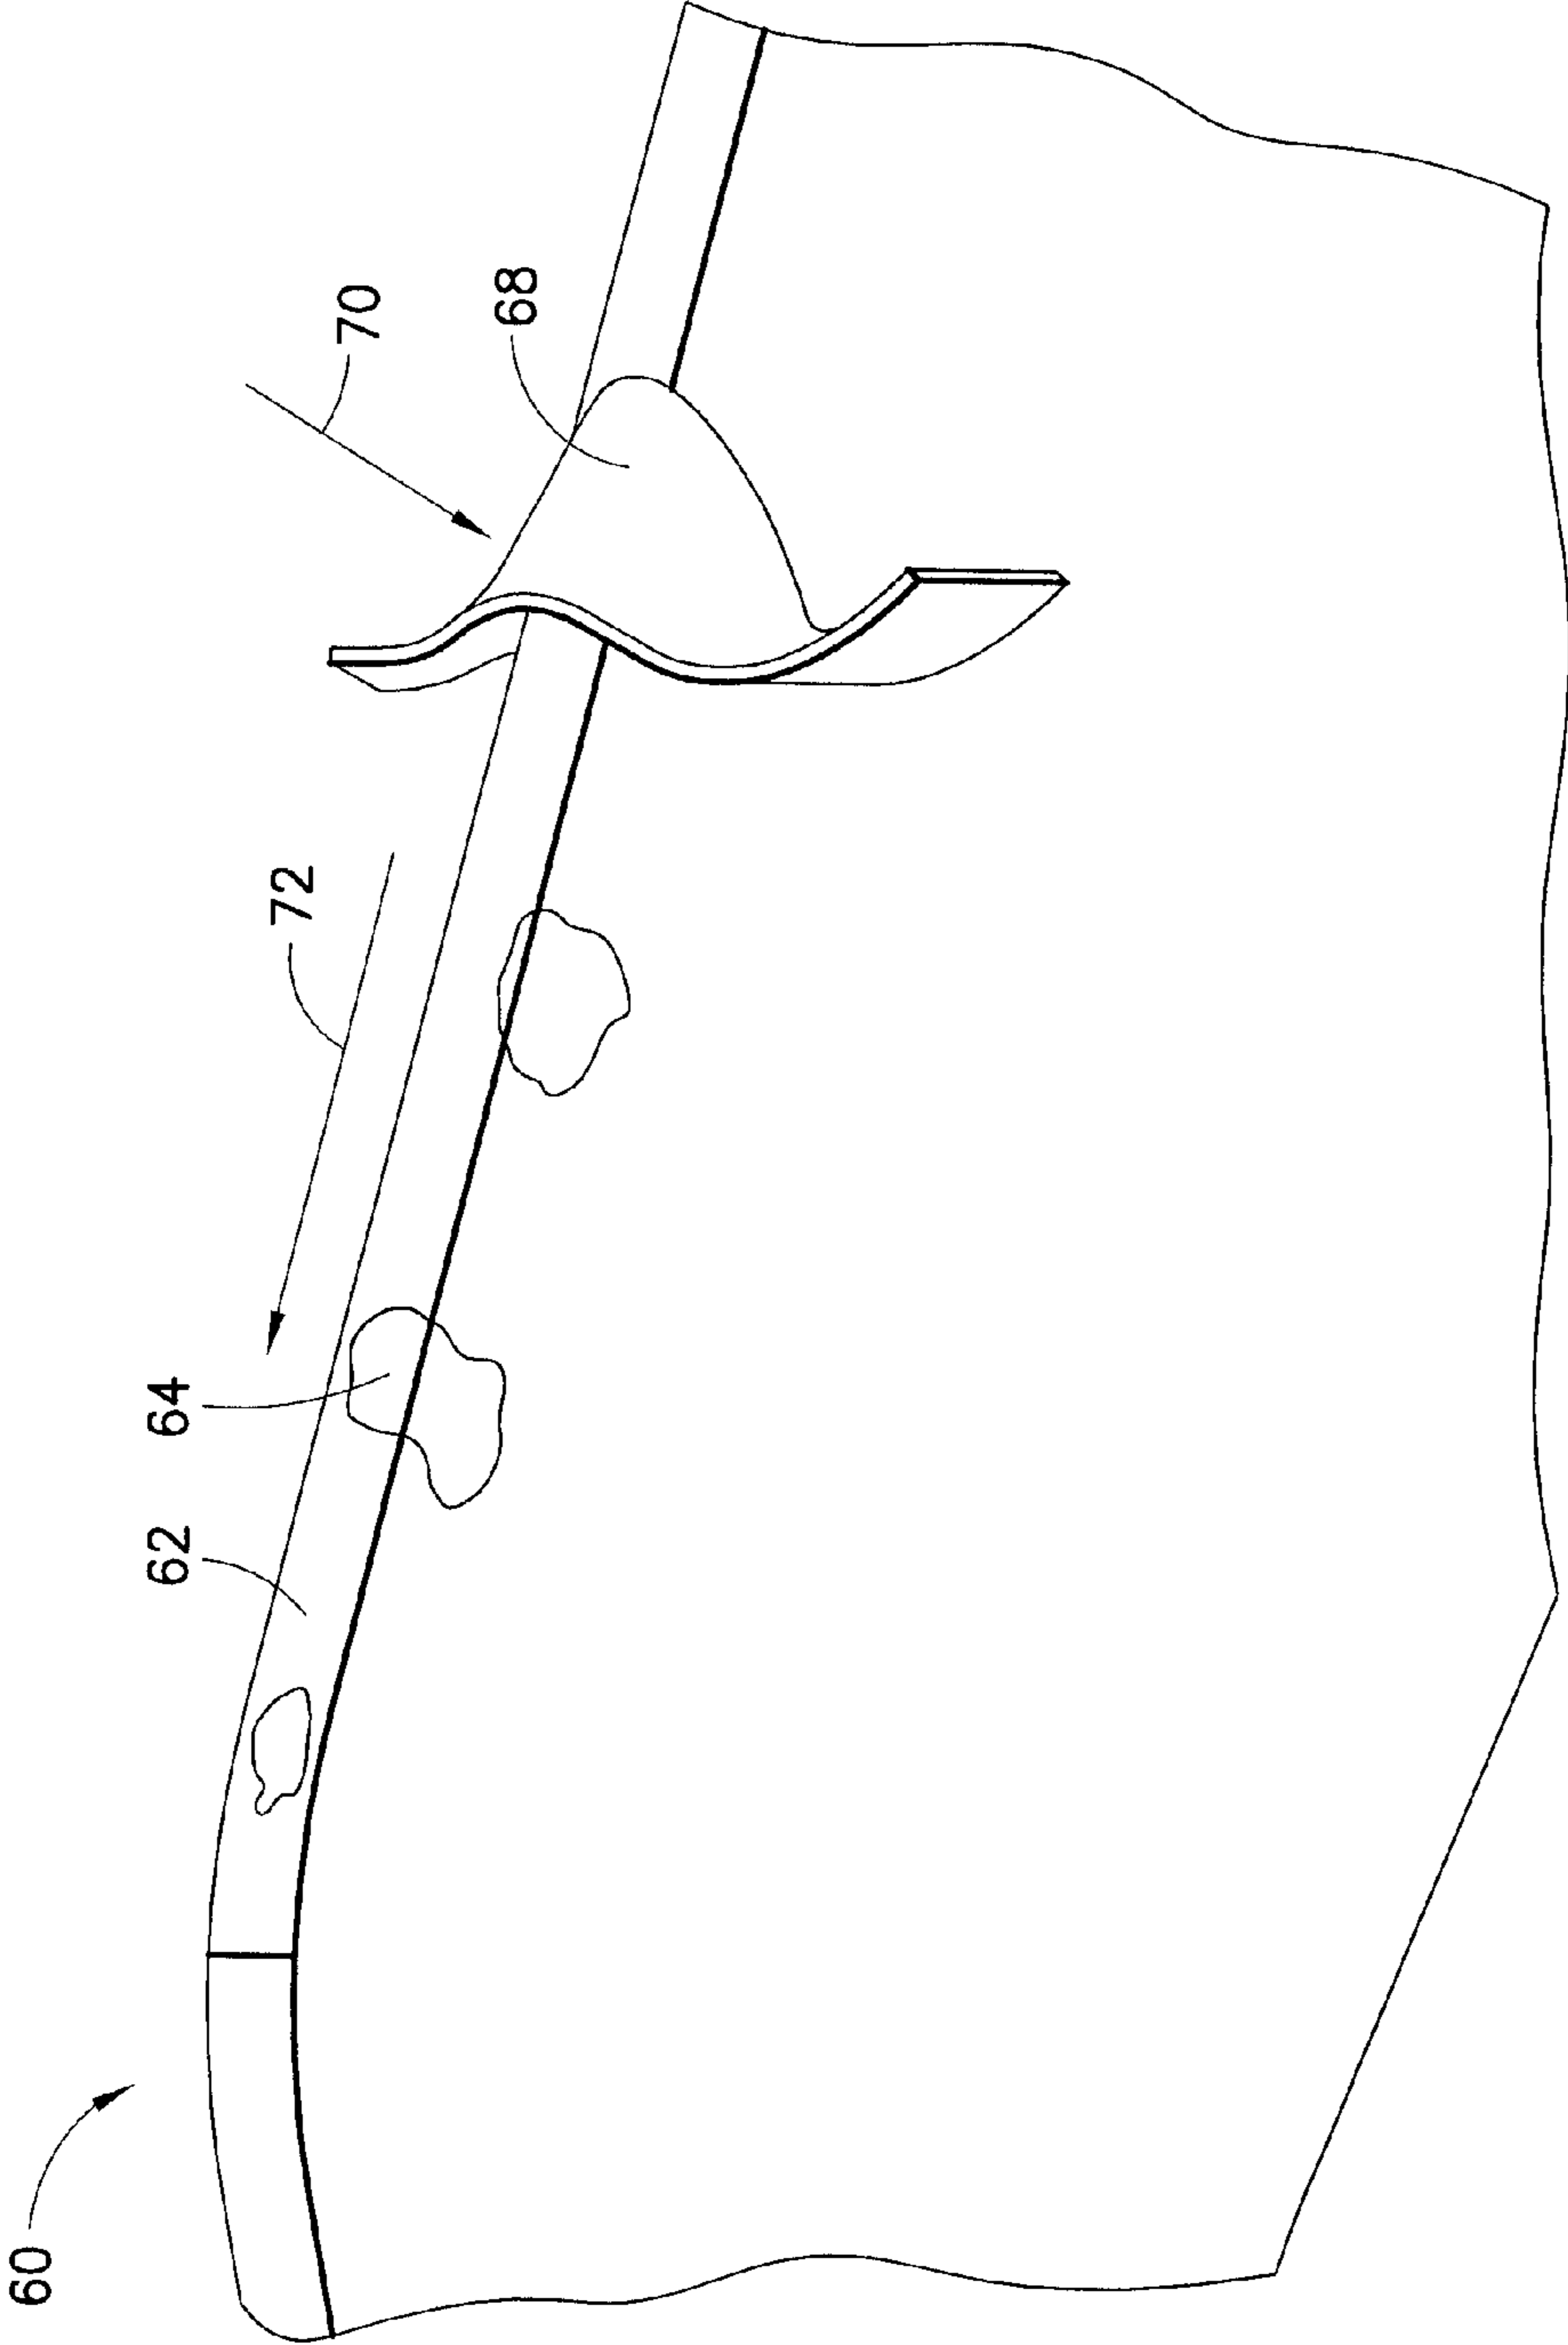
FIG.5

FIG. 5 is a perspective view of a leading edge being repaired using a flexible applicator

FIG. 5 is shown as a photograph because it provides the best visualization of the application technique of this embodiment. The airfoil chosen for illustration is a helicopter rotor blade 60 having a leading edge 62 which has damage cavities 64 in its contoured surfaces. The flexible applicator 66 is made of a 0.010" (0.25 mm) thick high density polyethylene sheet. The flexible applicator edge 68 forms a continuous line contact with the contoured surface of the leading edge using downward pressure indicated by the force vector arrow 70. At the same time the force 70 is applied in the direction of the surface, the flexible applicator is drawn in a direction 72 that is parallel to the leading edge 62. The basecoat repair material (not visible in this view) is under the curved surface of the flexible applicator in a rolling bank of material that is moved ahead of the flexible applicator edge 68 as the applicator is smoothly drawn in the direction 72. The basecoat repair material completely fills the damage cavities 64 as the rolling bank of repair material passes over the cavities. The applicator edge's continuous line contact with the contoured surface of the leading edge does not deposit significant amounts of repair material anywhere except in the cavities 64.

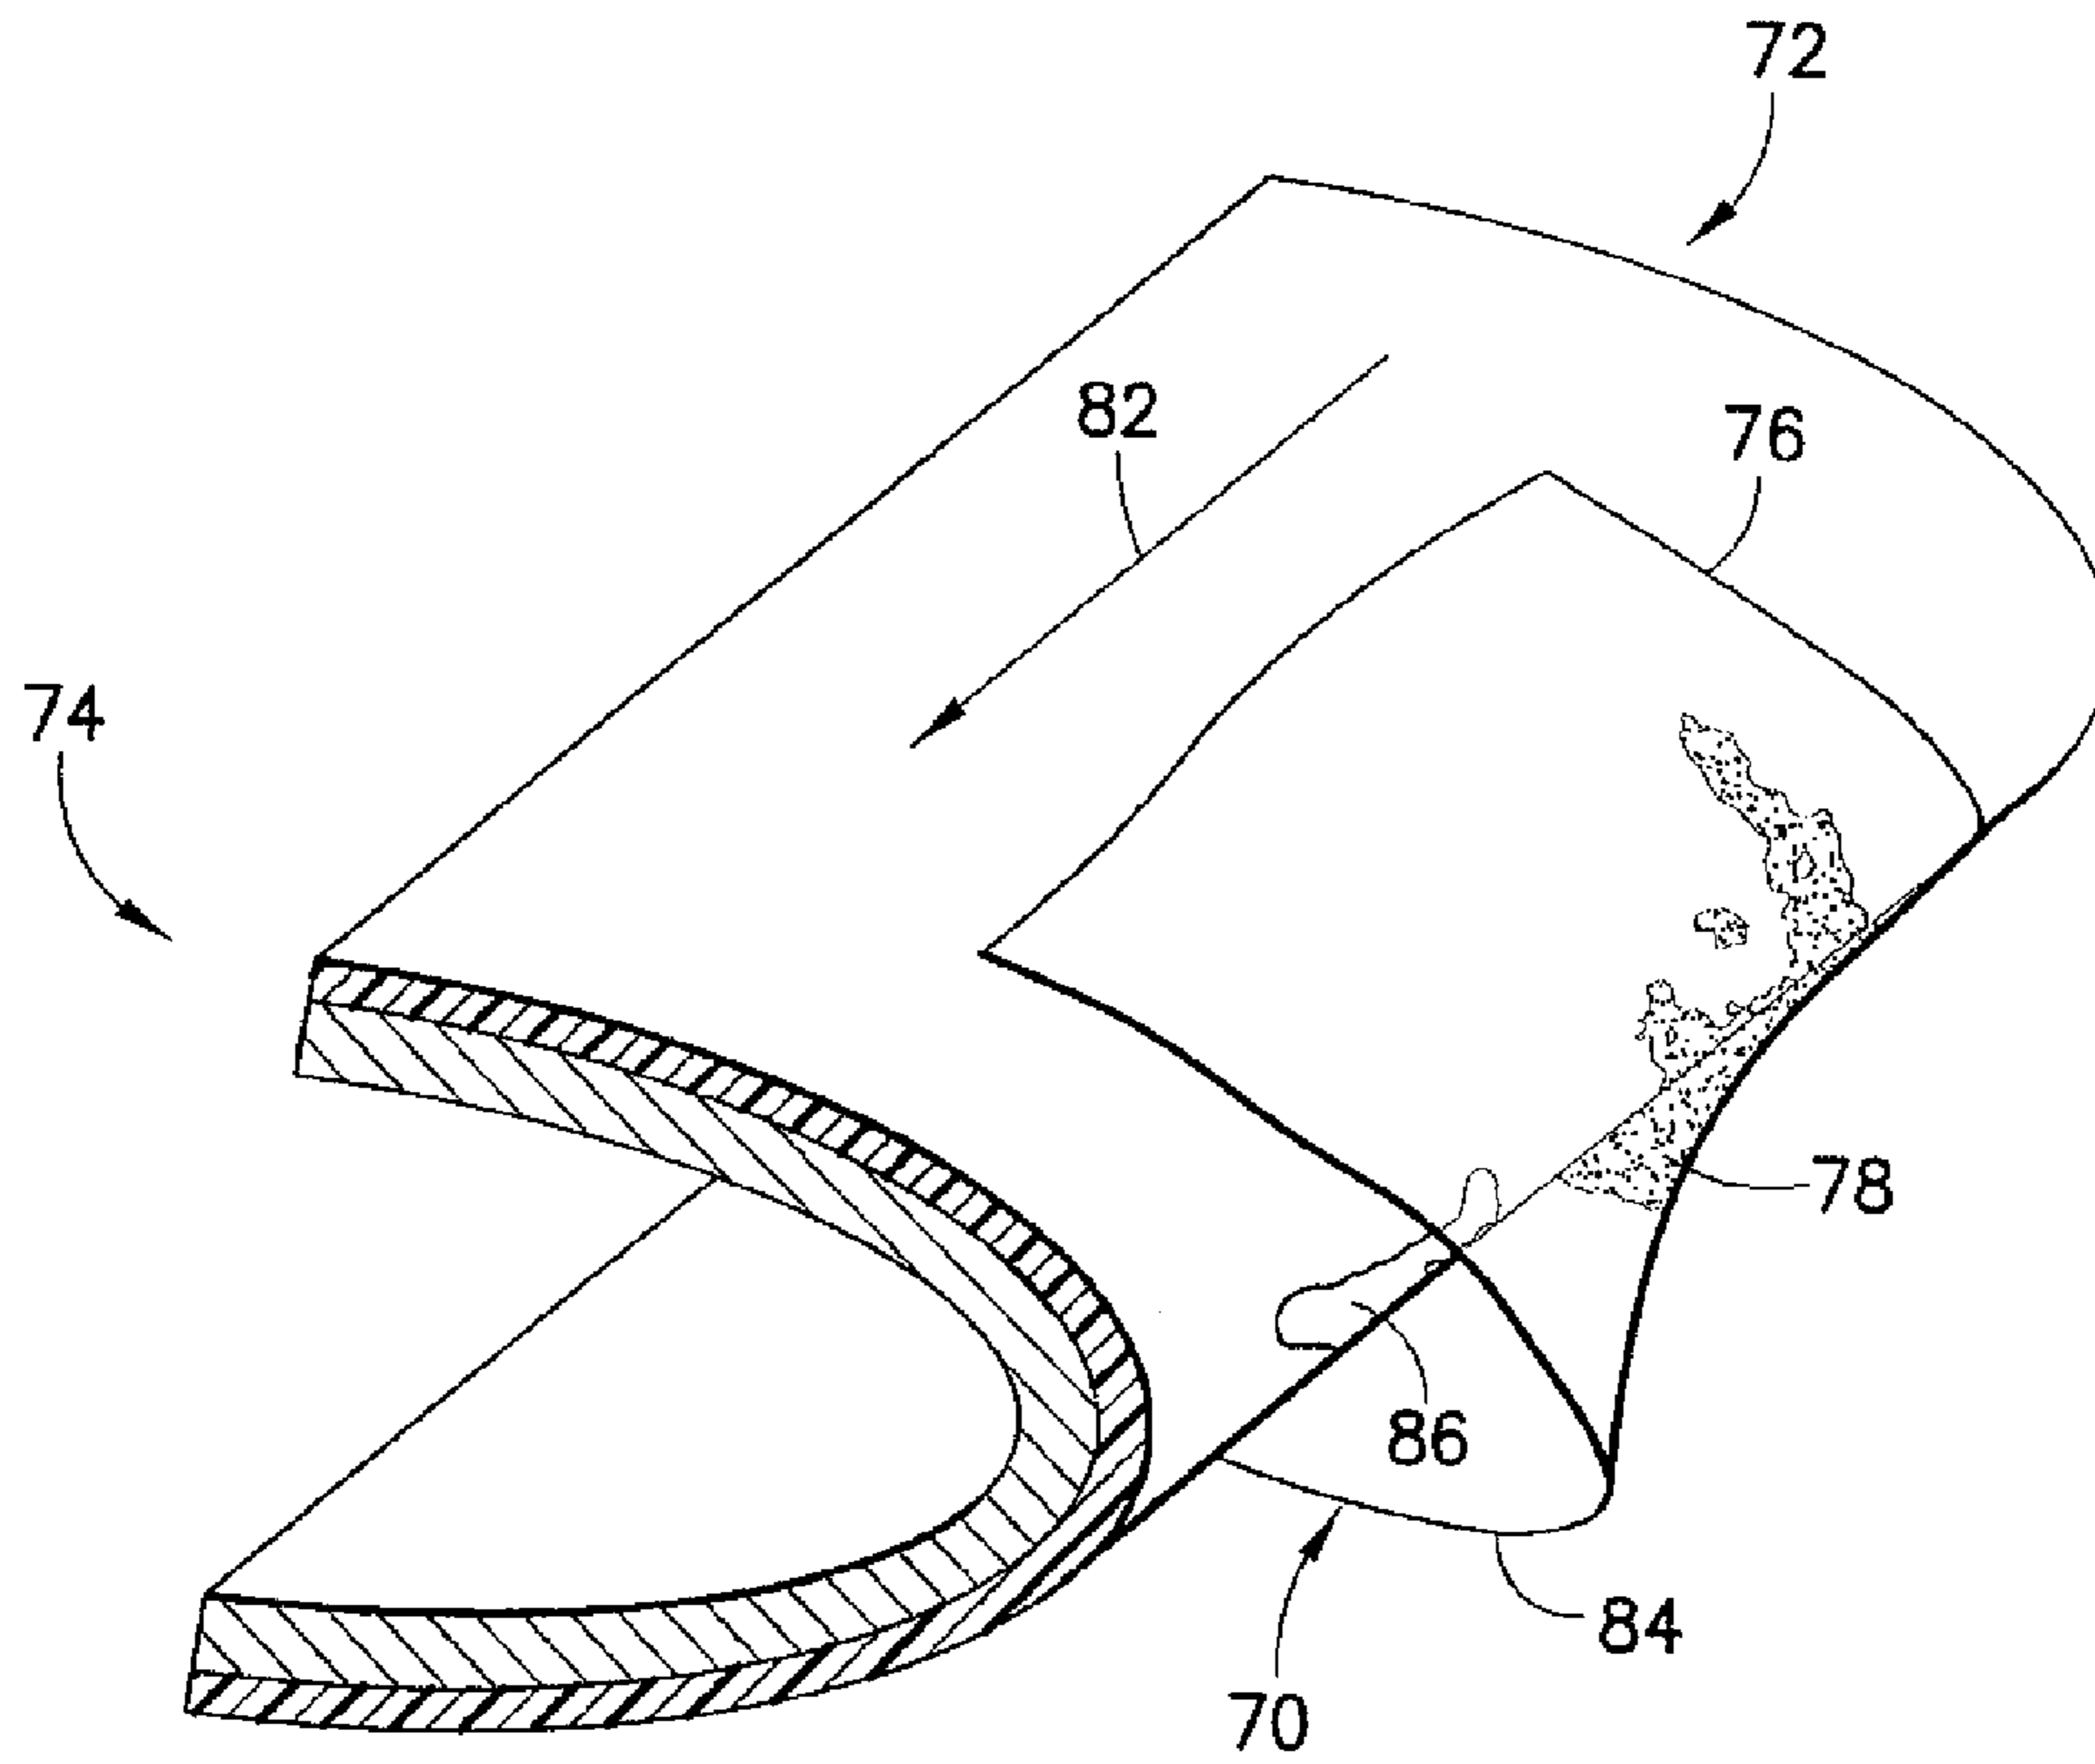
FIG. 6 is partial section of the leading edge portion of an airfoil structure showing sand and water erosion damage being repaired using a specially formed flexible applicator.
