(12) **United States Patent**
Hong

(10) **Patent No.:** **US 9,770,791 B2**
(45) **Date of Patent:** **Sep. 26, 2017**

(54) **METHOD FOR REPAIRING AN AIRFOIL SURFACE HAVING AN ELASTOMERIC PROTECTIVE COATING**

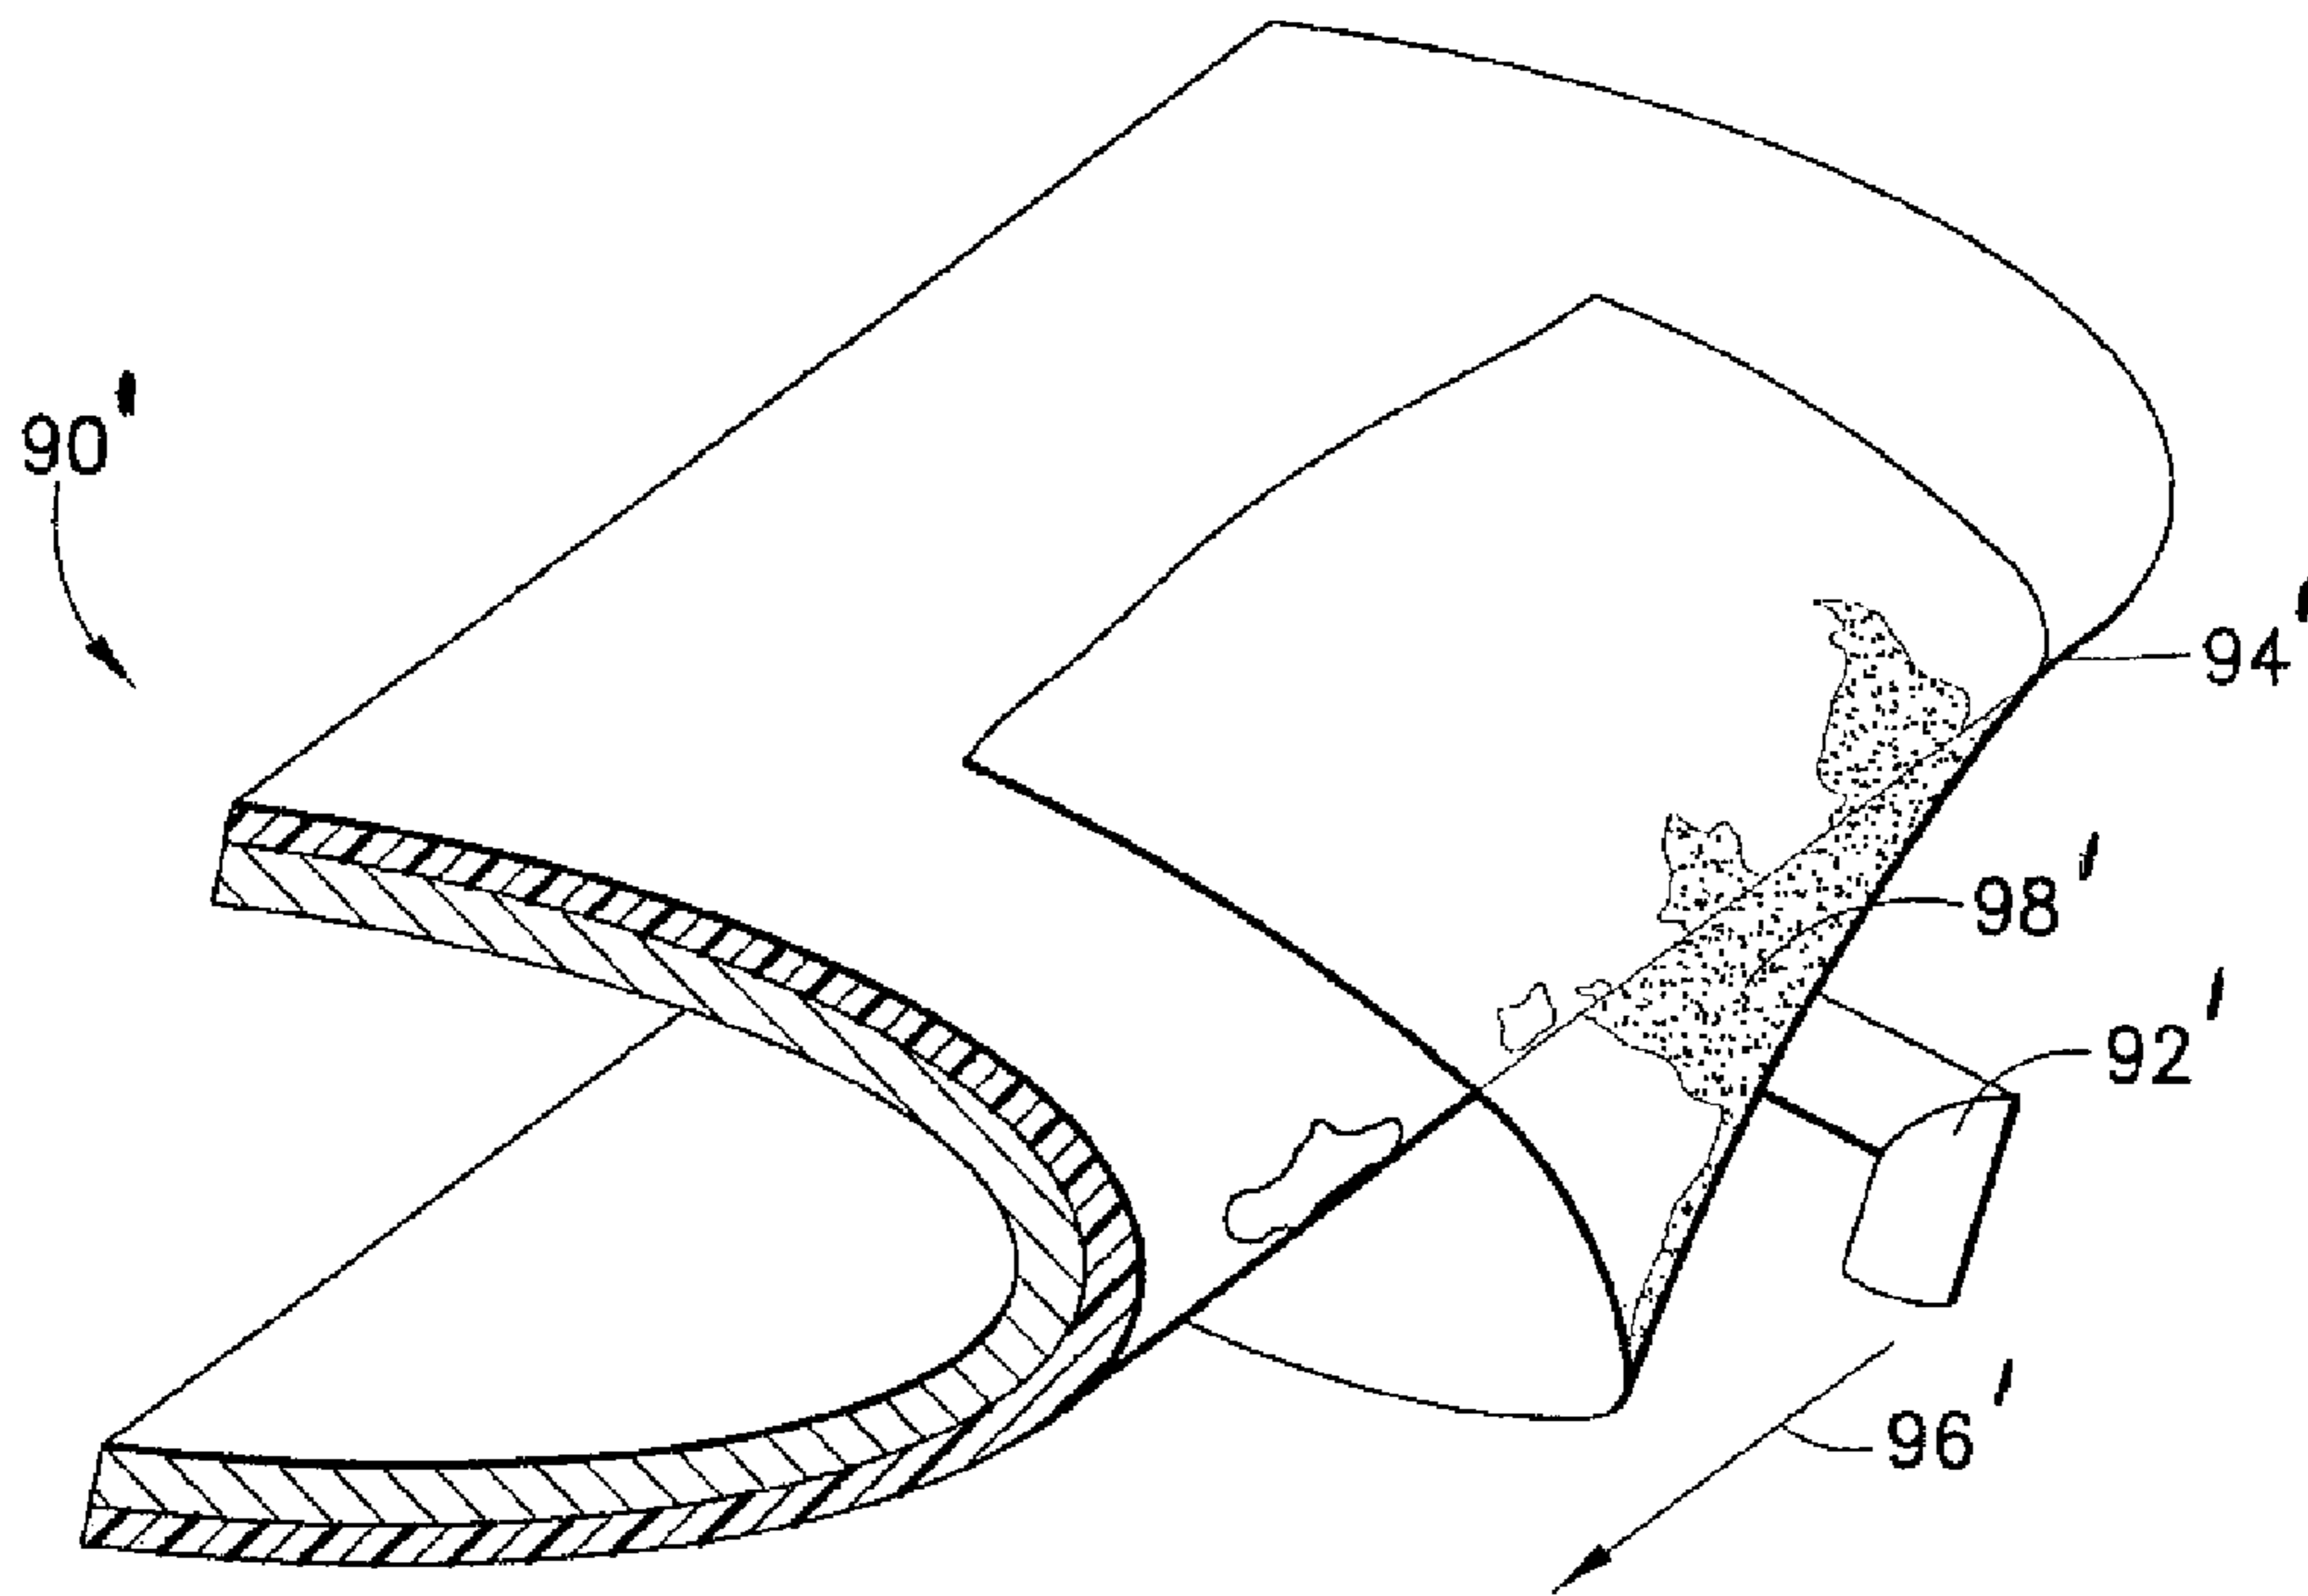
FIG. 7 is partial section of the leading edge portion of an airfoil structure showing sand and water erosion damage being repaired using a specially formed flexible applicator with a handle

allowing the other hand to be free to feed in repair material **98'** as needed during repair operations. It also is essentially self tensioning through the natural downward force applied by the operator while keeping it in position against the airfoil leading edge. The handle **92'** may be incorporated into the structure of the applicator by any conventional means, including being integrally molded into the applicator body or attached by any suitable method to the applicator body. The shape of the handle can be any suitable shape.

The embodiments of FIGS. **7** and **8** can also be consolidated such that the handle **92** of FIG. **7** and the fluid connector **102** of FIG. **8** are in a unitary dual function structure. Of course separate handle and fluid connector are also easily designed to fit onto the specialized flexible applicator which can be easily manipulated by a single person. For use as the repair basecoat, the coatings without filler should be elastomeric enough to be erosion resistant to rain or sand. Additional fillers may be added to increase the sand erosion rate.

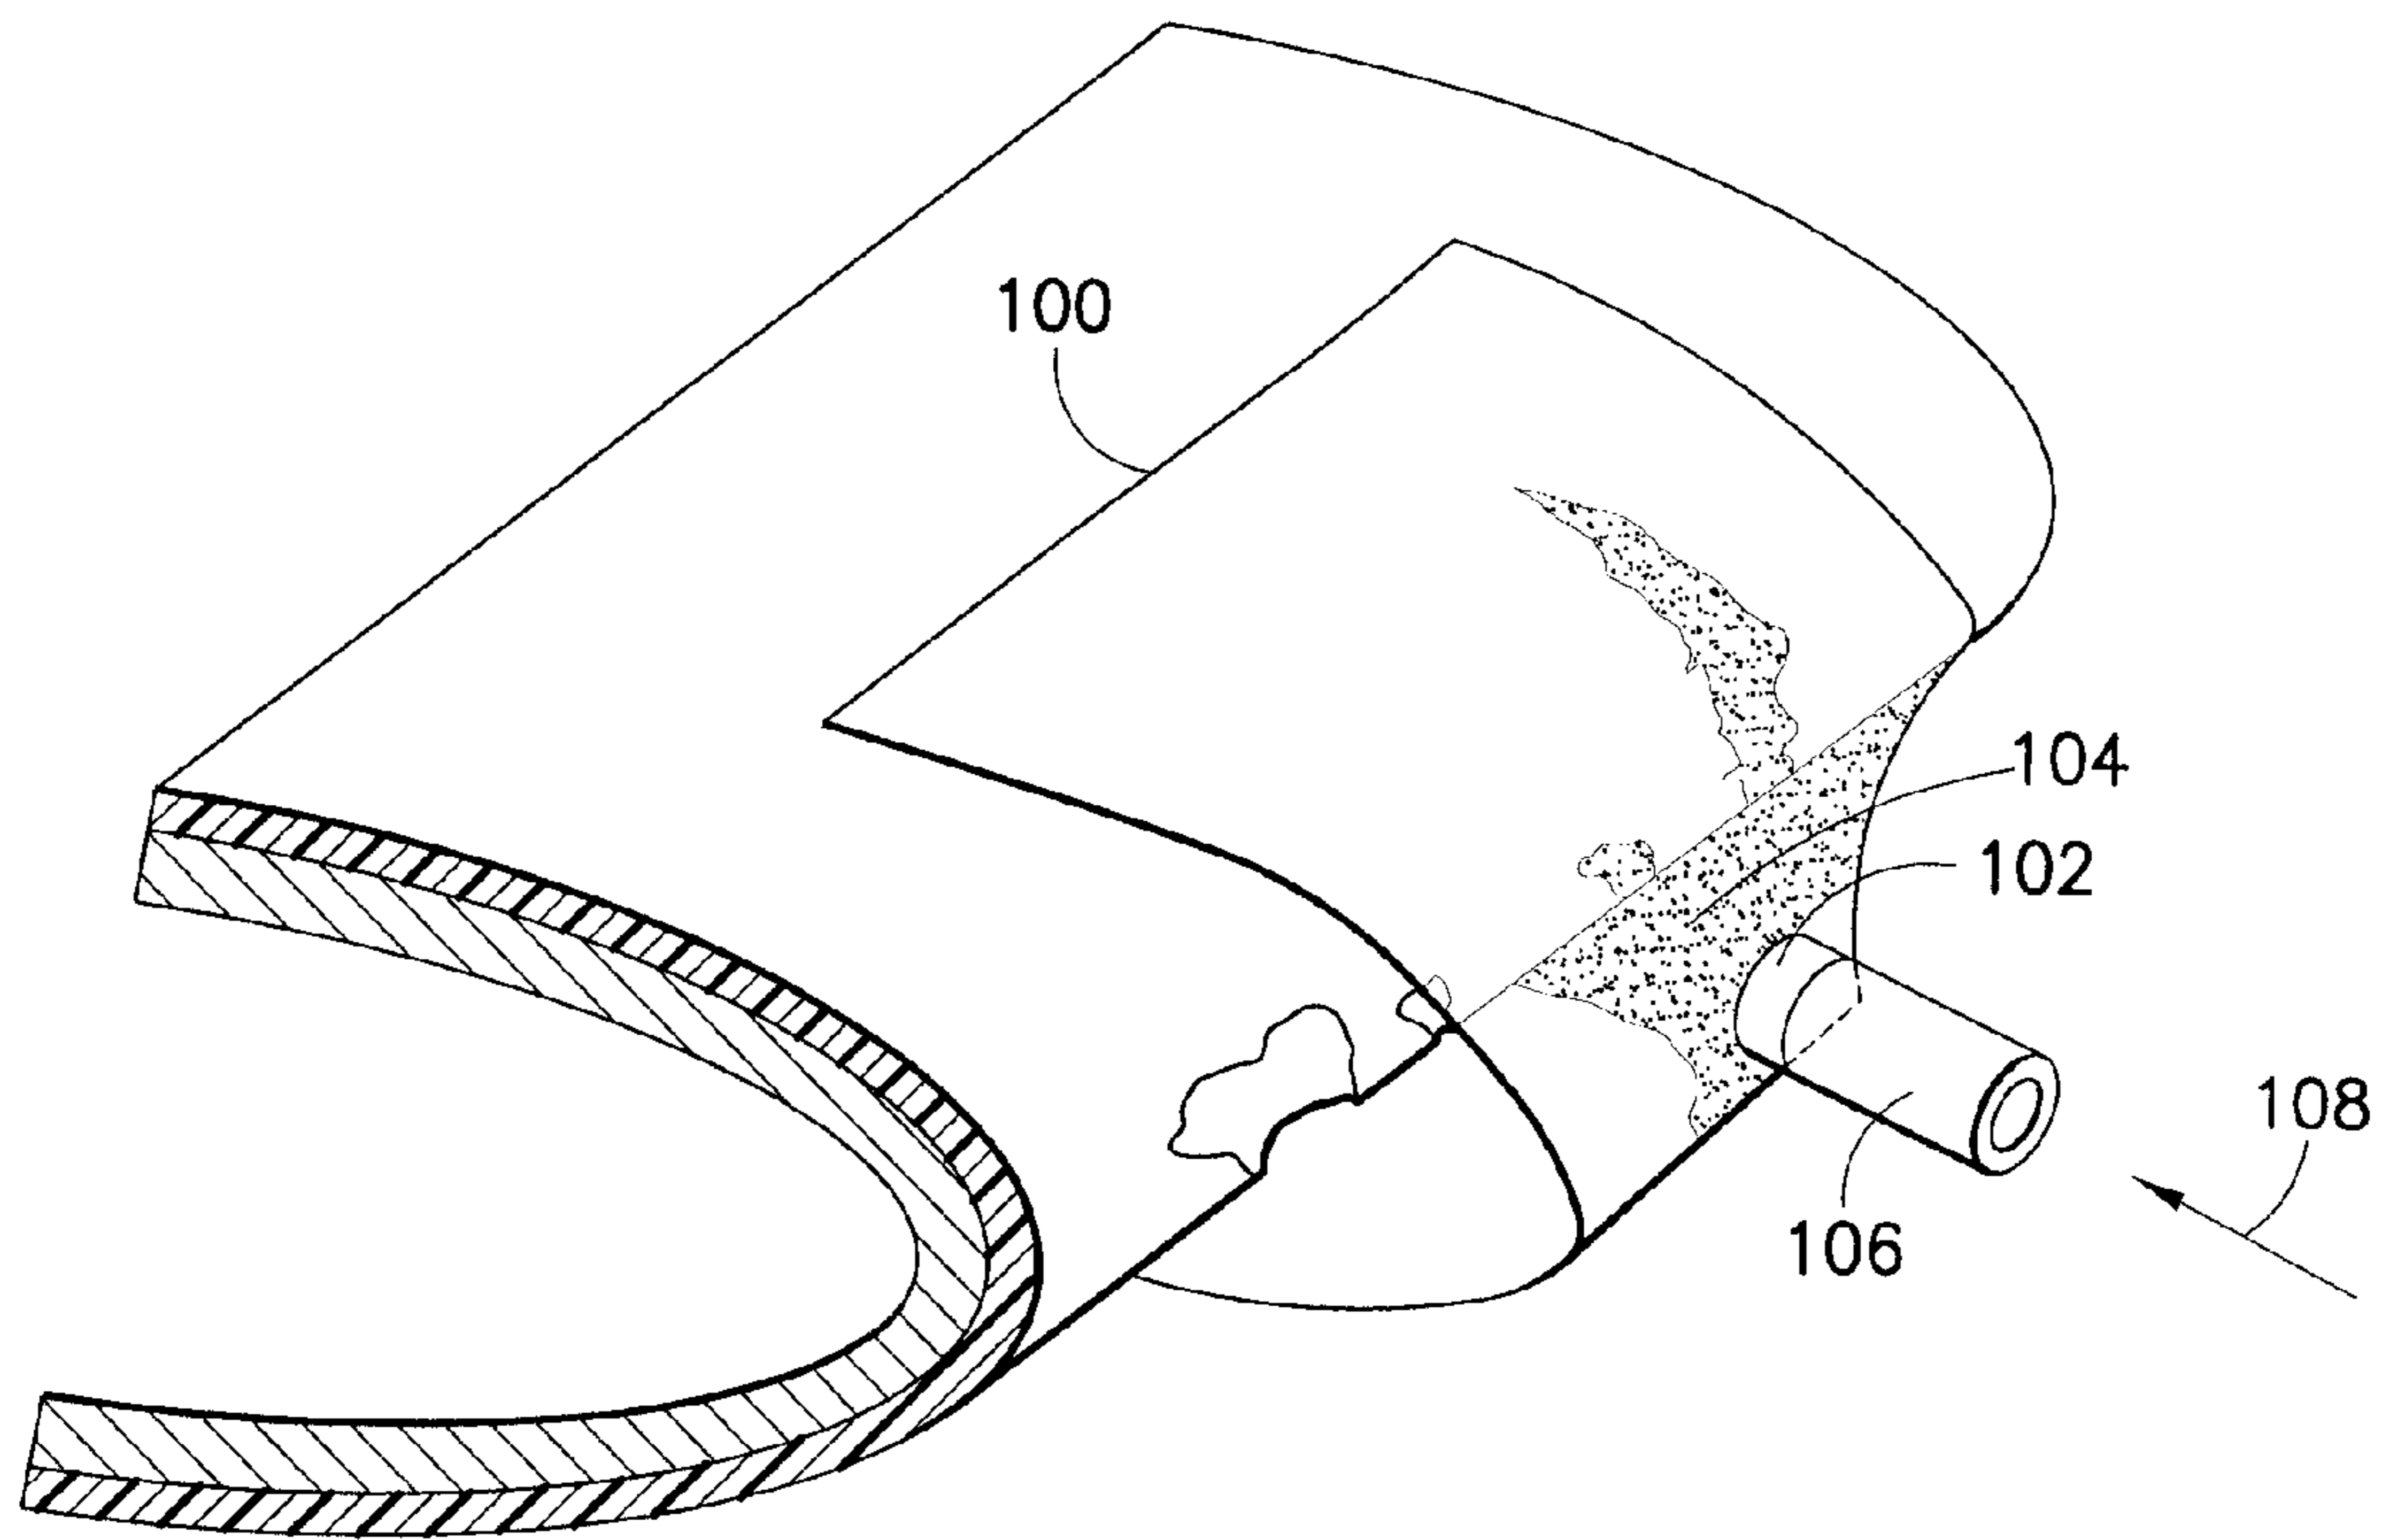
FIG. 8 is partial section of the leading edge portion of an airfoil structure showing sand and water erosion damage being repaired using a specially formed flexible applicator with an inlet for repair fluid built in to the body of the flexible applicator.

FIG. **8** shows another embodiment of a flexible applicator **100** which includes a fluid connector **102** which connects to the portion of the applicator that holds the repair material **104**. The fluid connector has adapter **106** to attach to any suitable reservoir of repair material (not shown). This reservoir may be a simple bottle which can manually dispense the repair material **108** as shown by the directional arrow **108** into the fluid connector by squeezing a flexible bottle. It may be a caulking gun configured to feed the repair material into the fluid connector. The dispensing device may be a triggered device for metering either a single fluid or multiple fluids. In an embodiment where the repair material is of the type that has a two part composition, such as a part a base component and a part b curative material, the dispensing device may be of the type that can meter the proper ratio of part a and part b and optionally also mix those parts together in a mixing apparatus prior to dispensing the repair material through the fluid connector into the working interior volume of the flexible applicator **102** where the rolling bank of repair material is positioned during use of the device.

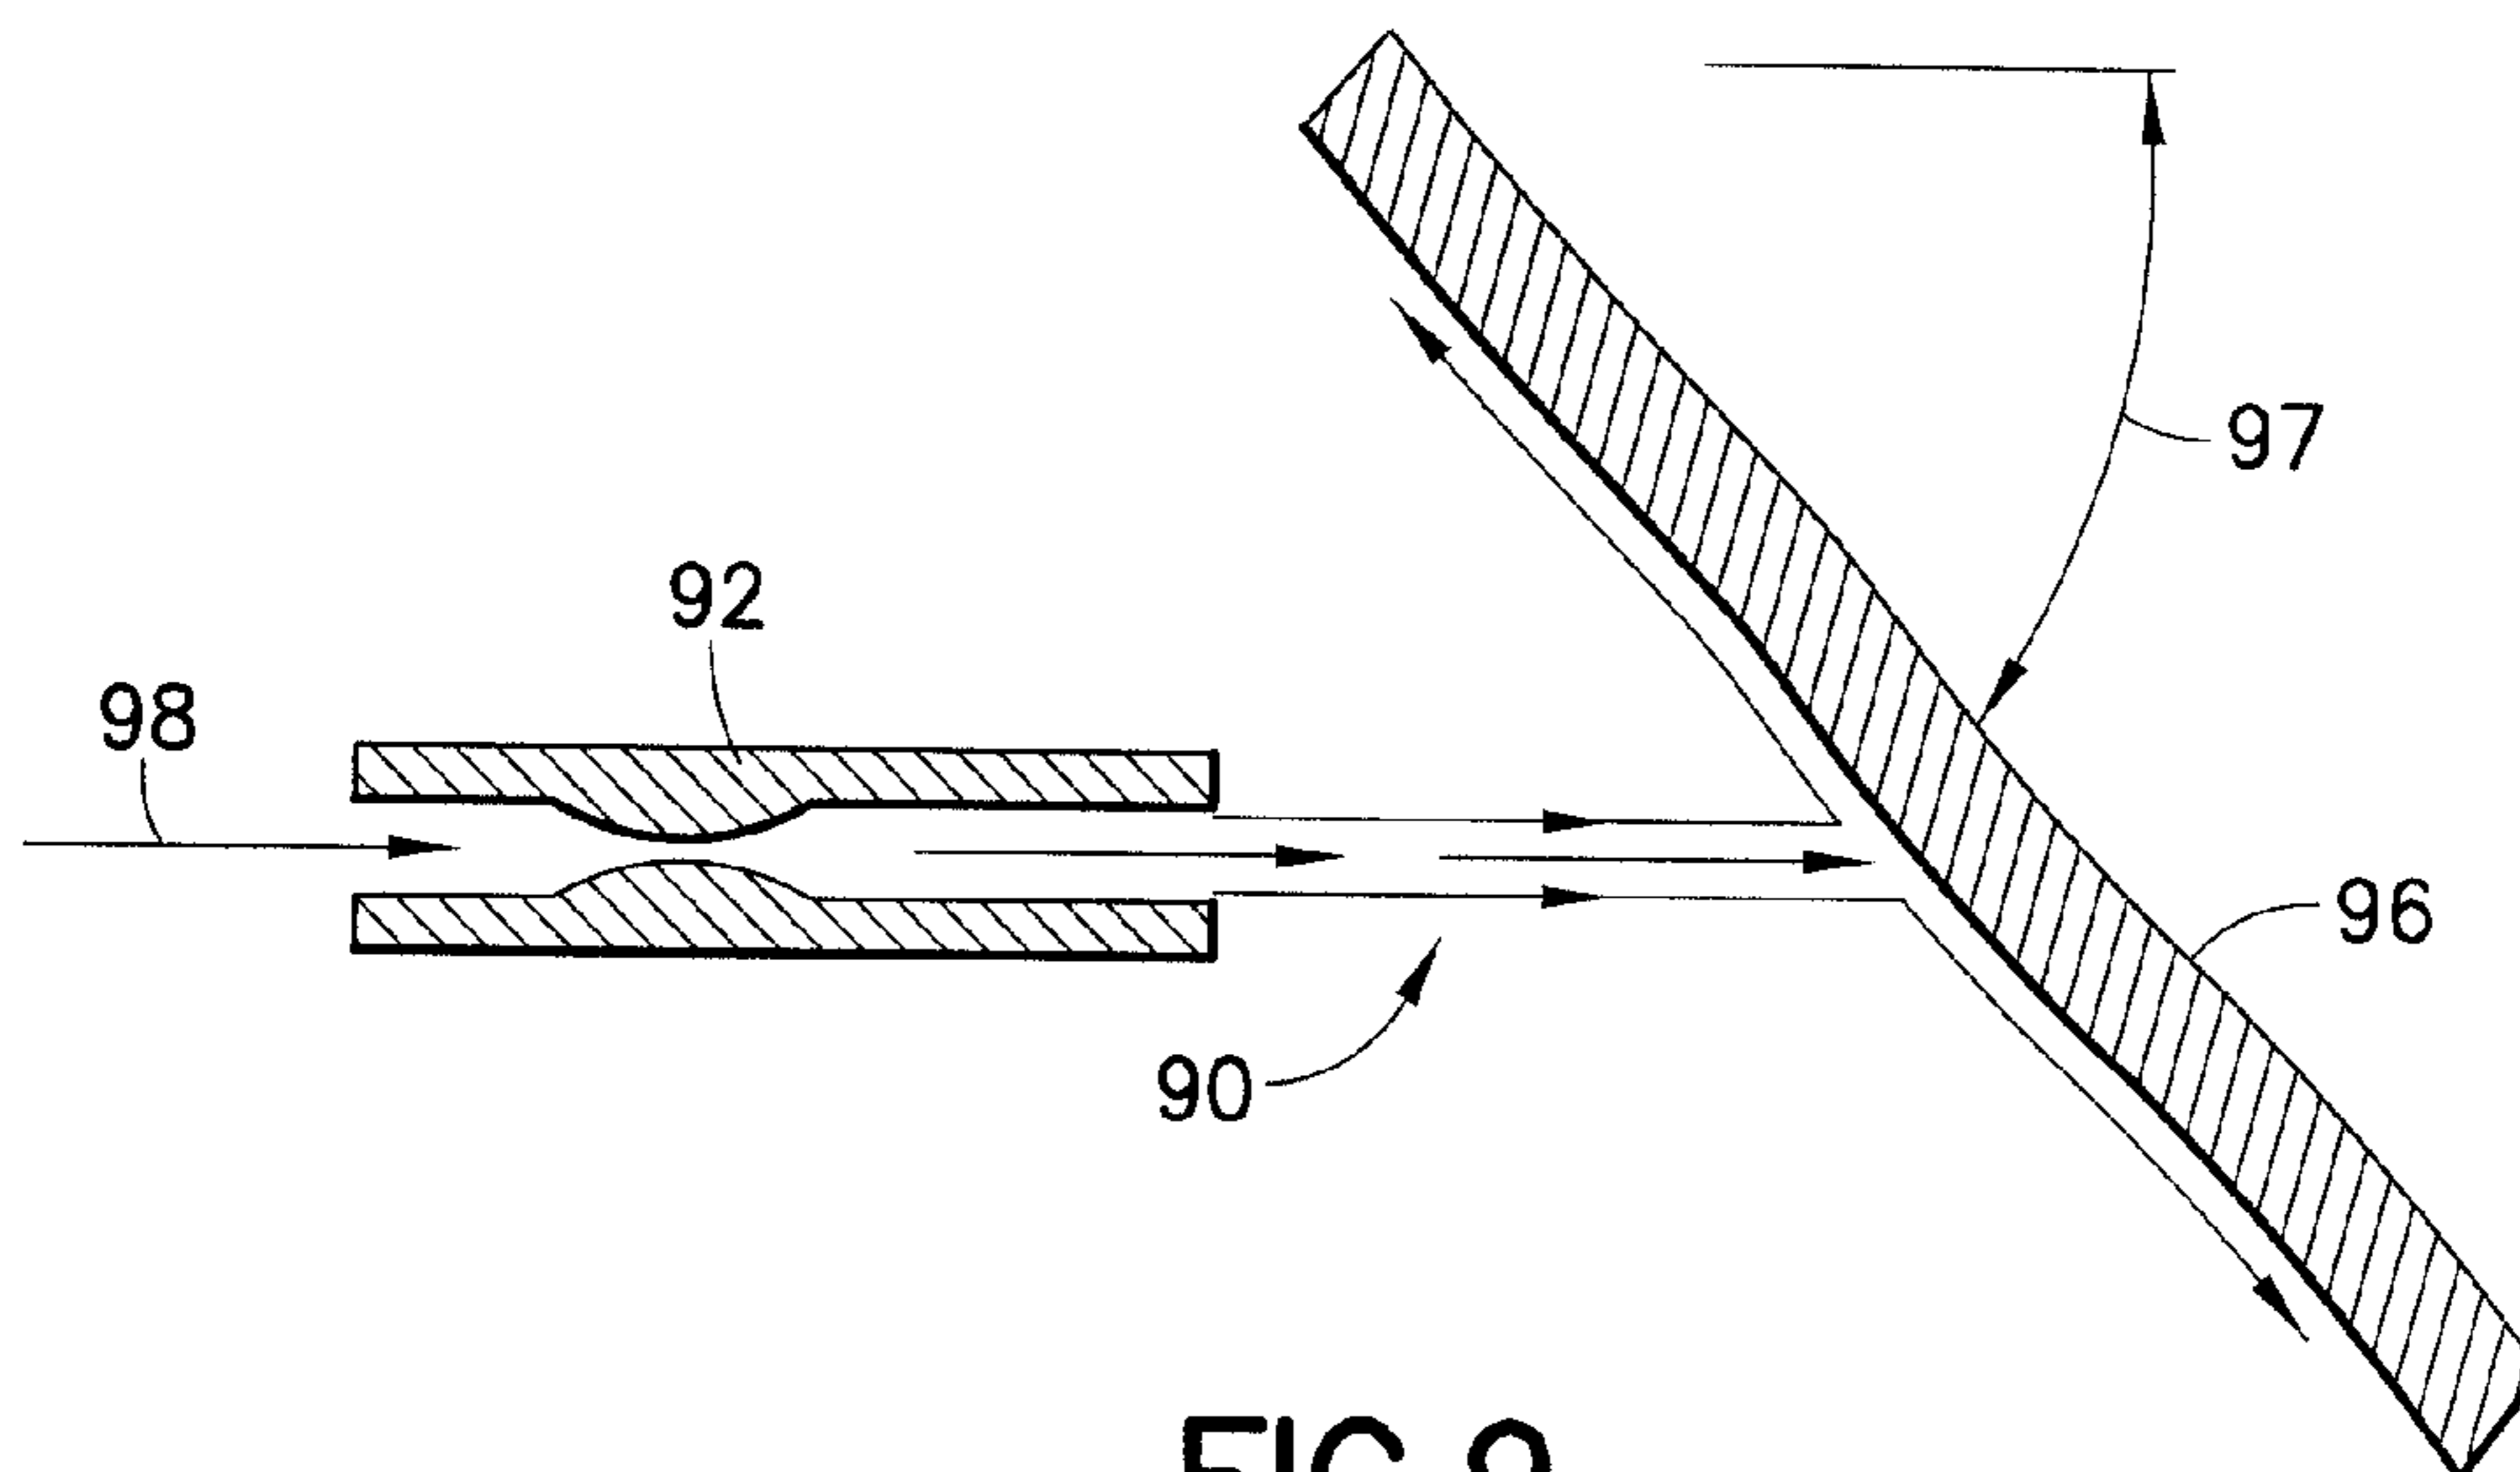
FIG. 9 is a schematic representation of a method of testing sand erosion resistance.
