(54) CRANKCASE INTEGRITY BREACH DETECTION

(71) Applicant: Ford Global Technologies, LLC,

Methods and systems are provided for using a crankcase vent tube pressure or flow sensor for diagnosing a location and nature of crankcase system integrity breach. The same sensor can also be used for diagnosing air filter plugging and PCV valve degradation. Use of an existing sensor to diagnose multiple engine components provides cost reduction and sensor compaction benefits.

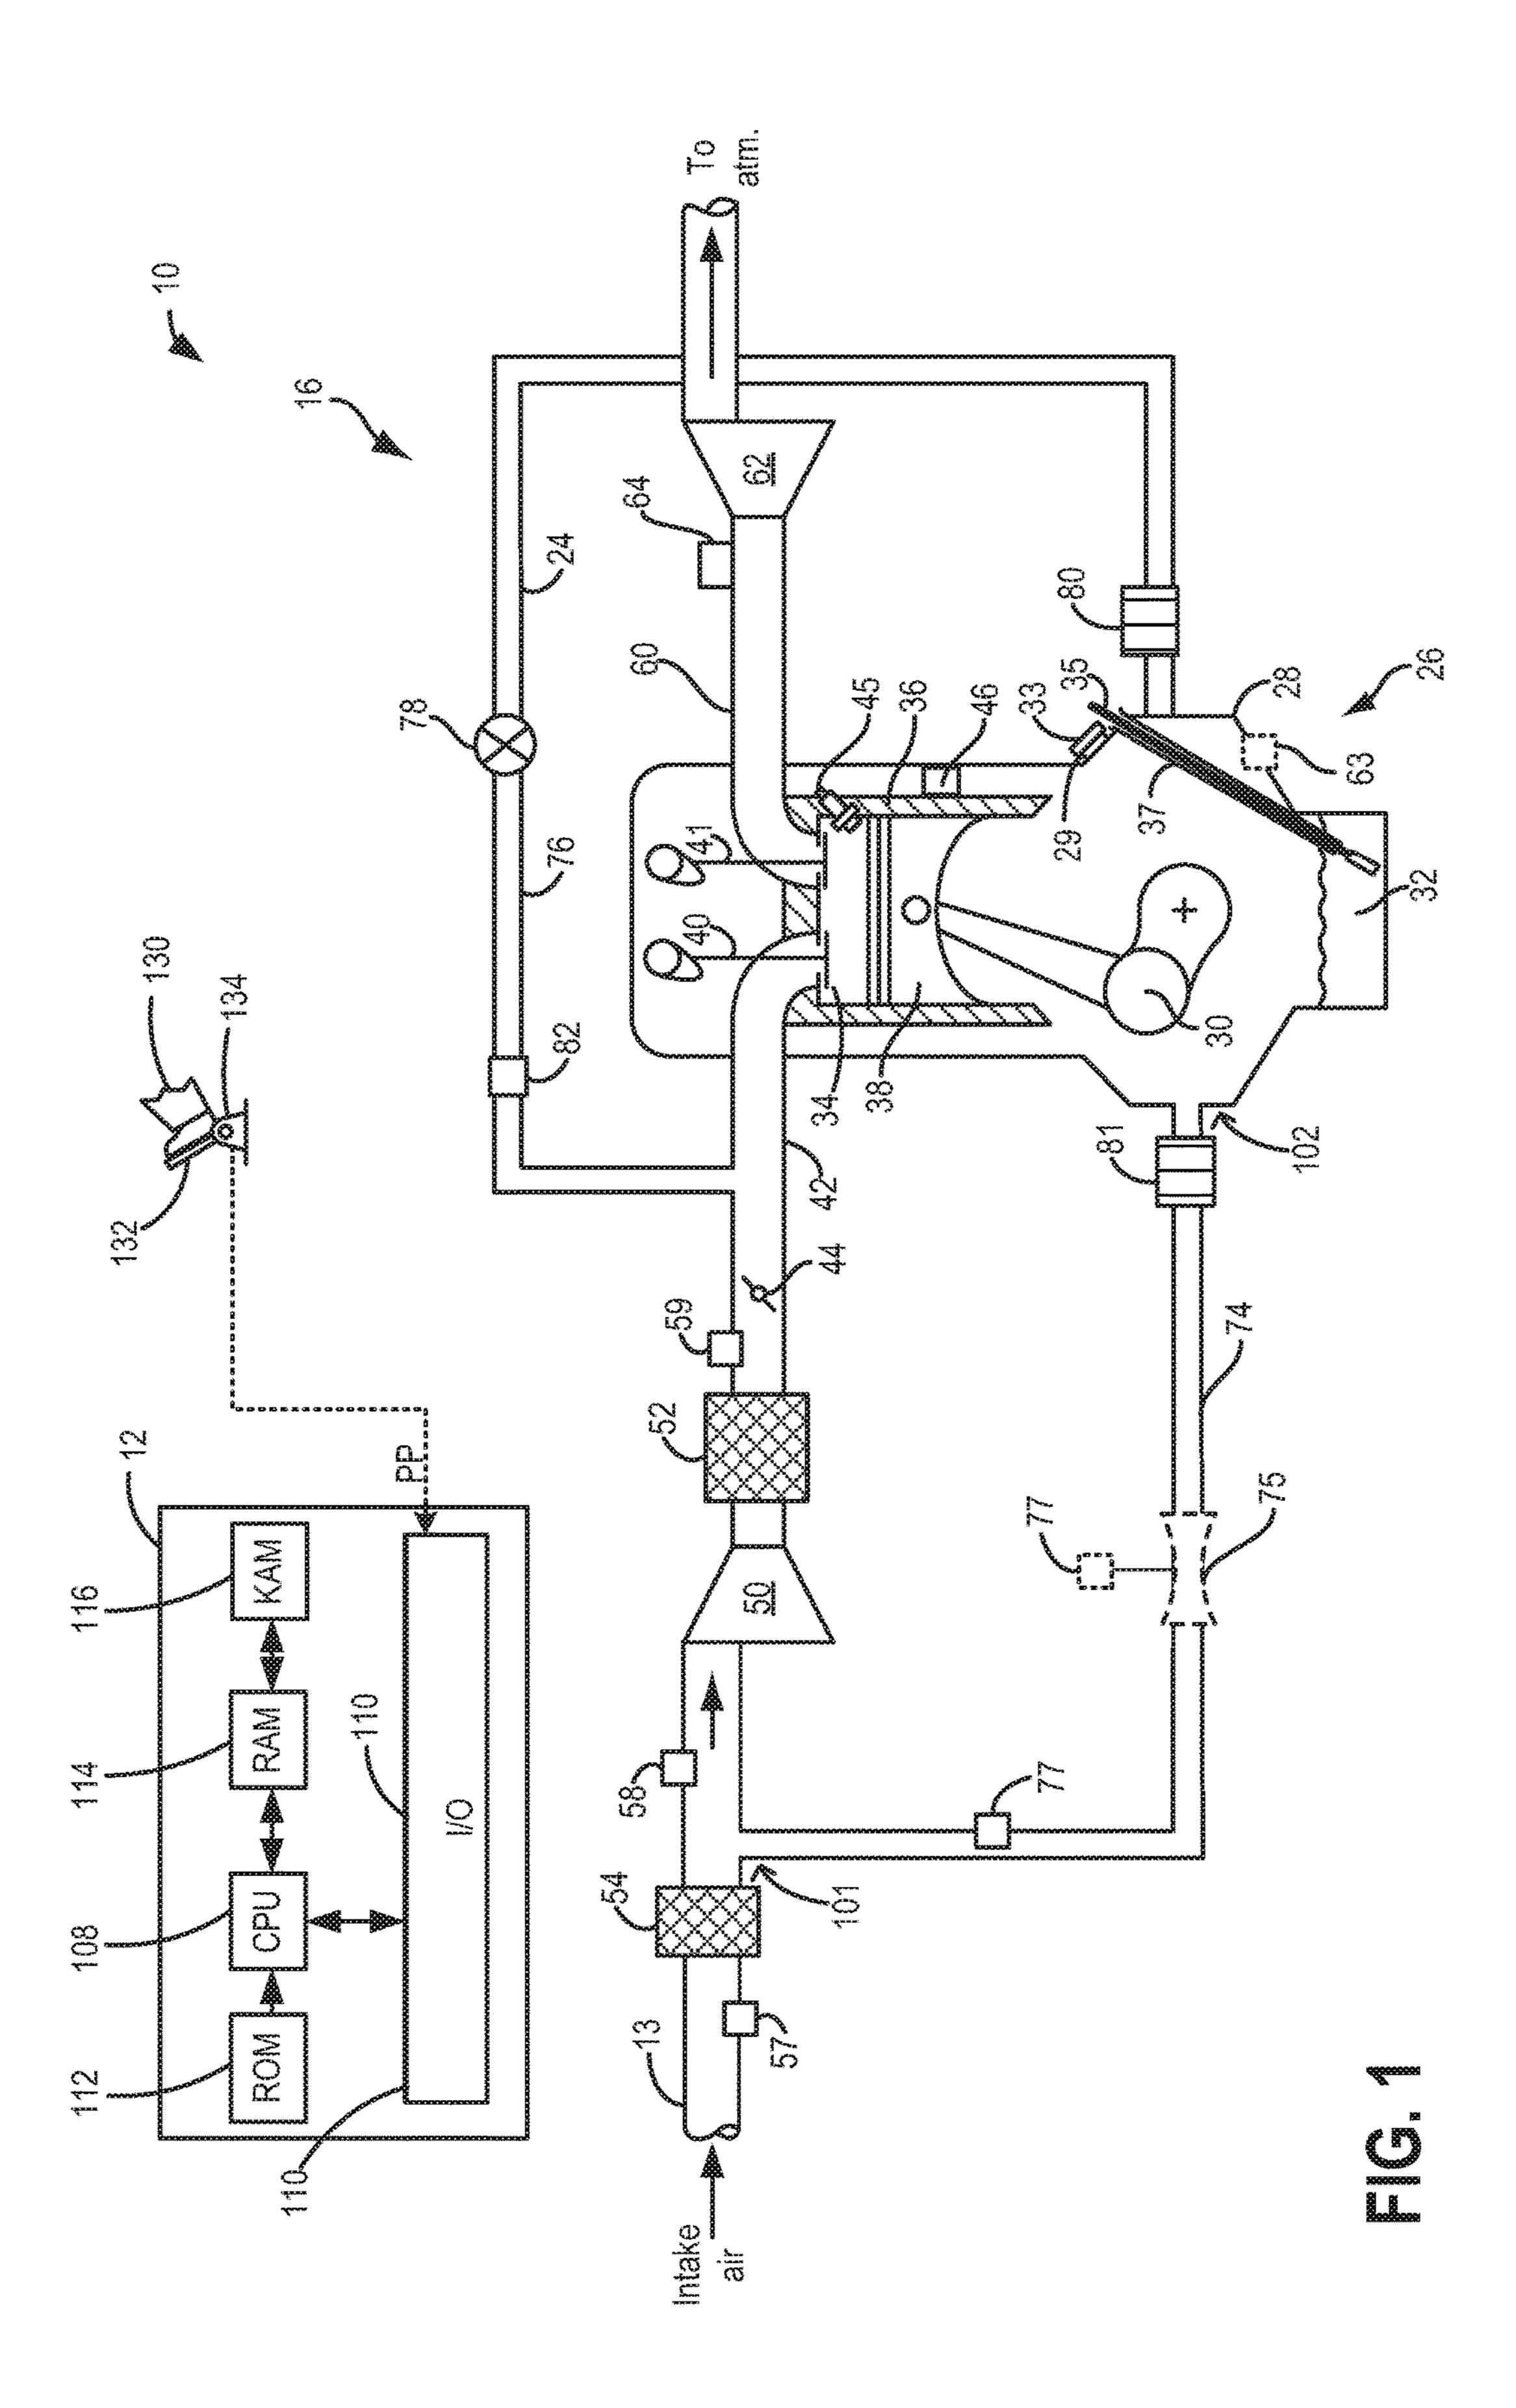
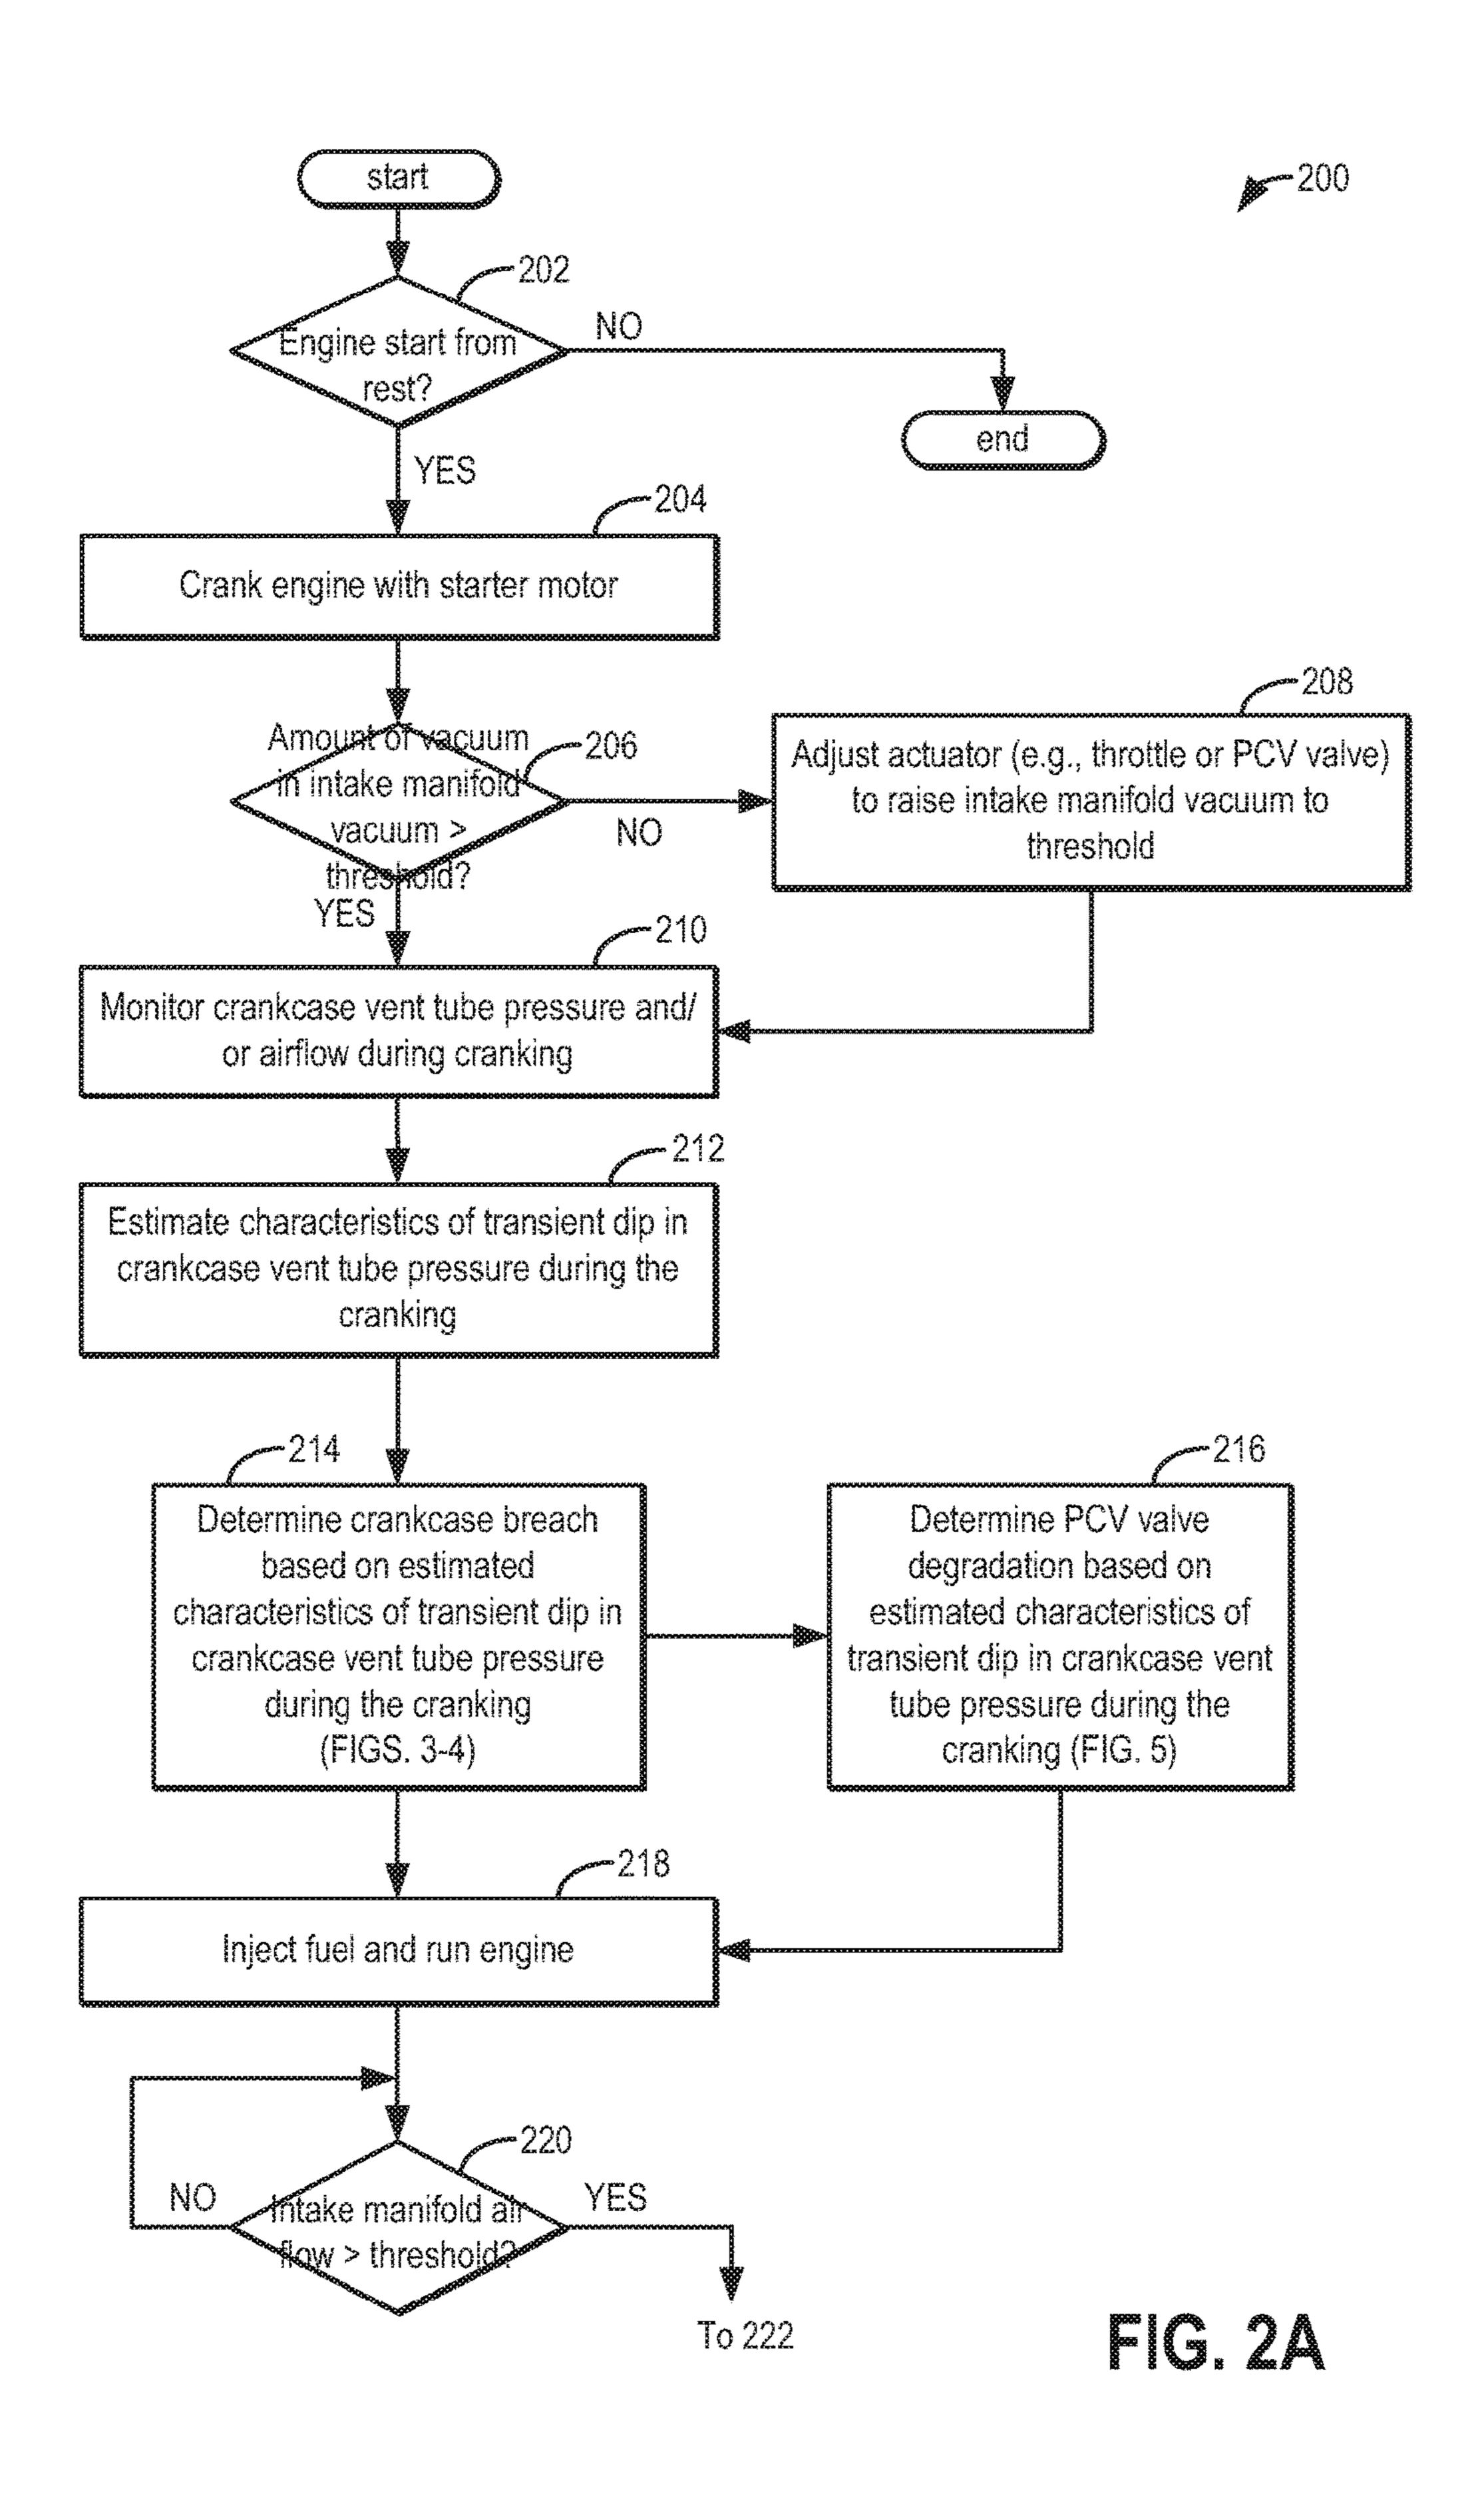
FIGS. 2A-2B show a high level flow chart for indicating degradation of one or more crankcase ventilation system components based on changes in crankcase vent tube pressure during cranking and/or engine running.

Now turning to FIGS. 2A-2B, a method 200 is illustrated for indicating degradation of one or more engine components, including crankcase ventilation system components and intake air filters, based on changes in crankcase ventilation pressure (or air flow) during engine cranking and running. By using the same sensor to detect degradation in multiple engine components, cost and component reduction benefits are achieved.

Next at 214, the routine includes determining and indicating crankcase ventilation system degradation based on one or more characteristics of the transient dip in crankcase vent tube pressure during engine cranking. As discussed above, during engine cranking, when manifold vacuum is 15 lower, an increased air flow from the air filter through the crankcase vent tube towards the intake manifold is seen as a transient dip in crankcase vent tube pressure (or transient increase in vent tube vacuum or air flow). However, this transient dip may be affected by the presence of a crankcase system breach (e.g., if the vent tube is disconnected), as well as the position of the PCV valve (e.g., the PCV valve being stuck open or stuck closed). Thus, as elaborated at FIGS. **3-4**, crankcase ventilation system integrity breach, as well as a location of the breach, may be indicated based at least on an amplitude of the transient dip in crankcase vent tube pressure. For example, in response to the amplitude of the transient dip being smaller than a threshold during cranking, a crankcase system breach may be determined.

Following crankcase system breach detection, the routine proceeds to 216 wherein PCV valve degradation is determined based on the characteristics of the transient pressure change at the crankcase vent tube. As elaborated at FIG. 5, this includes indicating PCV valve degradation based on an estimated profile of the crankcase vent tube pressure deviating from an expected profile during engine cranking. It will be appreciated that while the routine shows PCV valve degradation being determined after crankcase system breach is diagnosed, in alternate embodiments, the diagnostics may be performed in parallel.

After diagnosing crankcase system breach and PCV valve degradation during engine cranking, at 218, the routine includes injecting fuel to the engine cylinders and initiating a first cylinder combustion event. During the engine cranking, intake manifold air flow may be lower and as the engine speed increases (e.g., to an idling speed), the intake manifold air flow may gradually increase. The controller may then continue cylinder combustion events to enable engine runup. At 220, it may be confirmed that the intake manifold air flow (or engine inlet air flow) is higher than a threshold air flow. As such, once the engine is at or above an idling speed, manifold air flow as well as crankcase vent tube pressure may be at steady-state levels. In particular, engine speed (along with throttle position) impacts the intake manifold pump down characteristic during crank and run up, thereby 55 affecting a PCV valve position.

At 222, the routine includes monitoring the steady-state manifold air flow and the steady-state crankcase vent tube pressure. Then, at 224 and 226, the routine includes determining degradation of the crankcase ventilation system and degradation of an intake air filter based on the estimated change in crankcase vent tube pressure during steady-state conditions. As elaborated at FIGS. 3-4, this includes, at 224, indicating crankcase system degradation based on a change (e.g., decrease) in steady-state crankcase vent tube pressure relative to a change (e.g., increase) in the steady-state manifold air flow during engine running. As elaborated at FIG. 5, indicating air filter degradation includes, at 226,

indicating a degree of air filter plugging based on a rate of change (e.g., rate of decrease) in steady-state crankcase vent tube pressure during engine running. As elaborated therein, the air filter plugging/hose collapse detection is performed during engine running since the diagnostic has maximum sensitivity at high engine air flow rates. It will be appreciated that while the routine shows air filter degradation being determined in parallel to crankcase system breach diagnosis, in alternate embodiments, the diagnostics may be performed sequentially.

At 228, after all the diagnostic routines have been performed, one or more diagnostic codes may be set to indicate degradation of the affected engine component. As such, different diagnostic codes may be set to indicate air filter plugging, crankcase system breach (including different 15 codes to indicate the location/nature of the breach), and PCV valve degradation. At 230, the routine includes performing an appropriate mitigating action based on the indication and the diagnostic code that was set.

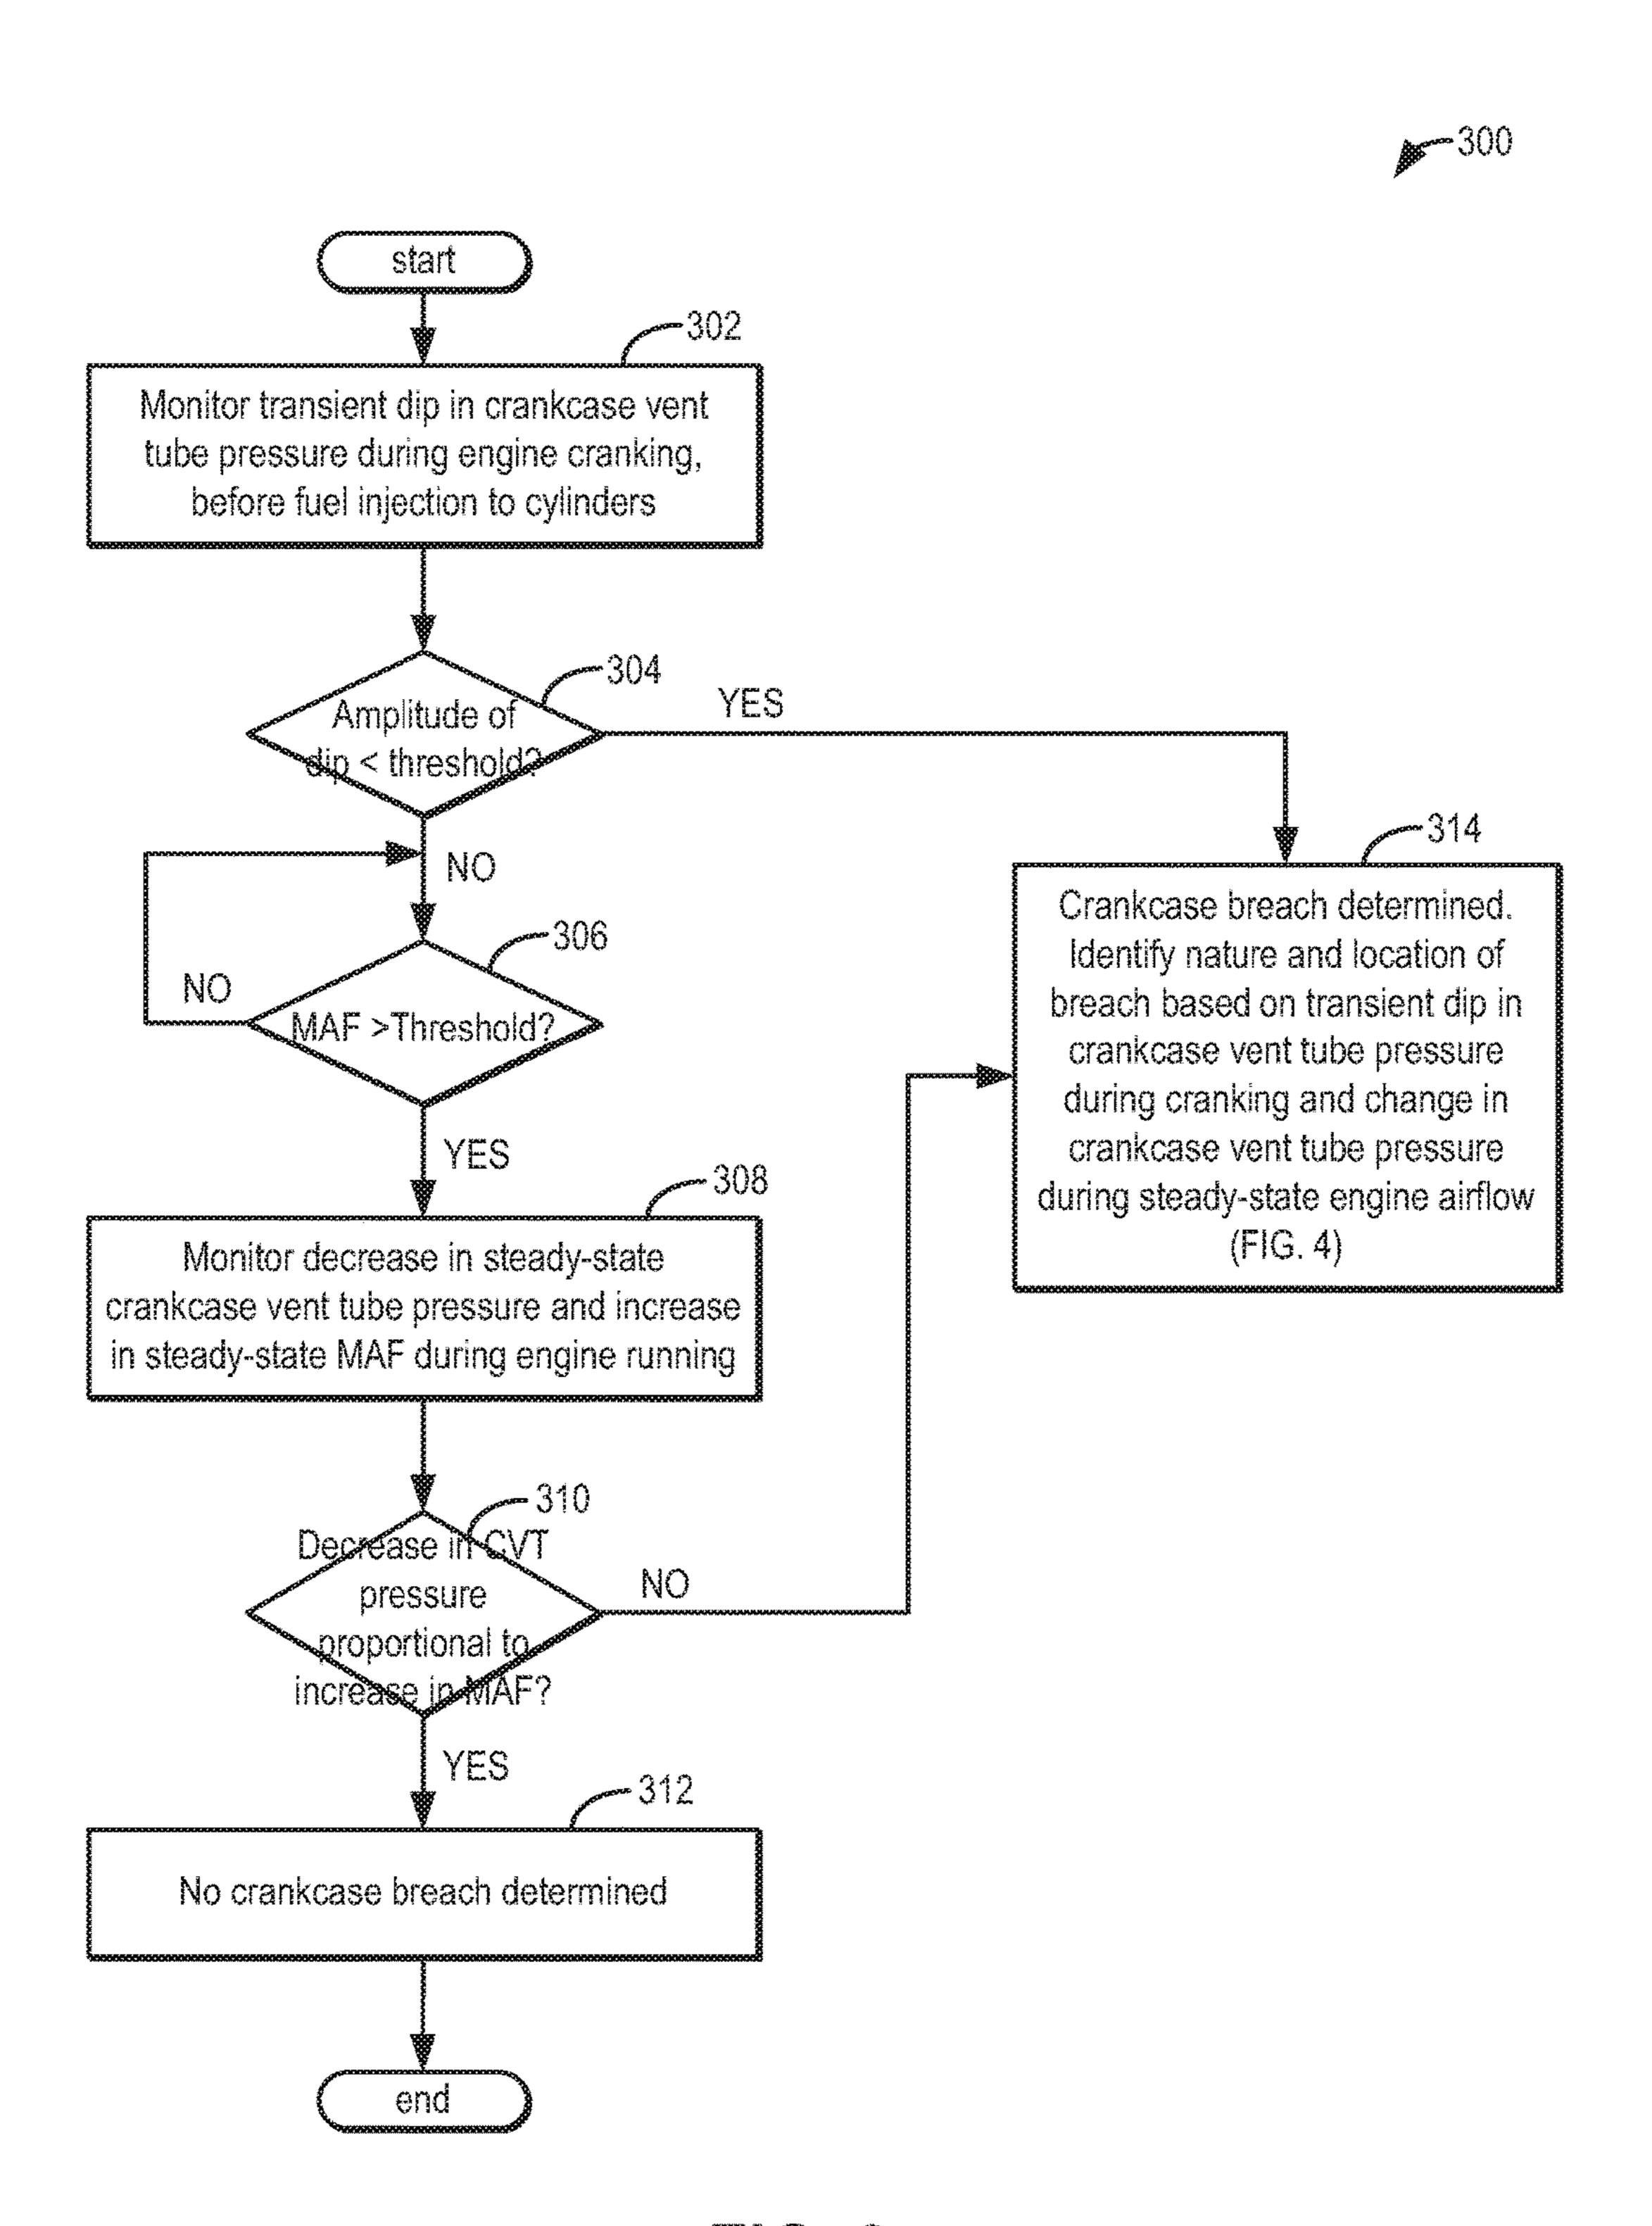
FIG. 3

Now turning to FIG. 3, a method 300 is shown for indicating crankcase ventilation system degradation based on characteristics of a transient dip in crankcase vent tube pressure during engine cranking. The method further enables crankcase ventilation system degradation to be determined based on a change in crankcase vent tube pressure relative to a change in manifold air flow during engine running conditions.

If the amplitude of the transient dip is lower than the threshold, then at **314**, the routine determines and indicates crankcase ventilation system degradation. That is, in response to insufficient air flow through the crankcase vent tube during cranking, a system breach may be determined. Indicating crankcase ventilation system degradation includes indicating that the crankcase vent tube is disconnected. For example, the crankcase vent tube may have 60 gotten disconnected at a first side where the vent tube is mechanically coupled to the air intake passage (upstream of a compressor), or at a second, opposite side where the vent tube is mechanically coupled to the engine crankcase via an oil separator. As elaborated at FIG. 4, the controller may be configured to perform an additional routine to identify the location and nature of the breach (e.g., location of the disconnection of the vent tube) based on each of the transient

dip in crankcase vent tube pressure during engine cranking (when an engine air flow is lower) and a change in steadystate crankcase vent tube pressure relative to a change in steady-state manifold air flow during engine running conditions (when the engine air flow is higher). In this way, a 5 controller may indicate disconnection of a crankcase vent tube from an engine crankcase ventilation system based on changes in air flow through the crankcase vent tube during engine cranking and engine running.

Returning to 304, if the amplitude of the transient dip is 10 not lower than the threshold, it may be possible that there is no crankcase system breach. To confirm this, the routine proceeds to further determine crankcase system breach during engine running conditions, after engine cranking. 15 Specifically, at 306, it may be confirmed that manifold vacuum is higher than a threshold. That is, it may be confirmed that the engine has crossed the engine cranking state and is running at or above a defined engine speed (e.g., at or above engine idling speed) when engine air flow rate 20 (inferred of measured) is higher. Upon confirming that manifold air flow is higher than the threshold, at 308, the routine includes monitoring a change in steady-state crankcase vent tube pressure relative to a change in steady-state manifold air flow. In particular, as the engine runs and 25 engine speed increases, the steady-state manifold air flow may gradually increase. At the same time, in the absence of any breach, the crankcase vent tube pressure may be expected to gradually decrease (that is, an amount of vacuum generated in the crankcase vent tube may increase 30 due to increased air flow through the crankcase vent tube).

At 310, it may be determined if the decrease in steadystate crankcase vent tube pressure (CVT) is proportional to the increase in steady-state manifold air flow during the than a threshold amount of vacuum being generated at the crankcase vent tube during engine running at high engine air flow. If the change in steady-state crankcase vent tube pressure and steady-state manifold air flow during engine running is proportional, then at 312, it may be determined 40 that there is no crankcase ventilation system degradation, or breach. If the change is not proportional, then the routine proceeds to 314 to indicate crankcase ventilation system degradation (e.g., that the crankcase vent tube is disconnected) based on a decrease in crankcase vent tube pressure 45 not being proportional to an increase in manifold air flow over a duration while the engine speed is at or above a threshold speed. For example, in response to reduced or no vacuum generation in the crankcase vent tube at higher engine air flows, crankcase breach is determined. As used 50 herein, determining if the decrease in steady-state crankcase vent tube pressure (CVT) is proportional to the increase in steady-state manifold air flow during the engine running may include determining if their ratio deviates from a threshold ratio, or if their absolute difference is larger than 55 a threshold difference.

A controller may indicate the crankcase ventilation system breach at 314 by setting a diagnostic code. Further, in response to the indication, one or more mitigating actions may be performed. These may include, for example, limiting 60 of an engine speed and load so as to reduce/delay leaking of lubricant from the crankcase and aspiration of lubricant into engine components. Example maps used to identify crankcase system breach are illustrated herein at FIGS. 7-8.

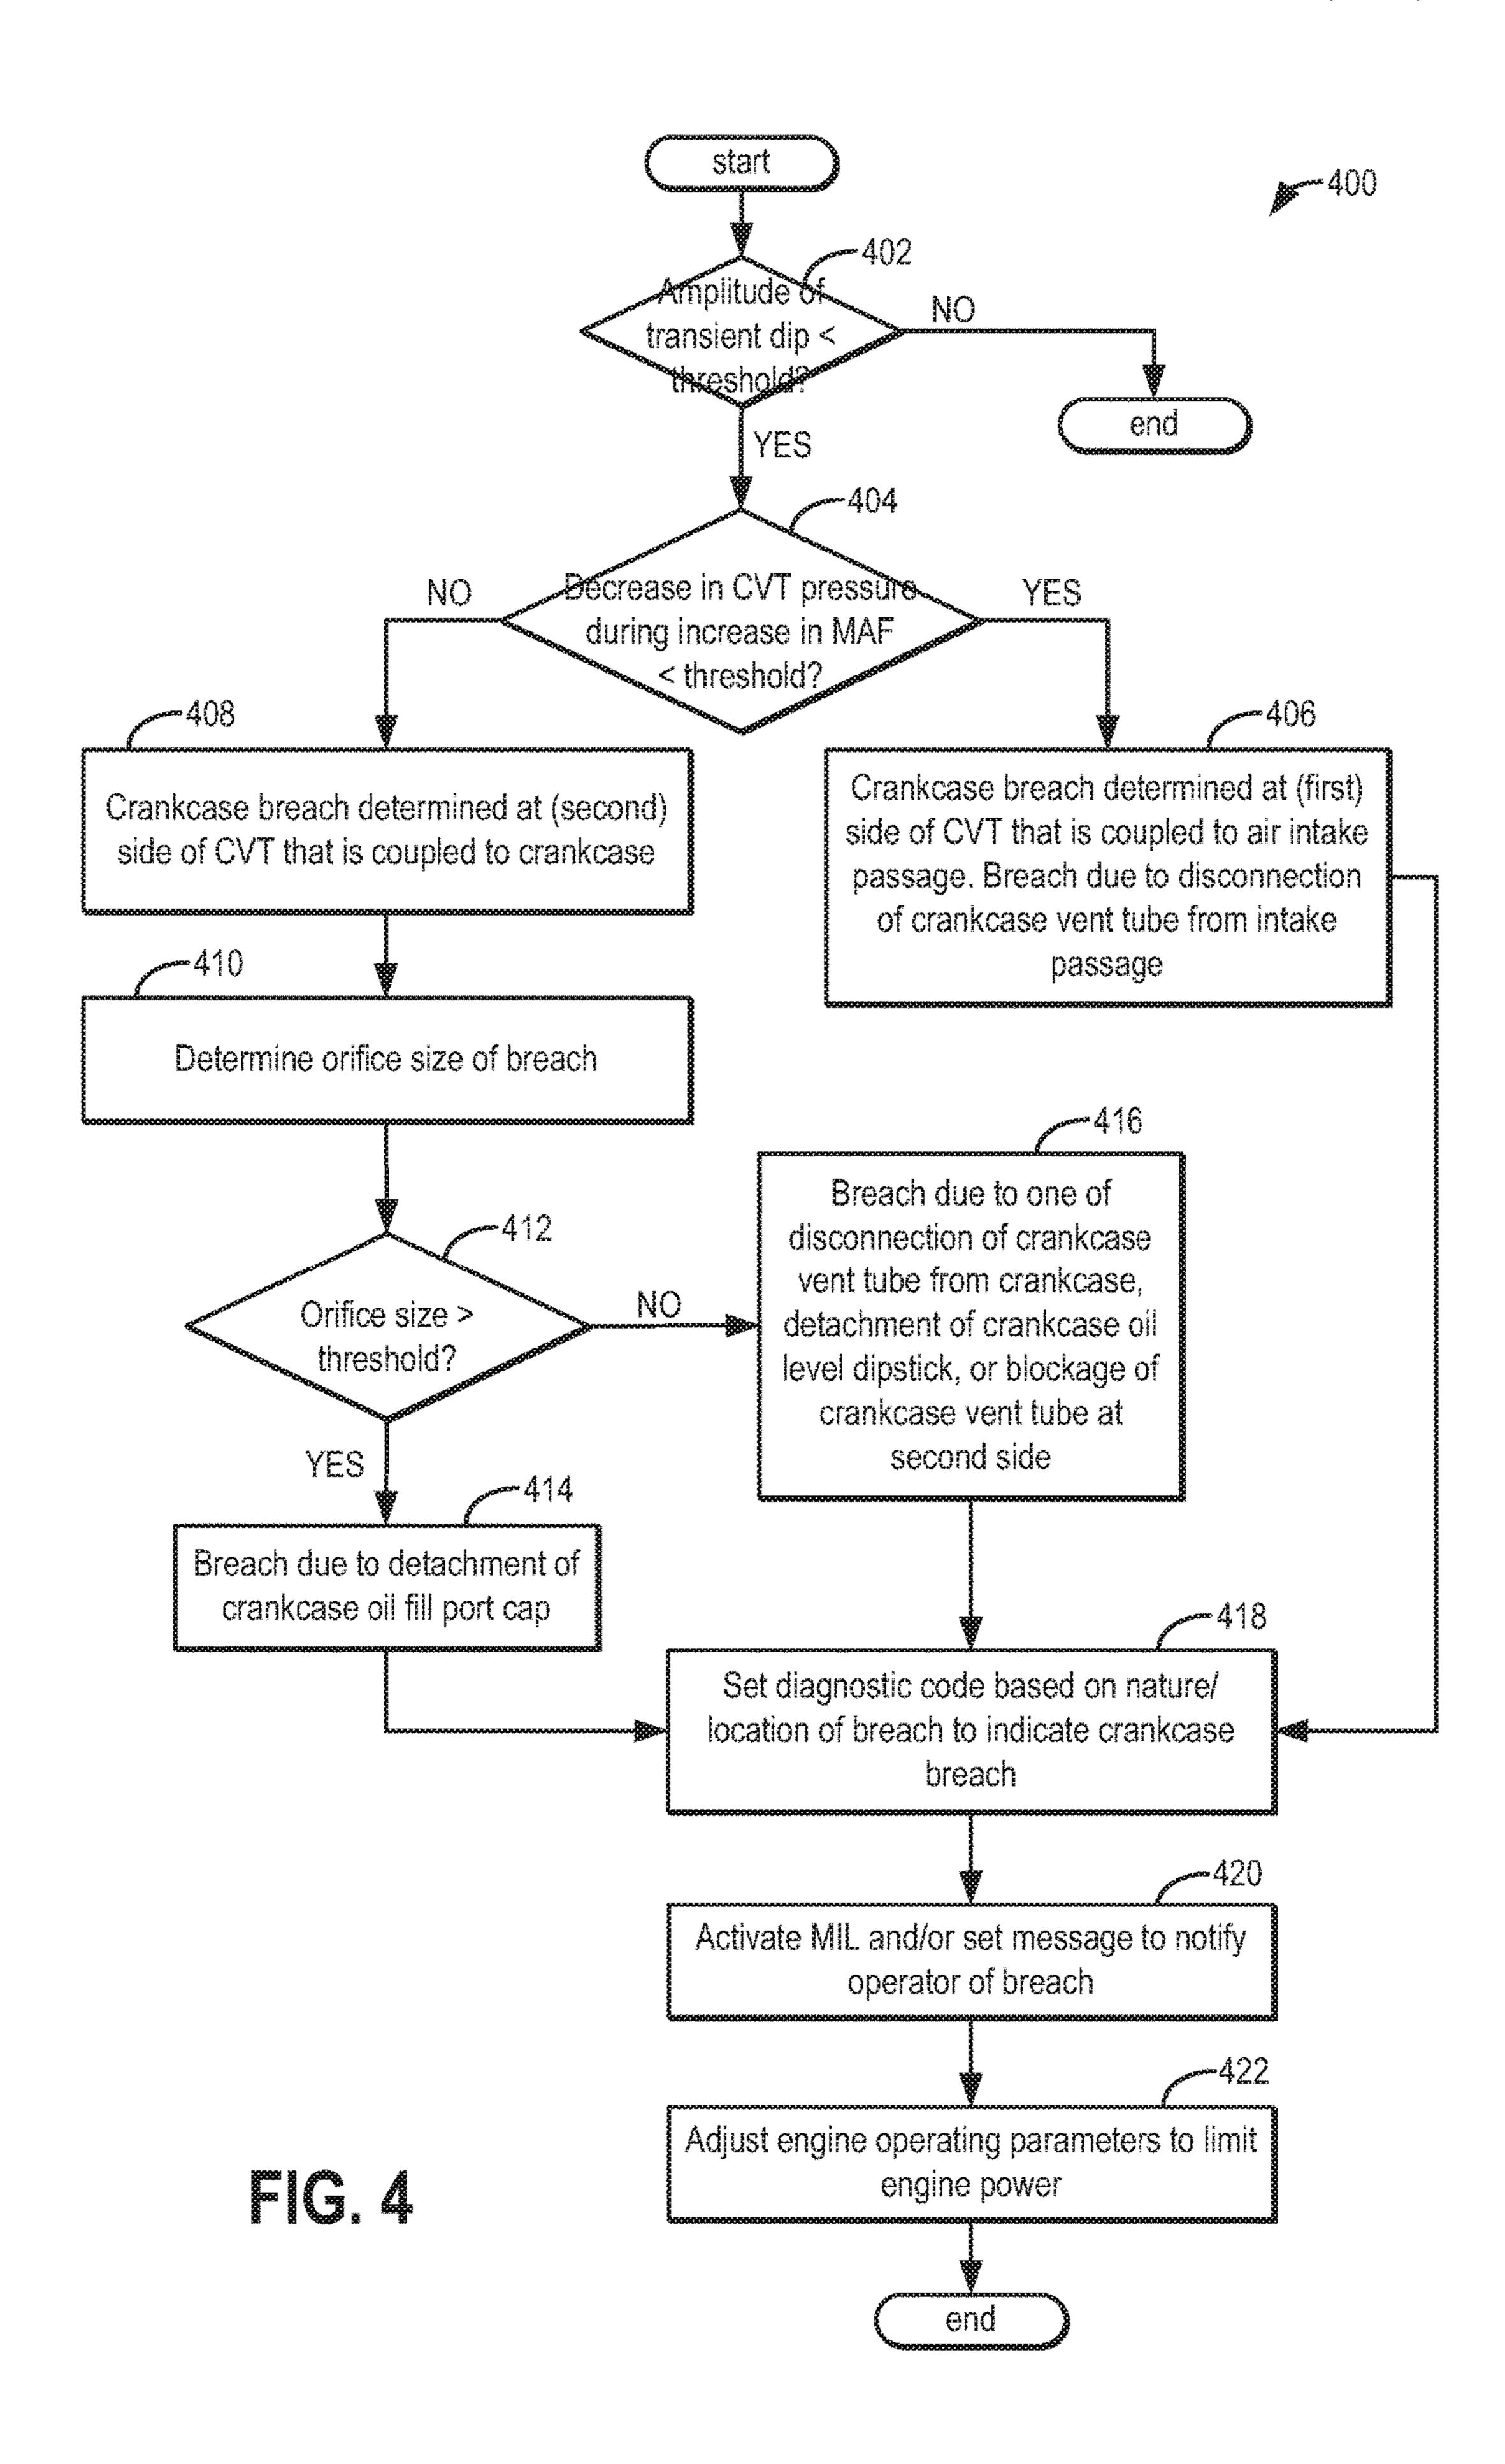
The routine of FIG. 3 works on the principle that if the dip occurs (that is, if there is high CVT flow while a PCV valve is in a low restriction position) then PCV system integrity can be confirmed (with the exception of a disconnect at first side 101). A disconnect at first side 101 can be easily determined in vehicles equipped with a MAF sensor. For vehicles without a MAF sensors, the disconnect at first side 101 is detectable by the lack of pressure drop with high engine air flow at MAF sensor 58 or CVT pressure sensor 77

At 402, it may be confirmed that the amplitude of the transient dip in crankcase vent tube pressure at cranking is smaller than a threshold. As elaborated at FIG. 3, during engine cranking, when engine air flow is lower, a higher air flow through the crankcase vent tube may be experience (in the absence of a breach) which is detected by the crankcase vent tube pressure sensor as a transient dip in vent tube pressure (or transient increase in vent tube vacuum). If there is a breach, an amplitude of the transient tube may be reduced.
