(54) CRANKCASE INTEGRITY BREACH DETECTION

(71) Applicant: Ford Global Technologies, LLC,

Methods and systems are provided for using a crankcase vent tube pressure or flow sensor for diagnosing a location and nature of crankcase system integrity breach. The same sensor can also be used for diagnosing air filter plugging and PCV valve degradation. Use of an existing sensor to diagnose multiple engine components provides cost reduction and sensor compaction benefits.

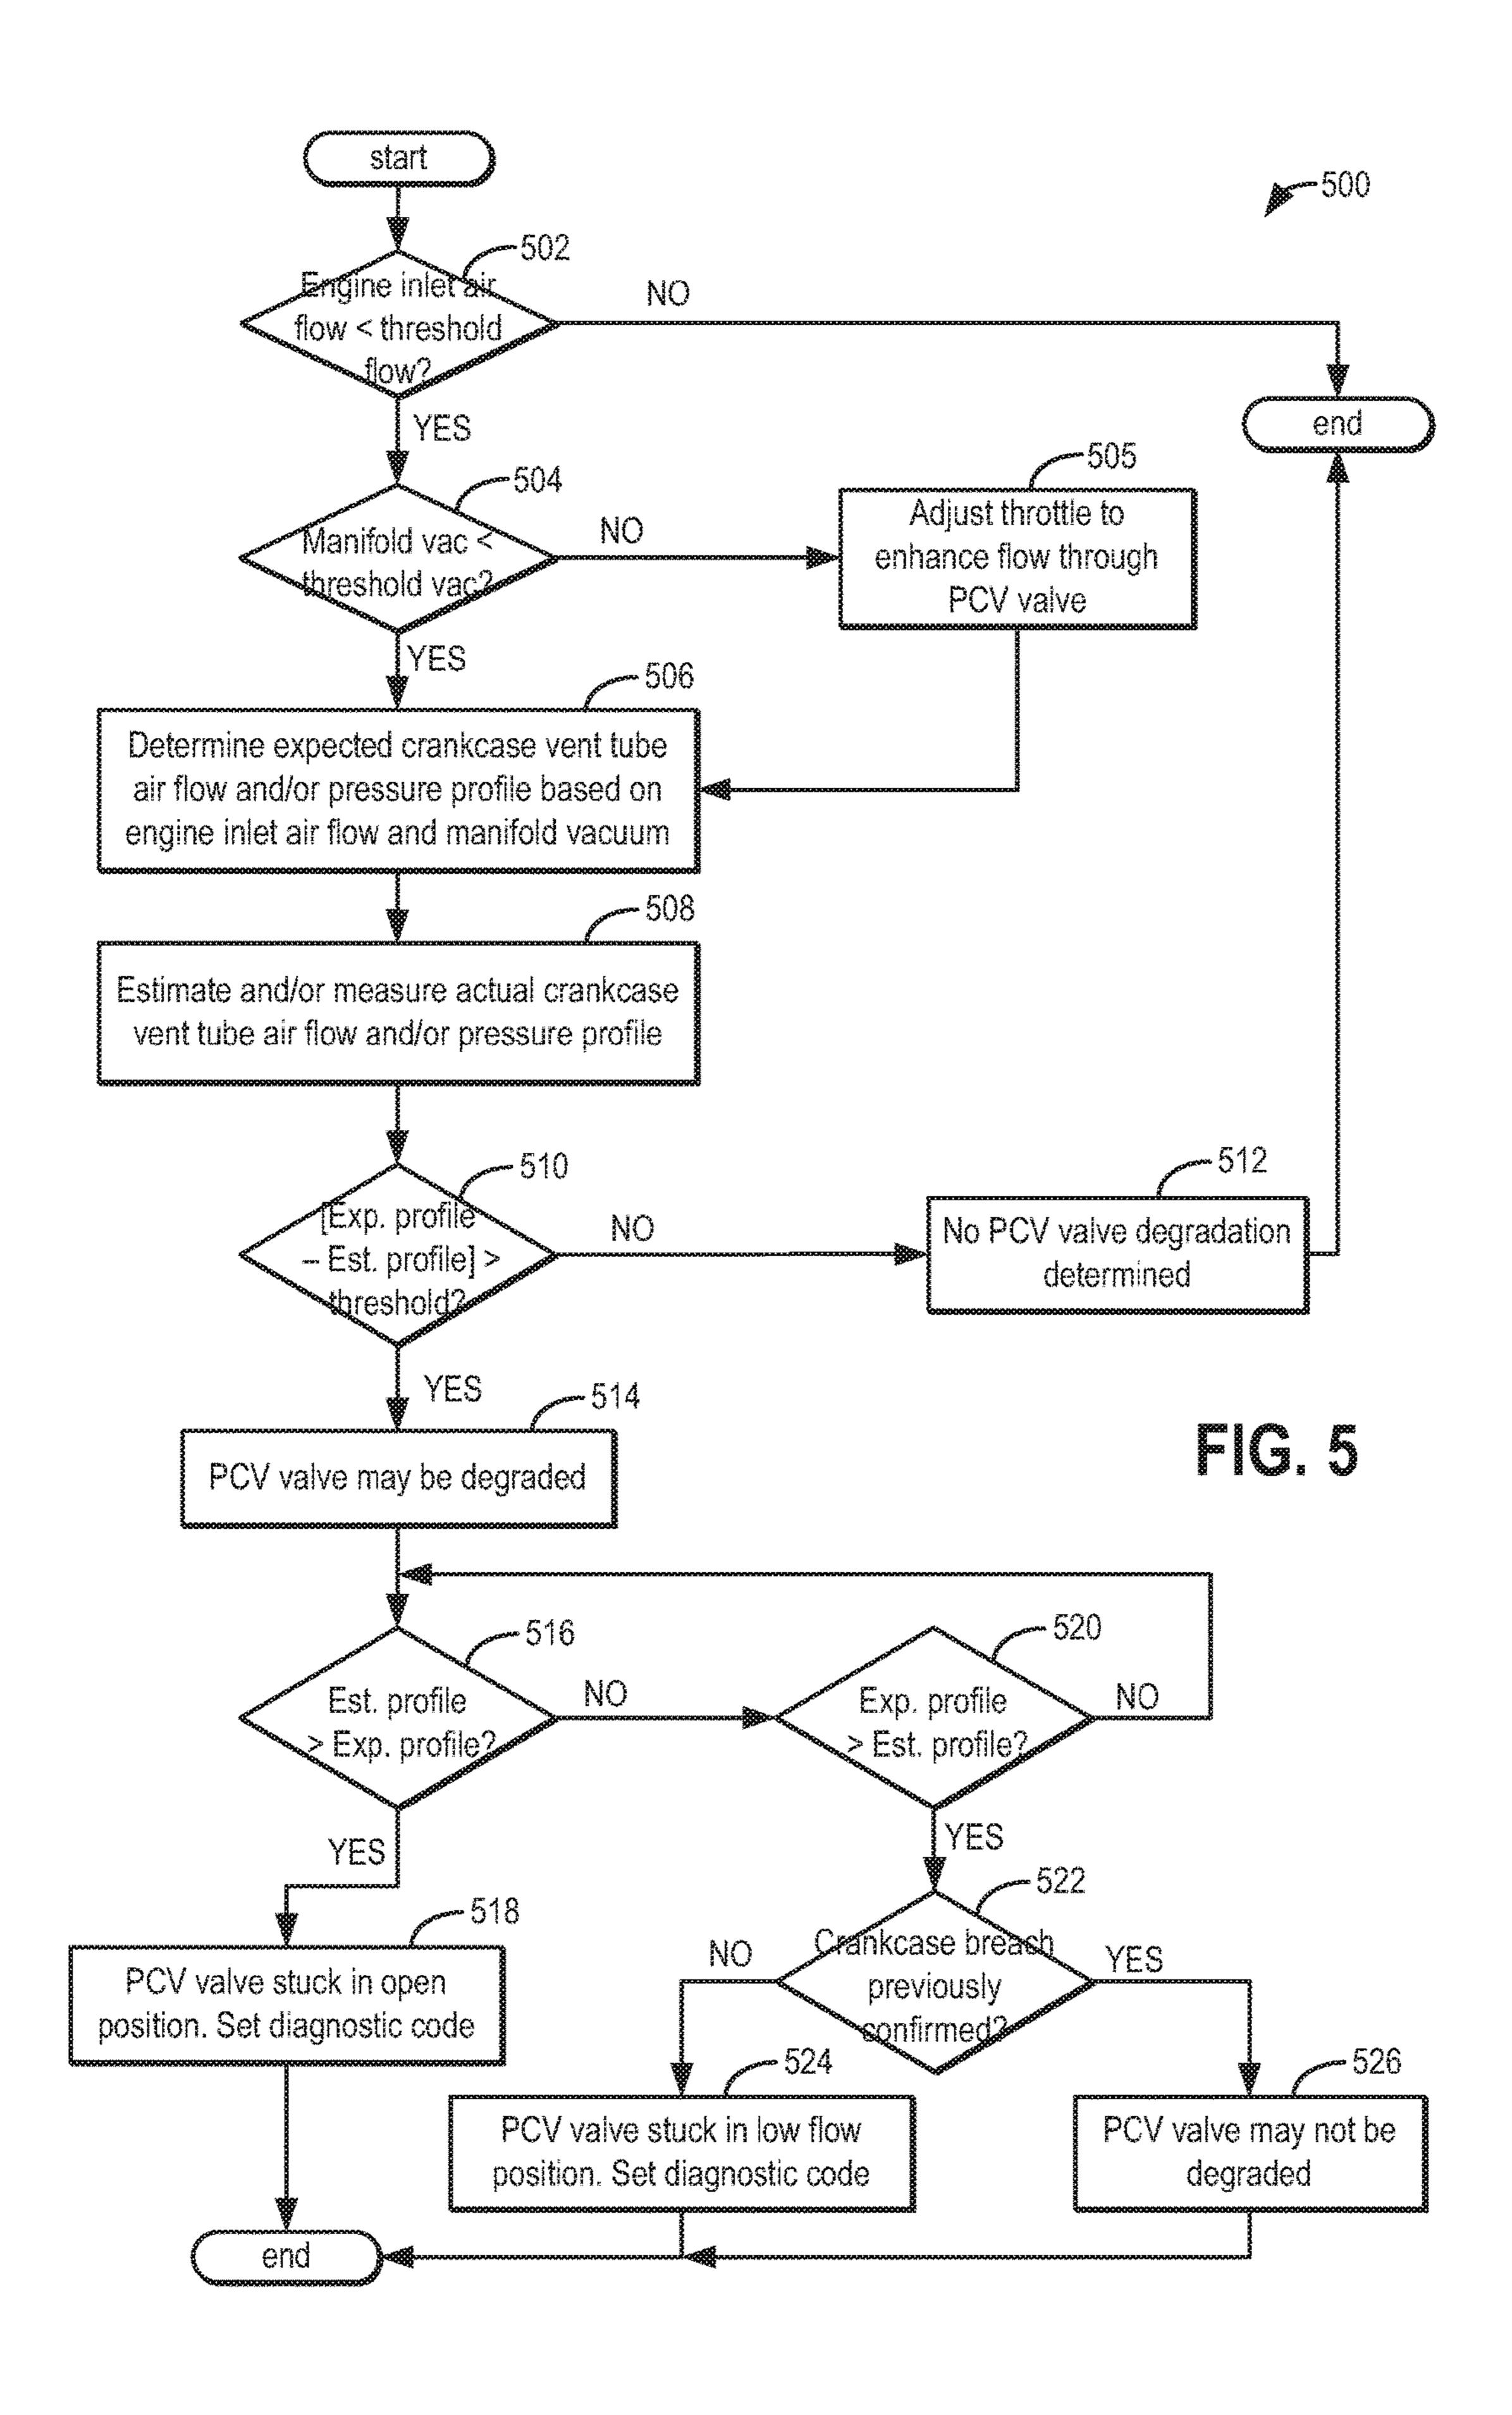
FIG. 5 shows an example method for indicating PCV valve degradation based on changes in crankcase vent tube air flow during condition of low manifold air flow.

Now turning to FIG. 5, an example method 500 is shown for indicating degradation of a PCV valve (that is, a valve coupled in a positive crankcase ventilation line between a crankcase and an intake manifold) based on changes in crankcase vent tube pressure and/or air flow rate during engine cranking. As such, the routine of FIG. 5 may be performed after confirming whether a crankcase breach has been determined based on characteristics of the transient dip.

The routine of FIG. 5 uses the output of a crankcase vent tube pressure sensor to estimate PCV valve degradation. Specifically, a gauge pressure sensor in the crankcase vent 50 tube may be advantageously used as a flow meter to sense changes in air flow rate in the crankcase vent tube. However, such a pressure sensor may correlate any vacuum in the crankcase vent tube as a flow. In other words, a flow through the crankcase vent tube may be sensed as a vacuum at the crankcase vent tube pressure sensor, and likewise, a vacuum in the crankcase vent tube may also be sensed as a vacuum at the crankcase vent tube pressure sensor. Thus, by performing the diagnostic routine when engine inlet air flow is lower than a threshold flow, a crankcase vent tube pressure sensor output is relied on only during conditions when the engine inlet air flow is itself not causing a vacuum to be sensed. Likewise, by performing the diagnostic routine when manifold vacuum is lower than a threshold vacuum level, a crankcase vent tube pressure sensor output is relied on only during conditions when the manifold vacuum is itself not causing a vacuum to be sensed. In addition, during conditions when engine inlet air flow is low and manifold

Accordingly, at **510**, the measured or estimated crankcase vent tube pressure profile and/or air flow profile may be compared to the expected crankcase vent tube pressure profile and/or air flow profile and it may be determined if an absolute difference between the profiles is larger than a 55 threshold. That is, it may be determined if the expected and actual crankcase vent tube pressure values or flow rates deviate from each other by more than a threshold amount. If not, then at **512**, the routine determines that there is no PCV valve degradation.

If there is a deviation, then at **514**, it is determined that the PCV valve may be degraded and the routine may proceed to determine the nature of the degradation based on characteristics of the estimated crankcase vent tube pressure and/or flow rate profiles. In particular, at **516**, it may be determined 65 if the estimated crankcase vent tube pressure or air flow rate is greater than the expected crankcase vent tube pressure (or

If the estimated crankcase vent tube pressure or air flow rate is not greater than the expected crankcase vent tube pressure (or air flow rate), then it may be confirmed that the estimated crankcase vent tube pressure or air flow rate is smaller than the expected crankcase vent tube pressure (or air flow rate) by more than the threshold amount. Alternatively, it may be determined if an estimated amplitude of a transient dip in crankcase vent tube pressure is lower than an expected amplitude (or threshold amplitude). Upon confirmation, at **522**, it may be determined if a condition of crankcase breach has already been determined. As previously elaborated with reference to FIGS. 2A-2B, a crankcase ventilation system integrity breach may have been determined before initiating the PCV valve diagnostic routine of FIG. 5. As explained with reference to FIGS. 3-4, a breach in crankcase ventilation system integrity, as well as a location of the breach may be determined based on characteristics of a transient dip in crankcase vent tube pressure during engine cranking, as well as a change in steady-state crankcase vent tube pressure relative to a change in steady state manifold air flow during engine running.

In this way, PCV valve degradation may be determined based on changes in air flow rate through a crankcase vent 30 tube, as estimated by a crankcase vent tube pressure or flow sensor, during engine cranking. Based on deviations of an expected flow profile from an estimated flow profile, PCV valve degradation due to a stuck open valve may be better distinguished from degradation due to a stuck closed valve. 35 By performing the PCV valve diagnostic routine after completing a crankcase system breach diagnostic routine, changes in crankcase vent tube pressure or flow caused due to a crankcase system breach at either a crankcase side or an air intake passage side of the crankcase vent tube can be 40 factored in to enable a reliable PCV valve diagnostic. In particular, changes in crankcase vent tube air flow due to a crankcase system breach (e.g., due to a disconnected vent tube or a displace oil fill port cap) can be better distinguished from those due to a degraded PCV valve.

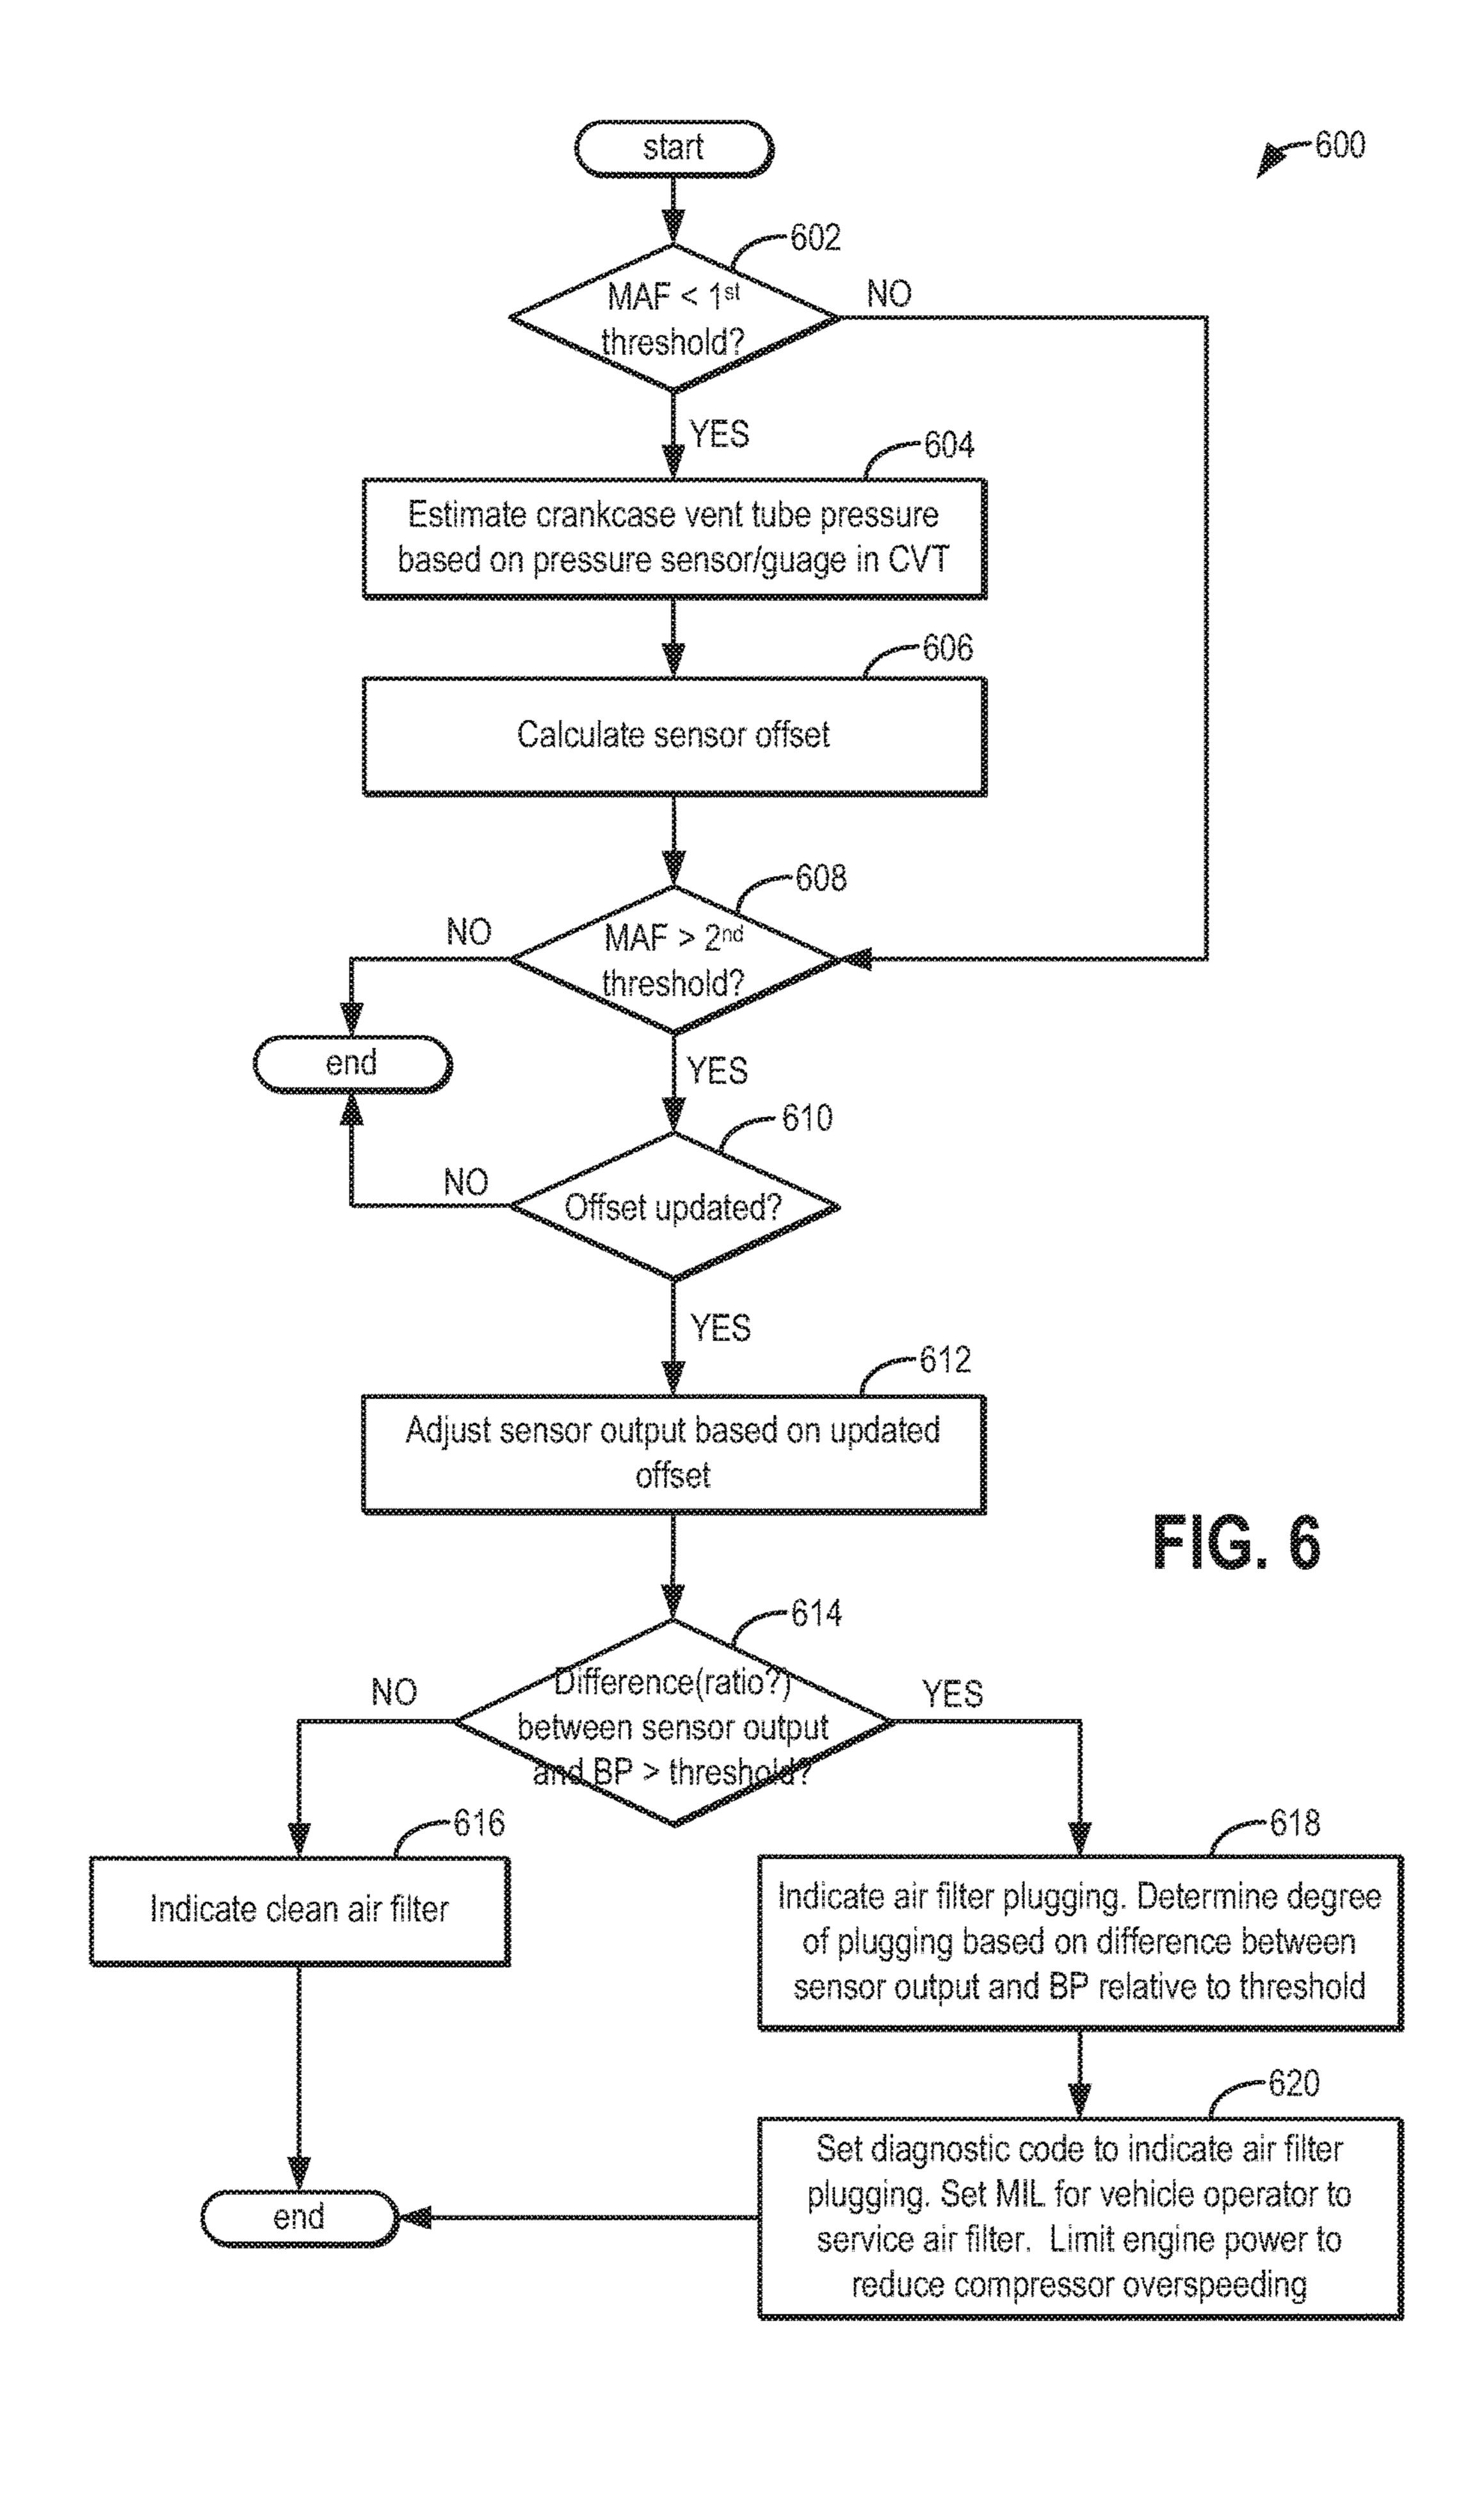
Now turning to FIG. 6, an example method 600 is shown for indicating degradation of an intake air filter based on crankcase vent tube pressure estimated by a pressure sensor ¹ in the crankcase vent tube. As such, the routine of FIG. 6 may be performed as part of the routine of FIGS. 2A-2B.

At 602, the routine includes confirming whether manifold air flow is lower than a first threshold. By confirming that manifold air flow is lower than the first threshold, it may be 20 confirmed that a sensor offset is calculated during low engine flow conditions (such as during no engine flow) so as to reduce noise disturbances arising in the calculation from engine flow. Next, at 604, a crankcase vent tube pressure may be estimated during the low manifold air flow condi- 25 tions by a pressure sensor positioned in the crankcase vent tube. The pressure sensor in the crankcase vent tube may be, for example, an absolute pressure sensor or a gauge pressure sensor. In embodiments where the pressure sensor is an absolute pressure sensor, it may or may not be coupled to a 30 barometric pressure sensor. In embodiments where the pressure sensor is a gauge sensor, an absolute barometric pressure sensor (e.g., BP sensor 57 of FIG. 1) may be coupled to it (e.g., additionally present outside of the filtered volume) or used in conjunction.

At 606, the routine includes calculating a sensor offset. Specifically, the algorithm used zeroes the gauge pressure sensor during low engine flows, or learns a sensor offset based on the barometric pressure reading from the BP sensor at low engine flow conditions. In this way, the controller effectively learns or infers the barometric pressure from the 40 crankcase vent tube pressure sensor and can either use the output of the crankcase vent tube pressure sensor at low engine flow as barometric pressure itself, or can use the output to ensure common and calibrated reference to a barometric pressure that is separately sensed. In one 45 example, barometric pressure may be separately learned from a dedicated barometric pressure sensor coupled to the intake passage (e.g., upstream of the air filter), or from a compressor inlet pressure sensor (CIP sensor) positioned in the intake upstream of the compressor and downstream of 50 the air filter. However, by using the existing crankcase vent tube pressure sensor to estimate BP, the need for a dedicated BP sensor or a CIP sensor is reduced.

Next, at 608, it may be determined if engine air flow (or any other signal related to engine air flow rate) is higher than a second threshold. By confirming that engine air flow is higher than the second threshold, it may be confirmed that air filter plugging is estimated during higher engine flow conditions, when the effect of air filter plugging on crankcase vent tube pressure is greater, so as to improve detection accuracy. If the engine air flow is not higher than the second threshold, the routine may wait until the desired engine air flow levels are reached to perform the air filter plugging diagnosis. At 610, upon confirming that manifold air flow levels are higher than the second threshold, it may be confirmed that the sensor offset has been updated. This may include confirming that the sensor offset that was learned during the lower engine flow conditions immediately preceding the higher engine flow conditions has been stored in the controller (e.g., a look-up table has been updated with the most recently learned offset).

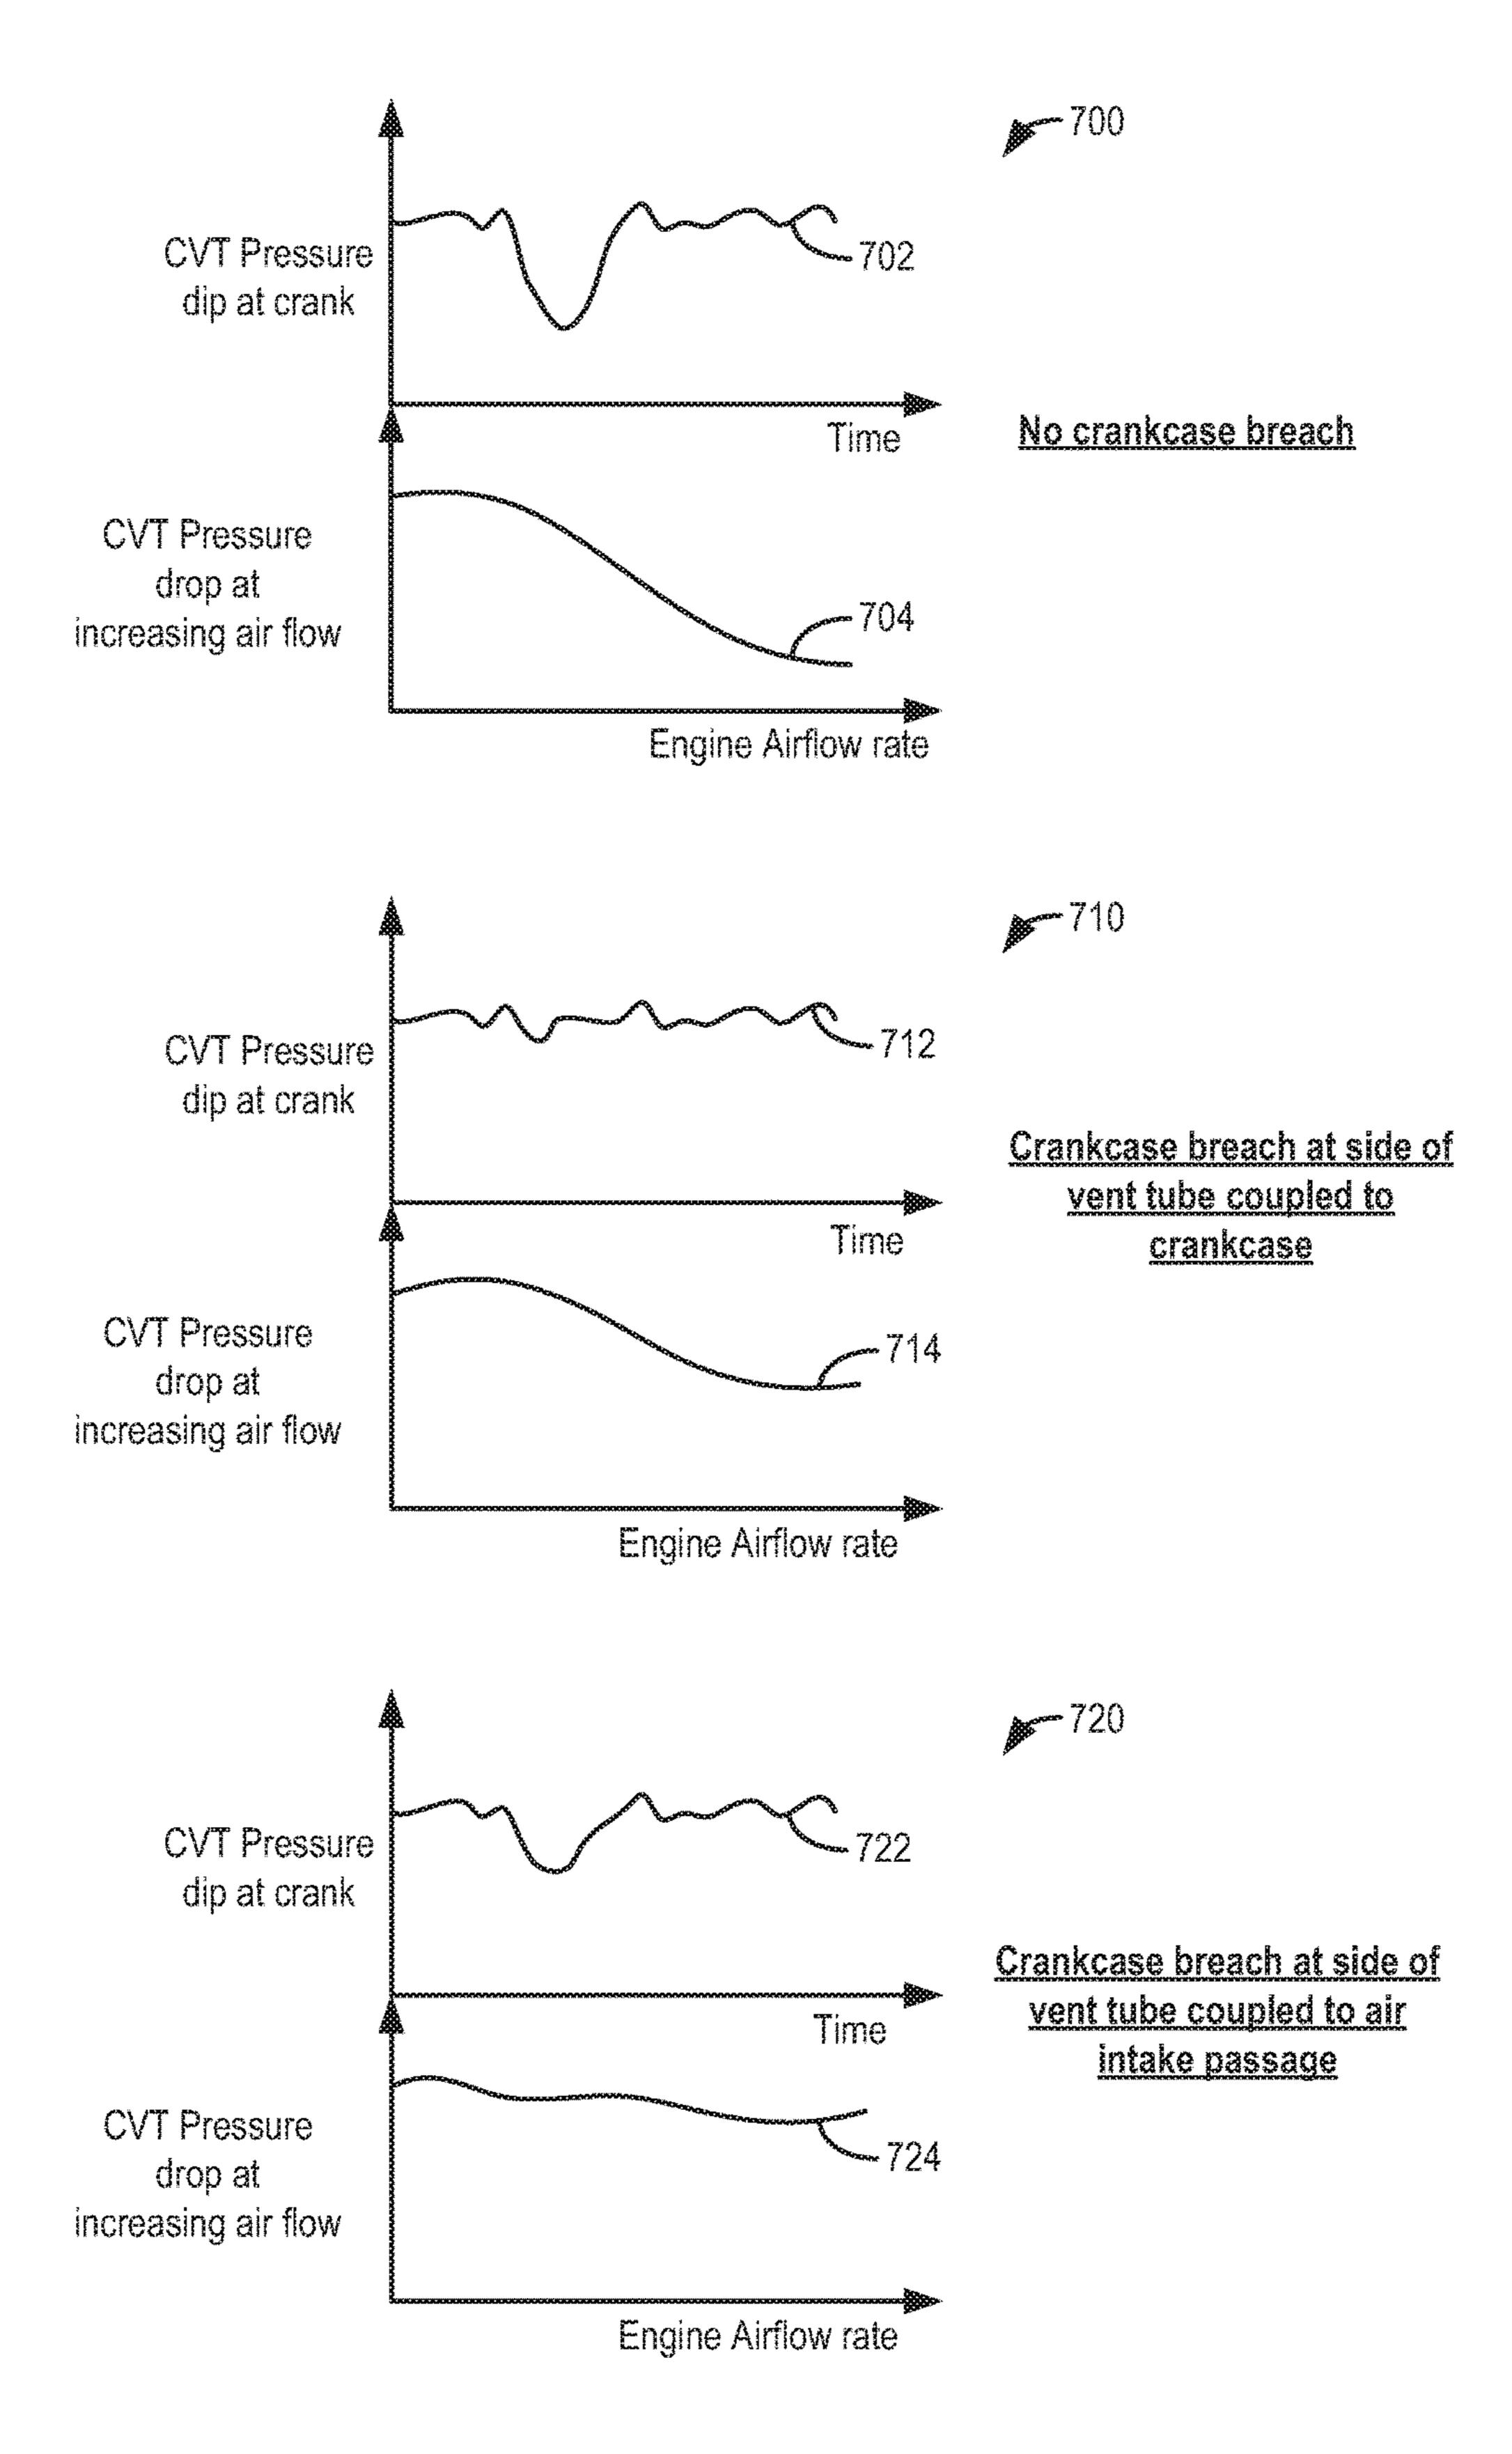
(steady-state conditions) at the respective lower plots (plots 704, 714, 724). The upper plots of the maps are plotted over time of engine operation while the lower plots of the maps are plotted over engine air flow rate (as depicted) along the x-axis.

> Map 710 shows a second example wherein the amplitude of the transient dip in CVT pressure (plot 712) is smaller than the threshold amount, indicating insufficient air flow through the vent tube during engine cranking. In addition, during engine running, a decrease in steady-state CVT pressure is not proportional to an increase in steady-state manifold air flow, but the decrease is still more than a threshold rate (plot 714). Specifically, reduced vacuum is sensed by a pressure or flow sensor in the crankcase vent tube during high engine air flow conditions (as compared to vacuum generated in the absence of a breach, as shown at plot 704). Herein, in response to the transient dip in crankcase vent tube pressure during cranking being lower than the threshold amplitude and the decrease in crankcase vent tube pressure during the steady-state increase in manifold airflow being higher than the threshold rate, crankcase ventilation system breach at a second side of the crankcase vent tube is indicated. The second side corresponds to a side where the crankcase vent tube is mechanically coupled to the crankcase. As elaborated at FIG. 8, various crankcase system breaches at the second side can be further distinguished based on crankcase vent tube pressure and flow characteristics.

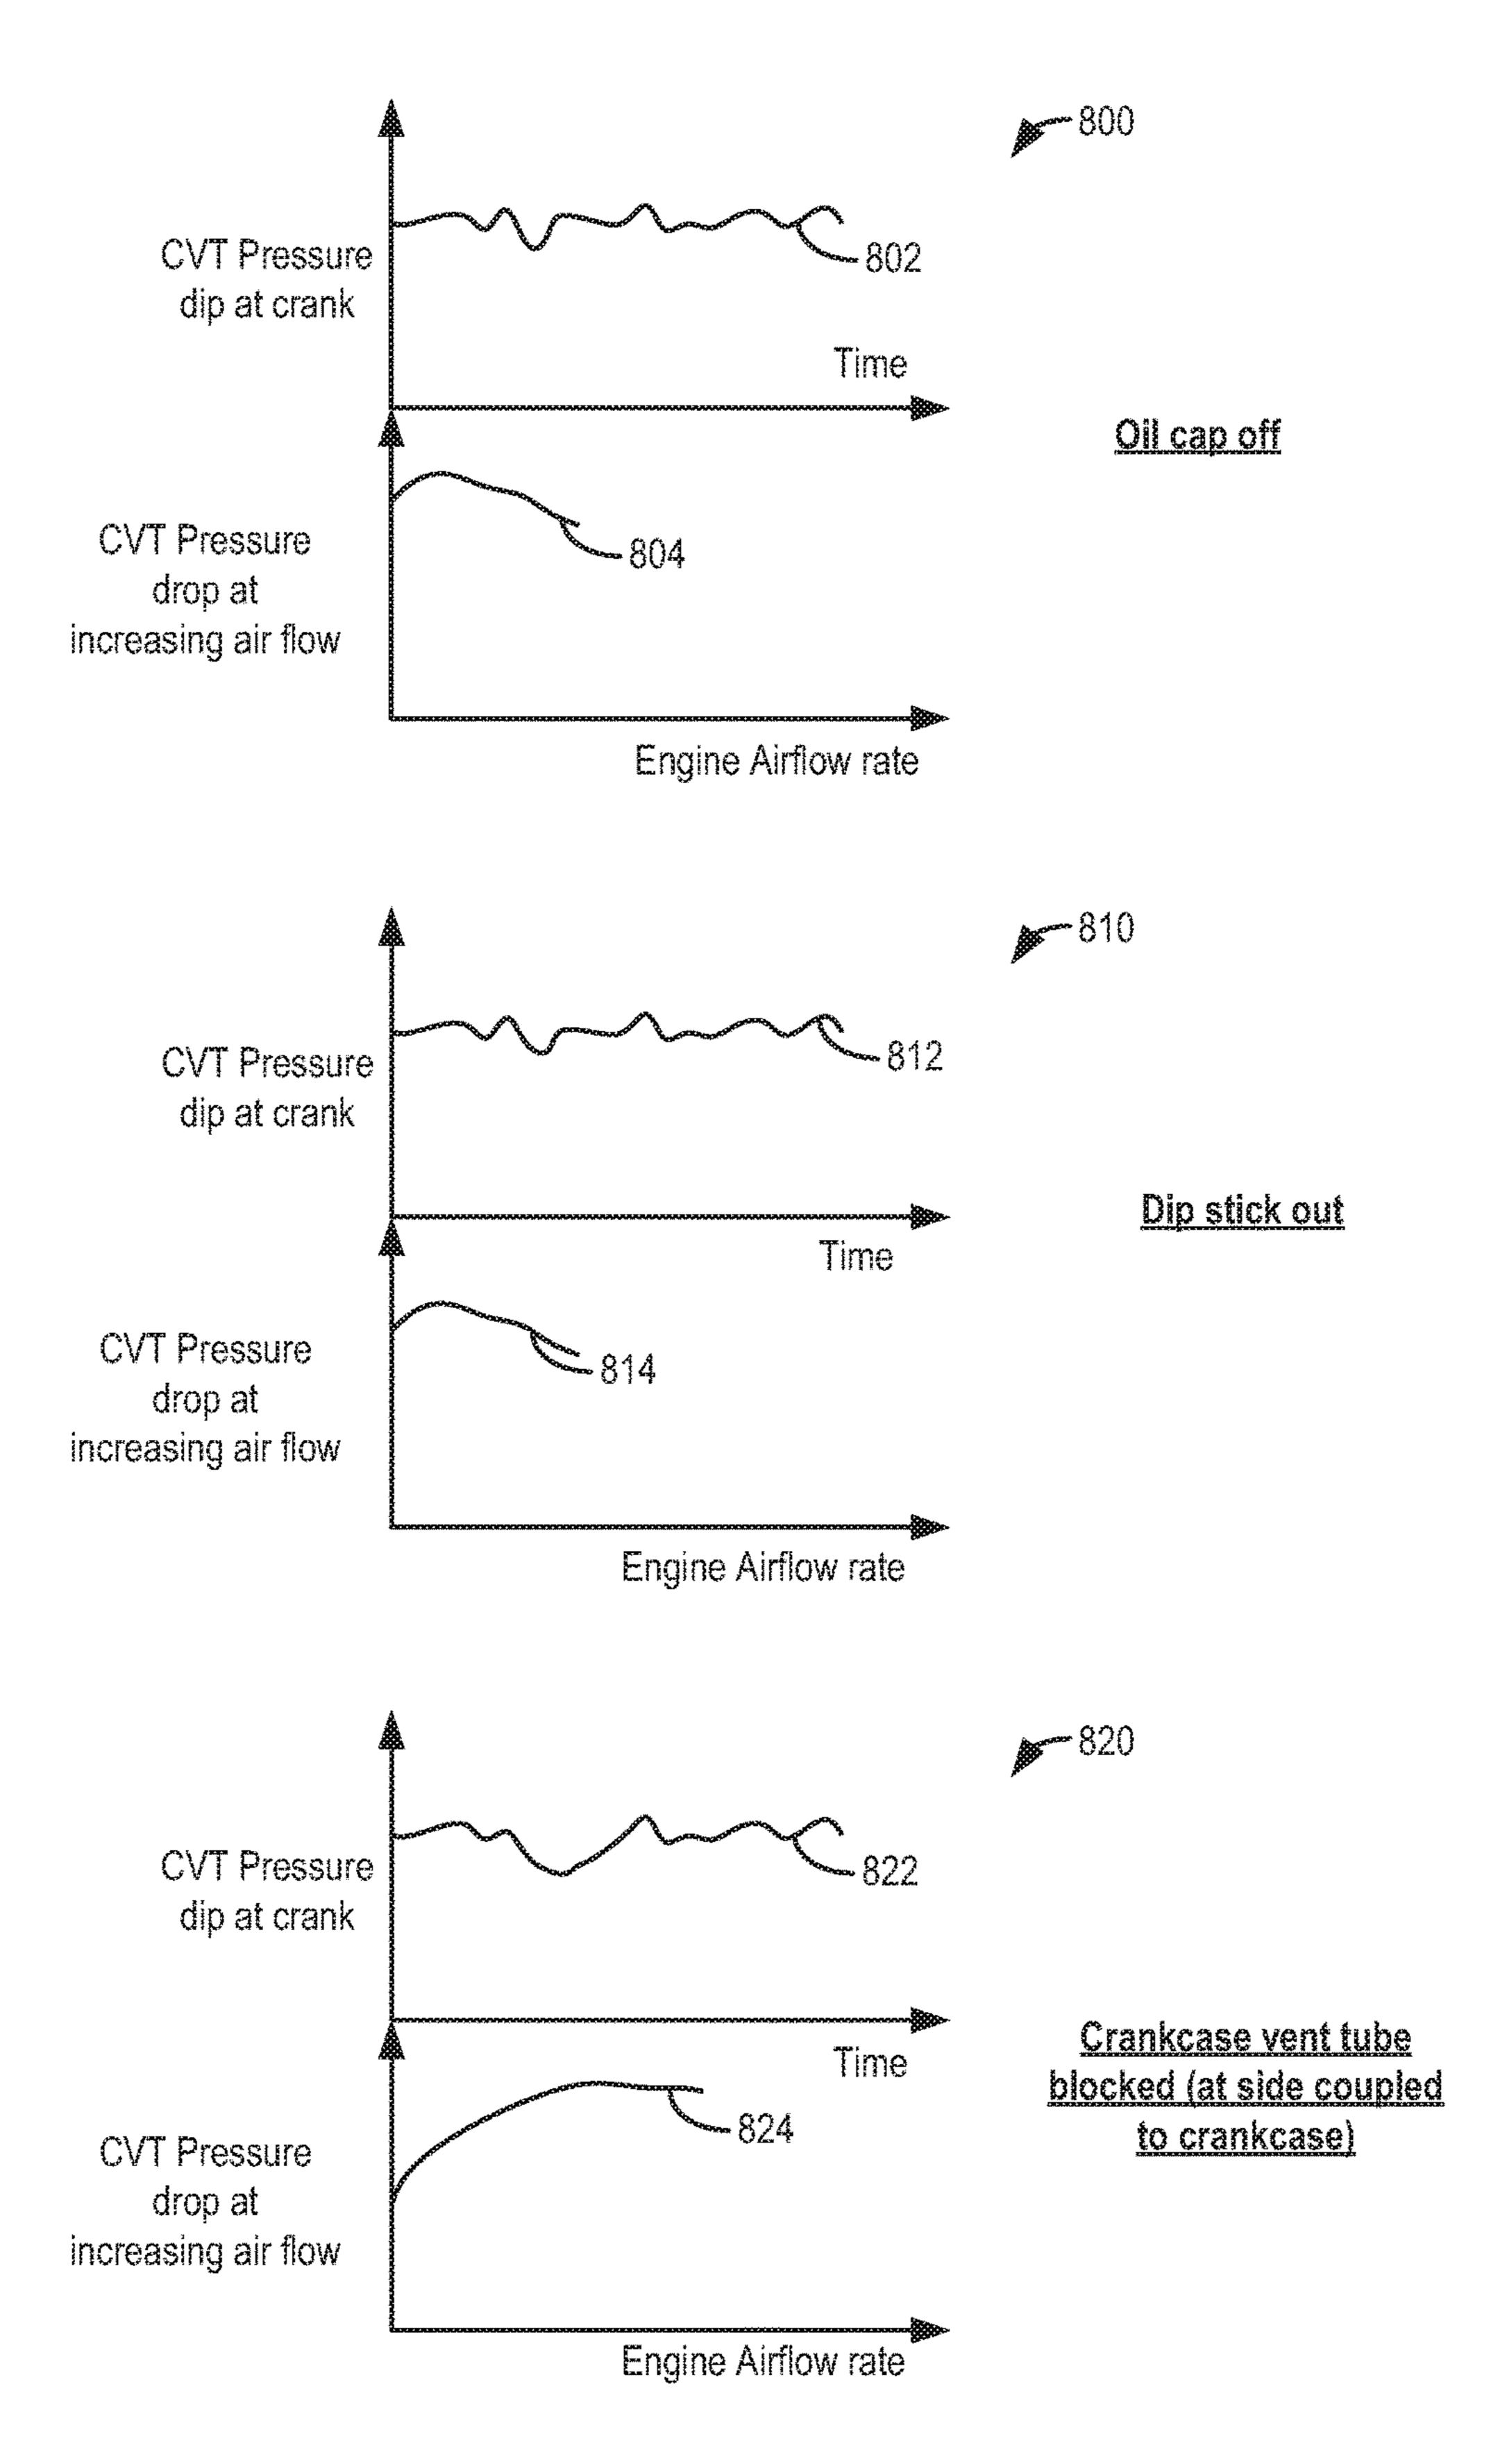
FIG. 8

Now turning to FIG. 8, an example crankcase system integrity breach diagnostic is shown at maps 800, 810, and **820** for differentiating between different conditions that may lead to a breach identified at the second side of the crankcase 15 vent tube. Specifically, maps 800-820 show characteristics of a transient dip in crankcase vent tube (CVT) pressure during cranking at the respective upper plots (plots 802, 812, **822**) and characteristics of a drop in crankcase vent tube pressure with increasing manifold air flow during engine 20 running (steady-state conditions) at the respective lower plots (plots 804, 814, 824). All upper plots are shown over time of engine operation along the x-axis while all lower plots are shown over engine airflow rates along the x-axis.

Map 800 shows a first example of a crankcase system 25 breach at the second side of the crankcase vent tube caused by a crankcase oil fill port cap coming off. Herein, an amplitude of the transient dip in CVT pressure (plot **802**) is smaller than the threshold amount, indicating insufficient air flow through the vent tube during engine cranking. In 30 addition, during engine running, a decrease in steady-state CVT pressure is not proportional to an increase in steadystate manifold air flow. Specifically, no vacuum is sensed by a pressure or flow sensor in the crankcase vent tube after a based on an orifice size of the breach being larger than a threshold amount, an oil cap off condition is indicated.

Map 810 shows a second example of a crankcase system breach at the second side of the crankcase vent tube caused by a crankcase oil level dipstick being dislodged. Herein, an 40 amplitude of the transient dip in CVT pressure (plot **812**) is smaller than the threshold amount, indicating insufficient air flow through the vent tube during engine cranking. In addition, during engine running, a decrease in steady-state CVT pressure is not proportional to an increase in steady- 45 state manifold air flow (plot 814). Specifically, no vacuum is sensed by a pressure or flow sensor in the crankcase vent tube during high engine air flow conditions. Herein, further based on an orifice size of the breach being smaller than a threshold amount, a dipstick out condition is indicated.

Map 820 shows a third example of a crankcase system breach at the second side of the crankcase vent tube caused 60 by the crankcase vent tube being blocked or clogged at the second side. Herein, an amplitude of the transient dip in CVT pressure (plot 822) is smaller than the threshold amount, indicating insufficient air flow through the vent tube during engine cranking. In addition, during engine running, 65 an increase in steady-state CVT pressure is observed during an increase in steady-state manifold air flow. Specifically,

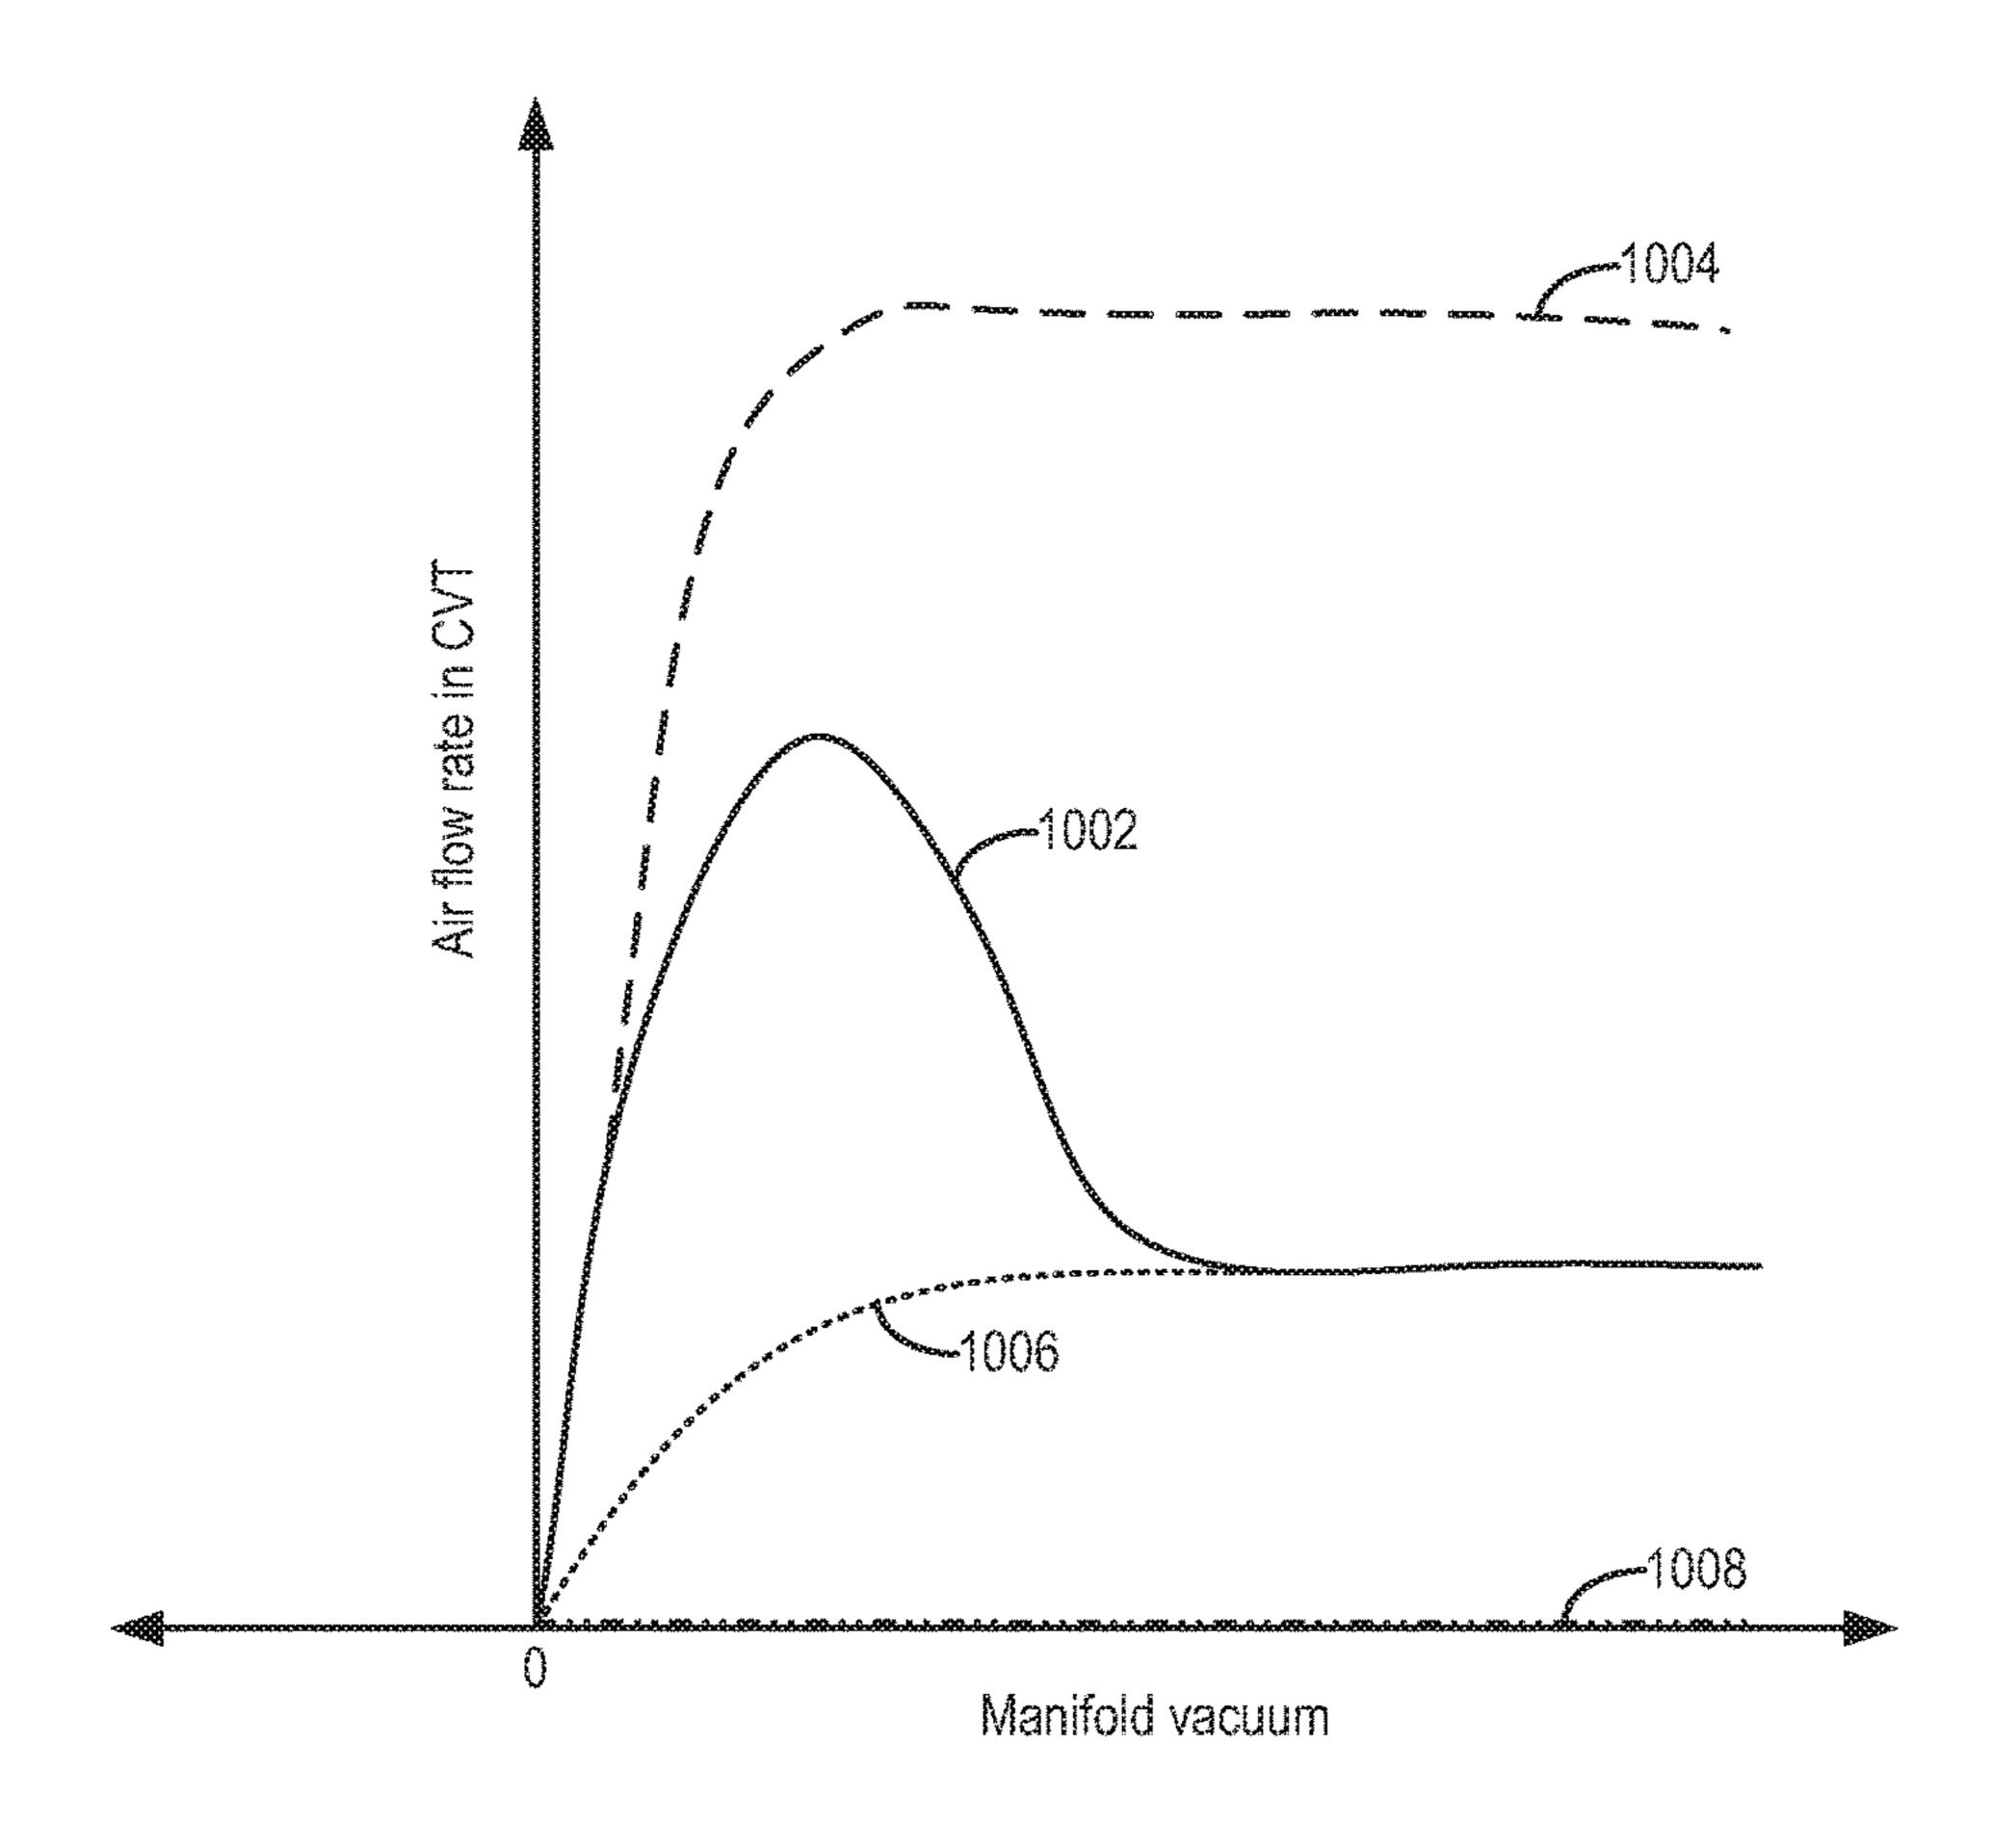
FIG. 10 shows example changes in crankcase vent tube pressure that may be used to indicate degradation of a PCV valve.

In one example, plot 1002 is observed if the PCV valve is not degraded, plot 1004 is observed if the PCV valve is stuck

in a low restriction position, plot 1006 is observed if the PCV valve is stuck in a high restriction position, and plot 1008 is observed if the air filter is clogged or frozen shut.

It will be appreciated that while the example of FIG. 10 illustrates determining PCV valve degradation based on deviations in an estimated vent tube air flow rate profile from an expected air flow rate profile, in alternate example, the same may be determined (or illustrated as) deviations in an estimated vent tube vacuum profile from an expected vacuum profile. In this way, an existing sensor used for crankcase ventilation system monitoring can be advantageously used to also reliably diagnose a PCV valve.
