(10) **Patent No.:** **US 9,873,459 B2**
(45) **Date of Patent:** **Jan. 23, 2018**

(54) **INSTRUMENT PANEL SECONDARY SERVICE JOINT**

A vehicle instrument panel attachment joint assembly includes a first bracket associated with a strut holding a portion of the instrument panel and a second bracket associated with a portion of the vehicle. The assembly is configured whereby the second bracket underlies the first bracket on attachment. One or fasteners pass first through one or more second bracket through-bores and next through one or more first bracket through-bores to attach the first and second brackets one to the other. The first bracket includes one or more associated cooperating fastener receivers aligned with the one or more first bracket through-bores.

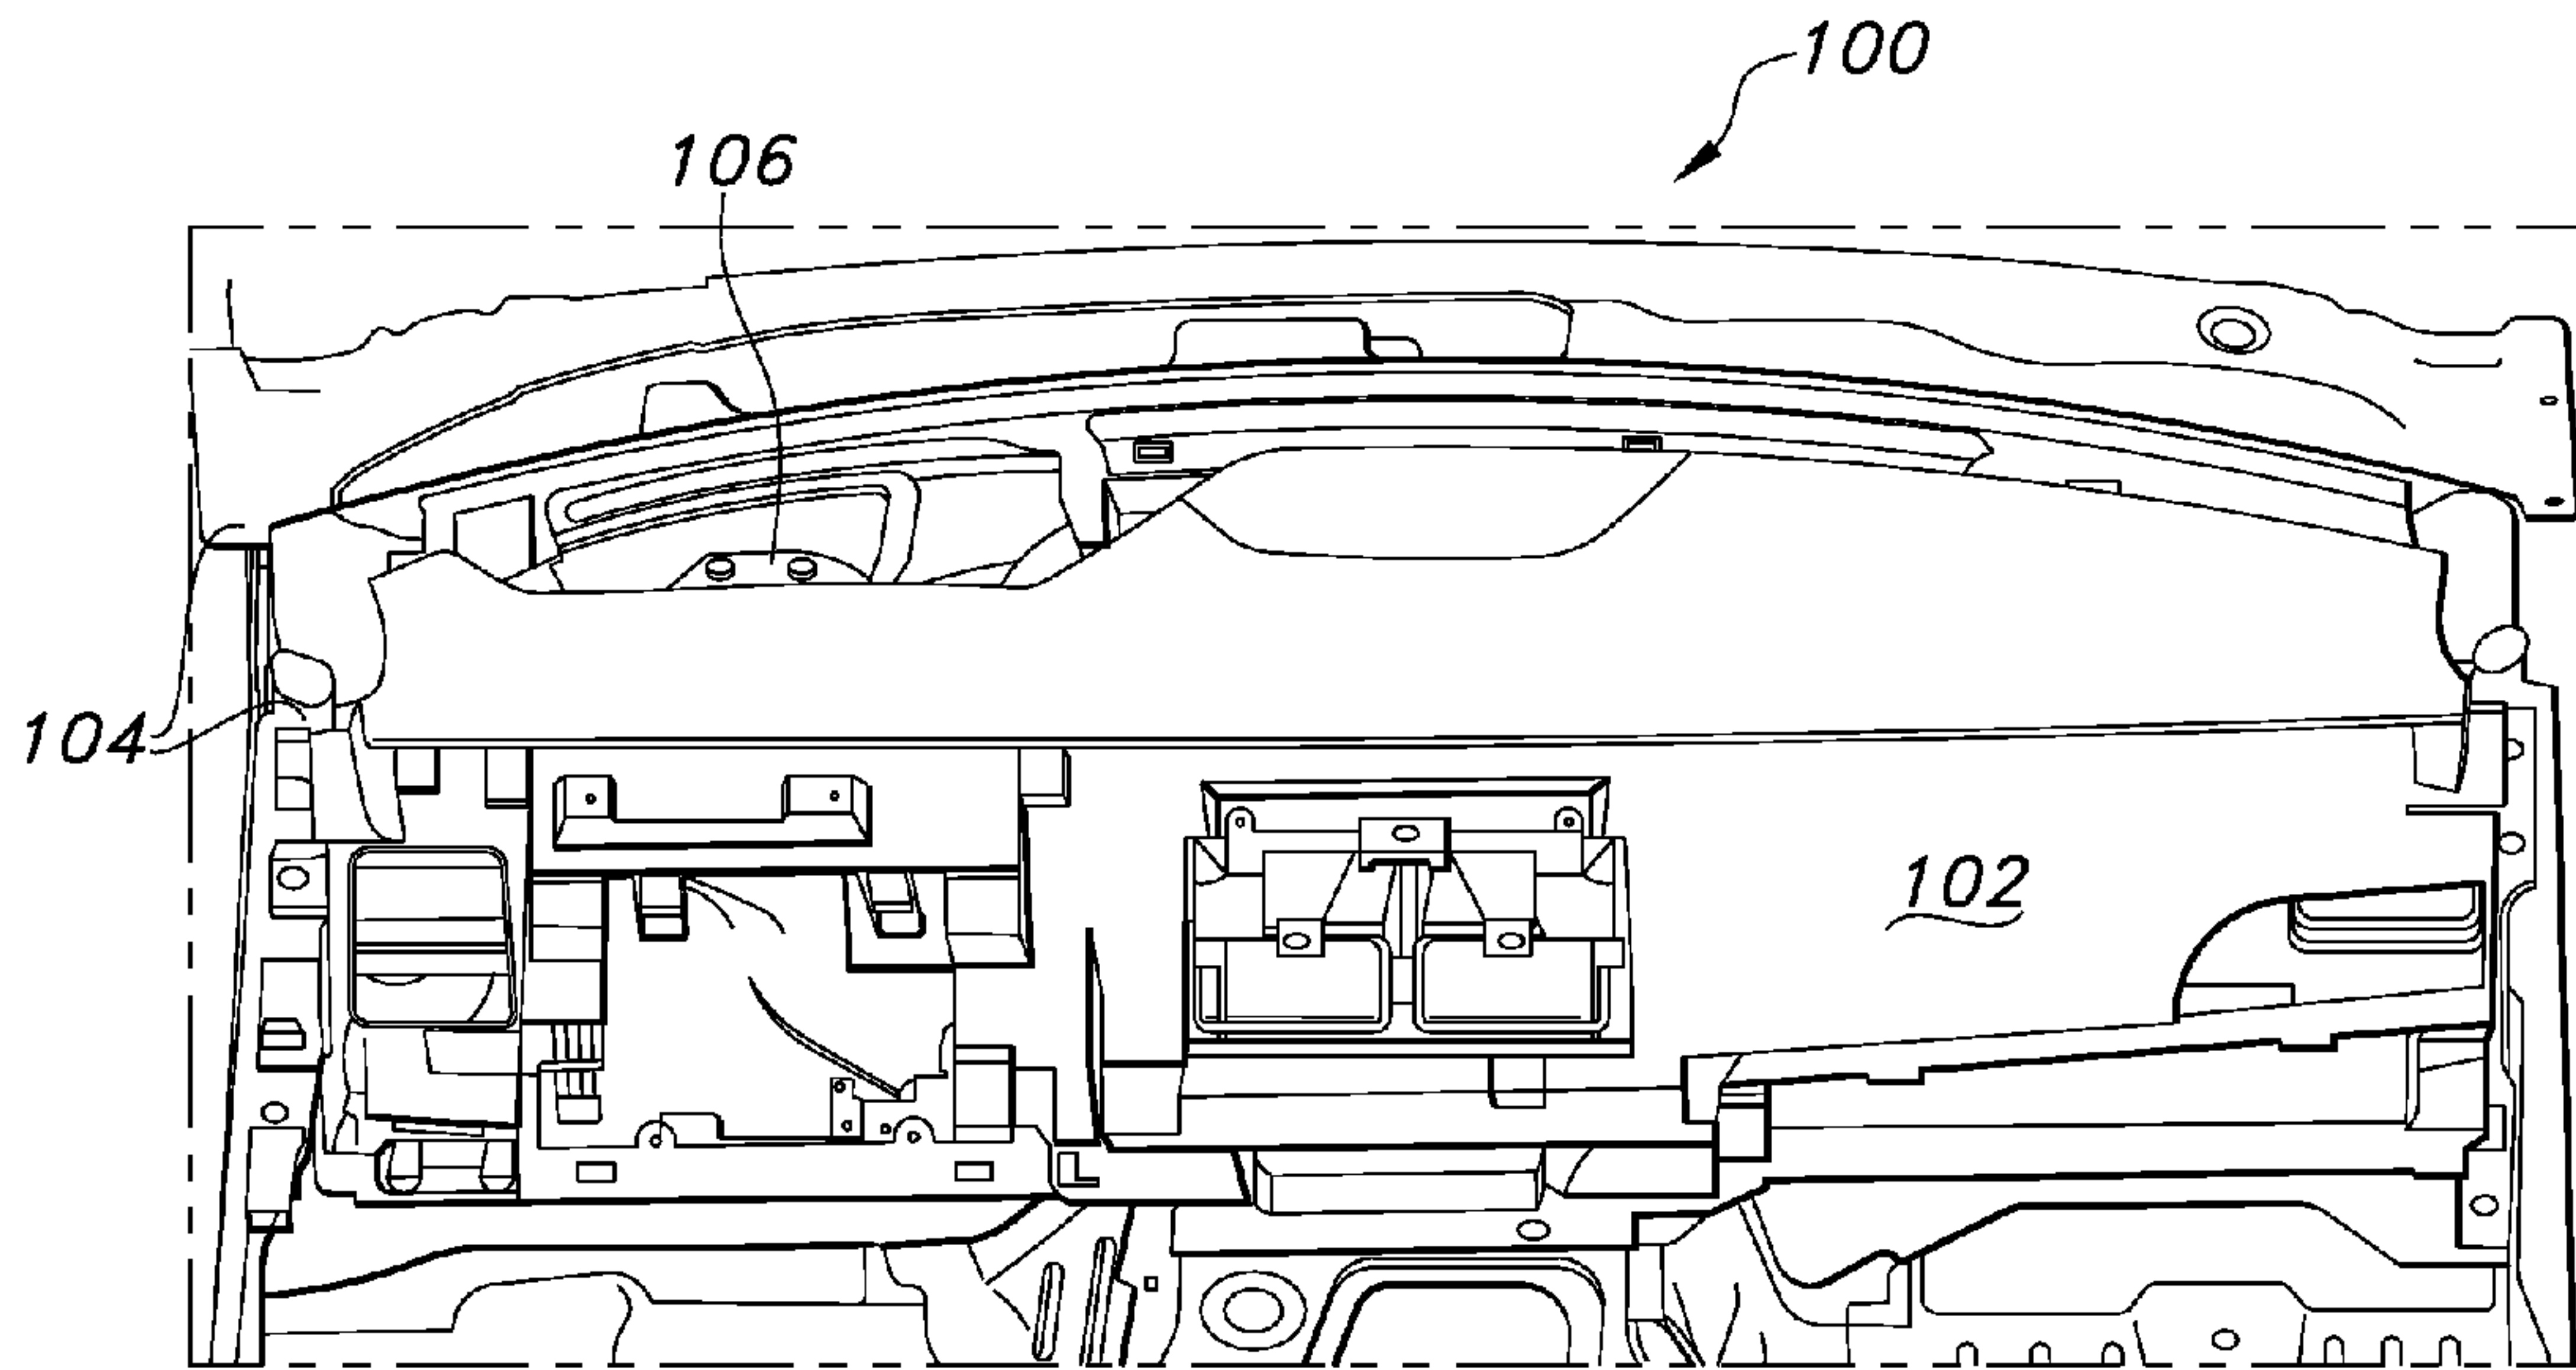
FIG. 1A
(PRIOR ART)

FIG. 1A depicts a top view of a prior art instrument panel to vehicle cowl assembly;

As an example, FIGS. 1A and 1B respectively show a top and a side view of a conventional instrument panel 100. During vehicle assembly, the instrument panel 100 is installed to the vehicle body structure and fastened to the vehicle cowl. As shown in the figures, an instrument panel 102 is typically secured to portions of a vehicle cowl and/or frame 104 by a "top down" or vertical attachment strategy at least at an instrument panel joint 106, such as by a bracket and fasteners of known design. While substantially effective for its intended purpose in a very simple instrument panel, consider the modern instrument panel including a number of tightly packaged components as described above. In such instrument panels, space is at a premium and a readily accessible instrument panel joint 106 may not be an option.

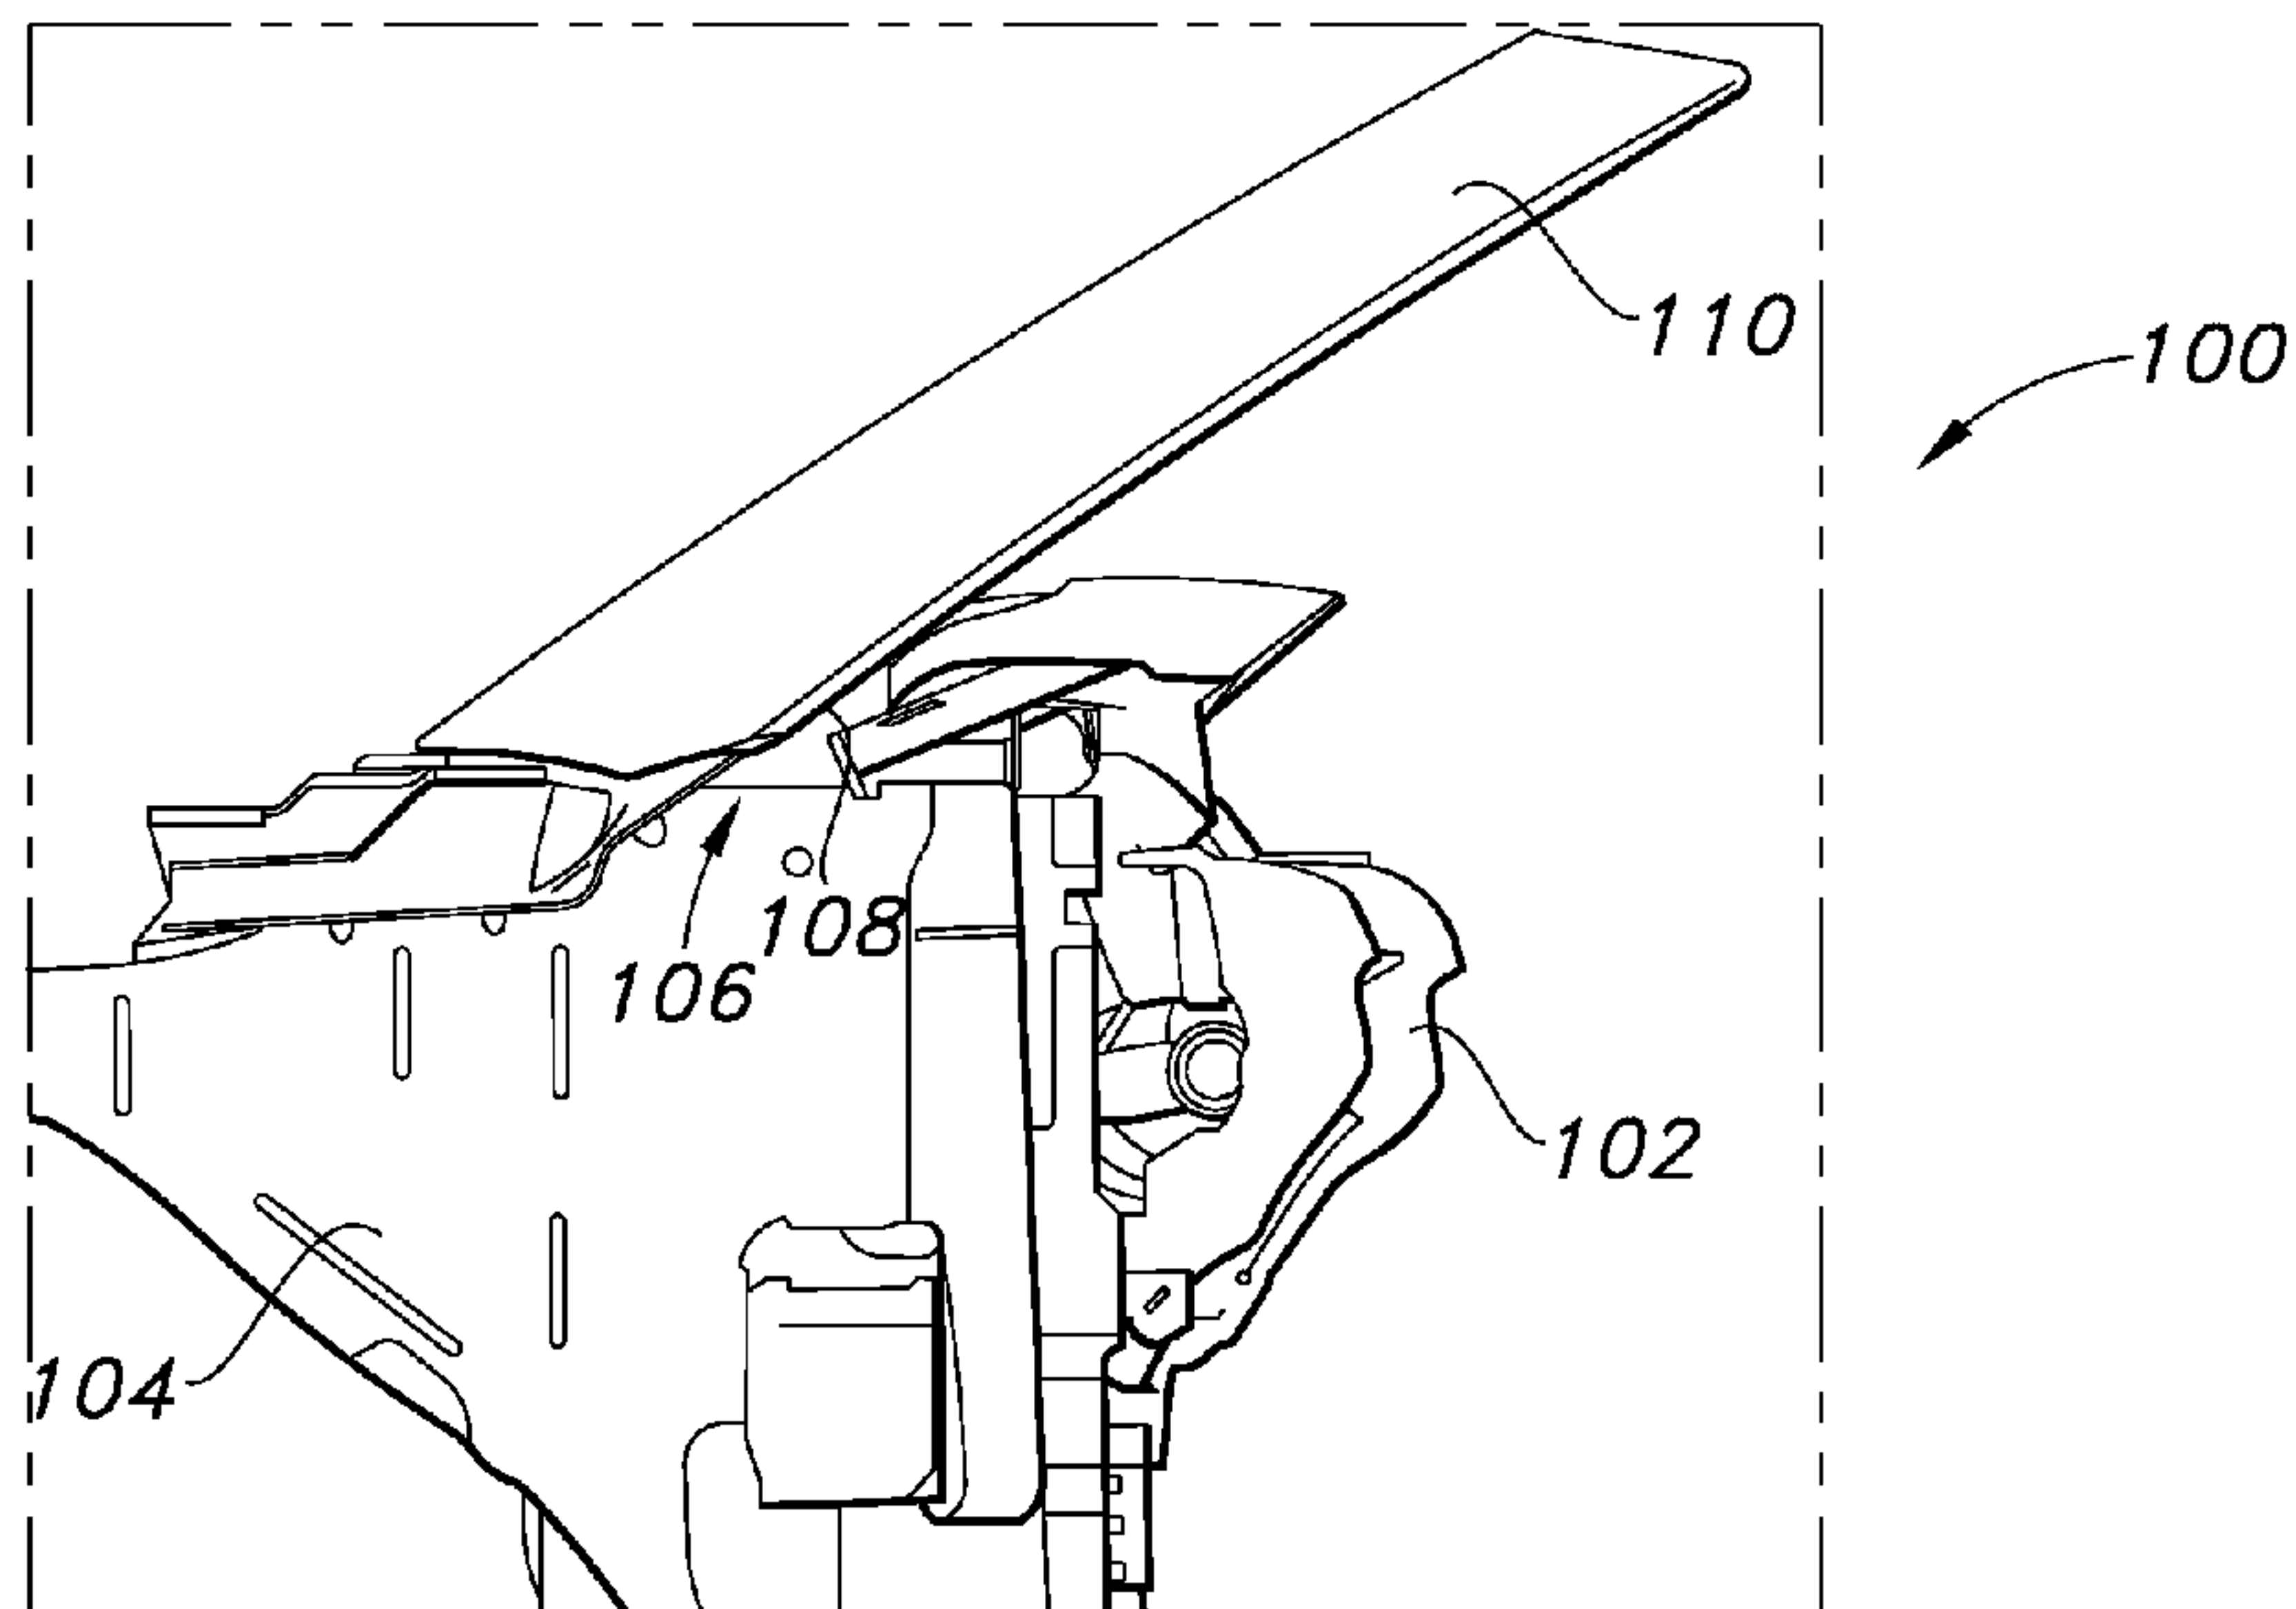
FIG. 1B
(PRIOR ART)

FIG. 1B depicts a side view of the assembly of FIG. 1A;

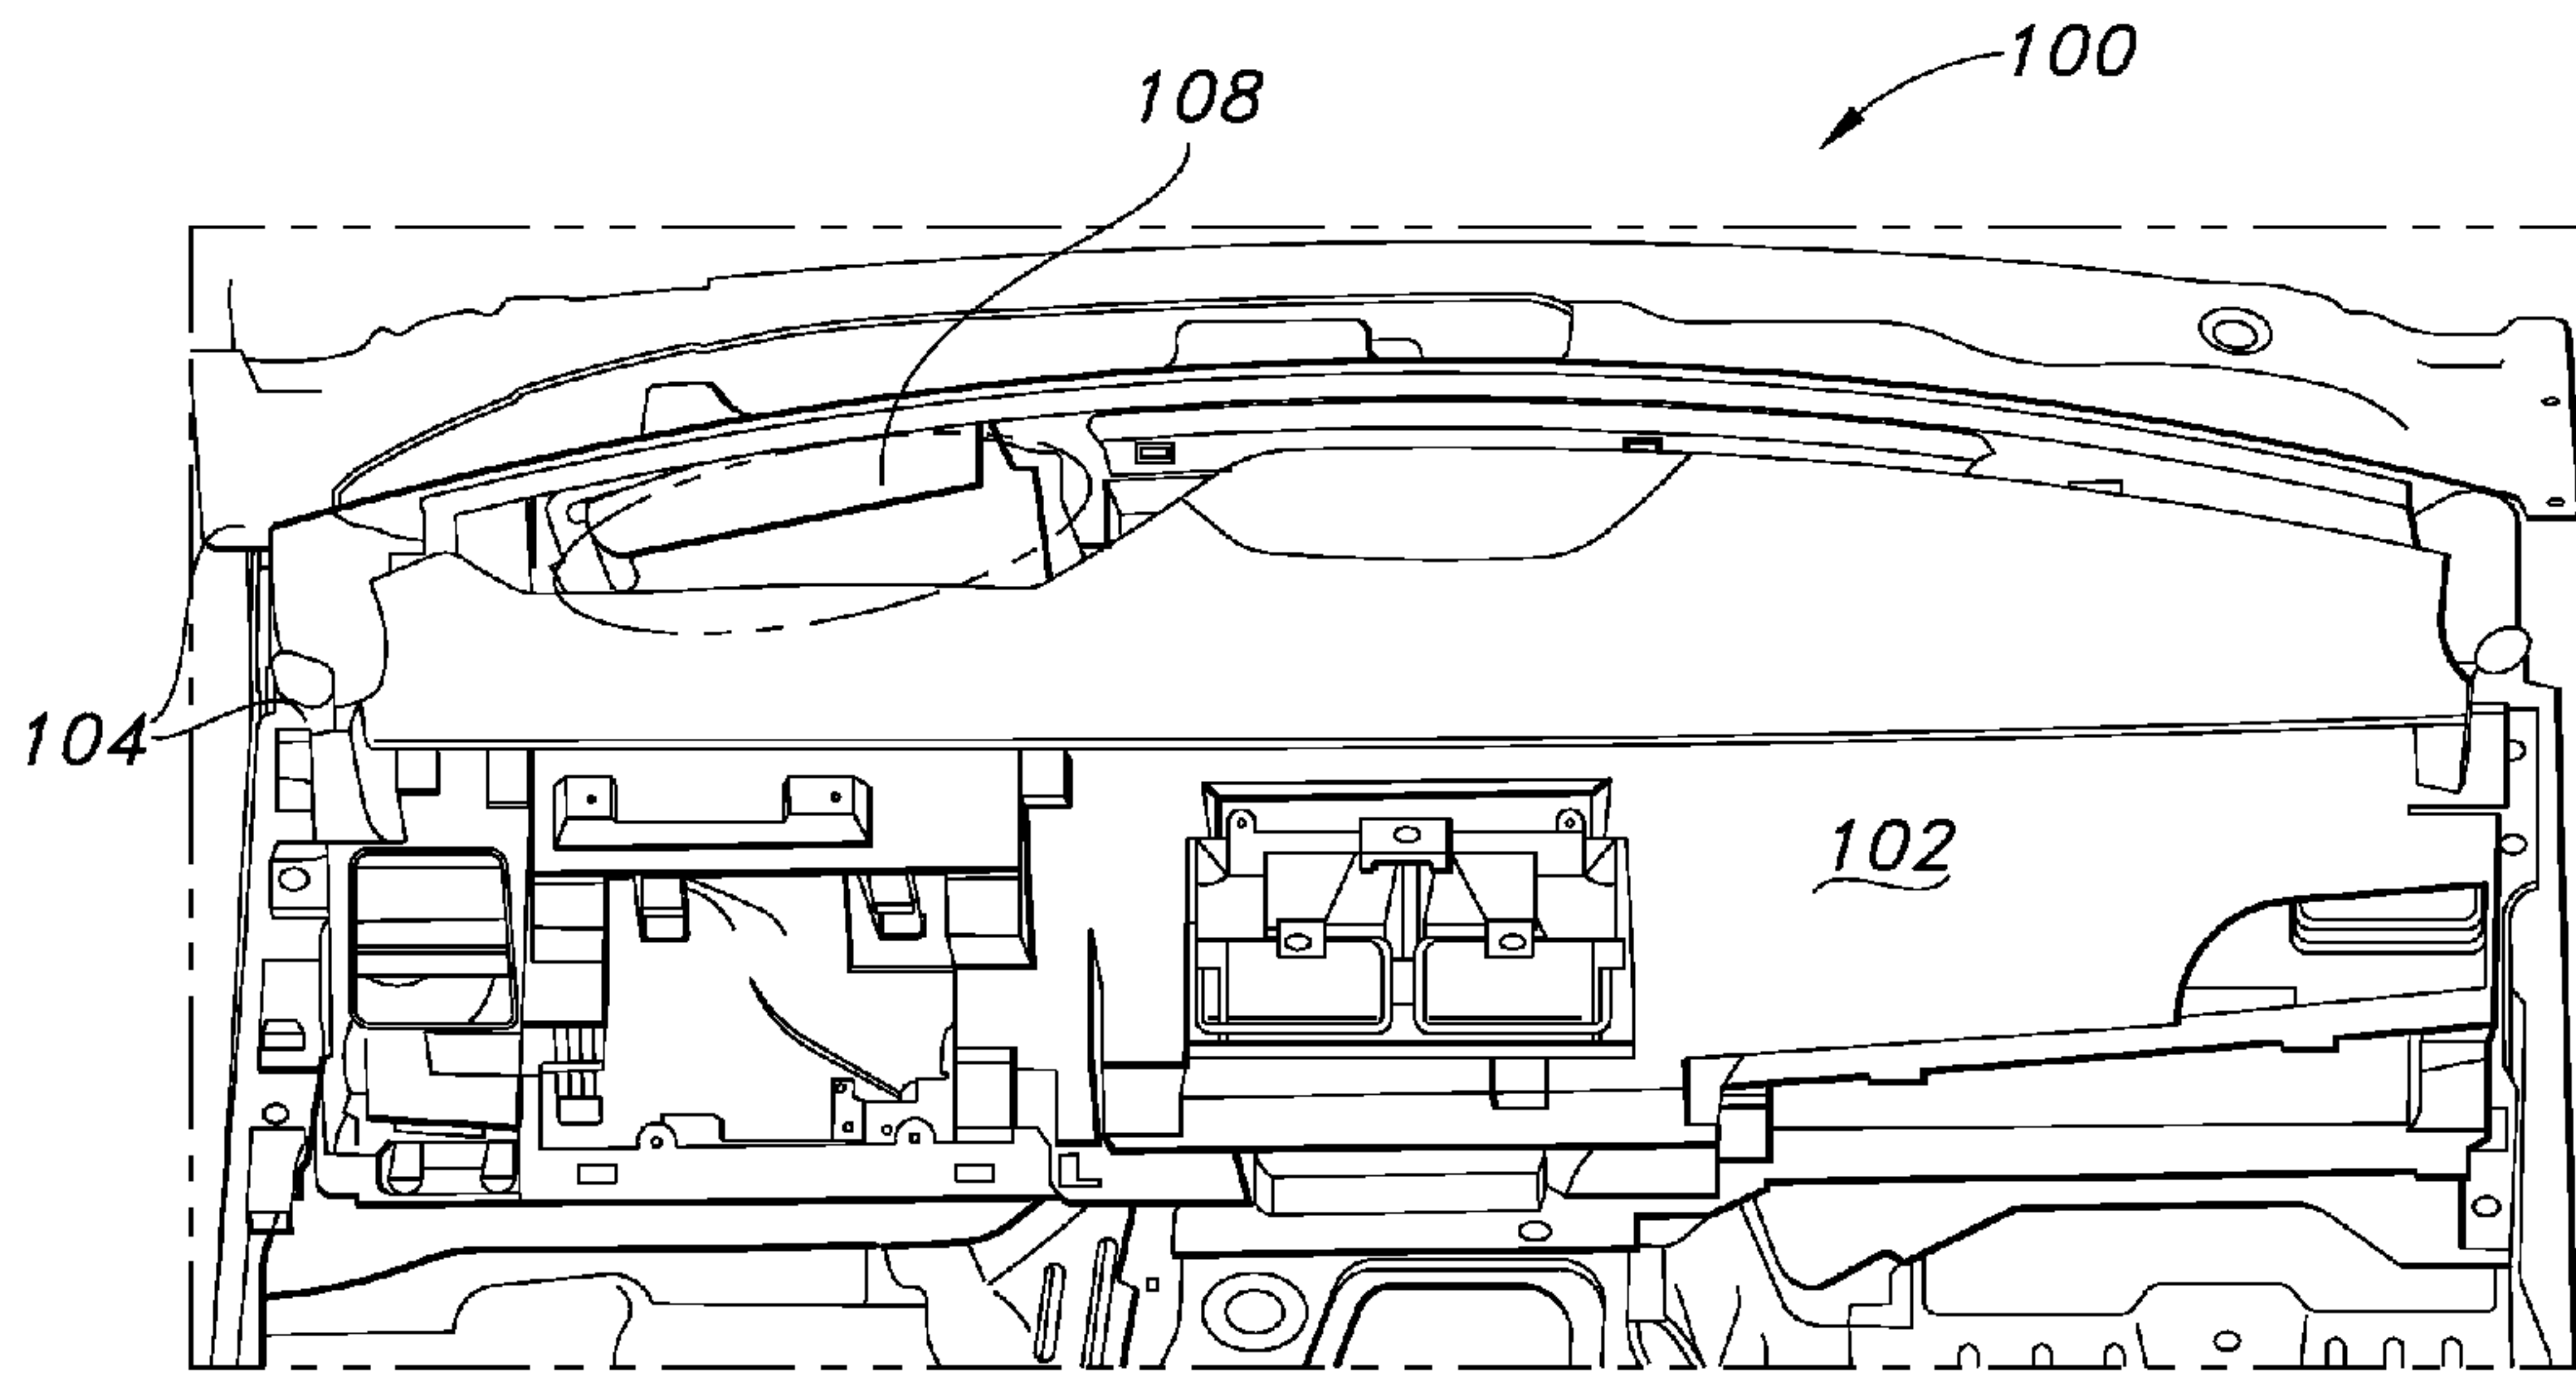
FIG. 1C
(PRIOR ART)

FIG. 1C depicts a top view of a prior art instrument panel to vehicle cowl assembly including an electronic module overlaying an attachment joint between the instrument panel and the vehicle cowl;

This is illustrated in FIG. 1C showing an electronic module 108 such as a module for a heads-up display (HUD) which for space and/or operability considerations is installed in a location preventing ready access to the instrument panel joint 106 (not visible in FIG. 3). After installation of the instrument panel 100 and HUD 108 (or other module), the vehicle windshield 110 is bonded in place to complete the assembly. In such designs, a repair or replacement strategy requiring removal of the instrument panel 100 would require first removing the vehicle windshield 110 and next the electronic module 108 to access the instrument panel joint 106. This is because in the assembled vehicle there is insufficient space between the windshield 110 and the instru-

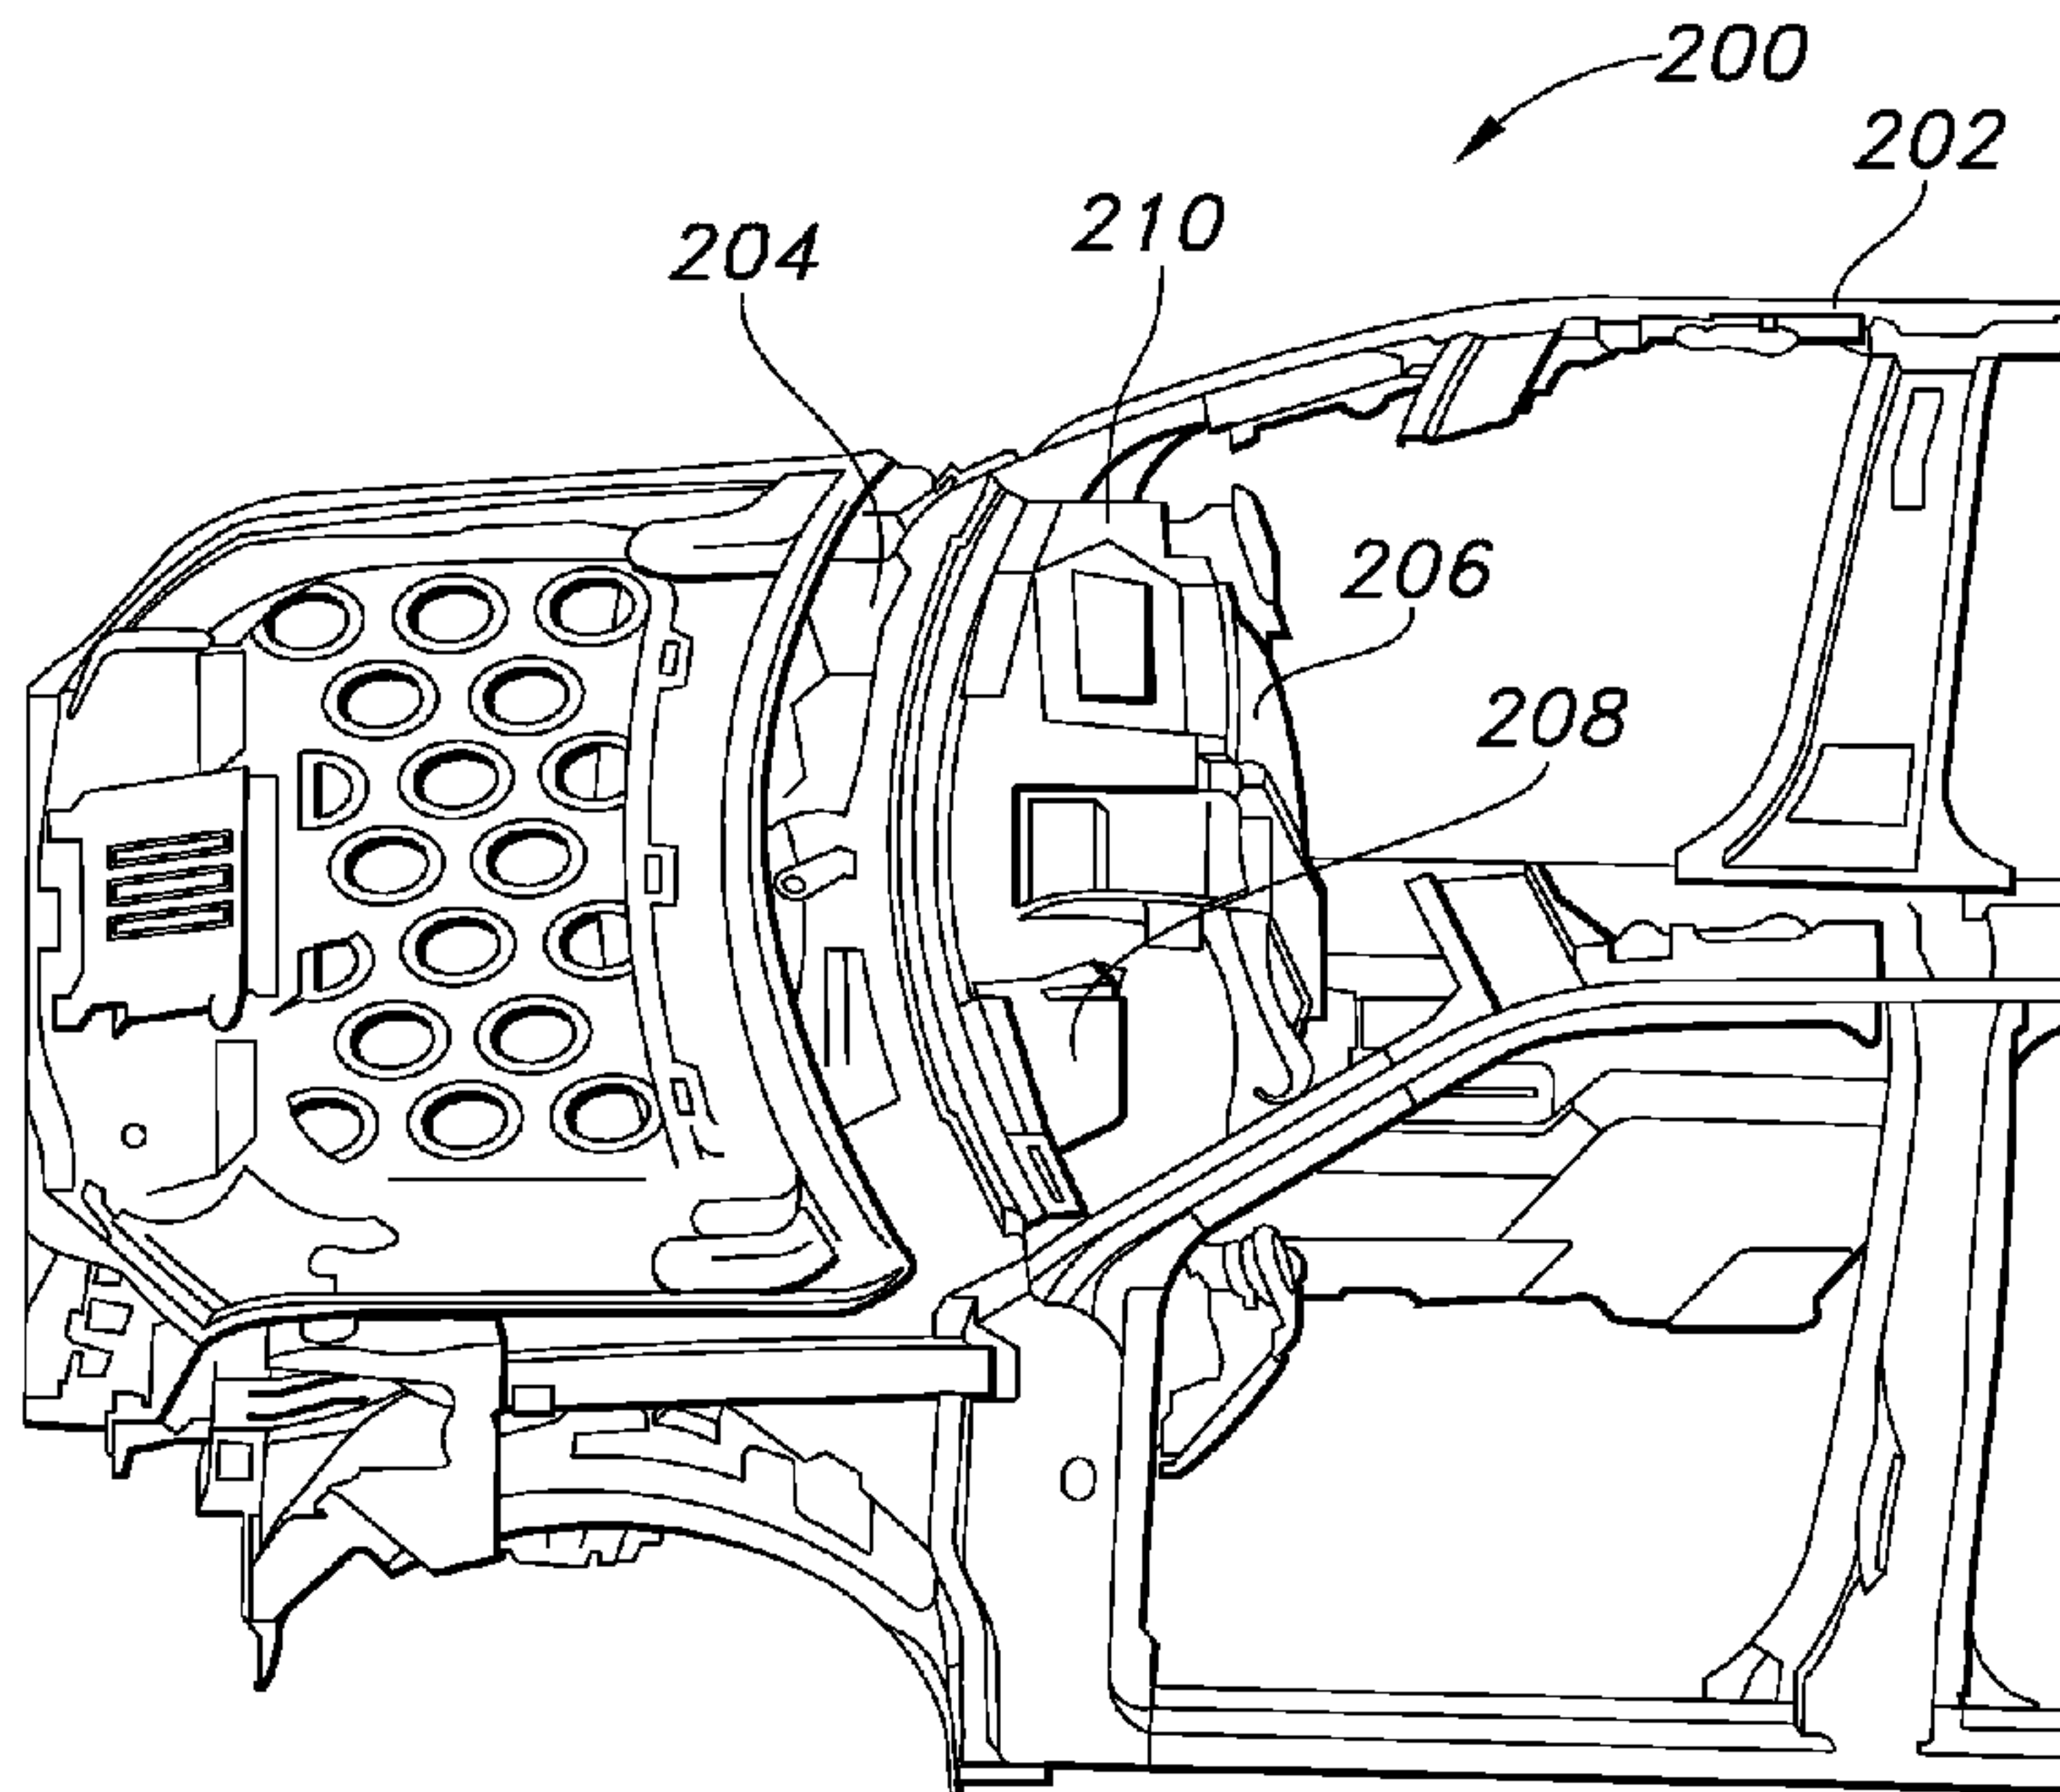
FIG. 2 depicts a vehicle including an instrument panel to vehicle cowl assembly according to the present disclosure, including an electronic module overlaying an attachment joint between the instrument panel and the vehicle cowl;

With reference to FIG. 2, a portion of a vehicle 200 is depicted including a frame 202, a cowl structure 204, and an instrument panel 206 attached to the cowl structure 204. An electronic module 208 such as an advanced heads-up display (AHUD) module overlays a site of the instrument panel attachment joint (not visible in this view). As summarized above, in a conventional vehicle assembly using a “top down” attachment of the instrument panel 206 to the vehicle cowl 204, removal of the vehicle windshield 210 and then the electronic module 208 would be required to access the attachment joint for subsequent removal of the instrument panel 204.

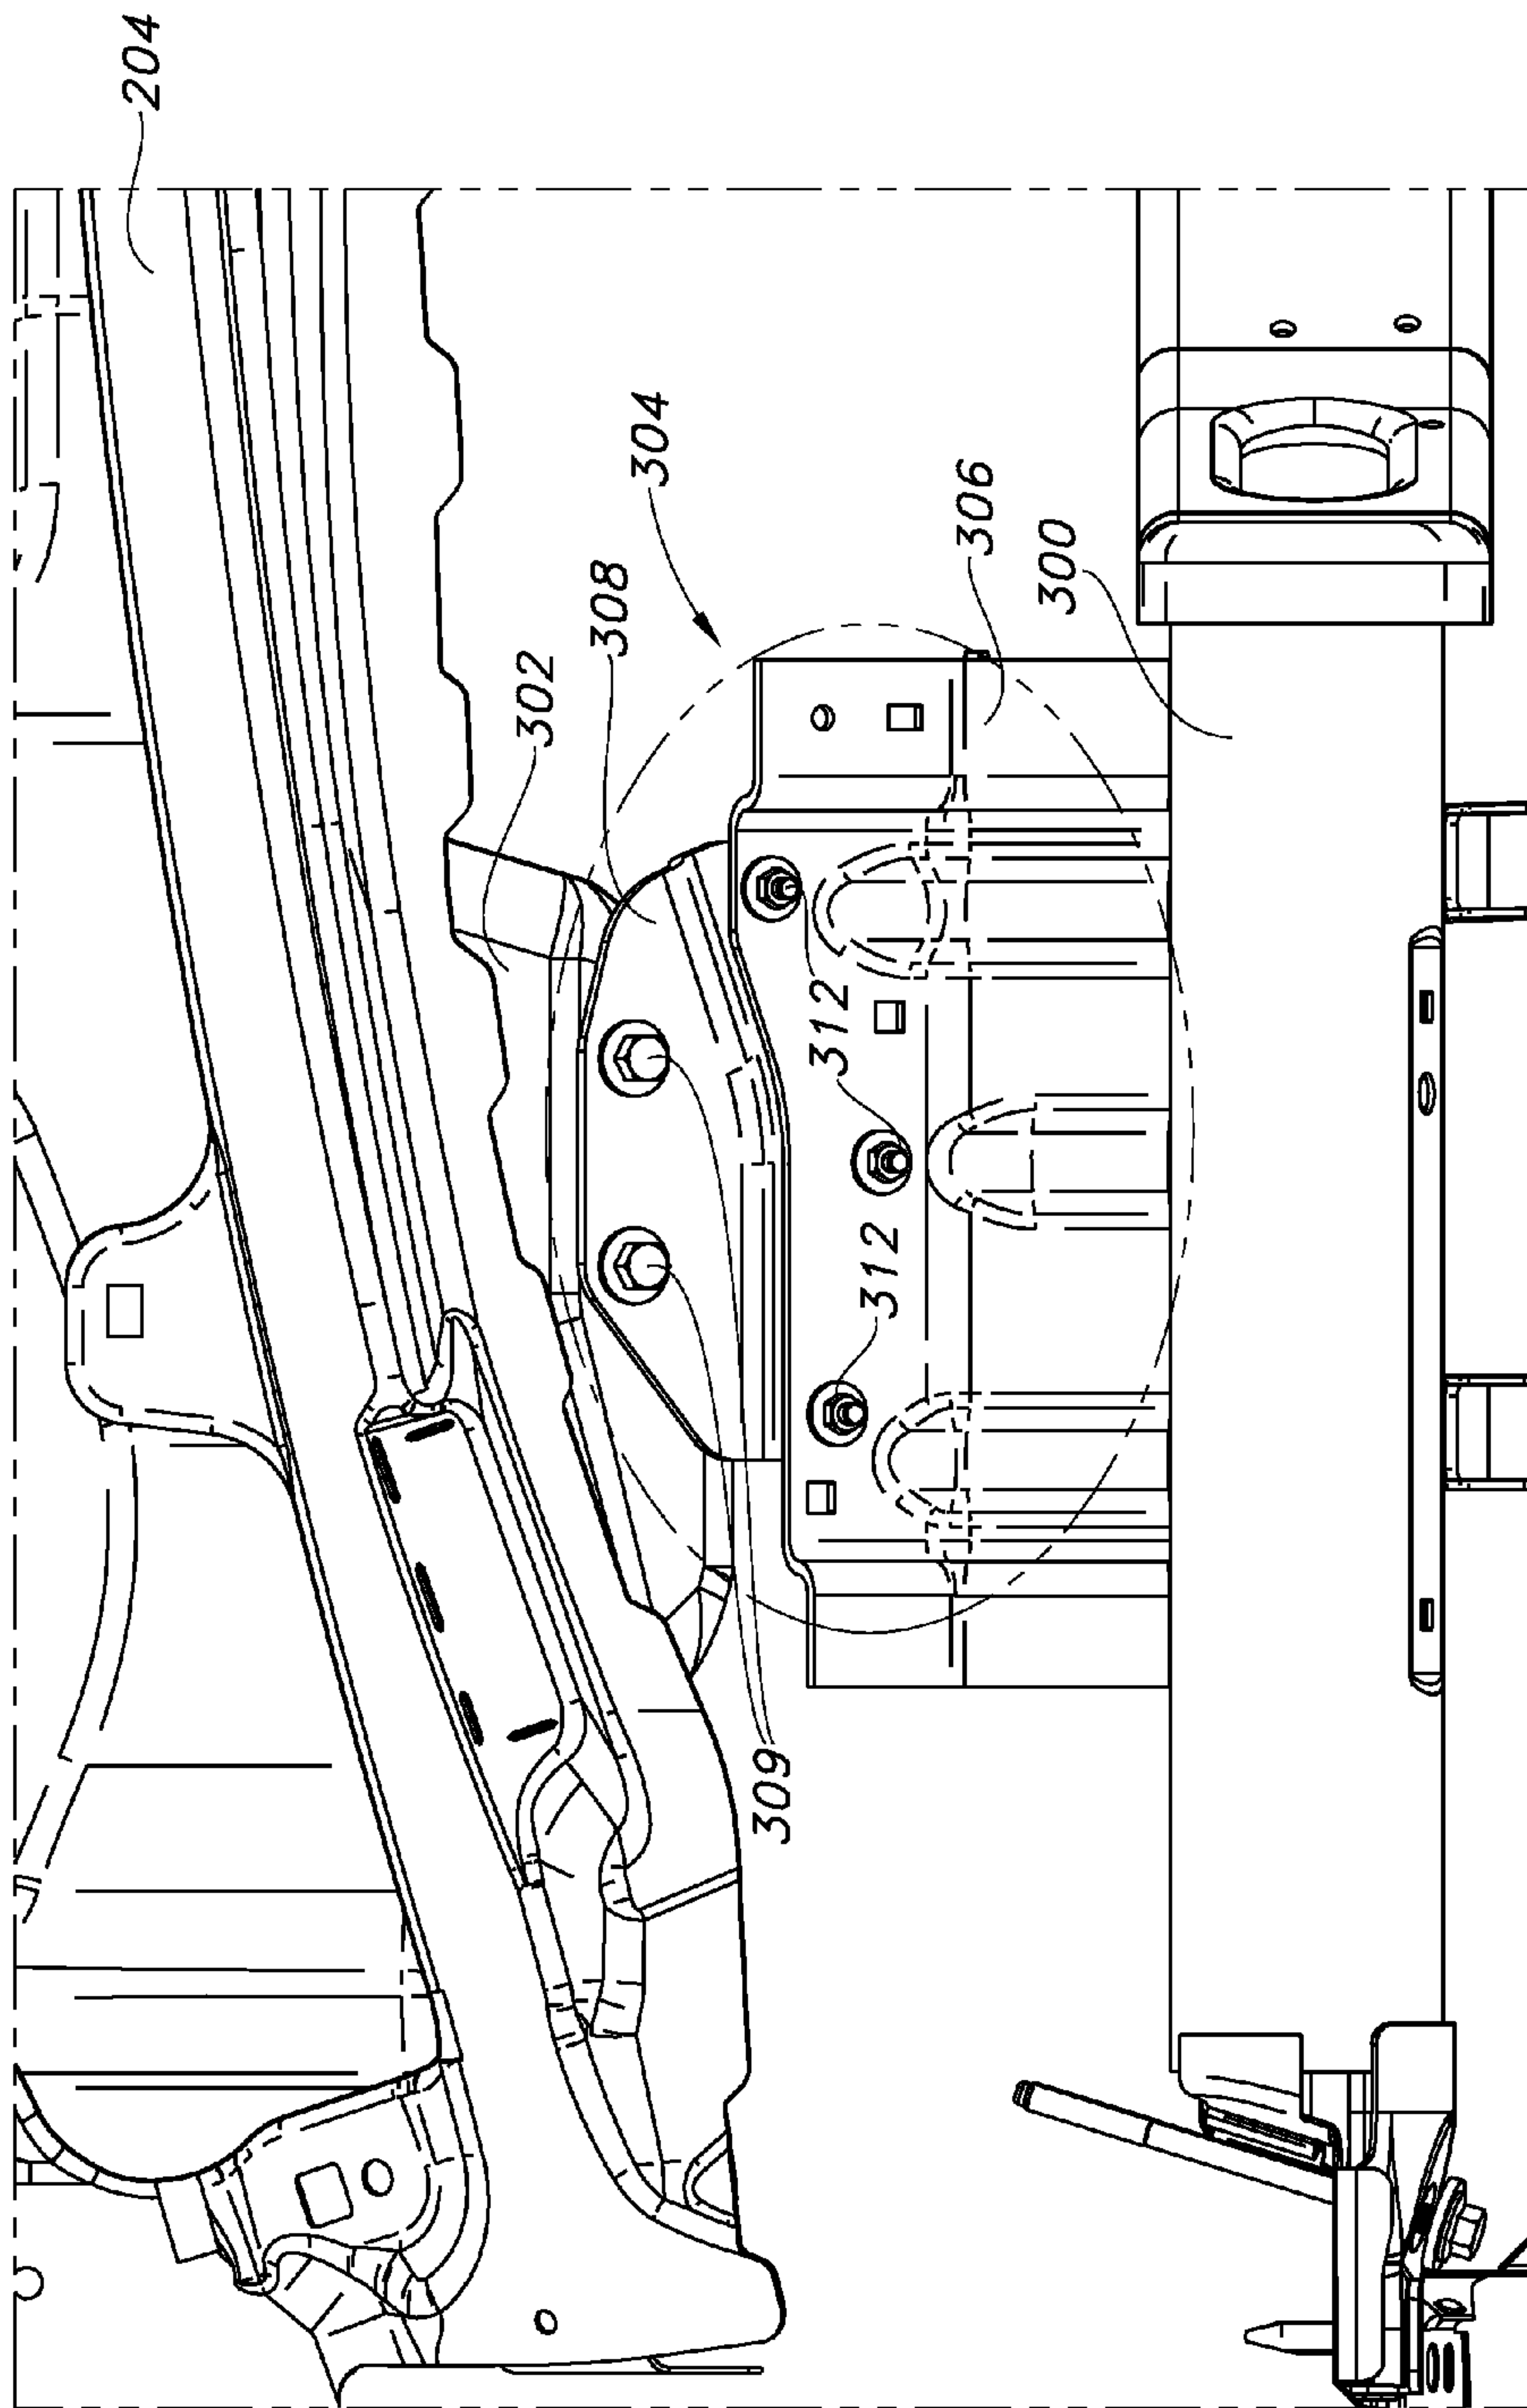
FIG. 3 depicts a top view of an attachment joint assembly according to the present disclosure;

With reference to FIG. 3, the present disclosure solves this problem by providing a split attachment bracket. As shown in the drawing figure providing a top view of the presently described bracket, the instrument panel (not shown in this view) is supported by a cross-vehicle strut 300 which is secured to the vehicle cowl 204, in the depicted embodiment to a cowl reinforcing bracket 302. This is accomplished by providing a split bracket assembly 304. In the depicted embodiment, the split bracket assembly 304 includes a cross-vehicle strut bracket 306 which is attached to a bridging bracket 308, which is in turn secured to the cowl

reinforcing bracket 302. As shown, cross-vehicle strut bracket 306 includes a plurality of through-bores 310 (not visible in this view) including fasteners 312 associated therewith, such as by welding or other suitable fastening methods. Bridging bracket 308 likewise includes through-bores 310 (not visible in this view) to allow attachment to the cowl reinforcing bracket 302 such as by bolts 309 and cooperating nuts (not shown). As shown in the figure, the bridging bracket 308 is secured to the cowl reinforcing bracket 302 in a “top down” direction.
