(10) **Patent No.:** **US 9,873,459 B2**
(45) **Date of Patent:** **Jan. 23, 2018**

(54) **INSTRUMENT PANEL SECONDARY SERVICE JOINT**

A vehicle instrument panel attachment joint assembly includes a first bracket associated with a strut holding a portion of the instrument panel and a second bracket associated with a portion of the vehicle. The assembly is configured whereby the second bracket underlies the first bracket on attachment. One or fasteners pass first through one or more second bracket through-bores and next through one or more first bracket through-bores to attach the first and second brackets one to the other. The first bracket includes one or more associated cooperating fastener receivers aligned with the one or more first bracket through-bores.

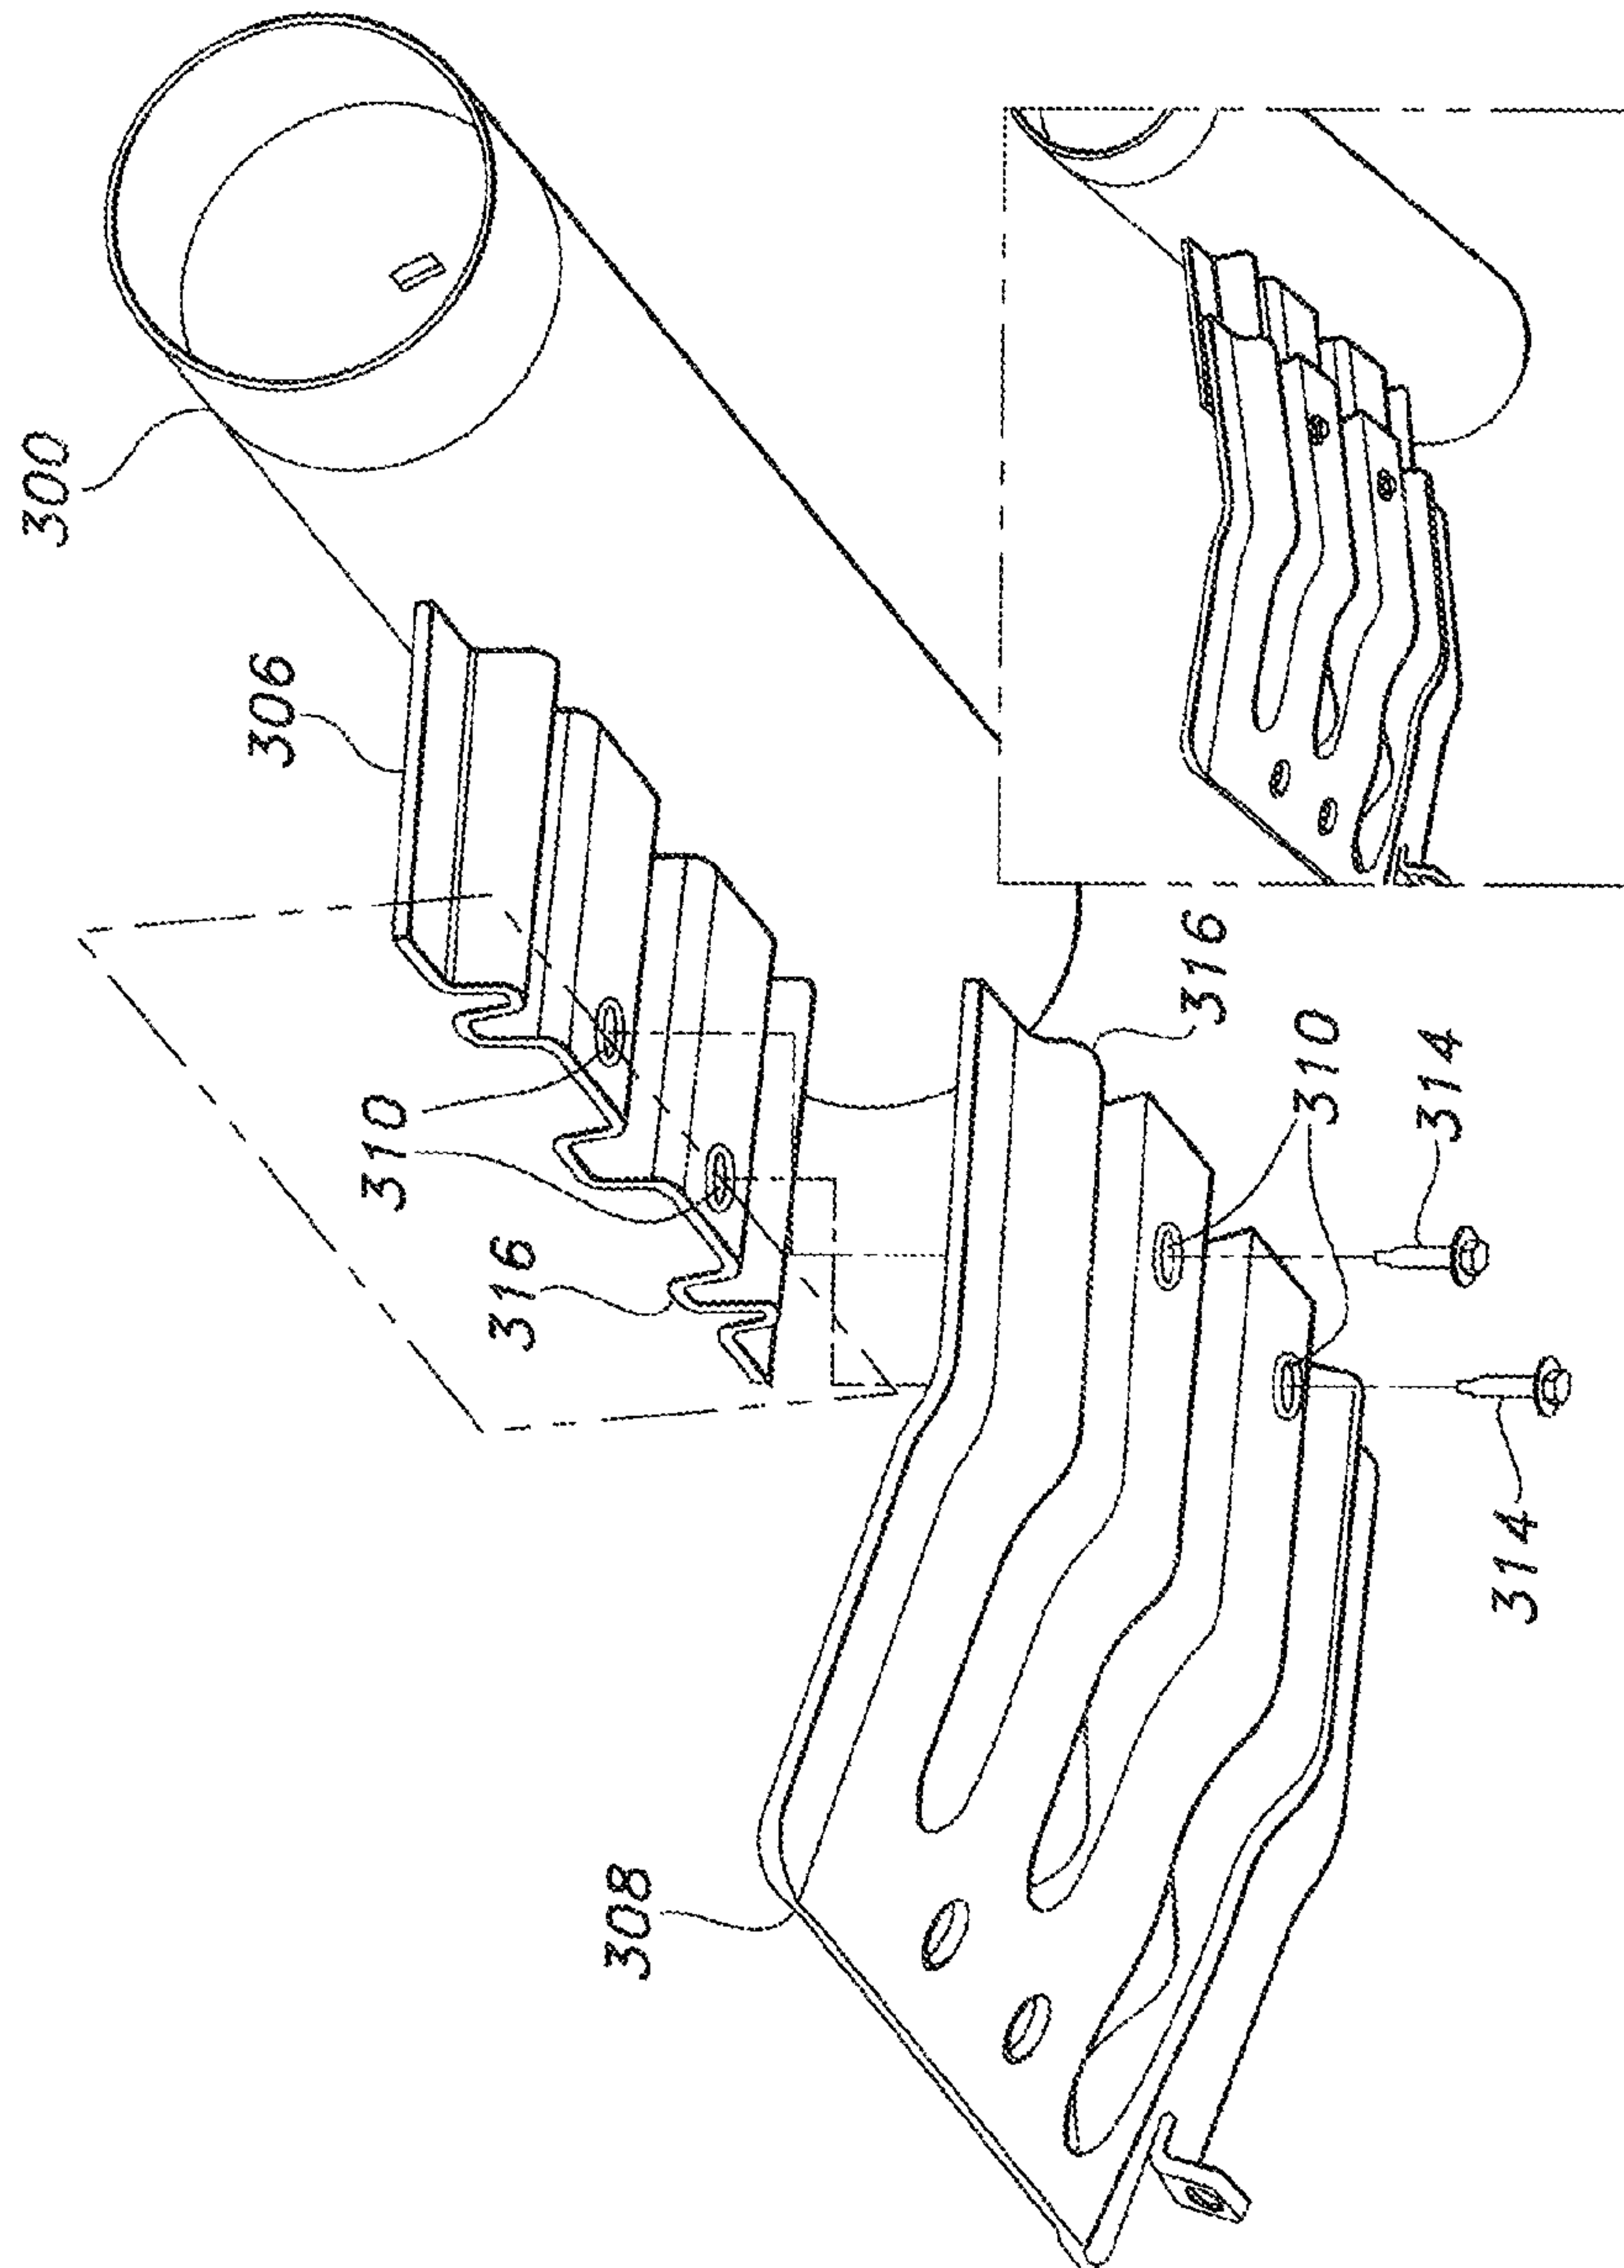
FIG. 4 depicts a bottom view of the attachment joint assembly of FIG. 3;

Turning to FIG. 4, as shown cross-vehicle strut bracket 306 is associated with the cross-vehicle strut 300. Cross-vehicle strut bracket 306 may be integrally formed with cross-vehicle strut 300 during fabrication, or may be attached thereto by suitable fastening means. As described above, apertures 310 include associated fasteners 312 (not visible in this view) for receiving and securing cooperating structures. In the depicted embodiment, fasteners 312 are nuts welded or otherwise secured to a top surface of the cross-vehicle strut bracket 306 and aligned with through-bores 310 for receiving cooperating bolts 314. Of course, the skilled artisan will readily appreciate that alternative fastener systems are suitable, including without intending any limitation screws, threaded speed nuts, and the like.

As depicted, each of cross-vehicle strut bracket 306 and bridging bracket 308 include mating ridges 316 formed therein to ensure a tight nesting fit therebetween. However, alternative structures/configurations for the brackets 306/308 are possible to provide the desired nesting fit, and are contemplated for use herein. During assembly, the cross-vehicle strut bracket 306 and the bridging bracket 308 are nested and secured one to another in a “bottom up” fashion as shown, with the bridging bracket 308 underlying the cross-vehicle strut bracket 306. It will be appreciated that the specific orientation of nuts 312 and bolts 314 could be reversed, i.e. with the bolts 314 secured to the cross-vehicle strut bracket 306 and passing through through-bores 310, while still preserving the desired “bottom up” fastening of the cross-vehicle strut bracket 306 to the bridging bracket 308.

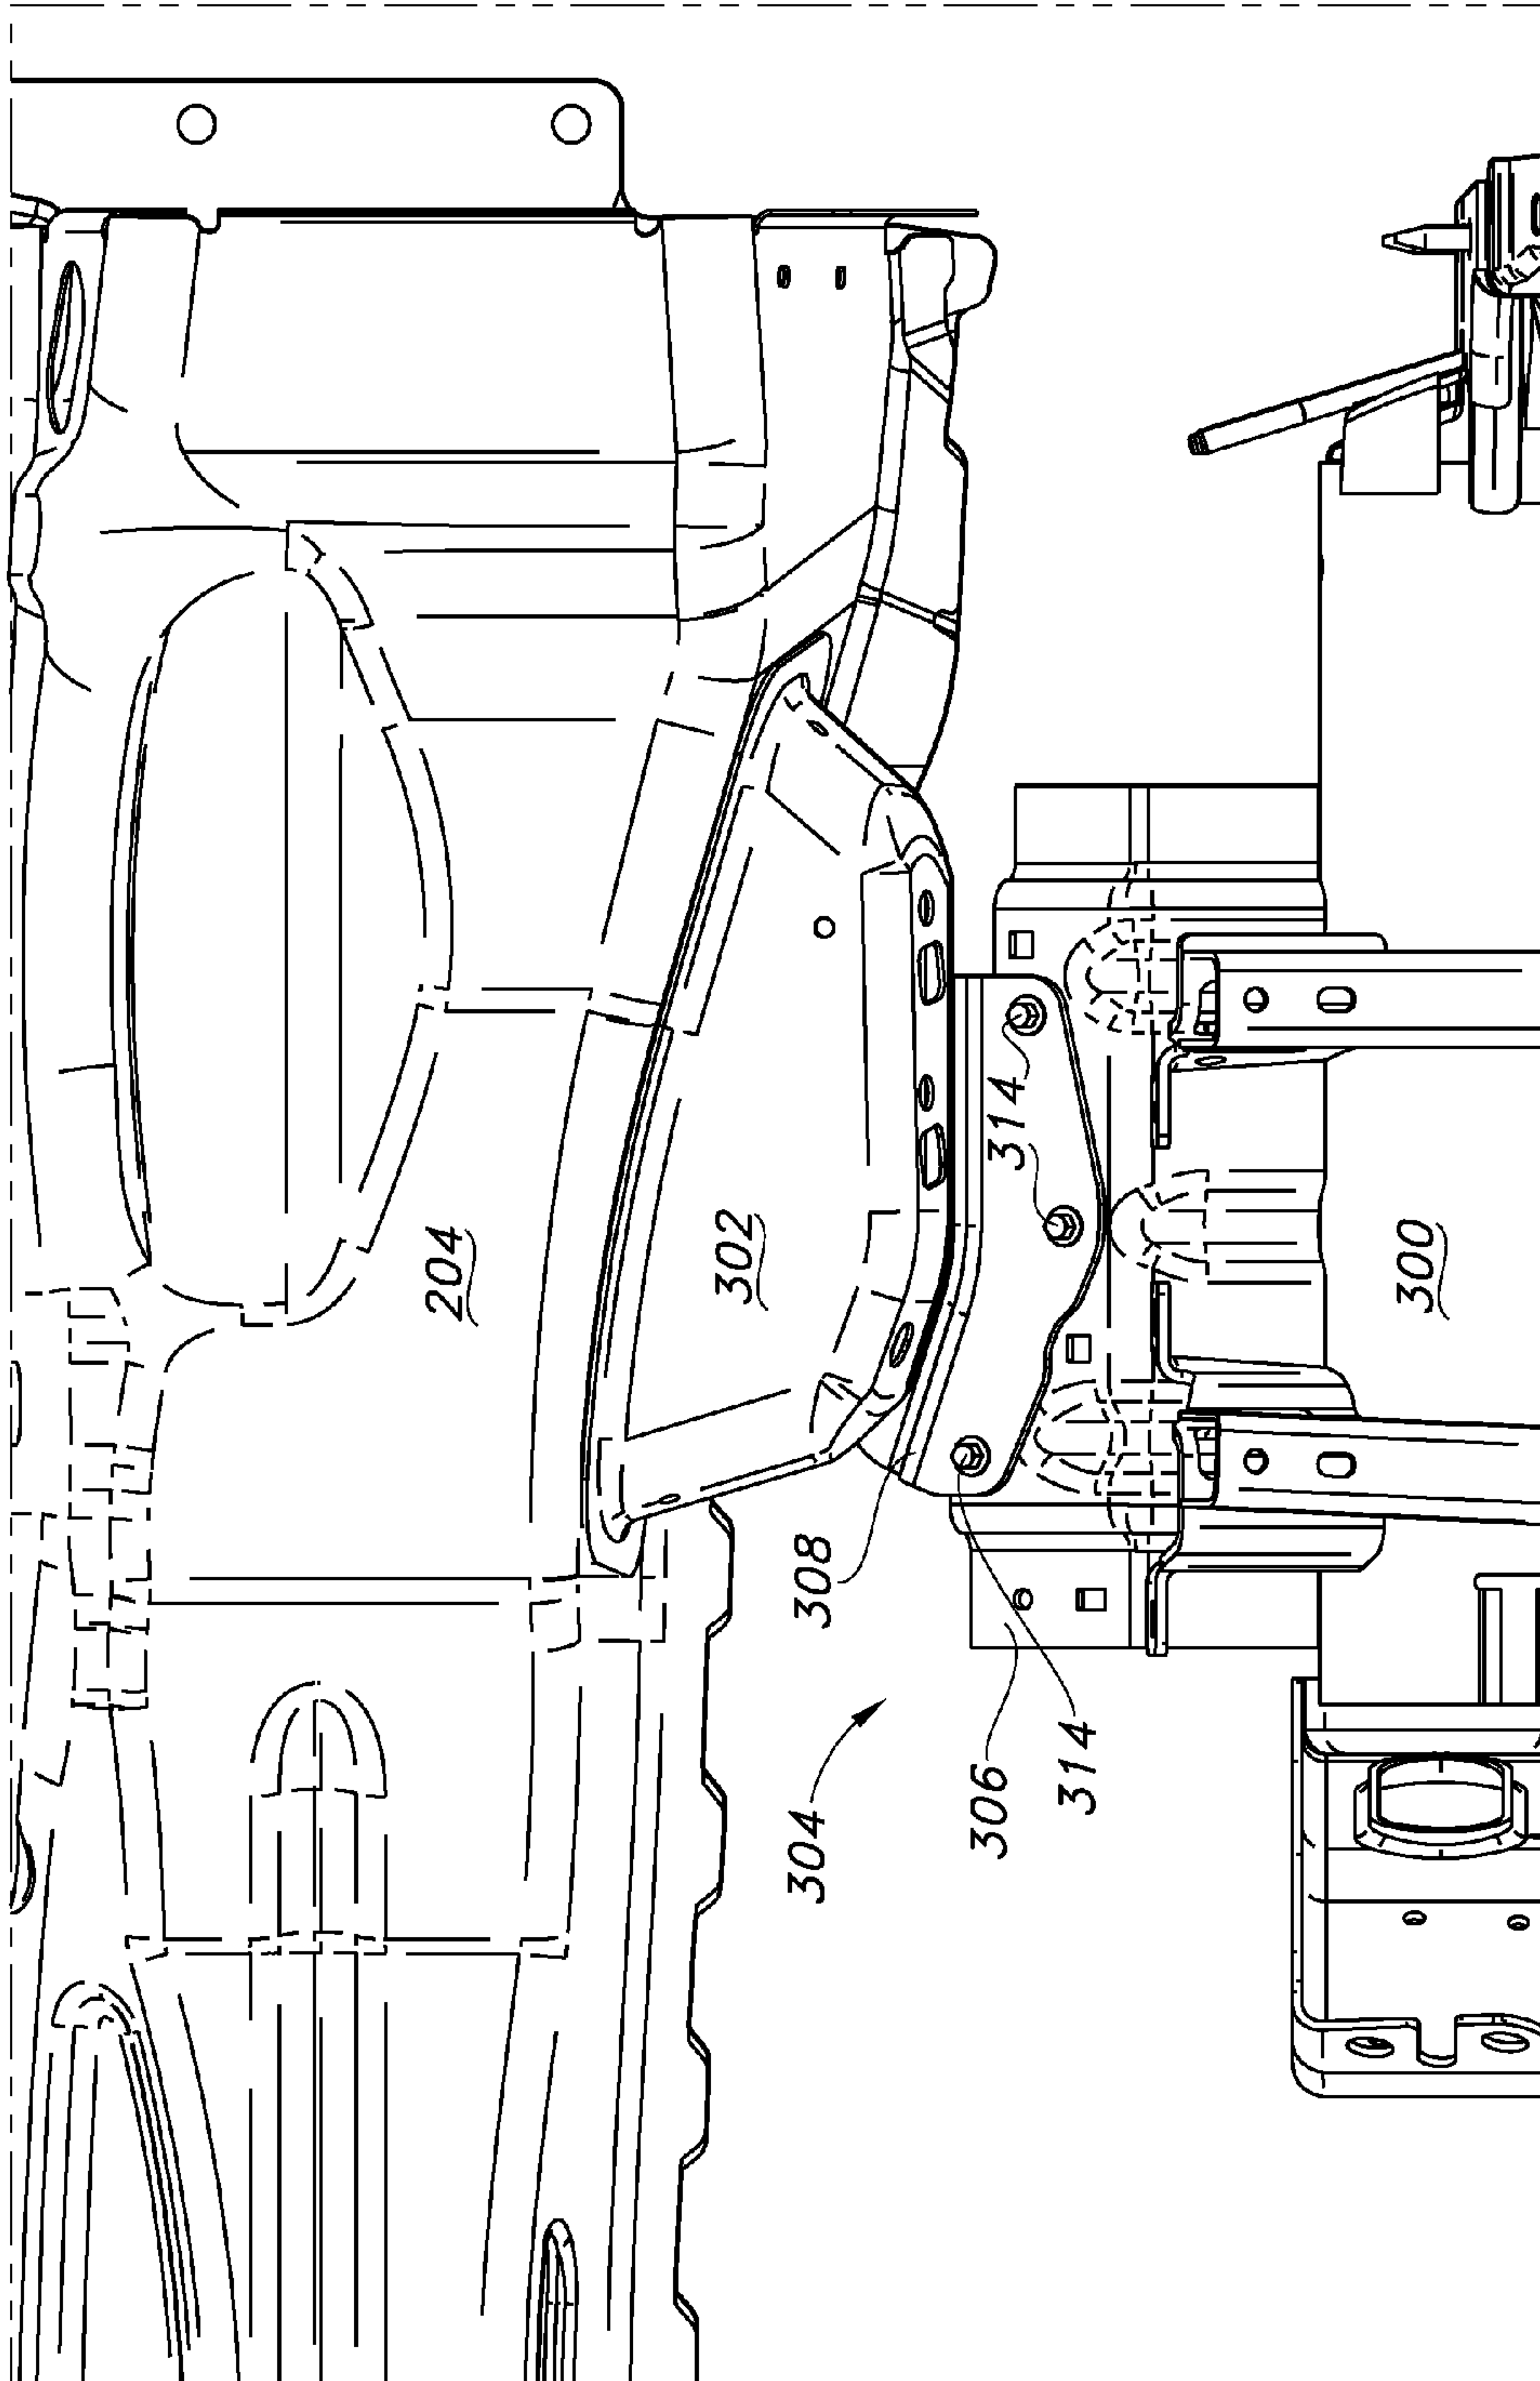
FIG. 5 depicts a bottom view of an instrument panel to vehicle cowl assembly including the attachment joint assembly of FIG. 3; and

FIG. 5 shows a bottom view of the cross-vehicle strut 300 attached to the cowl reinforcing bracket 302 using the described split bracket assembly 304. As will be appreciated, ready access to fasteners 314 for removal is possible due to the described “bottom up” attachment of the cross-vehicle strut bracket 306 to the bridging bracket 308, simply by removing fasteners 314 and separating the cross-vehicle strut bracket 306 from the bridging bracket 308 to allow removal of the instrument panel. Thus, as shown in FIG. 6, the split bracket assembly 304 is easily accessible from underneath the instrument panel 206 (see arrow) for removal of the instrument panel to allow repair or replacement of components thereof.

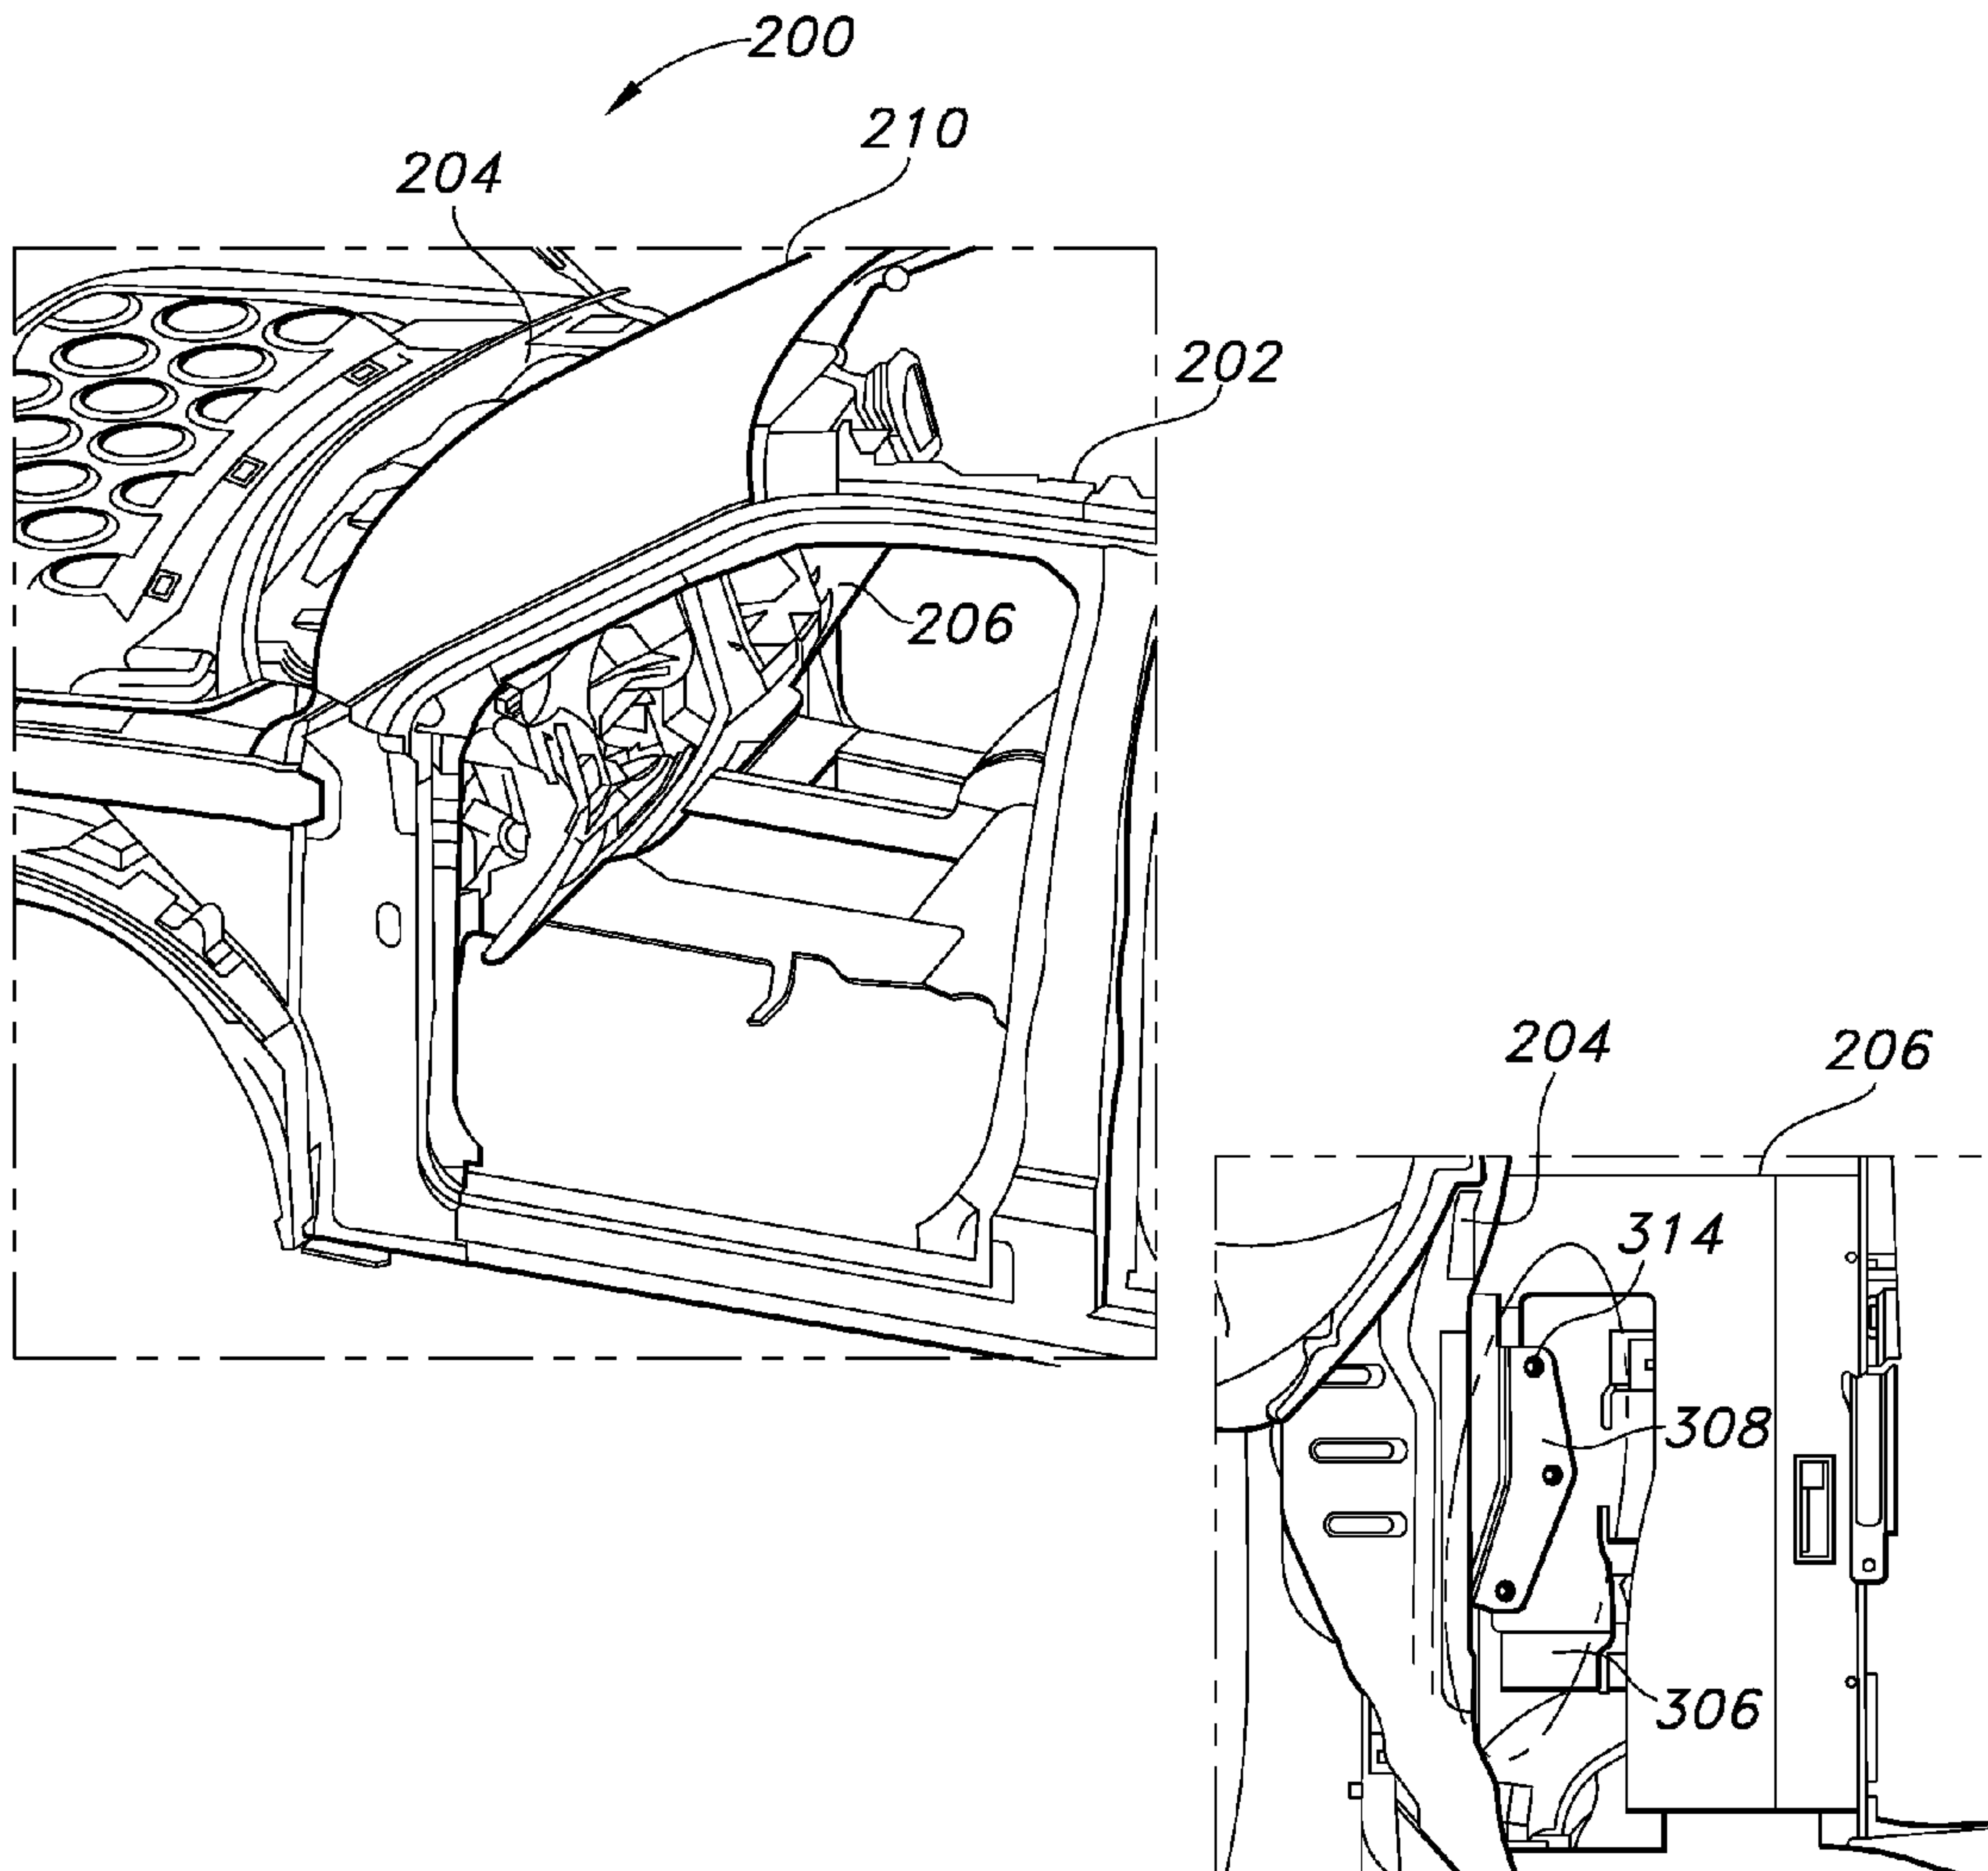
FIG. 6 depicts a vehicle including the instrument panel to vehicle cowl assembly of FIG. 5.
