(10) **Patent No.:** **US 9,950,873 B2**
(45) **Date of Patent:** **Apr. 24, 2018**

(54) **CONVEYOR INSPECTION WITH UNMANNED VEHICLE CARRYING SENSOR STRUCTURE**

(73) Assignee: **ABB Schweiz AG**, Baden (CH)

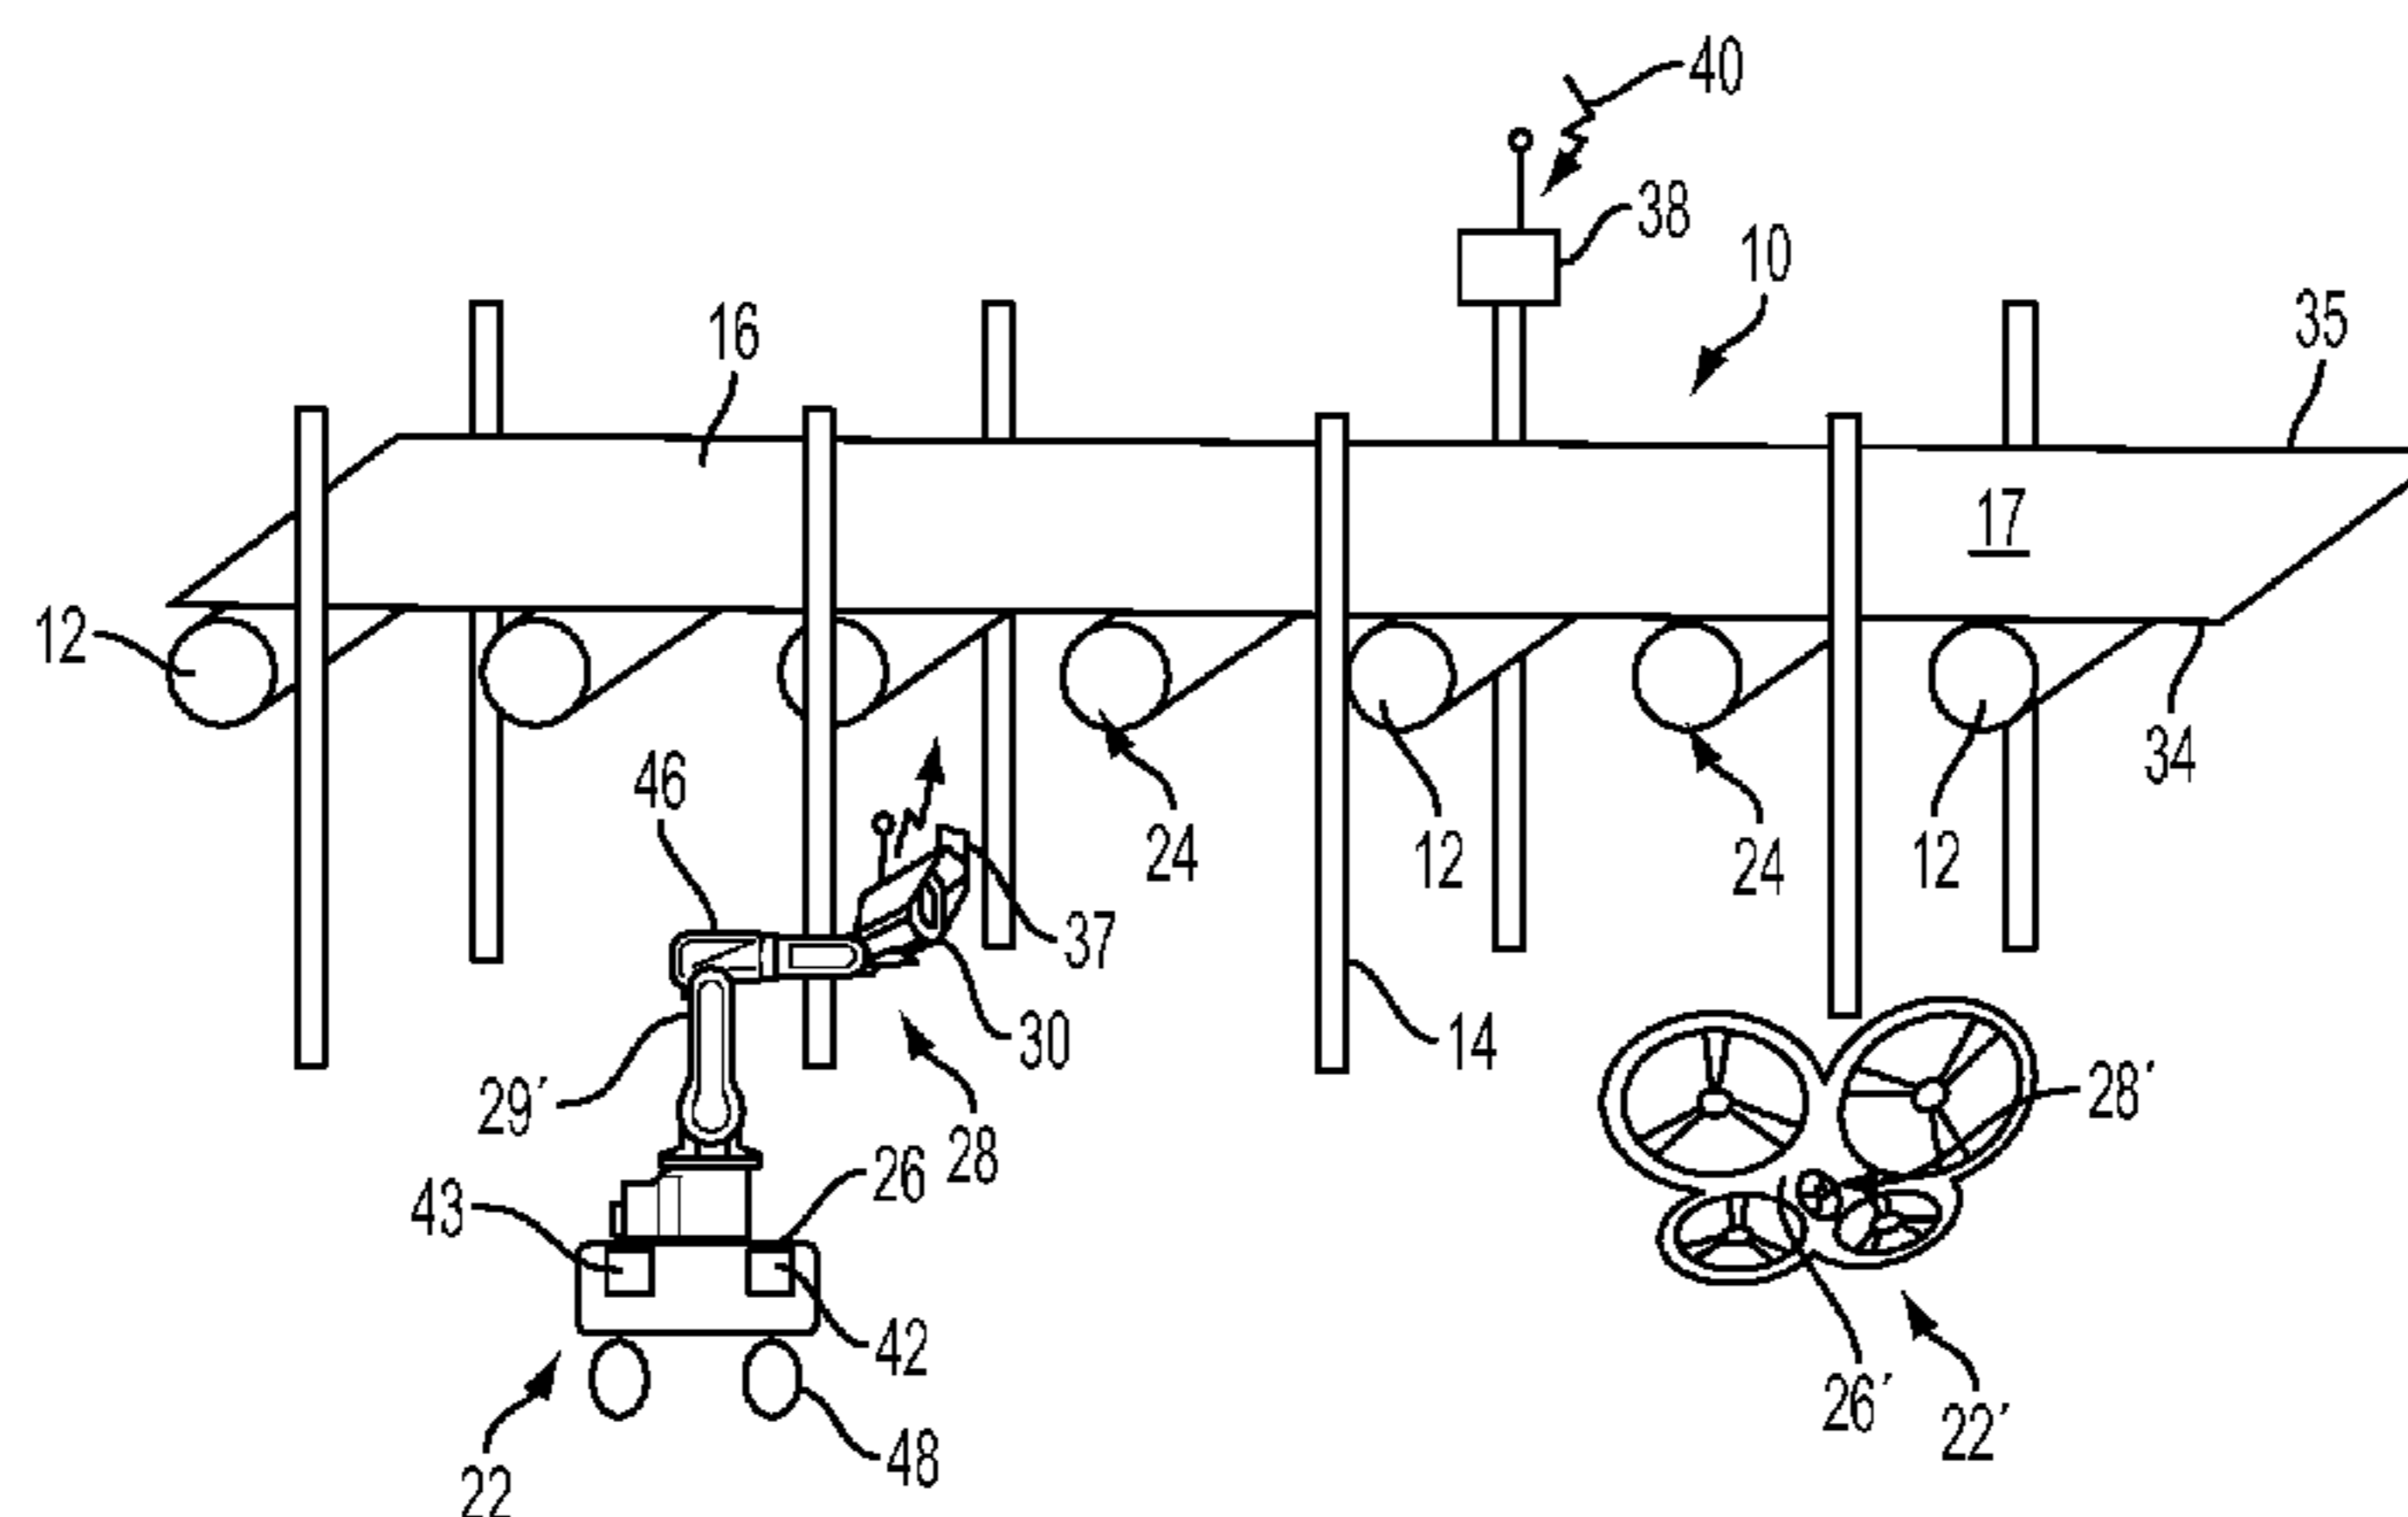
A method inspects a conveyor (10) having opposing sides (34, 35) and a length. The conveyor includes an endless belt (16) and a plurality of roller structures (24) disposed in

spaced relation along at least a portion of the length of the conveyor and under a top flight (17) of the belt for supporting the belt while material is being conveyed on the belt. Each roller structure includes at least one roller (12, 12') constructed and arranged to rotate about an axis as the belt is conveyed with the material. The method orients an unmanned vehicle (22), having sensor structure (28) thereon, at one side of the conveyor, and causes the vehicle to travel along the portion of the length of the conveyor while the sensor structure obtains data regarding a state of at least a portion of the belt and of rollers of the plurality of roller structures while the conveyor is operating.

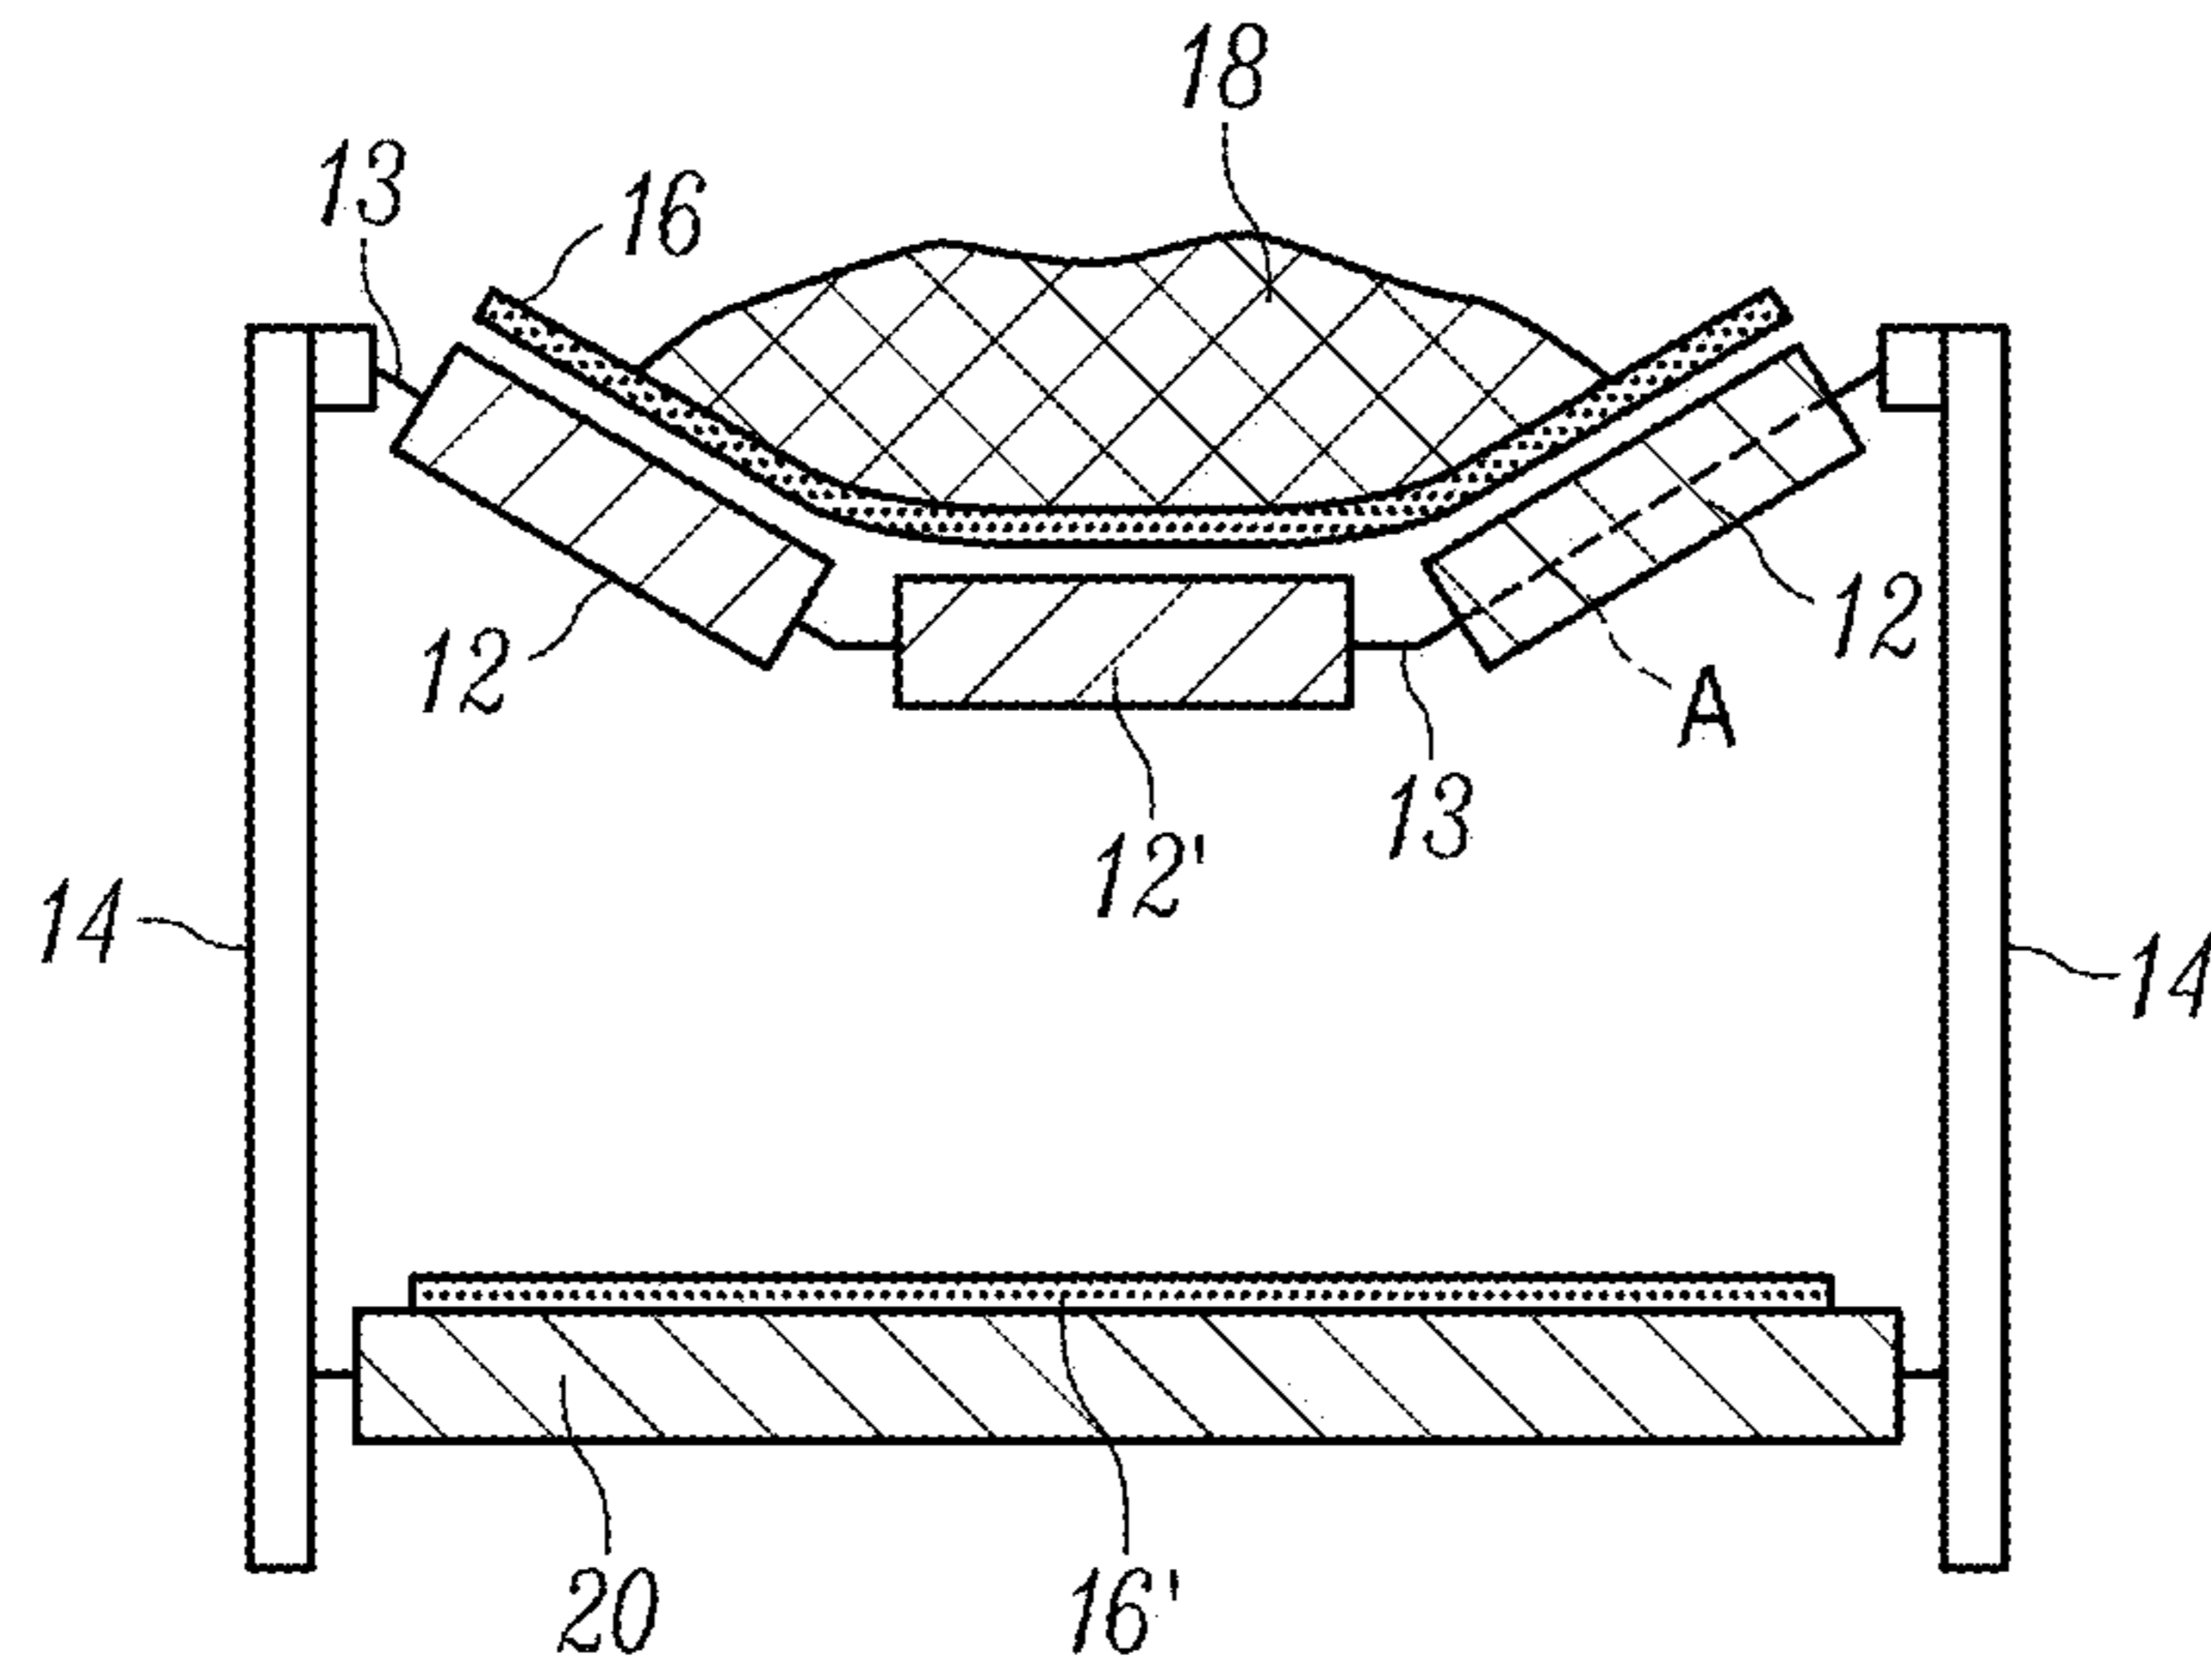
FIG. 1
(PRIOR ART)

FIG. 1 shows a sectional view of a portion of a conventional large conveyor, generally indicated 10, which is typically used in mining operations. A set of idlers or upper rollers is carried by a frame 14 and include outer rollers 12 and a central roller 12'. The rollers 12, 12' rotate with respect to the moving, endless belt 16 that carries the material 18. The rollers 12, 12' are provided to ensure that the belt 16 defines a trough for the material 18. A plurality of sets of the rollers is spaced to support the belt 16 along the length of the conveyor 10. Lower rollers 20 support the returning portion of the belt 16'.

FIG. 1 is a sectional view of a portion of a conventional conveyor showing the belt and upper and lower rollers thereof.

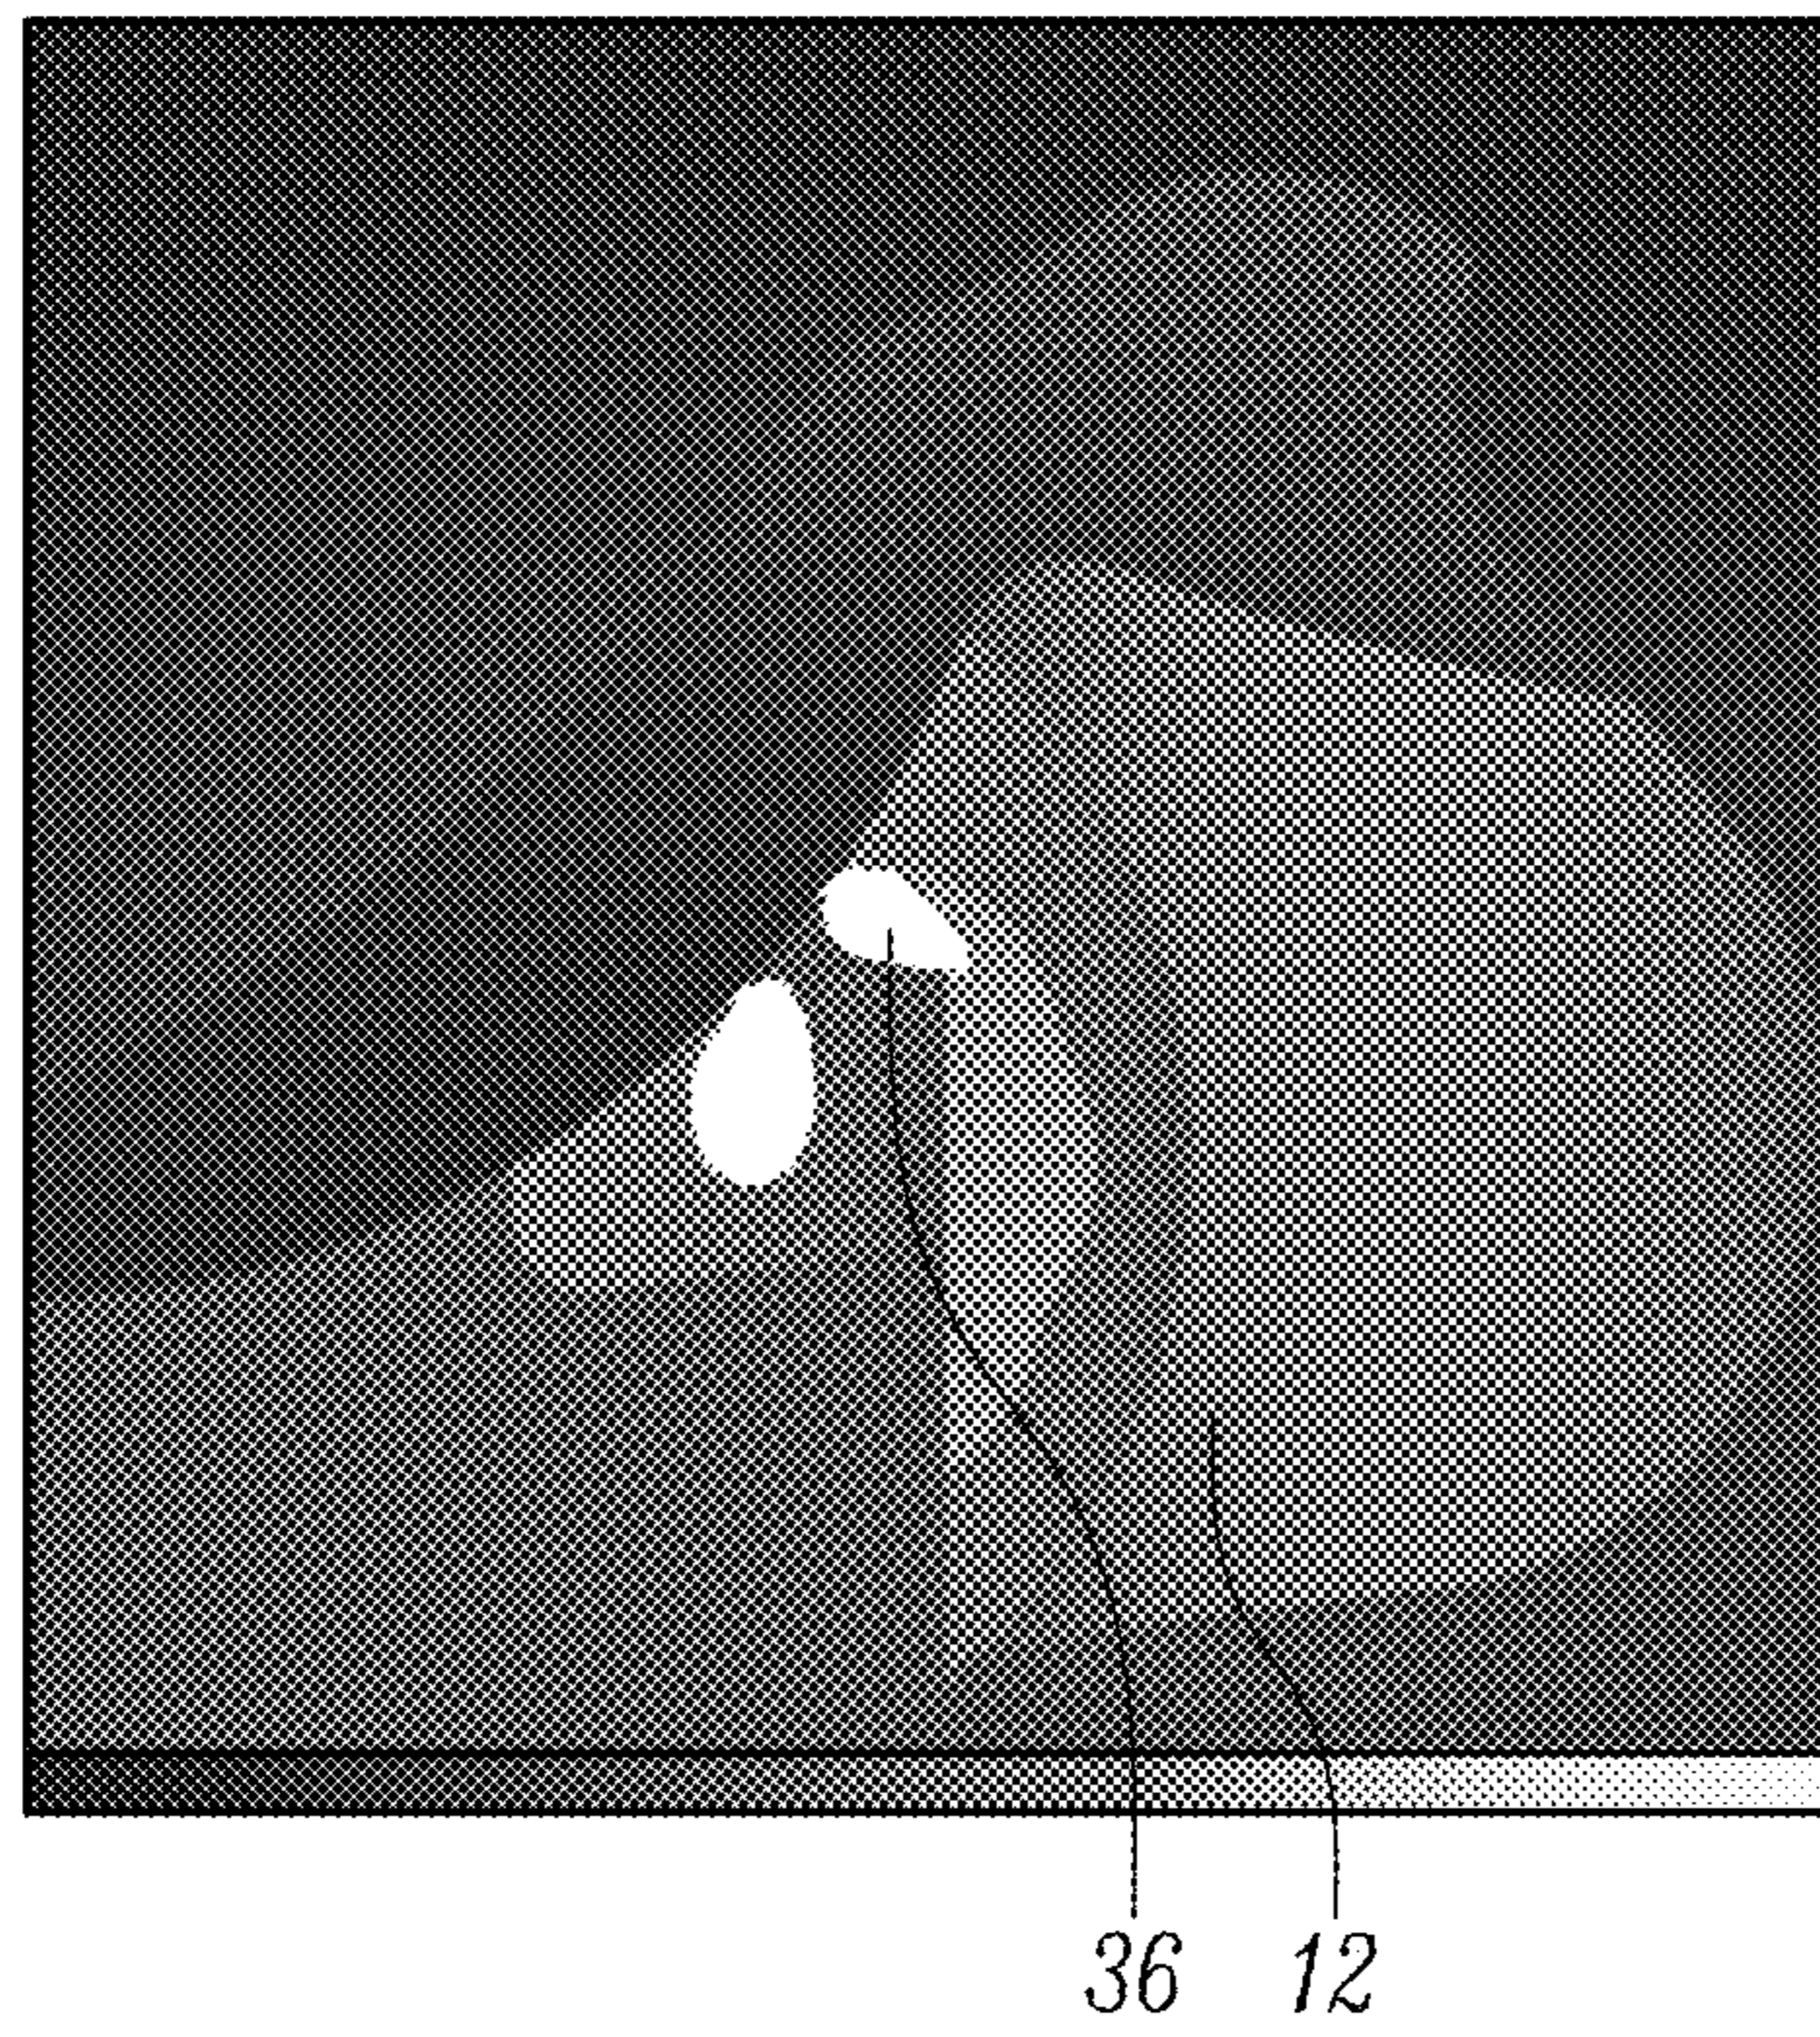
FIG. 3 is a thermal scan of a roller of the conveyor of FIG. 2 using the sensor structure.

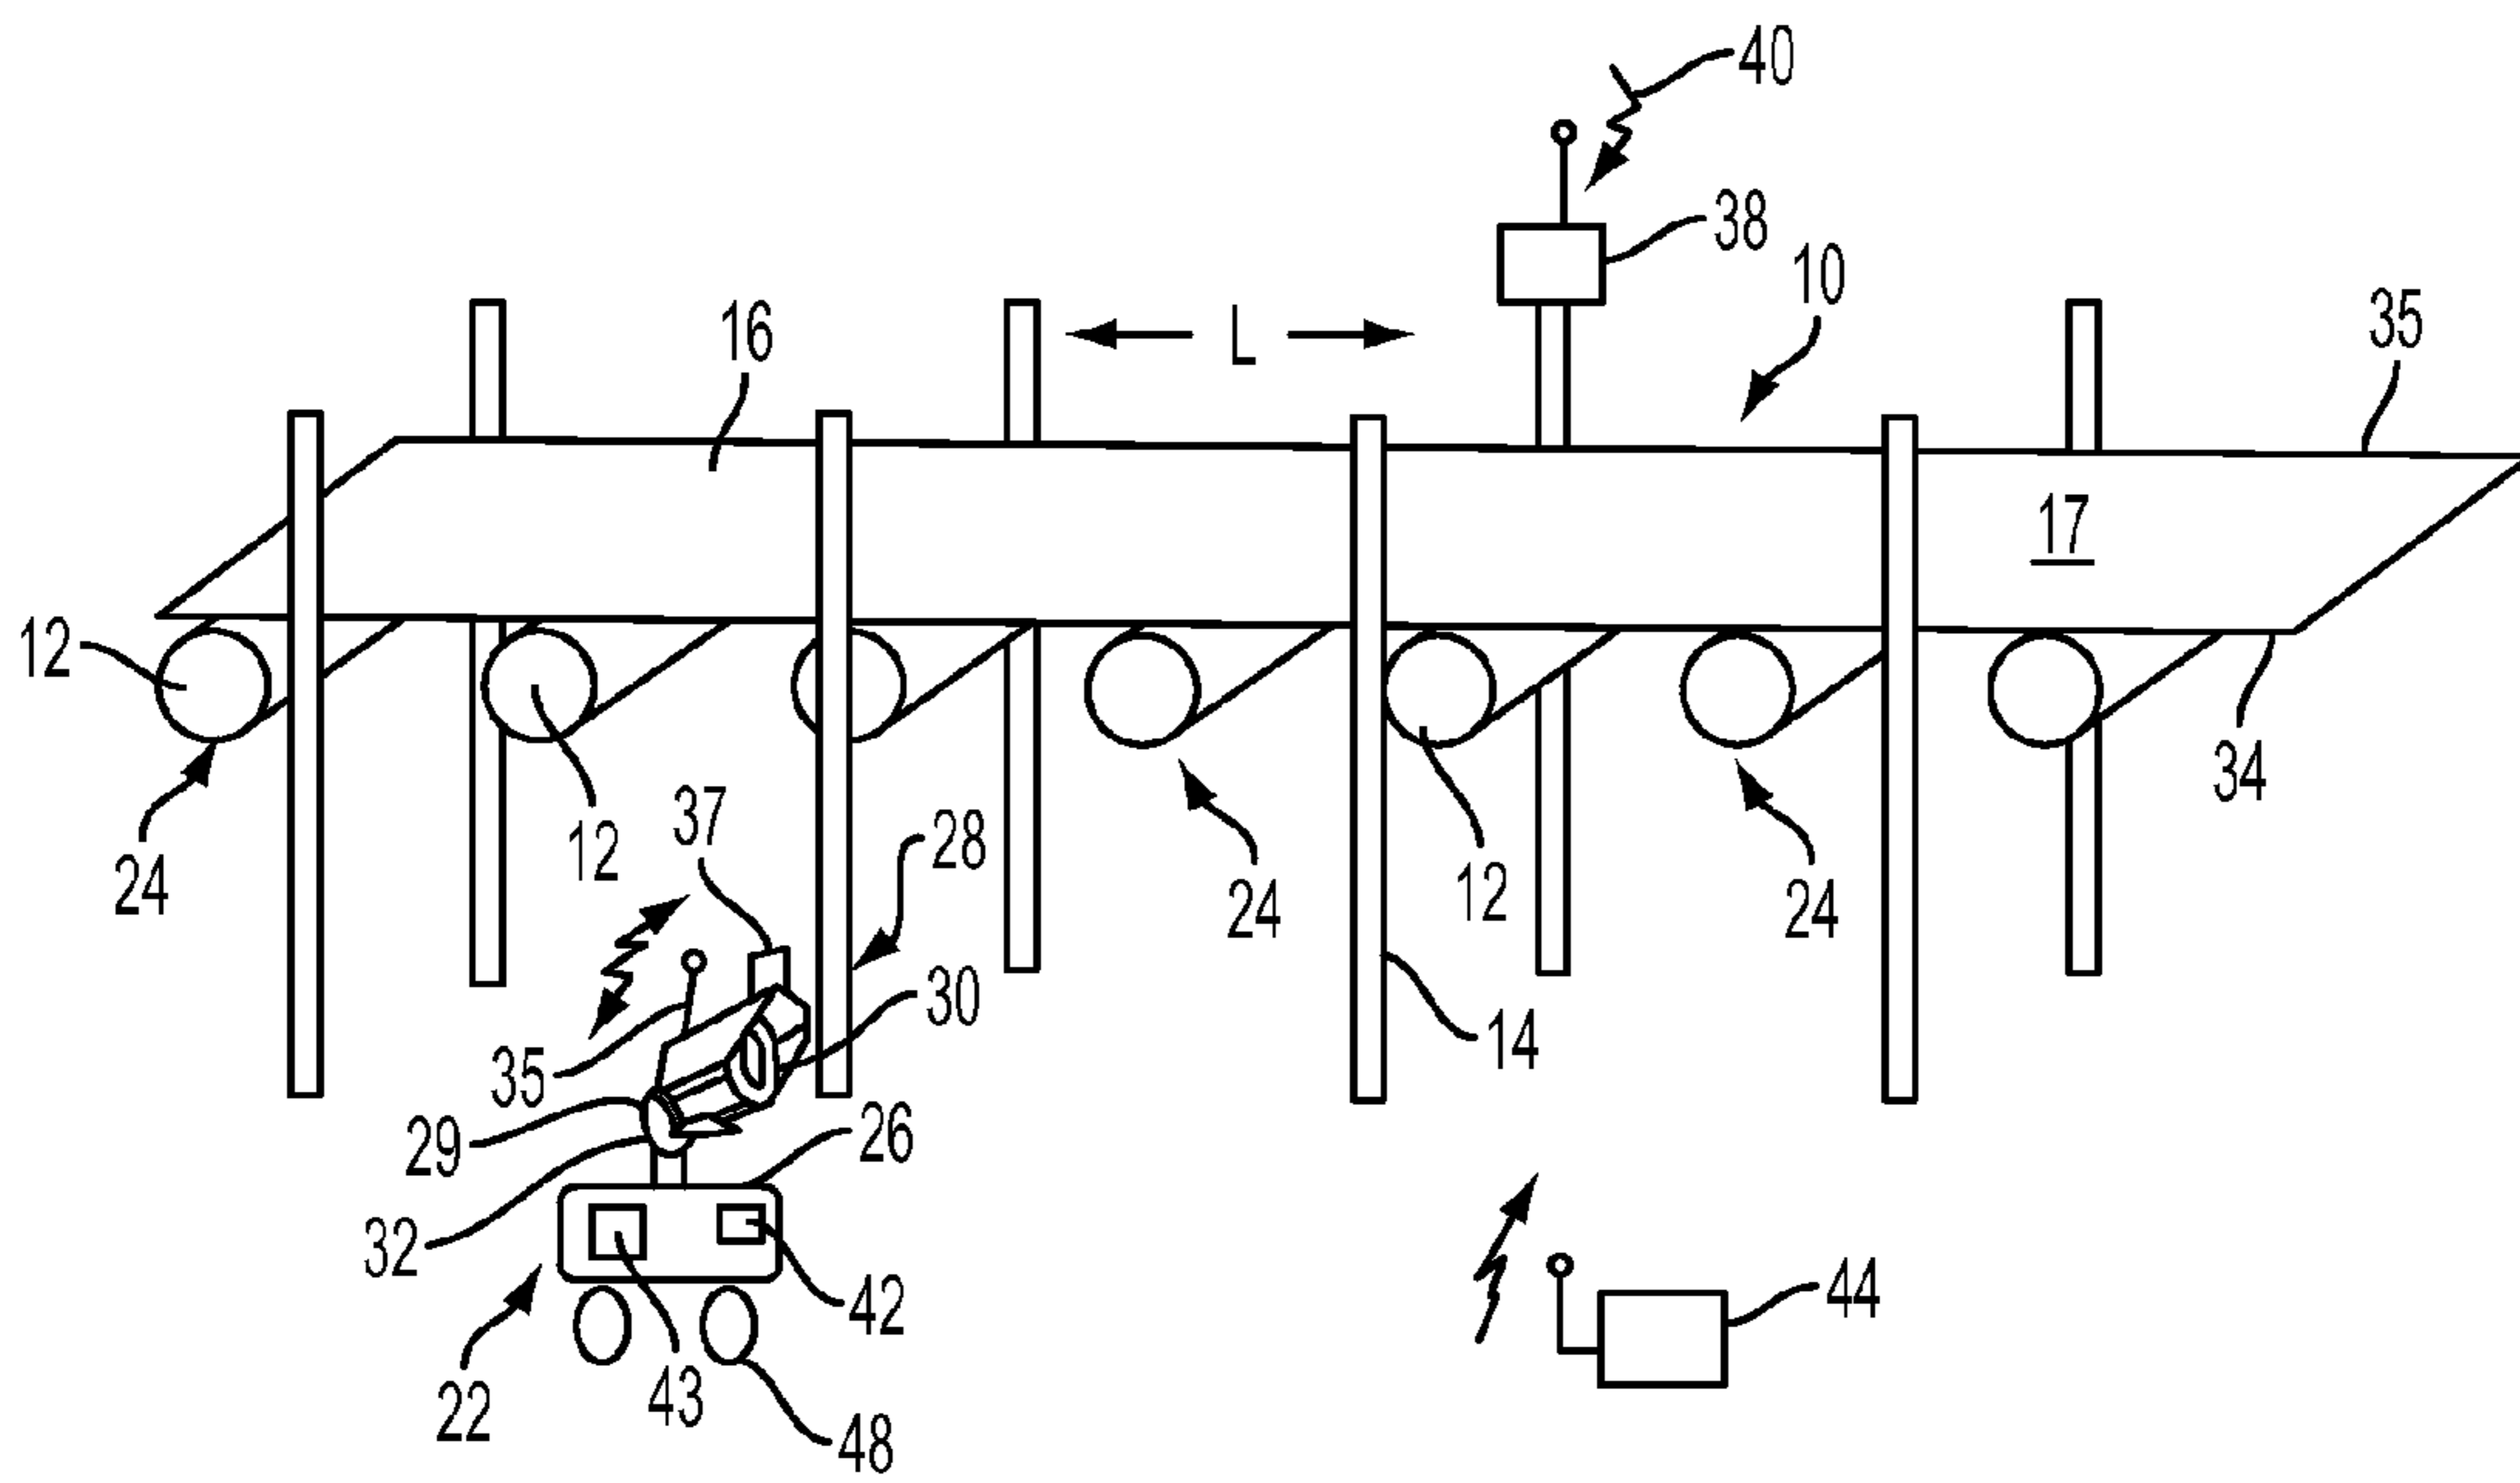
FIG. 2 is a schematic view of a portion of a forward flight of a conveyor with an unmanned vehicle, carrying sensor structure in a pan and tilt arrangement, to inspect rollers at a side of the conveyor in accordance with an embodiment.

With reference to FIG. 2, a schematic view of a portion of a forward flight of a conveyor is shown, generally indicated at 10, being inspected by an unmanned vehicle, generally indicated at 22. The conveyor 10 is conventional and is preferably of the type shown in FIG. 1, having a plurality of roller sets or roller structures 24 carried by the frame 14 under a top flight 17 of the belt 16. Each roller structure 24 preferably includes the two outer rollers 12 and the central roller 12' of FIG. 1. Each roller 12, 12' rotates about an axis A via bearings 13 as the endless belt 16 is conveyed along with material 18. The return flight of the belt 16, the lower rollers 20, and the material 18 being conveyed are not shown in FIGS. 2 and 4. Alternatively, the roller structure can comprise two or four rollers.

As noted above, wear and abrasion of the belt 16 is caused by slip, friction, material movement, belt deformation, static and dynamic stretching forces, and environmental conditions. Additionally, the belt 16 may be damaged by misalignment and foreign material. Furthermore, failure of the idlers or rollers 12, 12' and roller bearings causes friction and abrasion. The bearings fail with increasing temperature. Therefore, a conveyor 10 is inspected regularly to detect problems before they result in downtime and larger damage. In accordance with an embodiment and as shown in FIG. 2, the unmanned vehicle 22 is provided to travel along at least a portion of a length L of the conveyor 10 to inspect the belt 16 and rollers 12, 12' of the plurality of roller sets 24 while the conveyor 10 is operating.

The unmanned vehicle 22 may be conventional, such as of the type disclosed in U.S. Pat. No. 7,784,570 B2, having a platform 26 carrying sensor structure, generally indicated at 28. In the embodiment of FIG. 2, the sensor structure 28 includes an imaging sensor 30 disposed on mounting structure 29. In the embodiment of FIG. 2, the mounting structure 29 is a conventional pan and tilt mechanism 32 so as to be capable of motion in two degrees of freedom: rotation in a horizontal plane and in a vertical plane. The imaging sensor 30 is preferably a thermal imaging camera aimed at the roller structure 24 to capture visual and thermal images of the rollers 12, 12' of each roller structure 24 as the vehicle 22 travels along a side 34 of the operating conveyor 10. FIG. 3 is a thermal image captured by the imaging sensor 30 of FIG. 2, showing a hot spot 36 of a roller 12. The hot spot 36 indicates heat generated by friction which may indicate that the bearing of the roller 12 is damaged. A viewing angle of the imaging sensor 30 can be such that at least a portion of the underside of the belt 16 can be monitored to determine if there are defects in this belt portion.

In addition, the sensor structure 28 may include an acoustic sensor 37 to obtain acoustic signals along the length of the belt 16 as the vehicle 22 moves along the side 34 or

35 of the conveyor 10. Conventional frequency spectrum analysis of the acoustic data can be used to determine an abnormal pattern, for example, caused by jammed rollers 12, 12', or screeching of the belt 16. The sensor structure 28 may contain structure for obtaining thermal imaging data, infrared imaging data, visual imaging data, acoustic data or any combination of this data. If the data is thermal, infrared or visual, the sensor structure 28 may have zoom capabilities and can have an automatic or remote controllable focus.

Preferably, a wireless transceiver 35 on the sensor structure 28 or vehicle can communicate with a wireless receiver 38 that is provided on or near the conveyor 10. The receiver 38 receives signals 40 to thereby associate data that is captured by the imaging sensor 30 or the acoustic sensor 37 with position, so as to determine what part of the belt 16 or which roller 12, 12', of a set 24 is damaged or not functioning properly. Instead of transmitting the images or data, they can be stored in memory 42 that is provided on the vehicle 22 or that is part of the sensor structure 28, for later downloading.

The vehicle 22 can be controlled autonomously by an onboard control system 43 such as, for example, as disclosed in U.S. Pat. No. 7,499,776 B2. Alternatively, the vehicle can be controlled remotely by an operator using a remote control unit 44 such as, for example, as disclosed in U.S. Pat. No. 7,926,598 B2 or by GPS navigation. Manual and semi-autonomous control of the vehicle 22 is also contemplated. The content of each of U.S. Pat. No. 7,784,570 B2, U.S. Pat. No. 7,499,776 B2 and U.S. Pat. No. 7,926,598 B2 is hereby incorporated by reference into this specification. In another embodiment, a remote operator can take control of the system at any time during an autonomous inspection, such as when the system detects a problem. This would allow the remote operator to do a more thorough manual inspection of the equipment of interest.

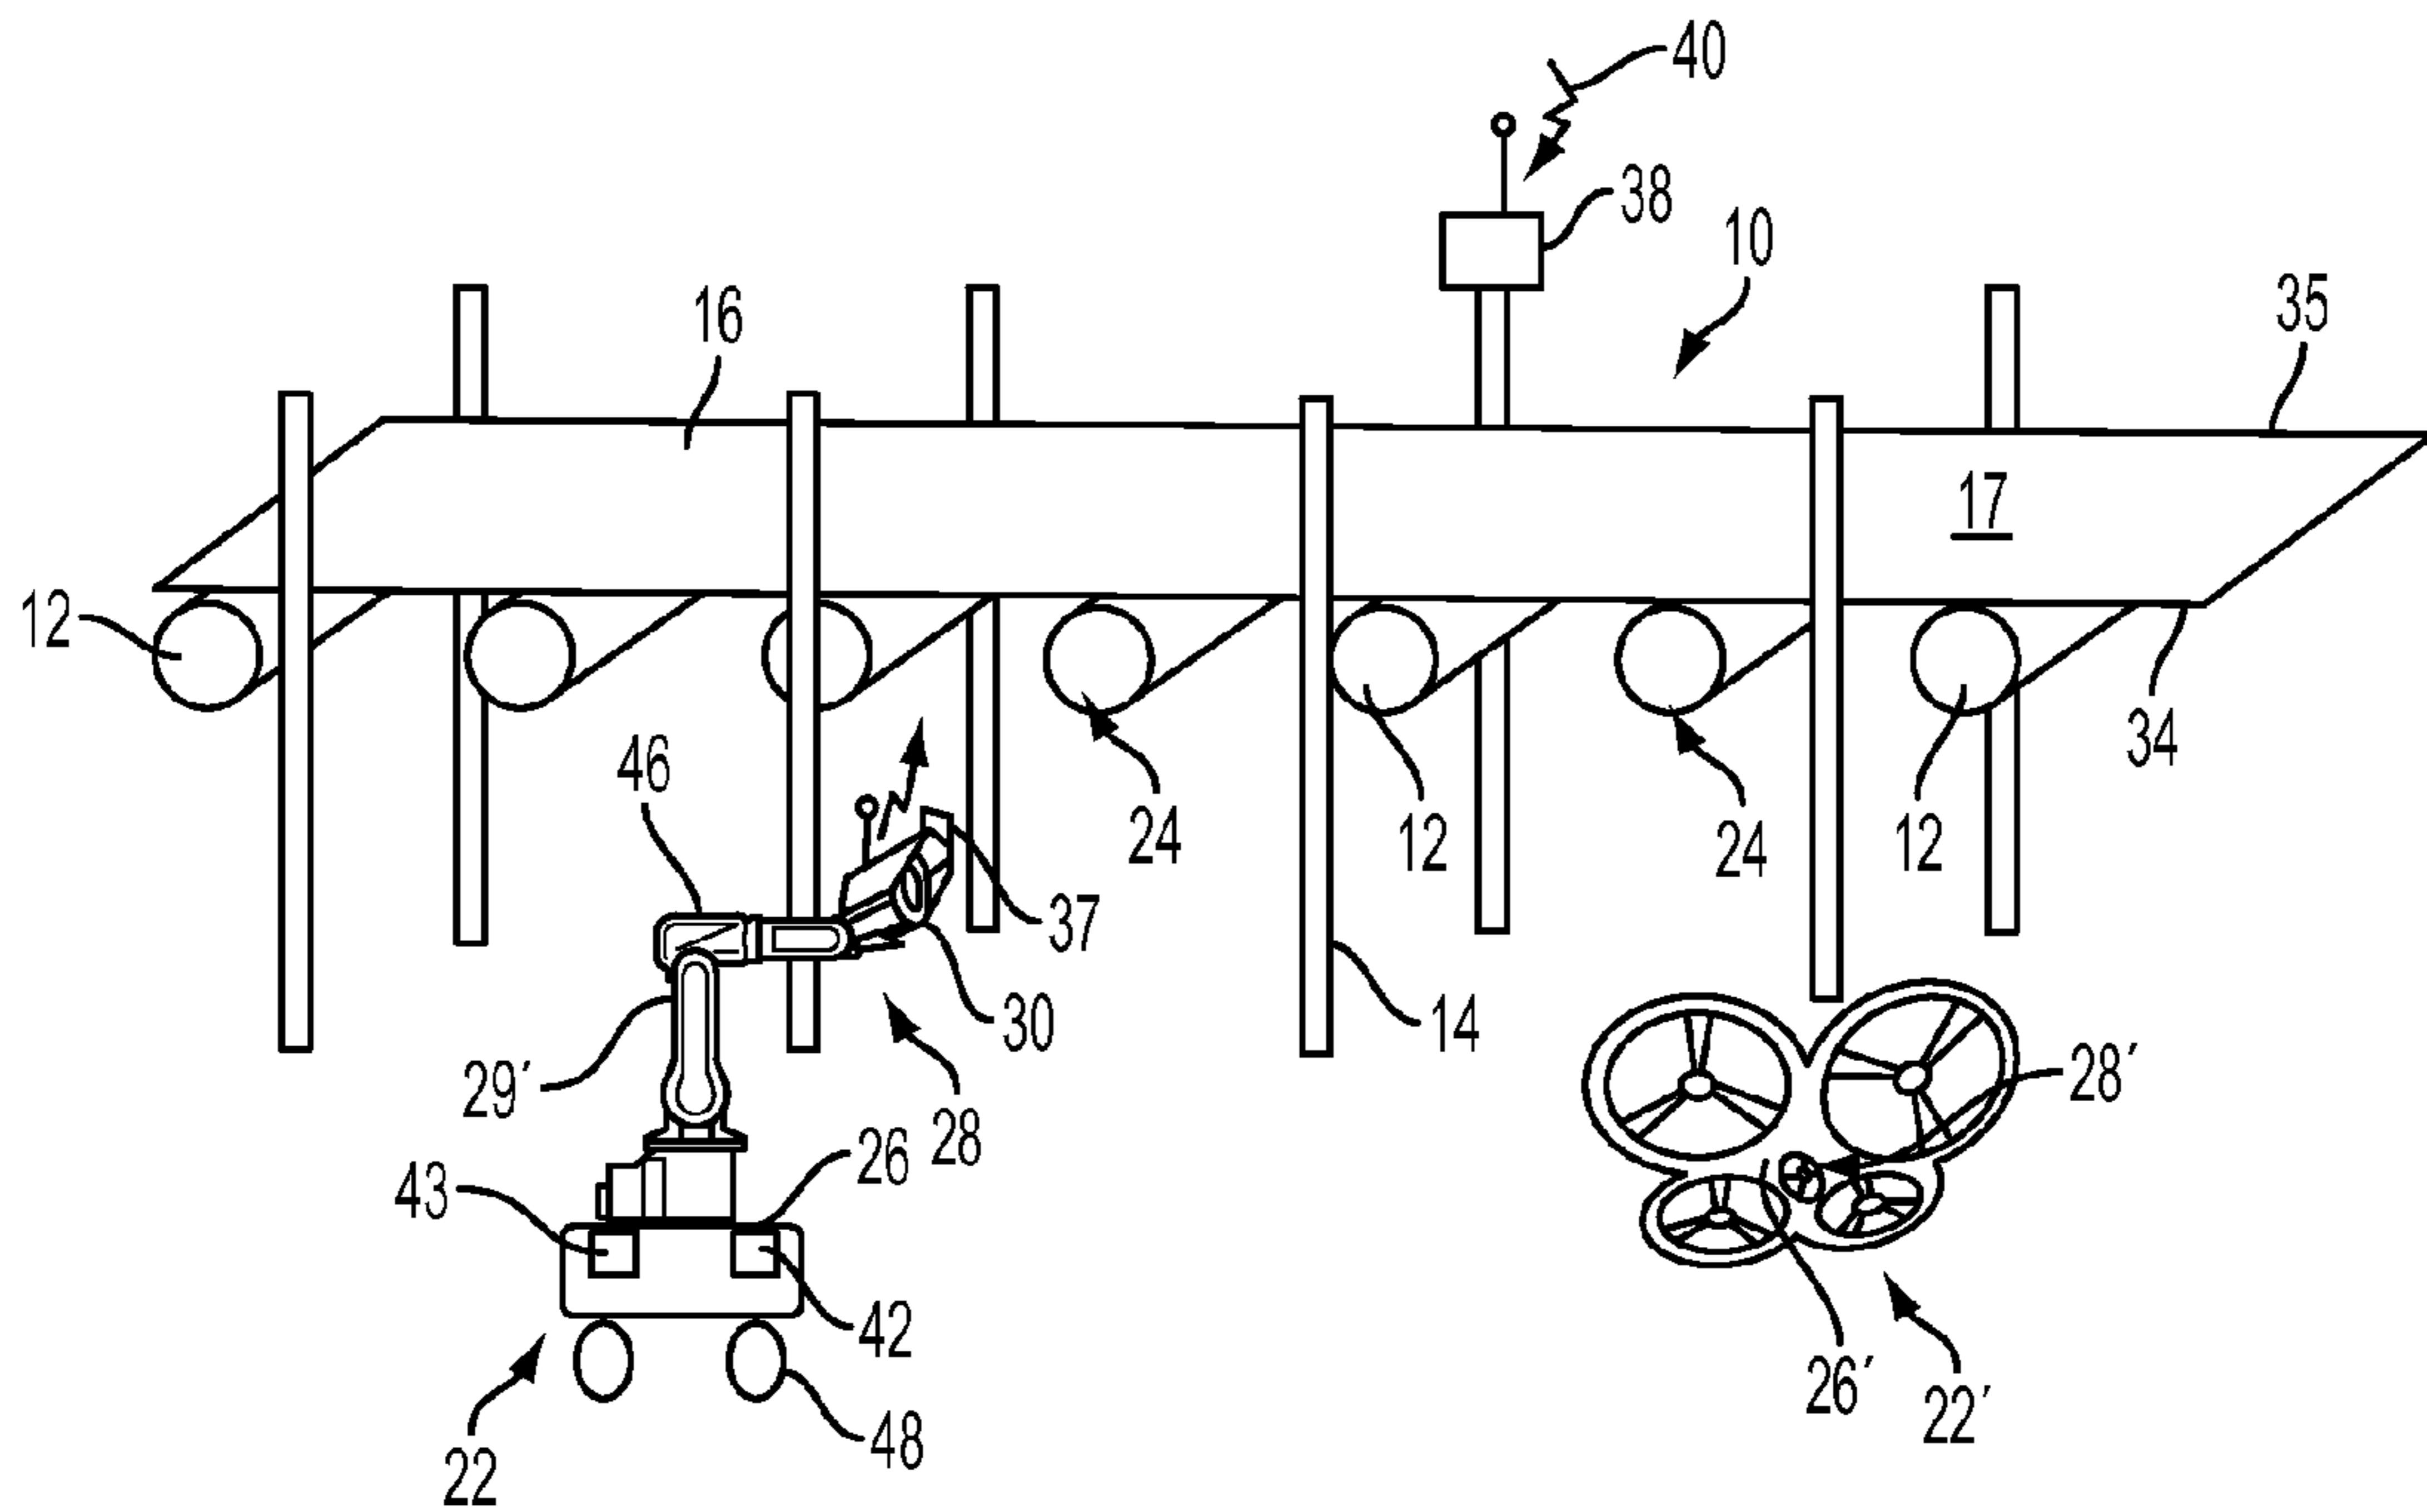
FIG. 4 is a schematic view of a portion of a forward flight of a conveyor with an unmanned vehicle having a robotic arm carrying sensor structure to inspect rollers at a side of the conveyor in accordance with another embodiment.

With reference to FIG. 4, instead of mounting the imaging sensor 30 and the acoustic sensor 37 on the two degree of freedom pan and tilt mechanism 32, the mounting structure 29' comprises a robot 46 that carries the sensors 30 and 37 for movement in more than two degrees of freedom. In the embodiment, the robot 46 has six degrees of freedom. This provides more mobility so as to move the sensors 30, 37 to ensure they are adjacent to the roller sets 24 as the vehicle 22 traverses changing terrain. Instead of providing the robot, the sensors 30 and 37 can be mounted on an extendable arm such as the Packbot® from iRobot Corp®. Preferably, the arm can be extended only when the vehicle 22 is stopped to closely monitor a point of interest on the conveyor 10. If desired, the arm can be extended to reach under the belt.

Since there are many portions of the frame 14 along the length of the conveyor 10 making it difficult to move the sensor structure 28' under the top flight 17 of the belt 16, the sensor structures 28 or 28' inspect only while being adjacent to a side 34 or 35 of the conveyor 10, without the need to move under the top flight of the belt 16. Once the vehicle 22 obtains data from one side 34 of the conveyor 10, the vehicle can move to the other side 35 and obtain data from that side while the conveyor 10 is in operation. As a result, more accurate data collection can be obtained from each of the outer rollers 12. It is noted that sensing of a roller 12, 12' of any set 24 may not occur due to accidentally being missed or because of the viewing angle, is not accessible, etc. In such cases, later attempts can be made to sense these missed rollers.

Any other unmanned vehicle capable of moving along rough terrain can be used to carry the sensor structures 28 or 28'. Alternatively, with reference to FIG. 4, a remote con-

trolled flying vehicle such as a miniature helicopter or drone, generally indicated at **22'**, including the sensor structure **28** on platform **26'**, can be used instead of the vehicle **22** that has ground-engaging structure such as tracks or wheels **48**. The vehicle **22'** can be controlled to fly adjacent to the conveyor **10** near the outer rollers **12**. The sensor structure **28'** can be mounted on the platform **26'** in the manner discussed above using regard to mounting structure **29** or **29**. Furthermore, if the vehicle **22** is controlled by the remote control unit **44**, the unit **44** can also control movement of the pan and tilt mechanism **32** or the robot **46**.
