(10) **Patent No.:** **US 9,950,873 B2**
(45) **Date of Patent:** **Apr. 24, 2018**

(54) **CONVEYOR INSPECTION WITH UNMANNED VEHICLE CARRYING SENSOR STRUCTURE**

(73) Assignee: **ABB Schweiz AG**, Baden (CH)

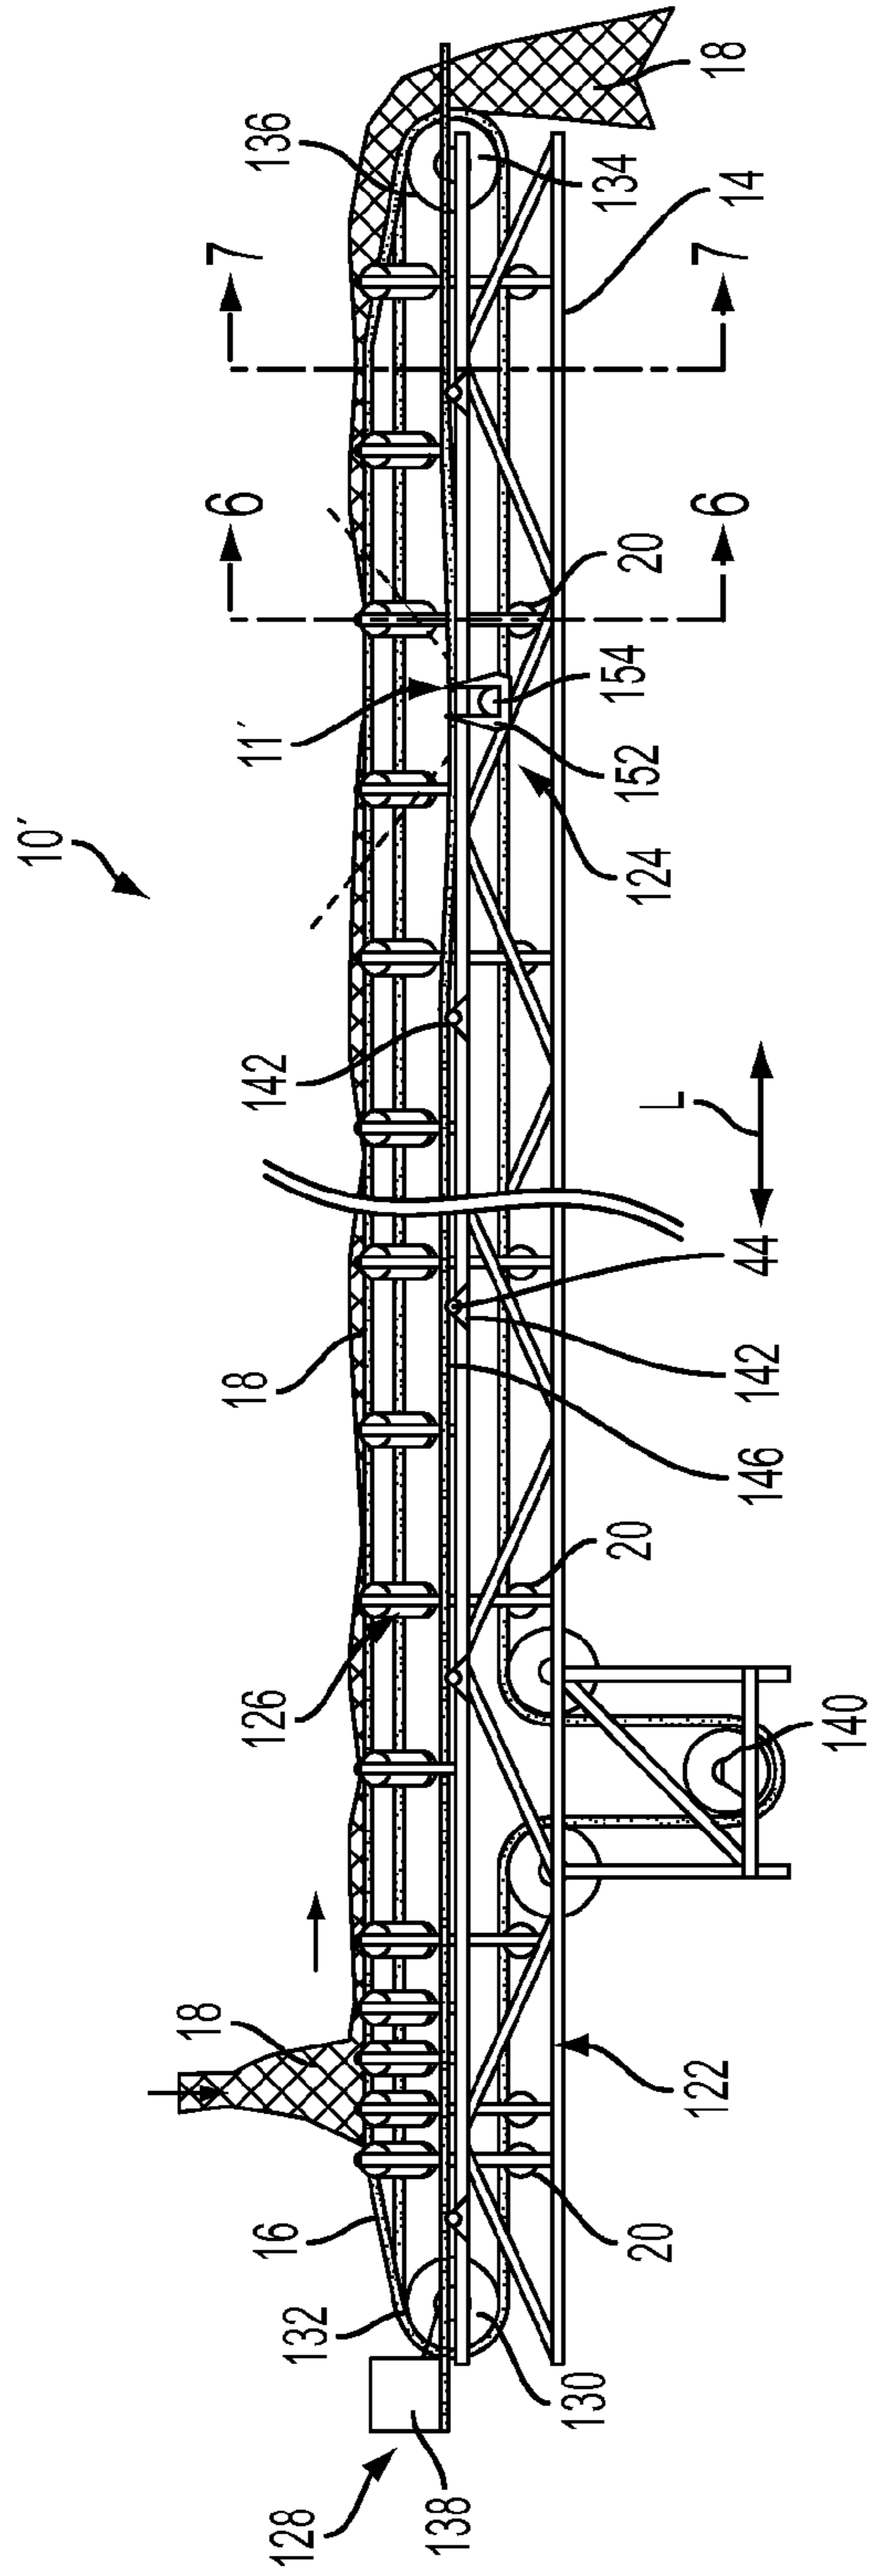
FIG. 5 is side schematic view of a conveyor with guide structure, in the form of a cable carrying sensor structure, at

a side of the conveyor to inspect rollers and an underside of the conveyor belt, in accordance with another embodiment.

With reference to FIG. 5, a schematic view of a conveyor, generally indicated at **10**, is shown with an associated inspection system, generally indicated at **11'**, to inspect rollers and an underside of the conveyor belt, in accordance with an embodiment. The inspection system **11'** comprises guide structure **122**, carrying sensor structure generally indicated at **124**, disposed adjacent to at least one side of the conveyor **10'**. The conveyor **10'** is conventional and is preferably of the type shown in FIG. 1, having a plurality of roller sets or roller structures **126** carried by the frame **14** under a top flight **15** of the endless belt **16**. Each roller structure **126** preferably includes the two outer rollers **12** and the central roller **12'** as shown in FIG. 6. Each roller **12**, **12'** rotates about an axis **A** via bearings **13** as the endless belt **16** is conveyed along with material **18**. The return flight of the belt **16'** is supported by the lower rollers **20** (FIG. 4). Alternatively, the roller structure **126** can comprise two or more rollers.

Drive structure, generally indicated at **128**, is provided for moving the belt **16**. In the embodiment, the drive structure includes a first pulley **130** at a first end **132** and a second pulley **134** at the second end **136** of the conveyor **10'**. At least one of the pulleys is powered. In the embodiment, a motor **138** drives the first pulley **130**. A conventional belt

ensioning roller **140** engages the return flight of the belt **16'**. The roller **140** is adjustable to adjust the tension in the belt **16'**.

As noted above, wear and abrasion of the belt **16** is caused by slip, friction, material movement, belt deformation, static and dynamic stretching forces, and environmental conditions. Additionally, the belt **16** may be damaged by misalignment and foreign material. Furthermore, failure of the idlers or rollers **12**, **12'** and roller bearings causes friction and abrasion. The bearings fail with increasing temperature. Therefore, a conveyor **10'** is inspected regularly to detect problems before they result in downtime and larger damage. In accordance with an embodiment and as shown in FIG. 5, the guide structure, generally indicated at **122**, carries the sensor structure **124** in a guided manner along the length **L** of the conveyor **10'** to inspect the belt **16** and rollers **12**, **12'** of the plurality of roller sets **126** while the conveyor **10'** is operating.

The guide structure **122** includes a plurality of supports **142** that are fixed to at least one side of the frame **14** of the conveyor **10'** and spaced along a length of the frame **14**. In the embodiment of FIGS. 6-8, each support **142** includes a roller **144** for supporting a cable **146** that extends along the length **L** of the conveyor **10'**. The cable **146** is moved by a pulley **148** driven by a motor **150** or by other systems for moving a cable.

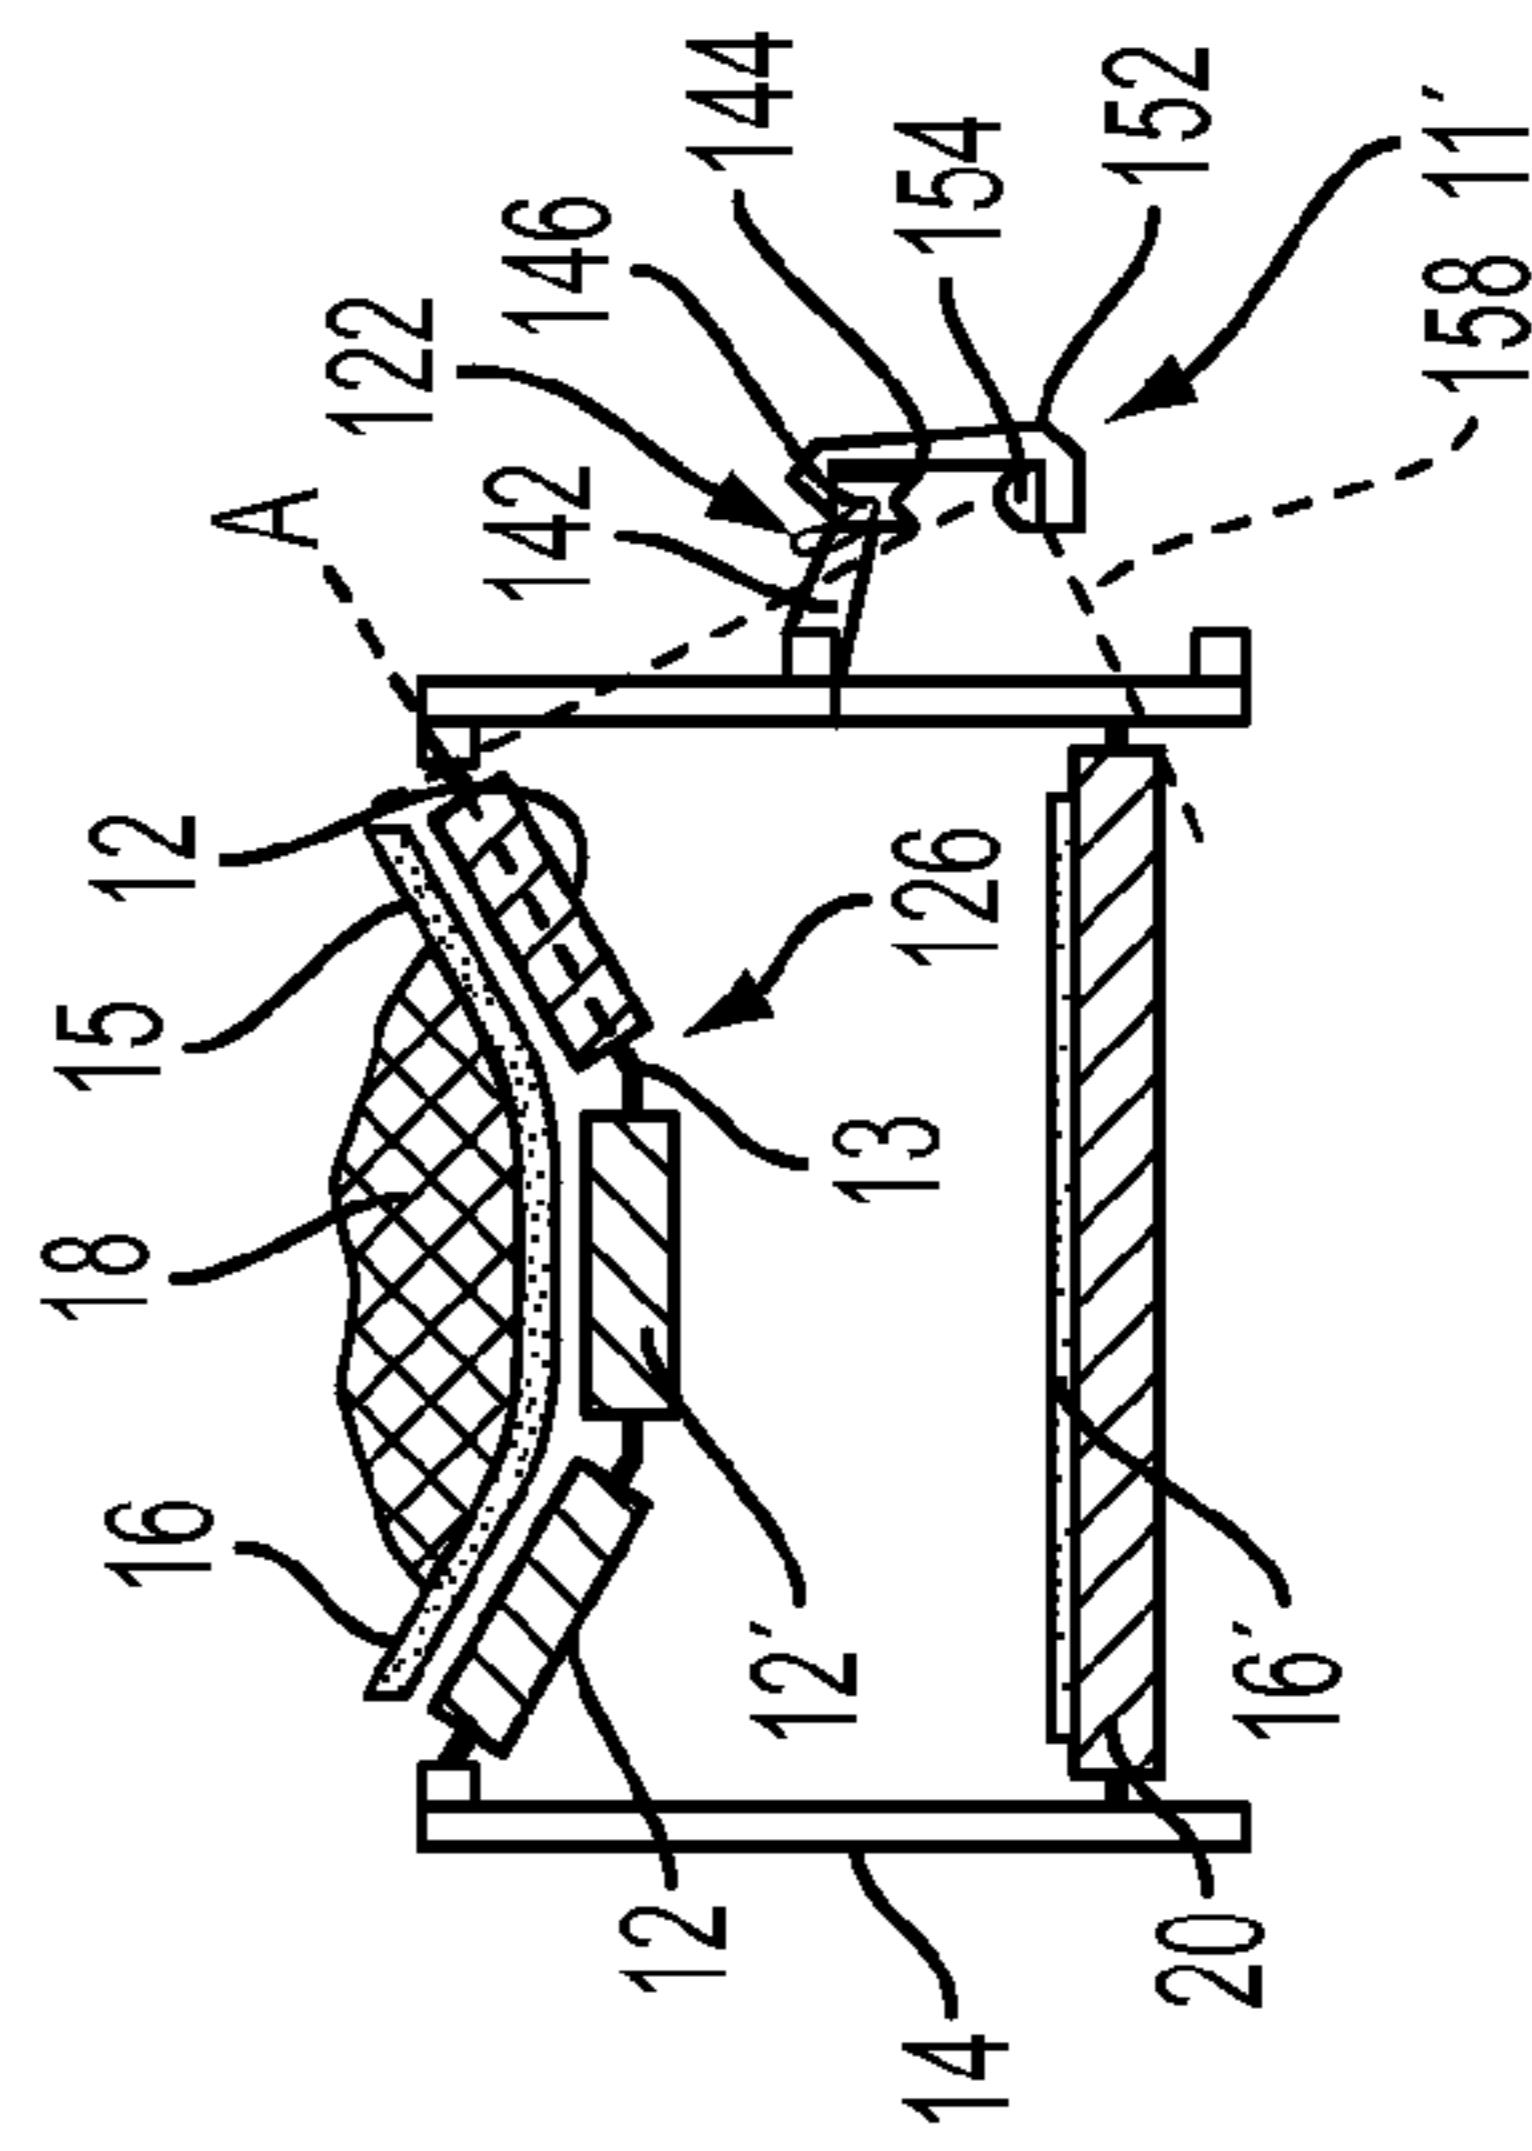
FIG. 6 is a sectional view taken along the line 6-6 in FIG. 5.

Preferably, a wireless transceiver **162** (FIG. 7) on the sensor structure **124** permits the transfer of data to and from the sensor structure **124**. The transceiver **162** receives signals to thereby associate data that is captured by the imaging sensor **154** with position, so as to determine what part of the belt **16** or which roller **12**, **12'**, of a set **126** is damaged or not functioning properly. Instead of transmitting the images or

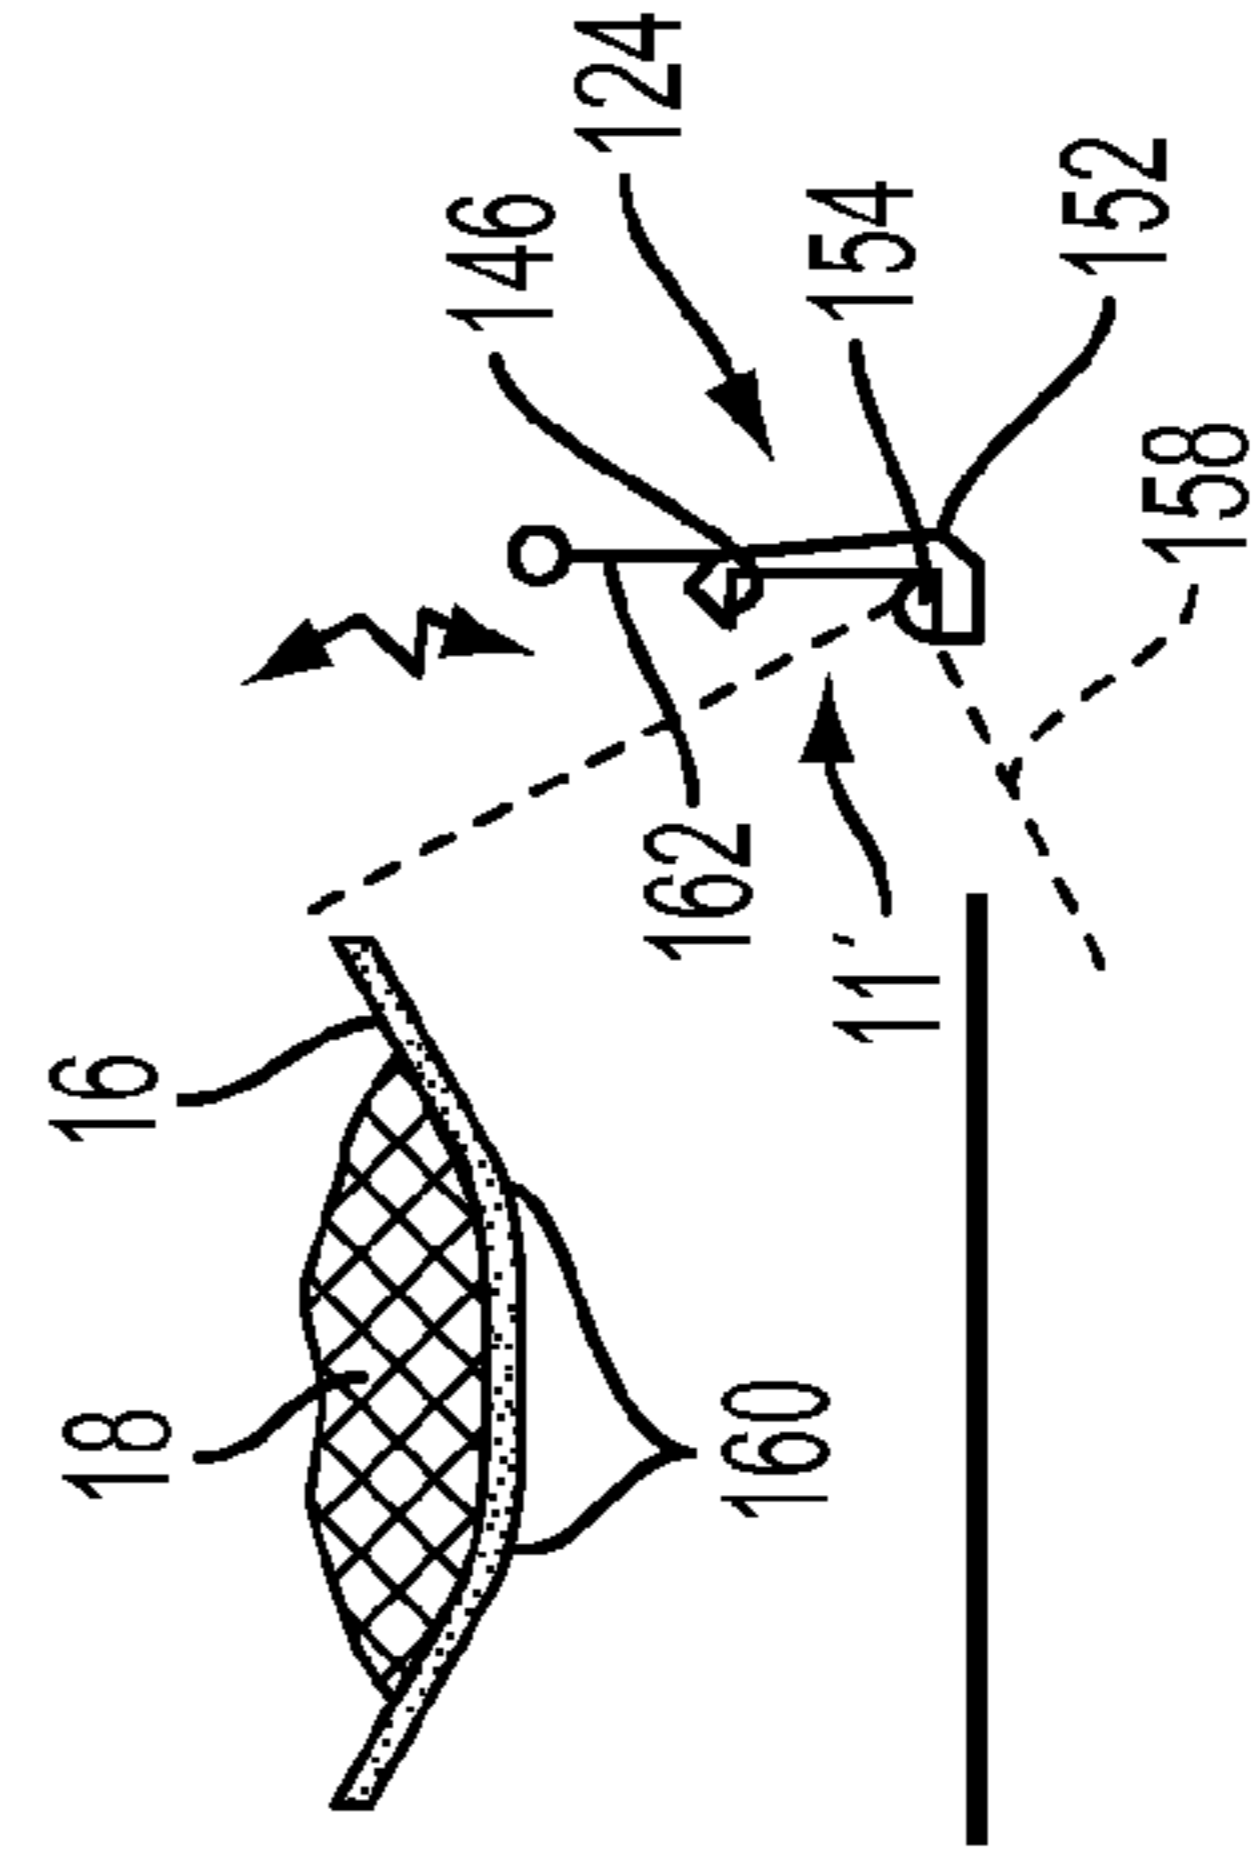
FIG. 7 is a sectional view taken along the line 7-7 in FIG. 5.

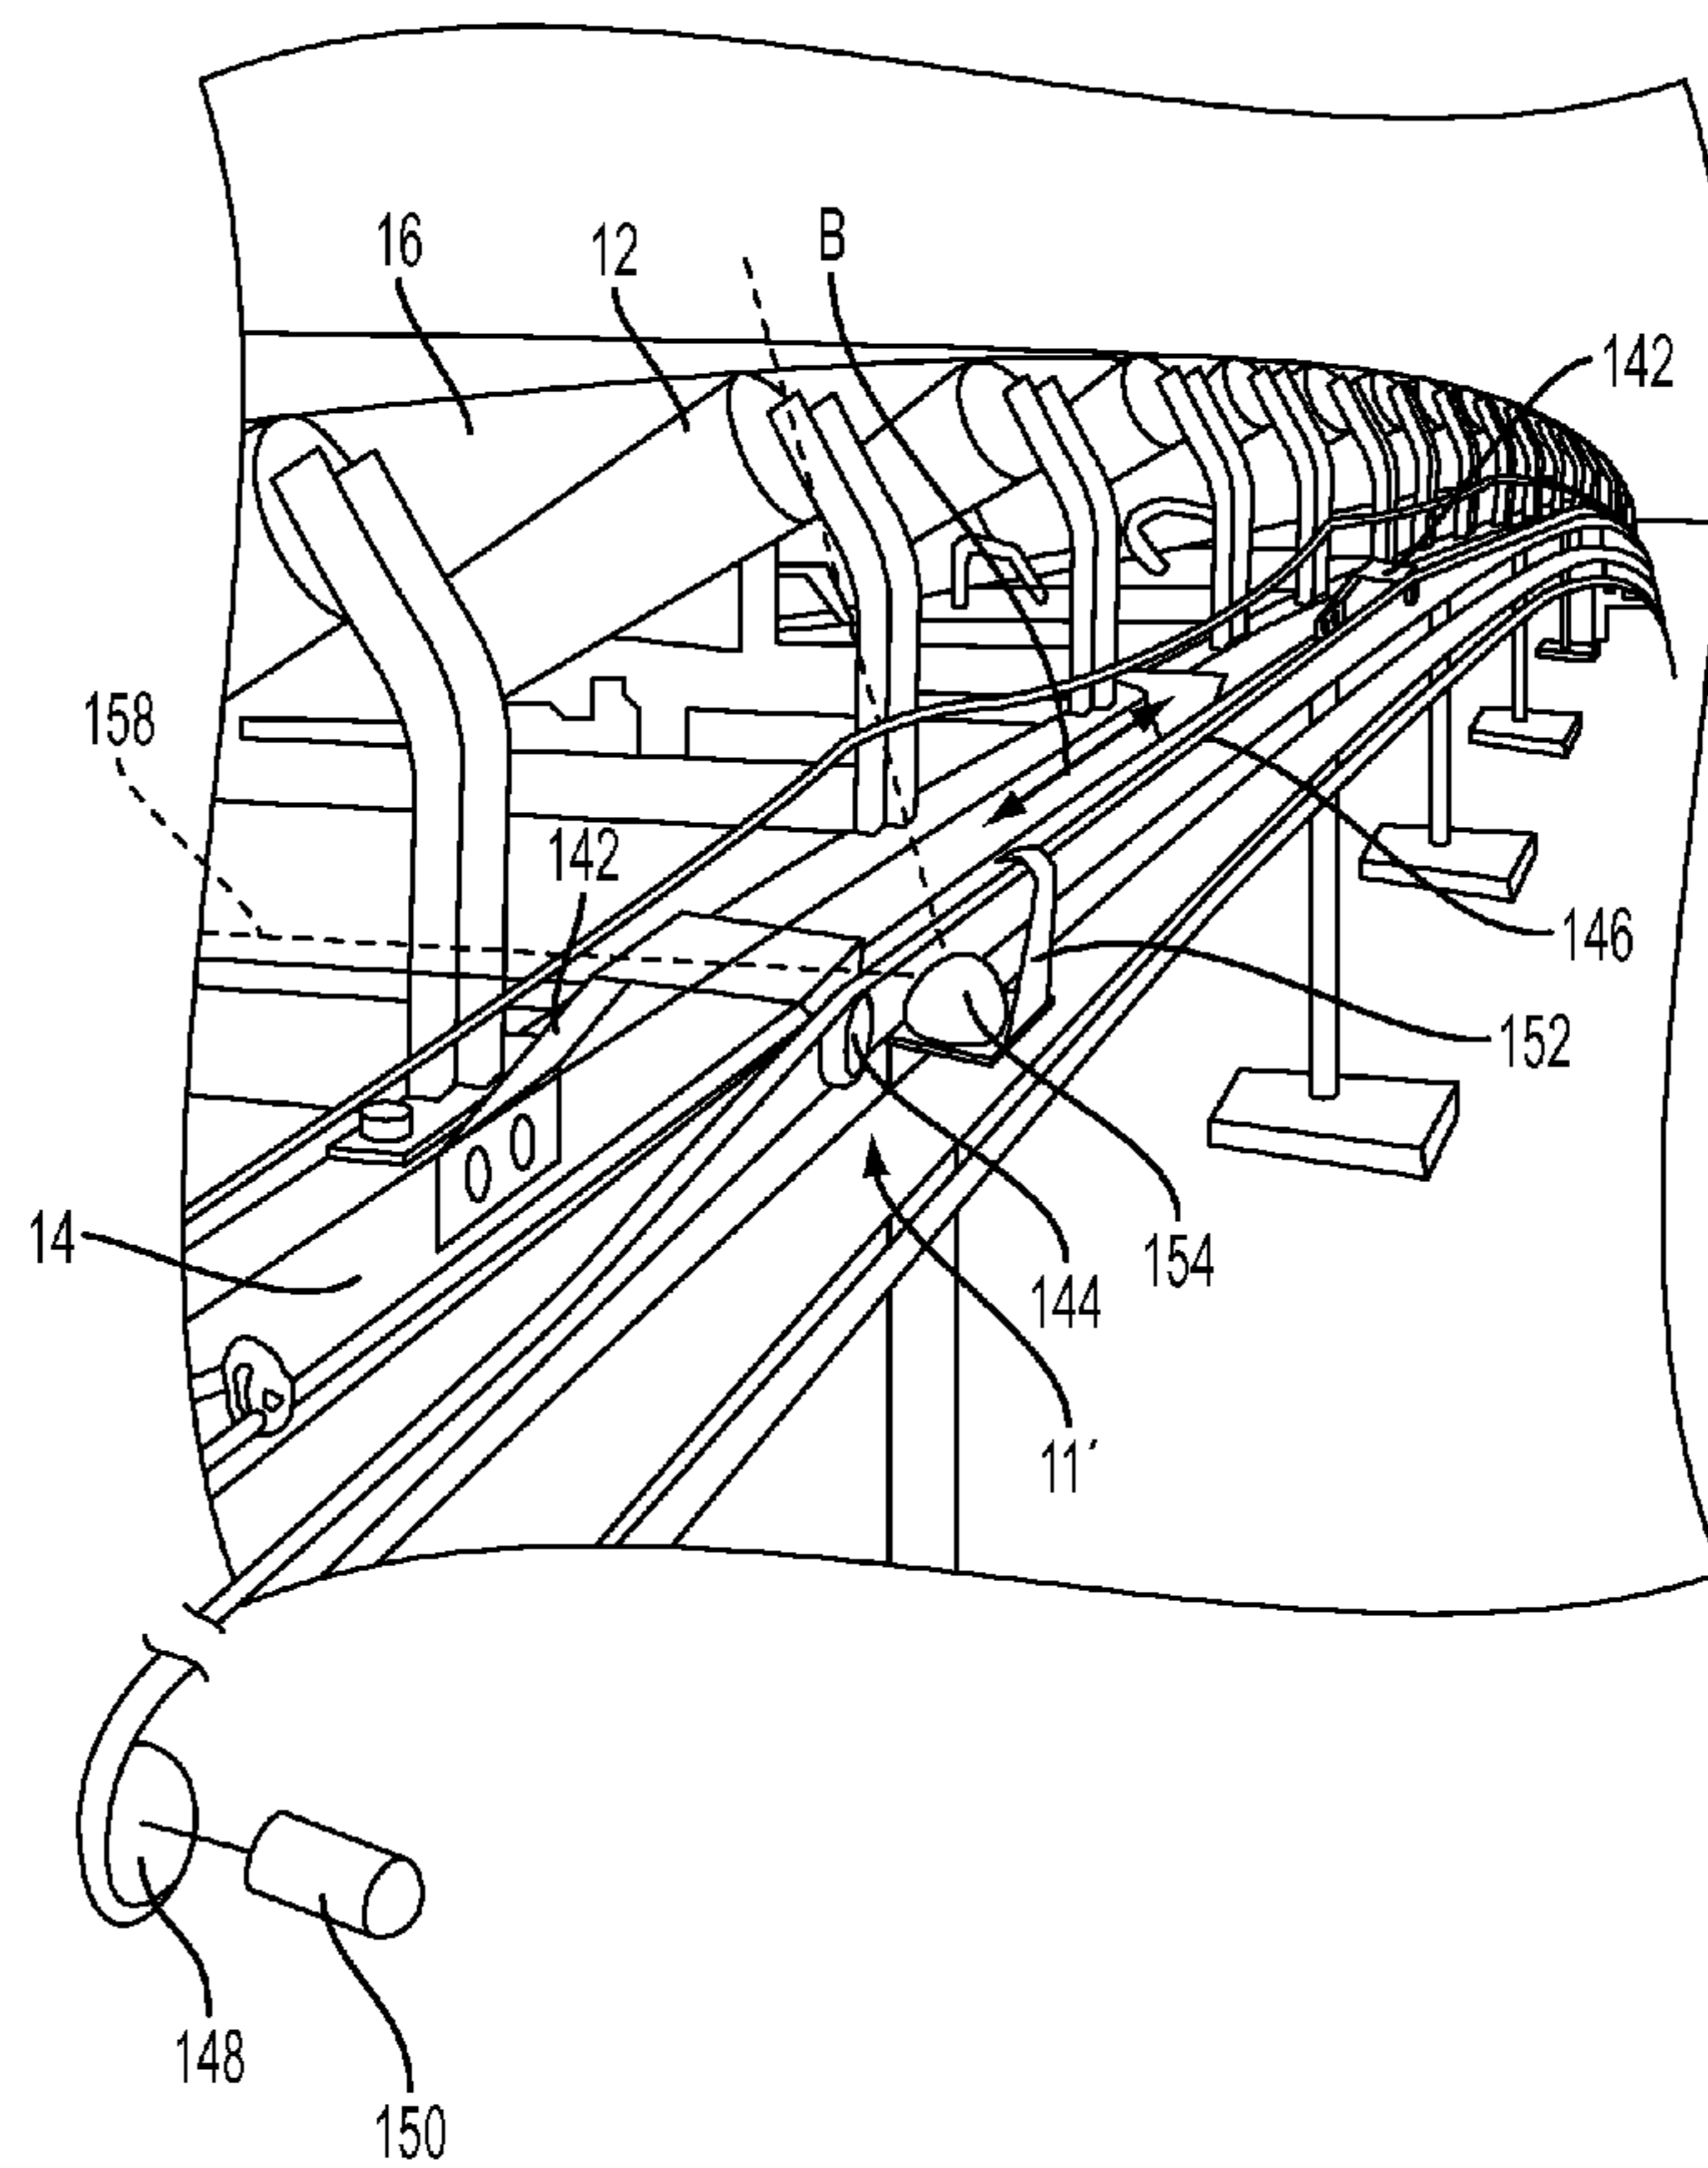
FIG. 8 is a view of a portion of the guide structure, in the form of a cable, which carries the sensor structure in accordance with an embodiment.

The sensor structure **124** includes a vehicle or carrier **152** that moves together with the cable **146** in a guided manner in the directions **B** of FIG. 8. The sensor structure **124** also includes an imaging sensor **154** disposed on the carrier **152** for movement therewith. The imaging sensor can be mounted to the carrier **152** using a conventional pan and tilt mechanism so as to be capable of motion in two degrees of freedom: rotation in a horizontal plane and in a vertical plane. The imaging sensor **154** is preferably a thermal imaging camera (capable of zooming) aimed at the roller structure **126** to capture visual and thermal images of the rollers **12**, **12'** of each roller structure **126** and underside of the belt **16** as the carrier, with sensor **154**, travels along a side of the operating conveyor **10'**. The imaging sensor **154** of FIG. 5 can be used to capture a thermal image (such as shown in FIG. 3) that indicates a hot spot **36** of a roller **12**. The hot spot **36** indicates heat generated by friction which may indicate that the bearing of the roller **12** is damaged. The field of view **158** of the sensor **154** is such that the roller structures **126** and at least a portion of the underside of the belt **16** (see FIG. 7) can be monitored to determine if there are defects in the monitored belt portion, particularly at the bent areas **160** of the belt **16**. Instead of or in addition to a thermal image camera, the imaging sensor **154** can be a visual image camera or a camera with sensitivity in the near infrared. In addition, or in the alternative, the sensor structure **124** can include a microphone such a directional microphone for obtaining acoustic signals from the conveyor **10'**. More than one sensor structure **124** can be provided on the cable **146**. Also, it can be appreciated that a guide structure **122** and associated sensor structure(s) **124** can be provided on each side of the conveyor. Furthermore, instead of moving the cable **146**, the cable can be static and the carrier **152** can be self-propelled.
