US009976477B2

(54)	SECONDARY ENGINE COVERS						
(71)	Applicant:	Lewis Banks Limited, Hertfordshire (GB)					
(72)	Inventor:	Graham Banks, Hertfordshire (GB)					
(73)	Assignee:	Lewis Banks Limited, Hertfordshire (GB)					
(*)	Notice:	Subject to any disclaimer, the term of this patent is extended or adjusted under 35 U.S.C. 154(b) by 57 days.					
(21)	Appl. No.: 15/139,944						
(22)	Filed:	Apr. 27, 2016					
(65)	Prior Publication Data						
	US 2017/0009650 A1 Jan. 12, 2017						
(30)	Foreign Application Priority Data						
Jul. 10, 2015 (GB) 1512085.0							
(51) (52)	F02B 77/08 (2006.01) B62J 27/00 (2006.01) B62J 23/00 (2006.01)						
(58)	Field of Classification Search CPC F02B 77/083; B62J 23/00; B62J 27/00 See application file for complete search history.						
(56)	References Cited

According to the present invention, there is provided a secondary engine cover formed from a polymeric material comprising a wear indicator, wherein the wear indicator comprises a region of reduced thickness of polymeric material and wherein the region of reduced thickness comprises a blind hole.

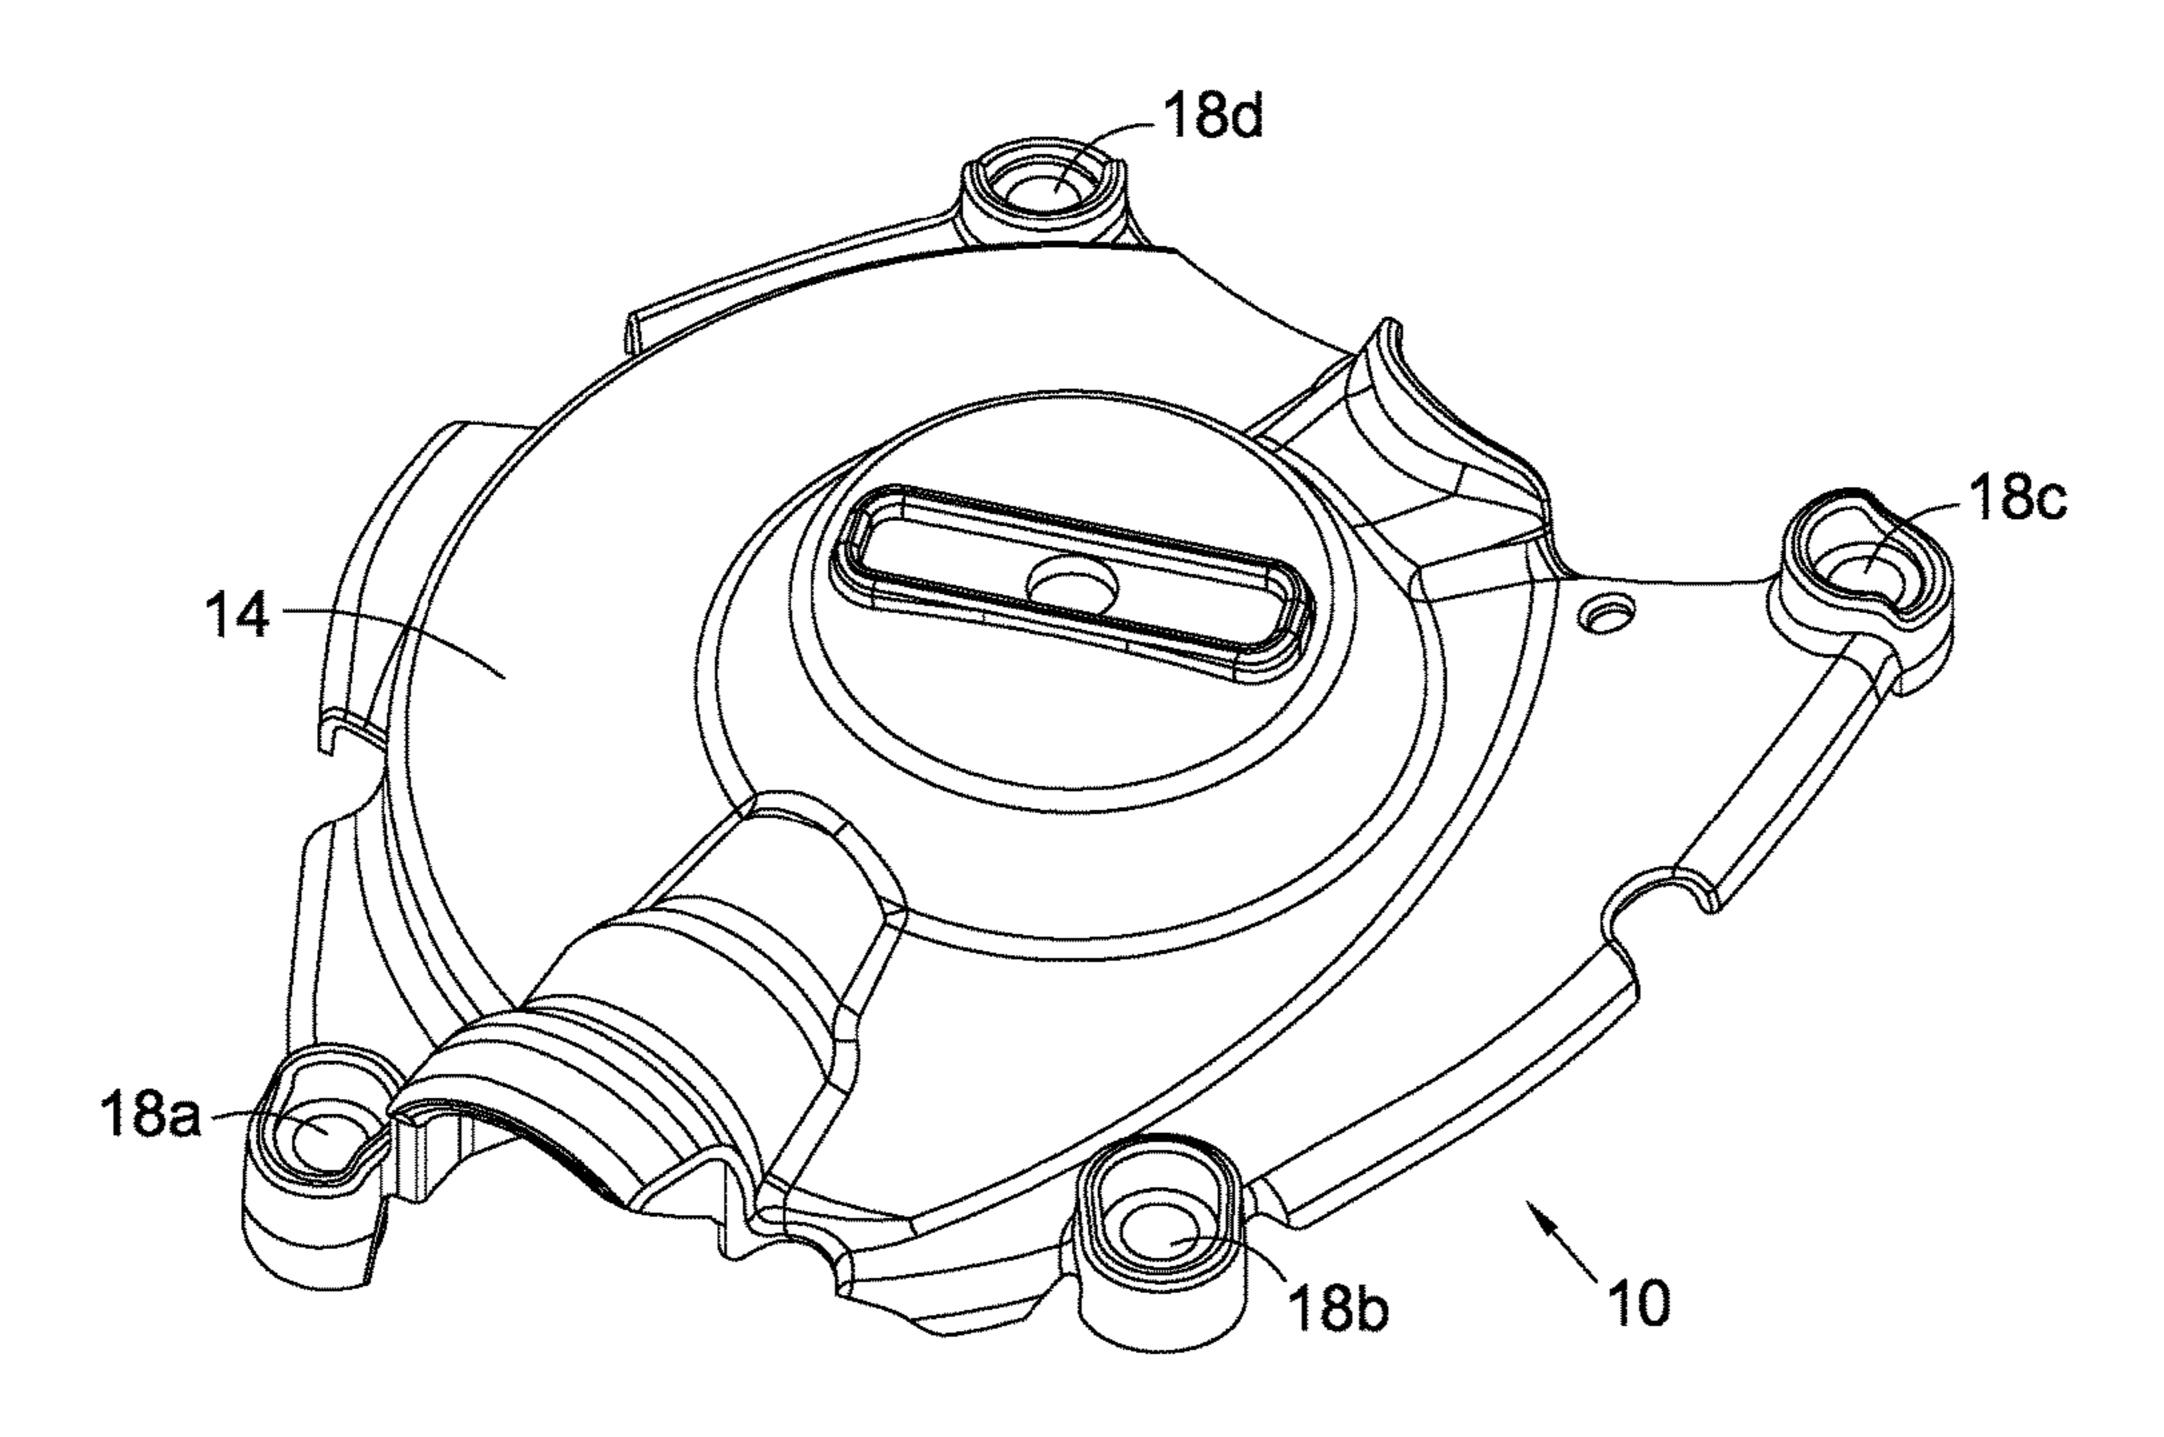
Figure 1

FIG. 1 illustrates a top view of a secondary engine cover according to a first embodiment of the present invention;

FIGS. 1 to 4 illustrate a secondary engine cover 10 according to a first embodiment of the present invention. The secondary engine cover 10 is intended, in use, to bolt on 35 top surface 14 of the secondary engine cover 10. to a motor cycle over an existing engine cover casing using bolt holes 18a to 18d. The secondary engine cover 10 has a top surface **14** and a bottom surface **16**. The thickness of the secondary engine cover 10 varies depending on the wear requirements across the secondary engine cover 10, but is 40 typically between 2 mm and 12 mm.

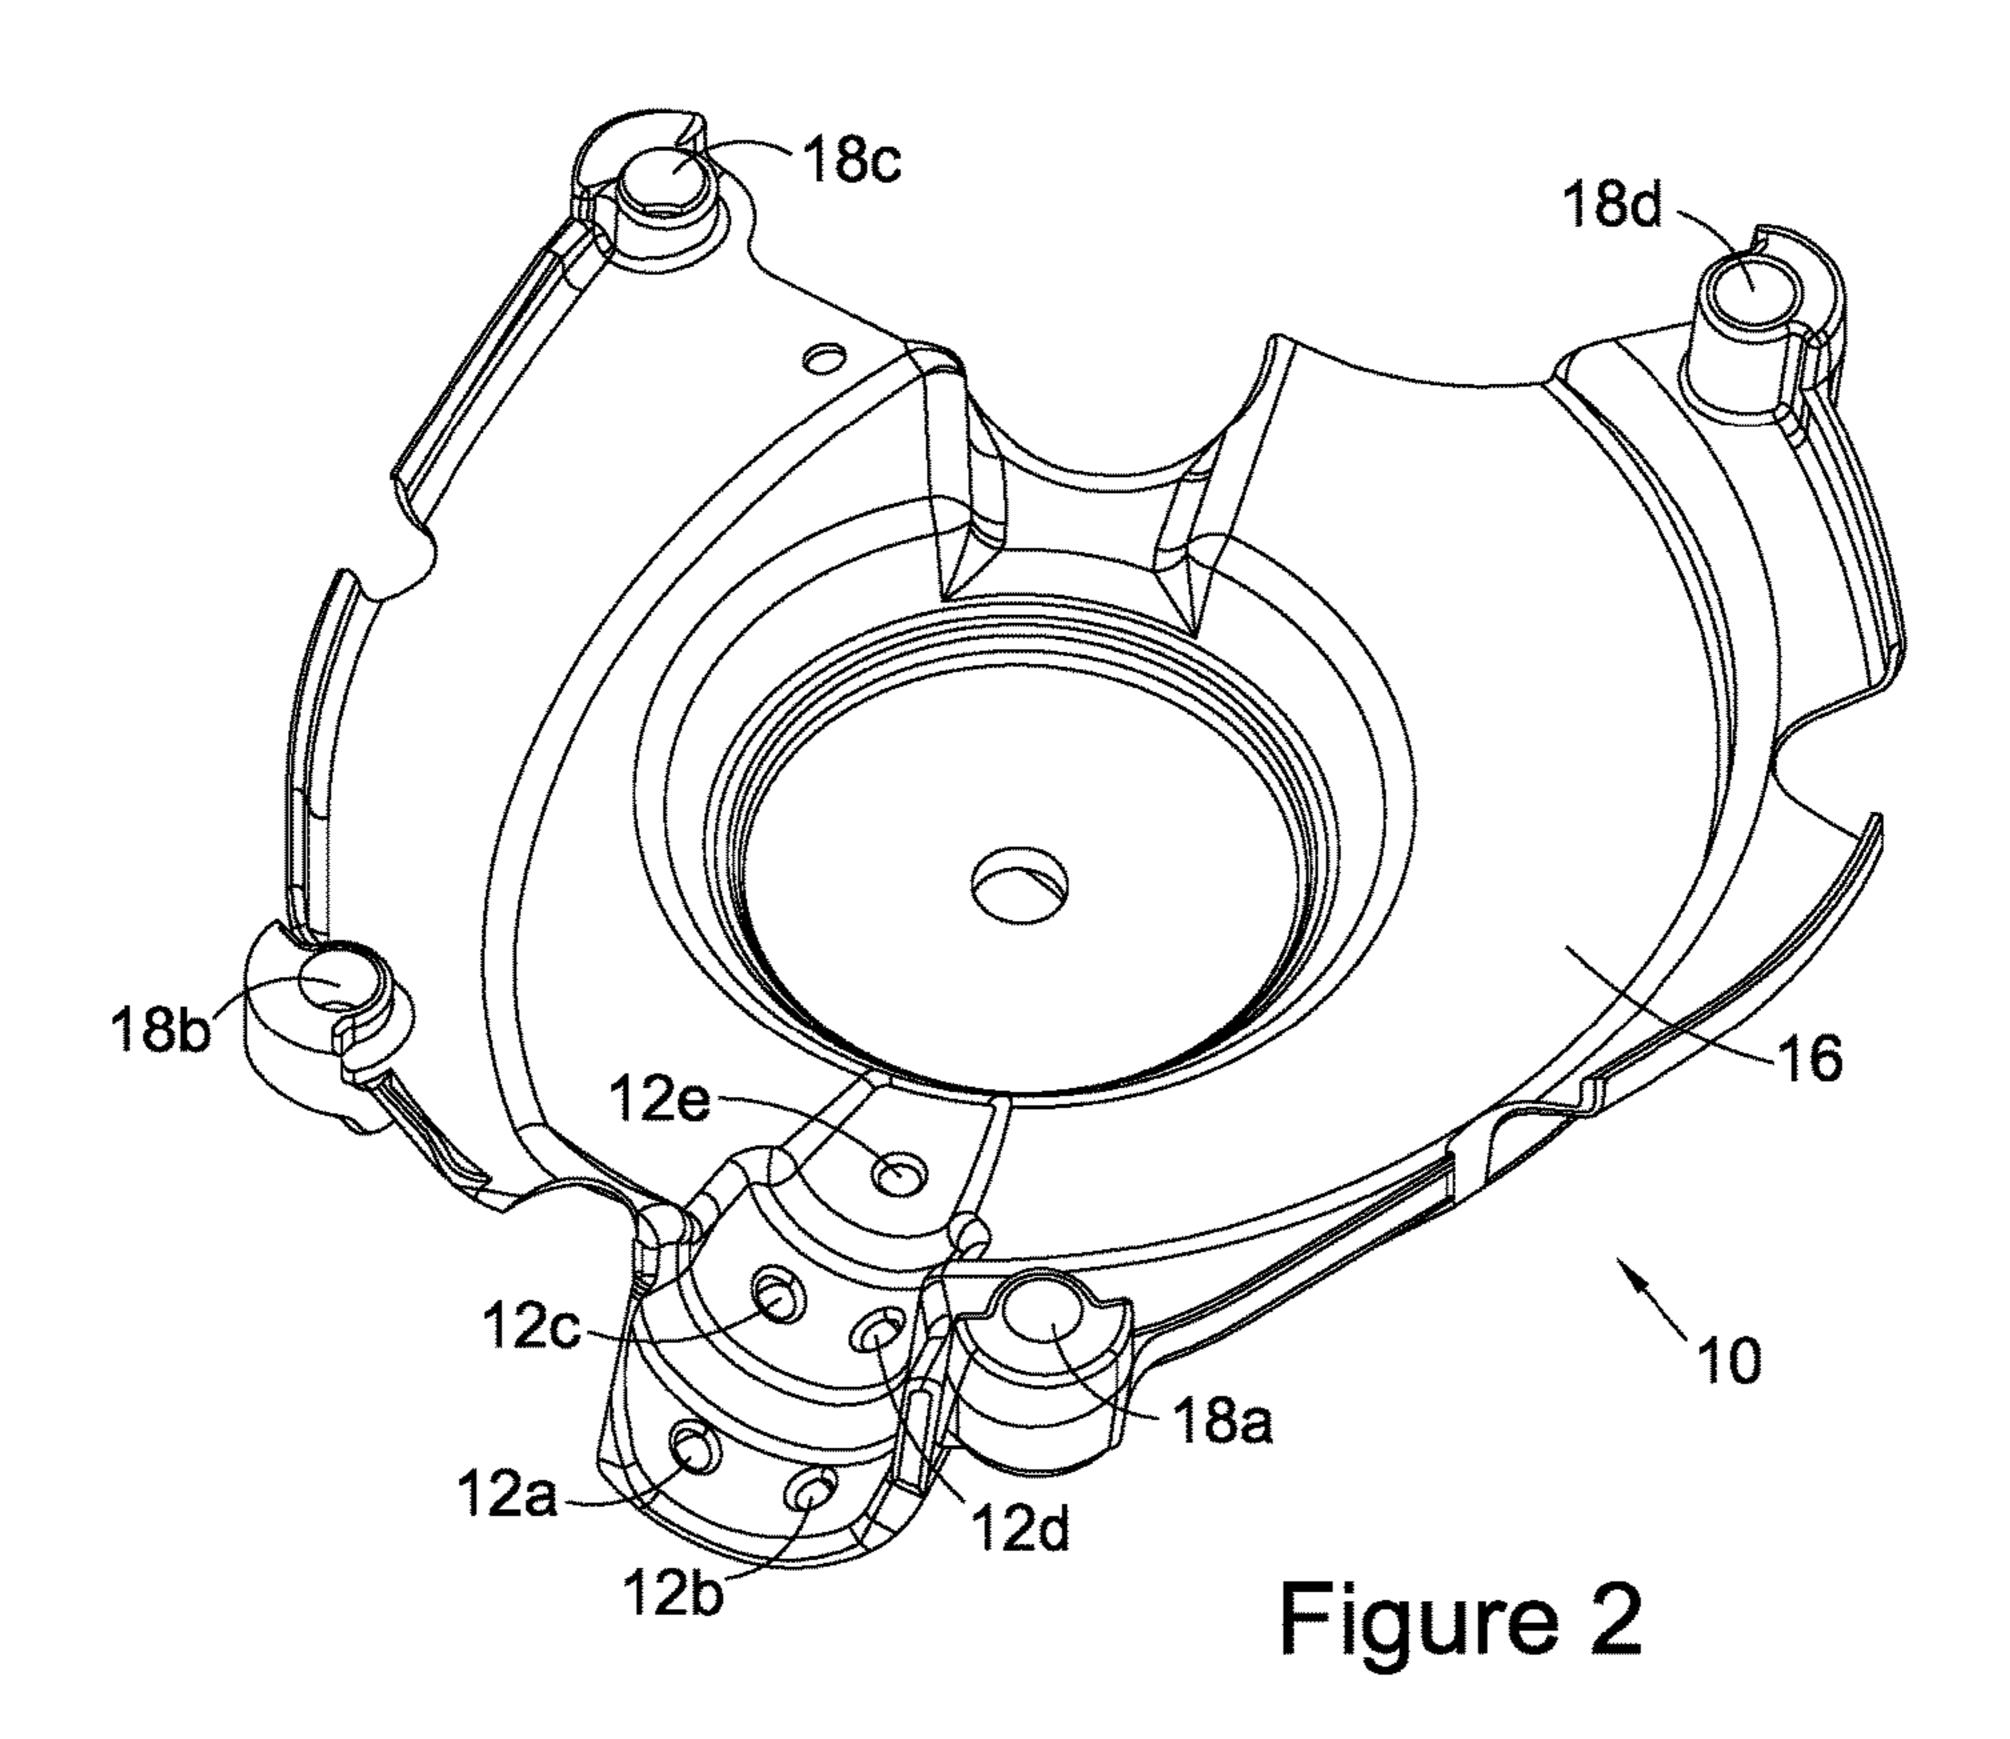
FIG. 2 illustrates a bottom view of a secondary engine cover according to a first embodiment of the present invention;

Turning to FIG. 2 which illustrates a bottom view of the secondary engine cover 10 a plurality of blind holes 12a to 12e are provided. The blind holes do not extend through to the top surface 14 of the secondary engine cover 10. The blind holes stop short of the top surface **14** of the secondary on engine cover 10. Typically, 1 mm to 2.5 mm of material is present between end of each of the blind holes 12a to 12e and the top surface 14 of the secondary engine cover 10. In the embodiment illustrated, 1.7 mm of material is present between end of each of the blind holes 12a to 12e and the

The blind holes 12a to 12e are located in the region(s) of the secondary engine cover 10 most prone to wear.

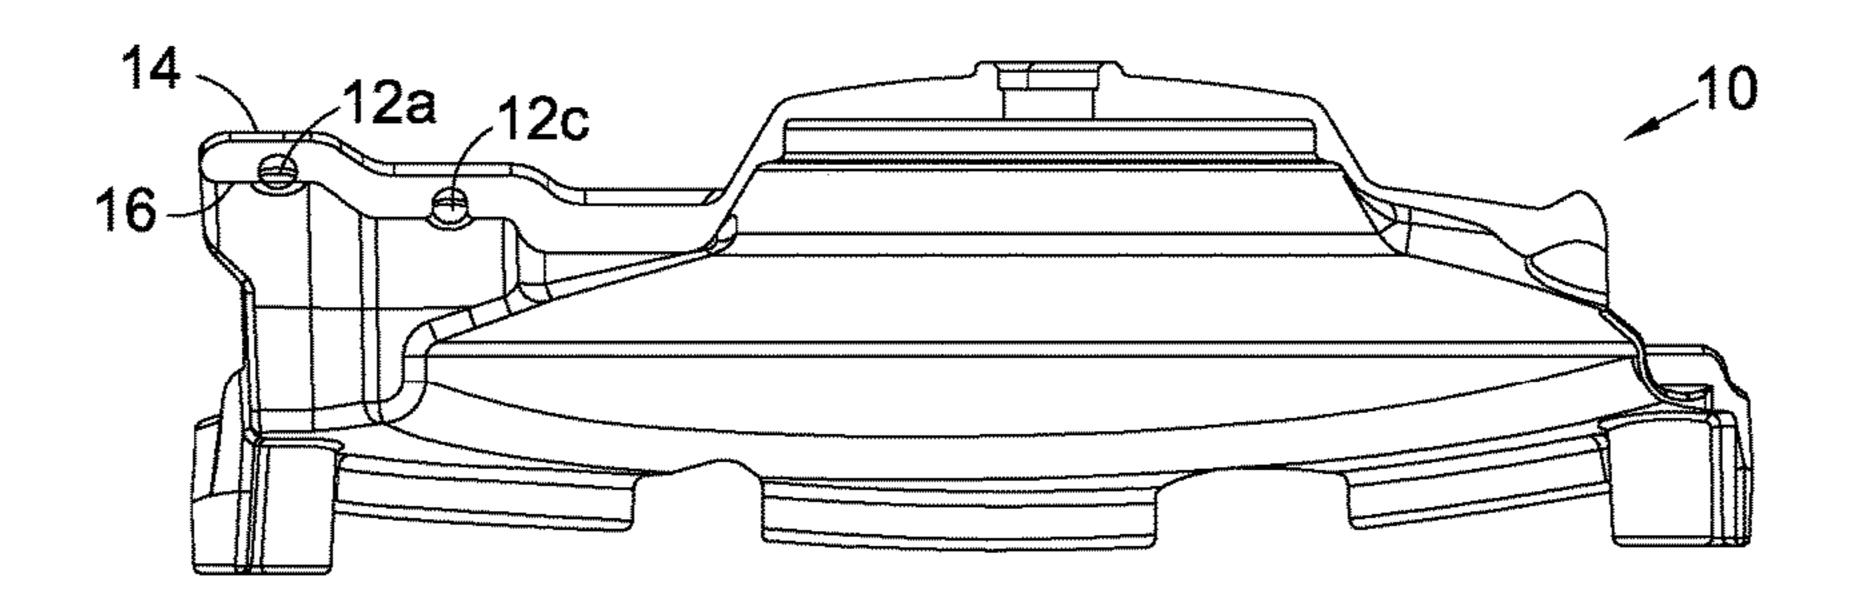
Figure 3

- FIG. 3 illustrates a cross-sectional view of a secondary engine cover according to a first embodiment of the present invention;
- FIG. 4 illustrates a top cut away view of a secondary engine cover according to a first embodiment of the present 5 invention;

FIG. 3 illustrates a cross-sectional view of the secondary engine cover 10 illustrating the depth of blind holes 12a and 12b and the amount of material present before the top surface 14.

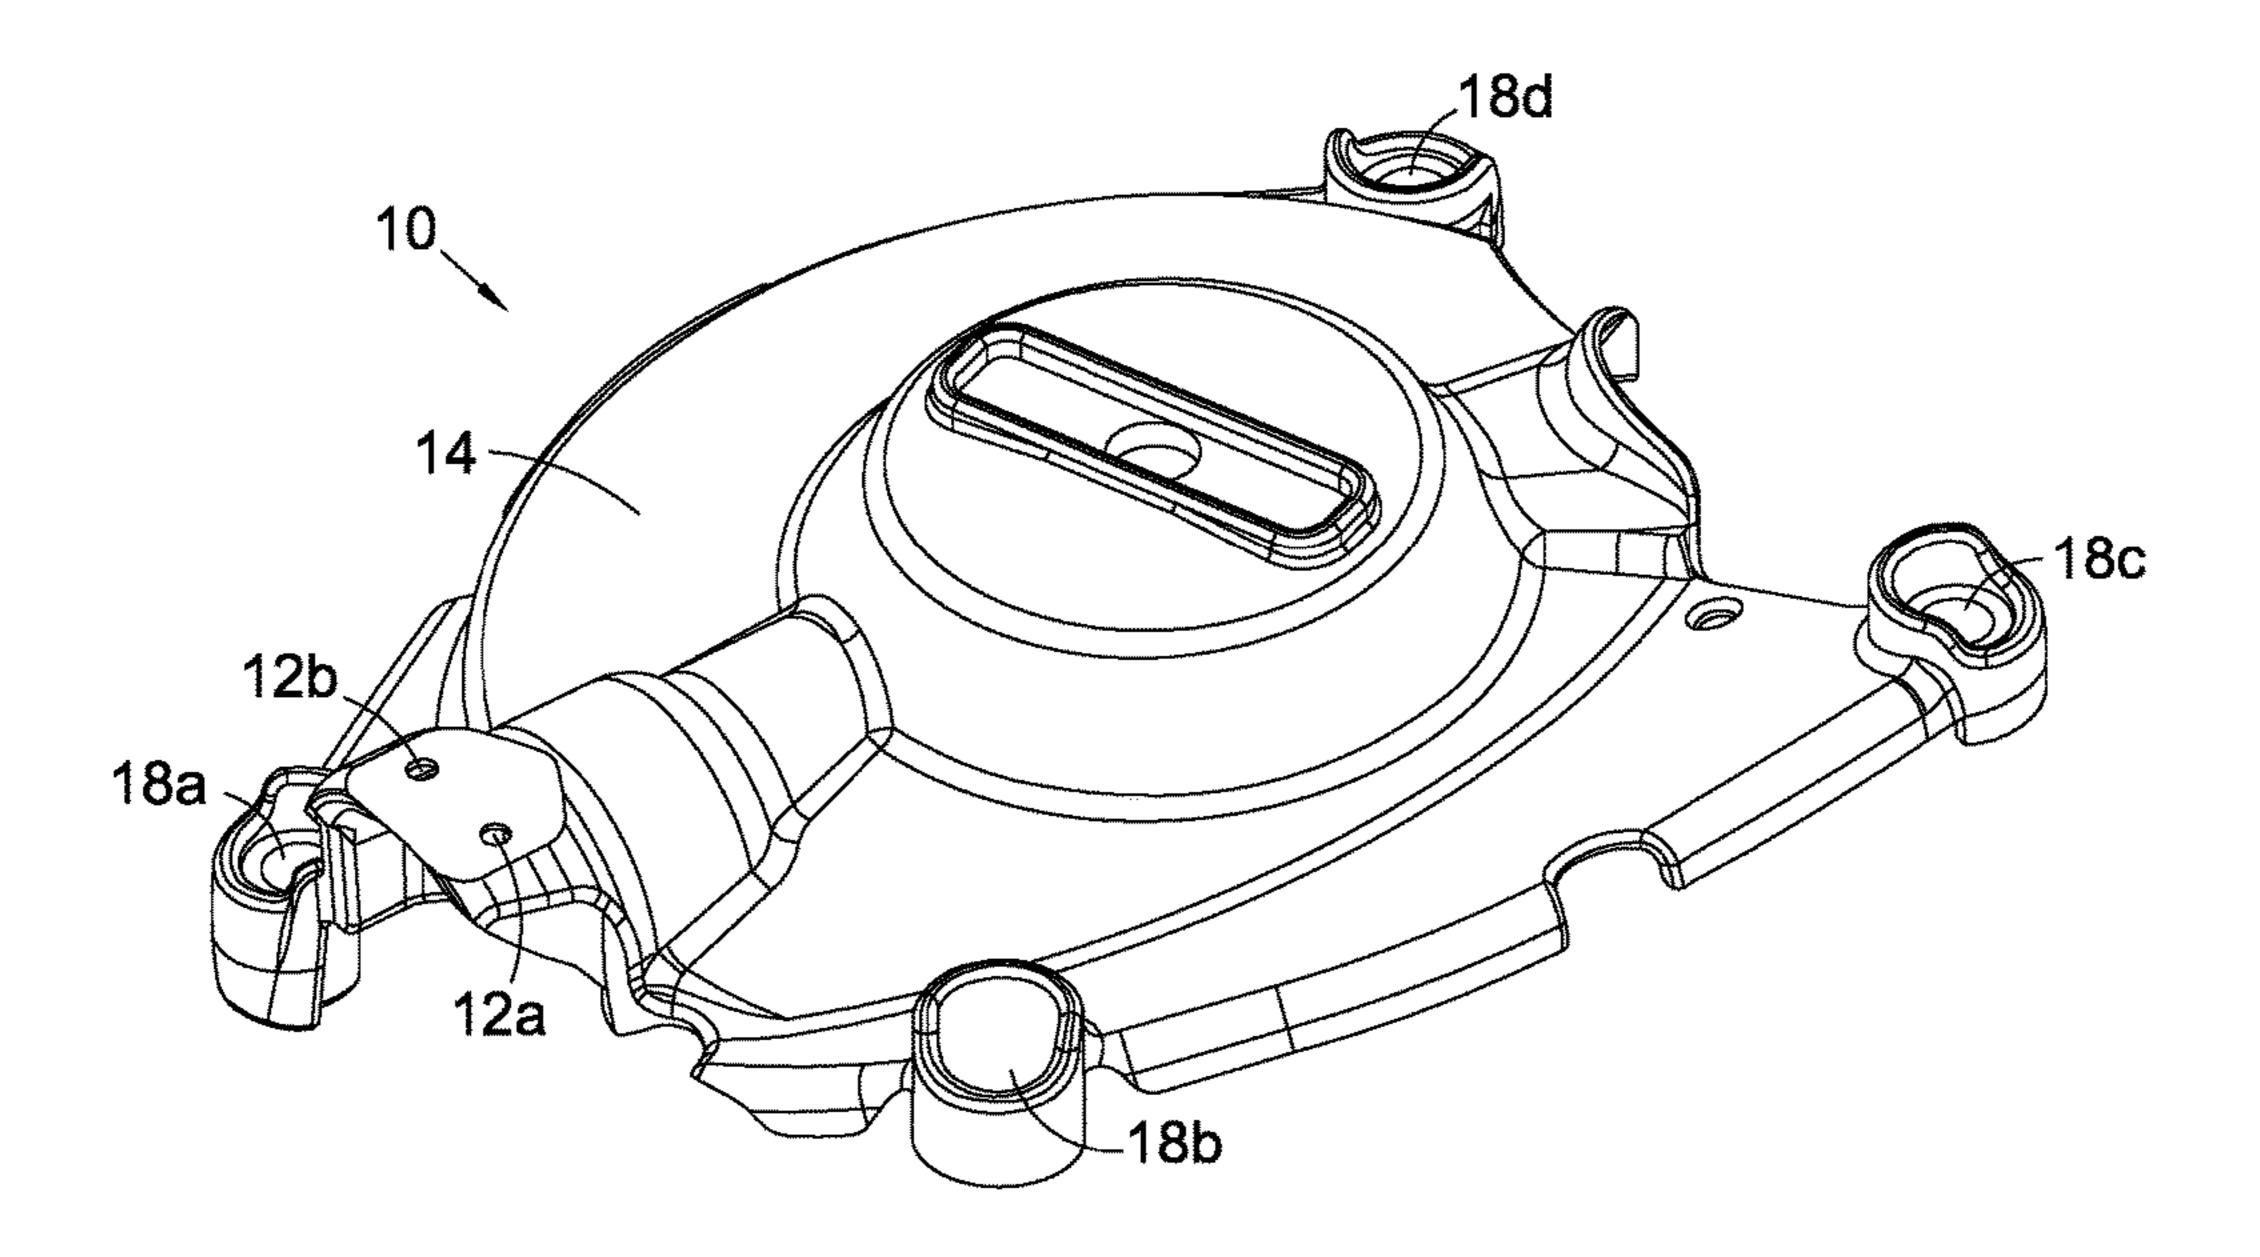
Figure 4

FIG. 4 illustrates a top cut away view of the secondary engine cover 10 in which two of the blind holes 12a, 12b have been exposed. This view exemplifies what would happen to the secondary engine cover 10 after the top surface has become worn, such as after a fall. In the areas 5

around exposed blind holes 12a and 12b, the top surface of the secondary engine cover 10 has become sufficiently worn for replacement as typically at least 1 mm to 2.5 mm of material (depending on the depth of material left between the end of each of the blind holes 12a to 12e and the top surface 14 of the secondary engine cover 10). As stated above in the embodiment illustrated, 1.7 mm of material is present between end of each of the blind holes 12a to 12e and the top surface 14 of the secondary engine cover 10. The visual presence of the blind holes (now holes) 12a and 12b indicates to the user that the secondary engine cover 10 needs to be replaced.

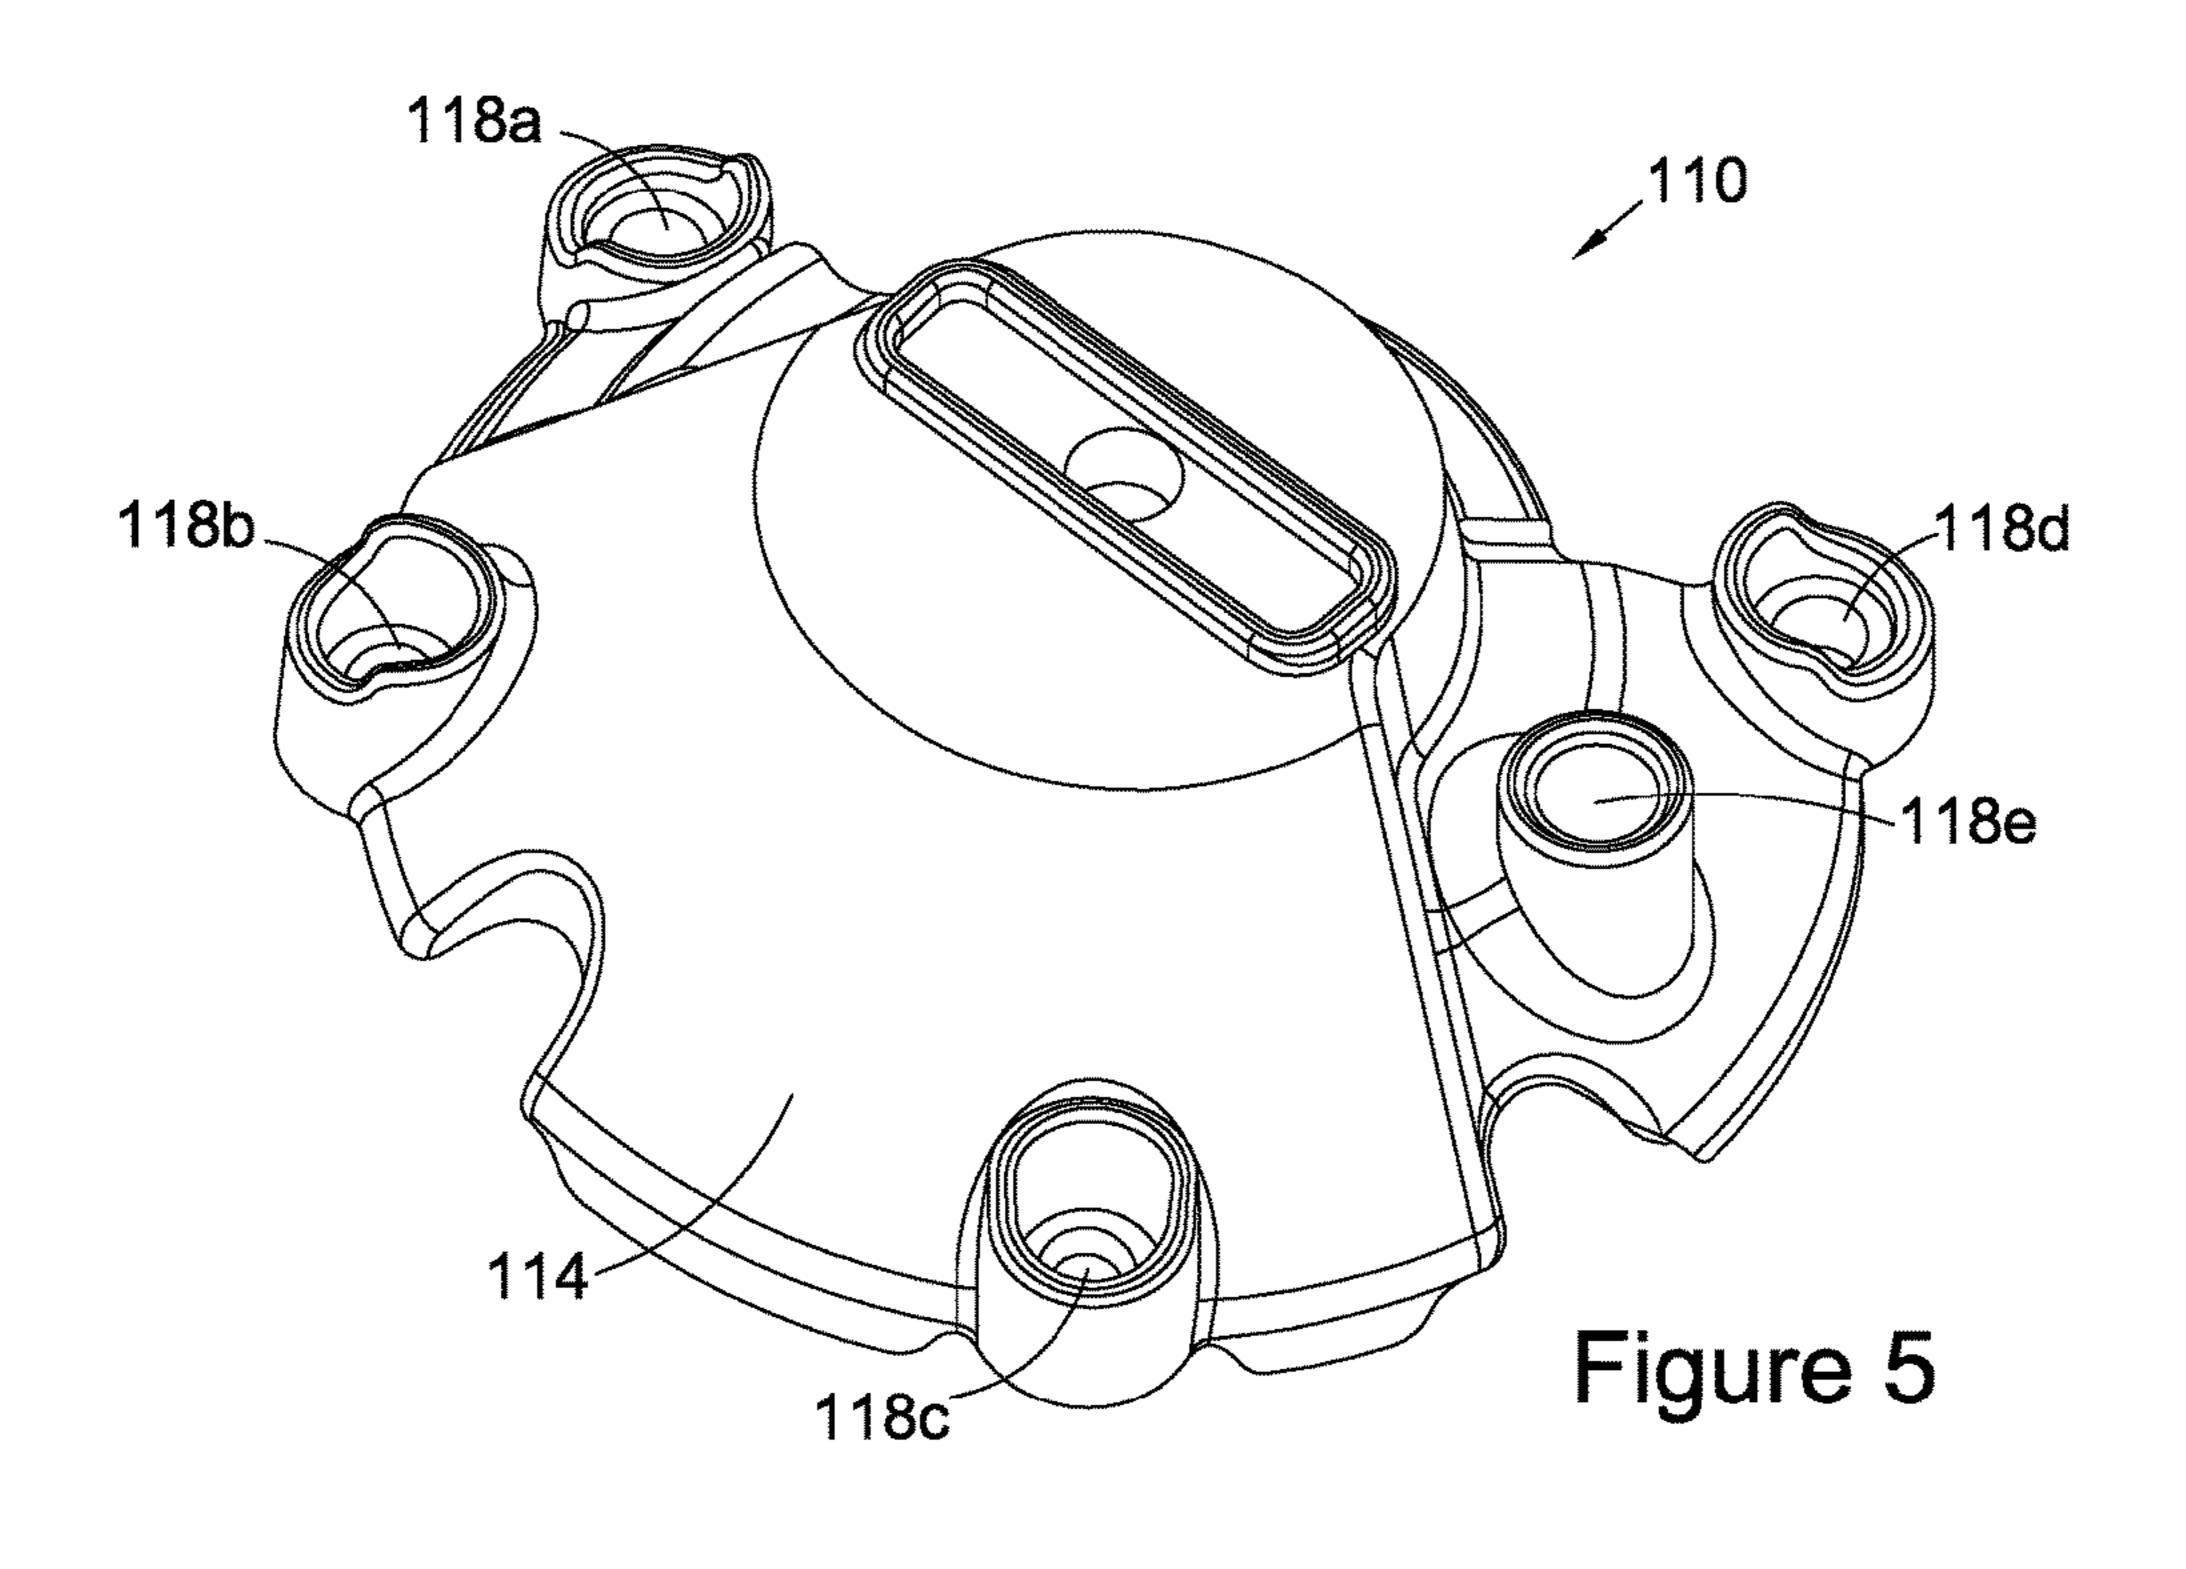
- FIG. 5 illustrates a top view of a secondary engine cover according to a second embodiment of the present invention;
- FIG. 6 illustrates a bottom view of a secondary engine cover according to a second embodiment of the present 10 invention;

FIGS. 5 to 8 illustrate a secondary engine cover 110 according to a second embodiment of the present invention. The secondary engine cover 110 is intended, in use, to bolt on to a motor cycle over an existing engine cover casing using bolt holes 118a to 118e. The secondary engine cover 110 has a top surface 114 and a bottom surface 116. The thickness of the secondary engine cover 110 varies depending on the wear requirements across the secondary engine cover 110, but is typically between 2 mm and 12 mm.

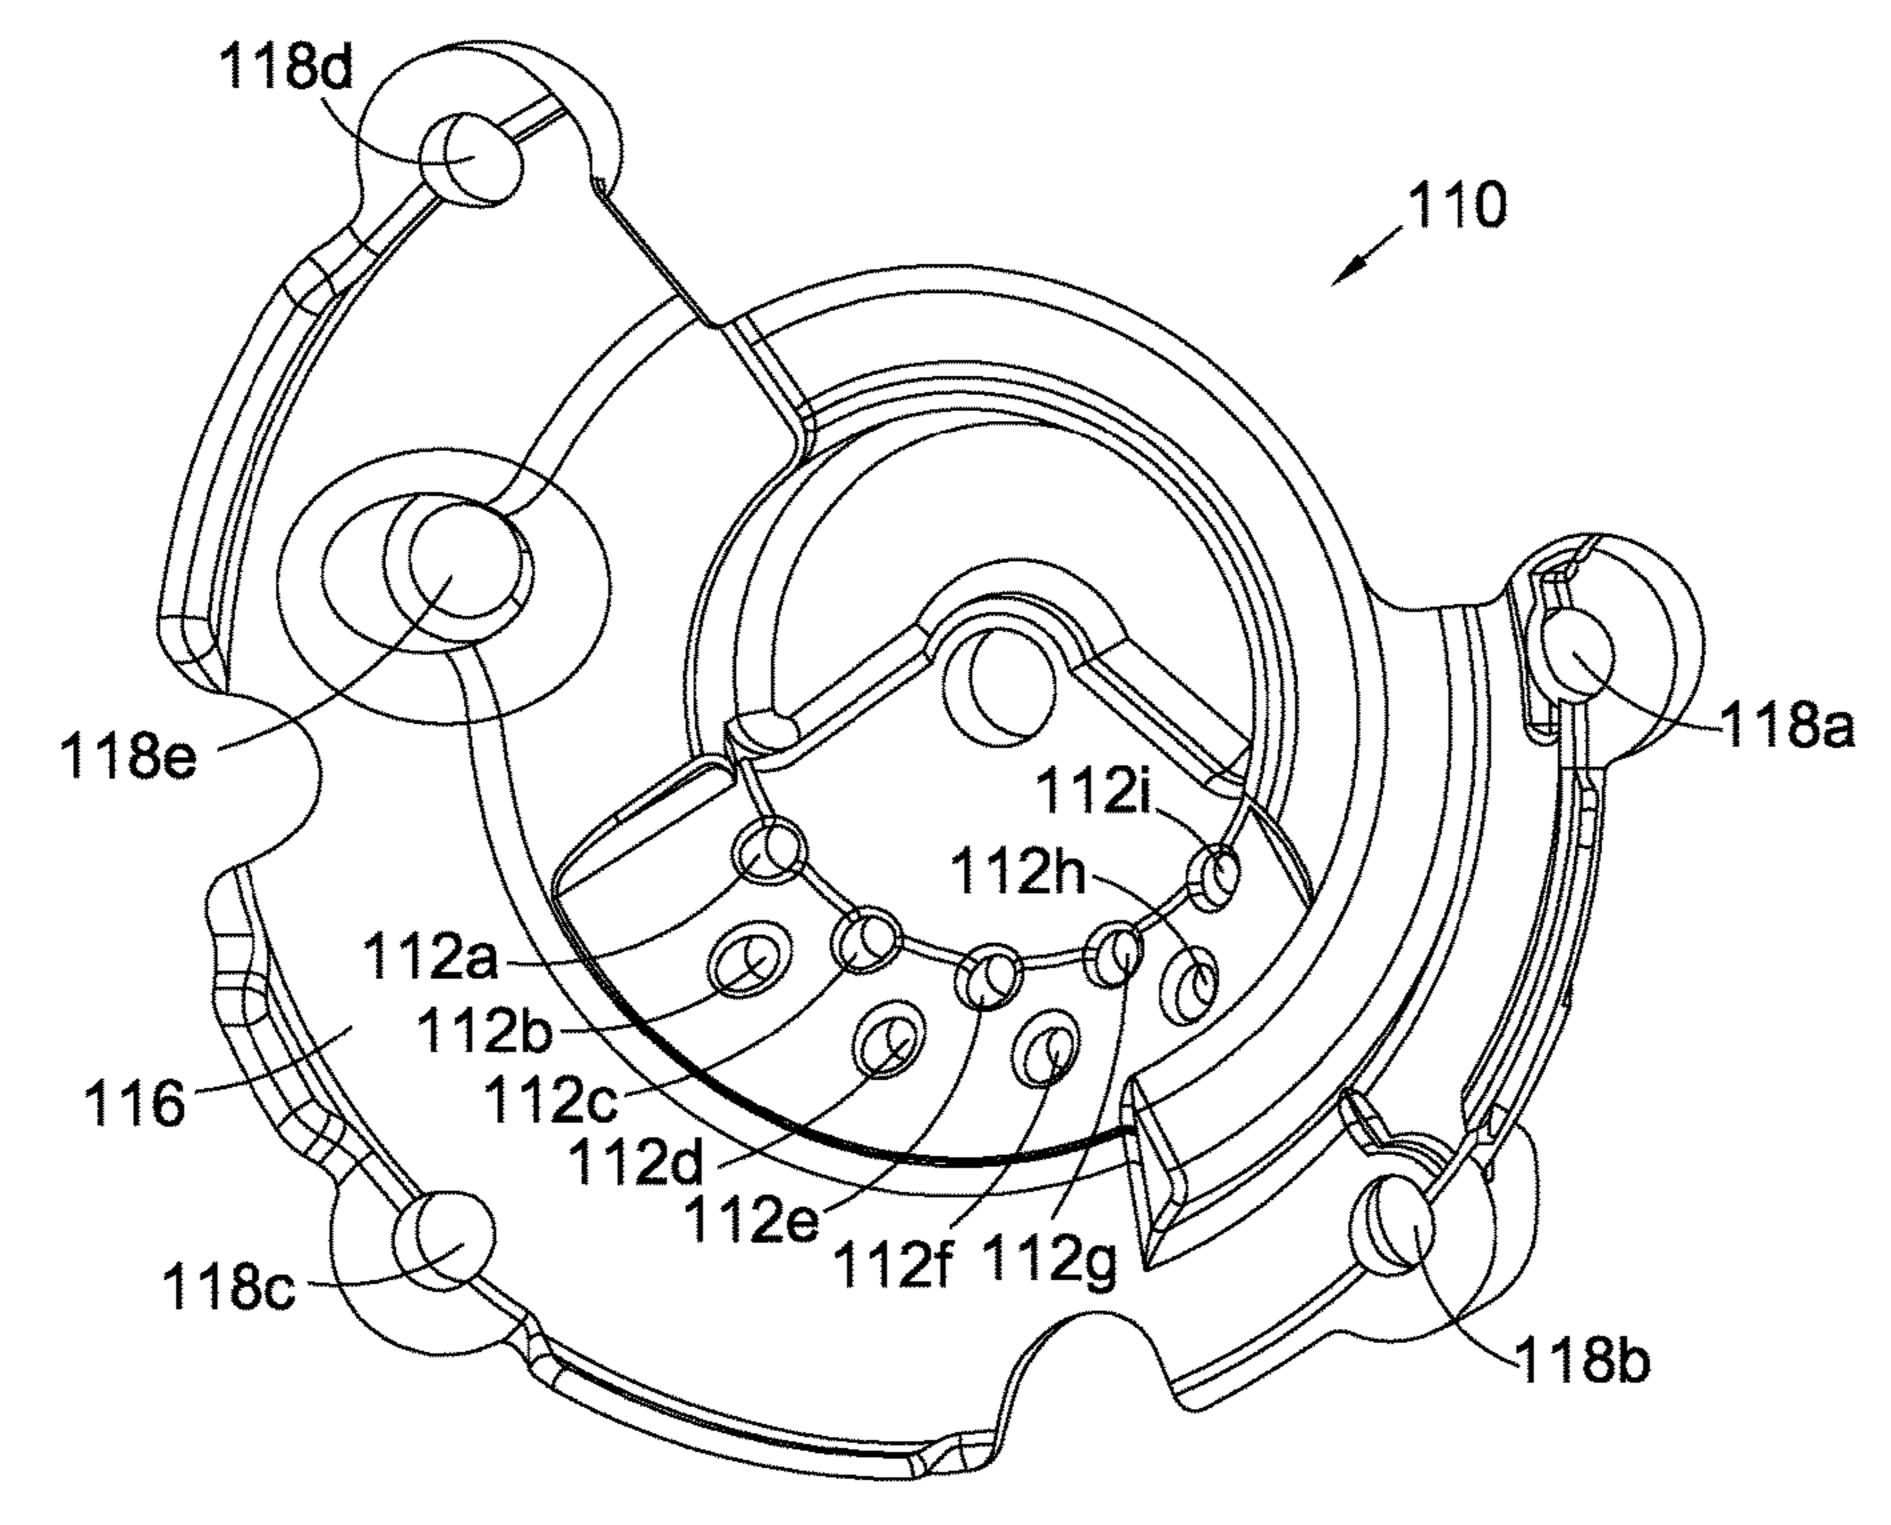
Figure 6

Turning to FIG. 6 which illustrates a bottom view of the secondary engine cover 110, a plurality of blind holes 112a to 112i are provided. The blind holes do not extend through to the top surface 114 of the secondary engine cover 110. 45 The blind holes stop short of the top surface 114 of the secondary engine cover 110. Typically, 1 mm to 2.5 mm of material is present between end of each of the blind holes 112a to 112i and the top surface 114 of the secondary engine cover 110. In the embodiment illustrated, 1.7 mm of material is present between end of each of the blind holes 112a to 112i and the top surface 114 of the secondary engine cover 110.

The blind holes 112a to 112i are located in the region(s) of the secondary engine cover 110 most prone to wear.

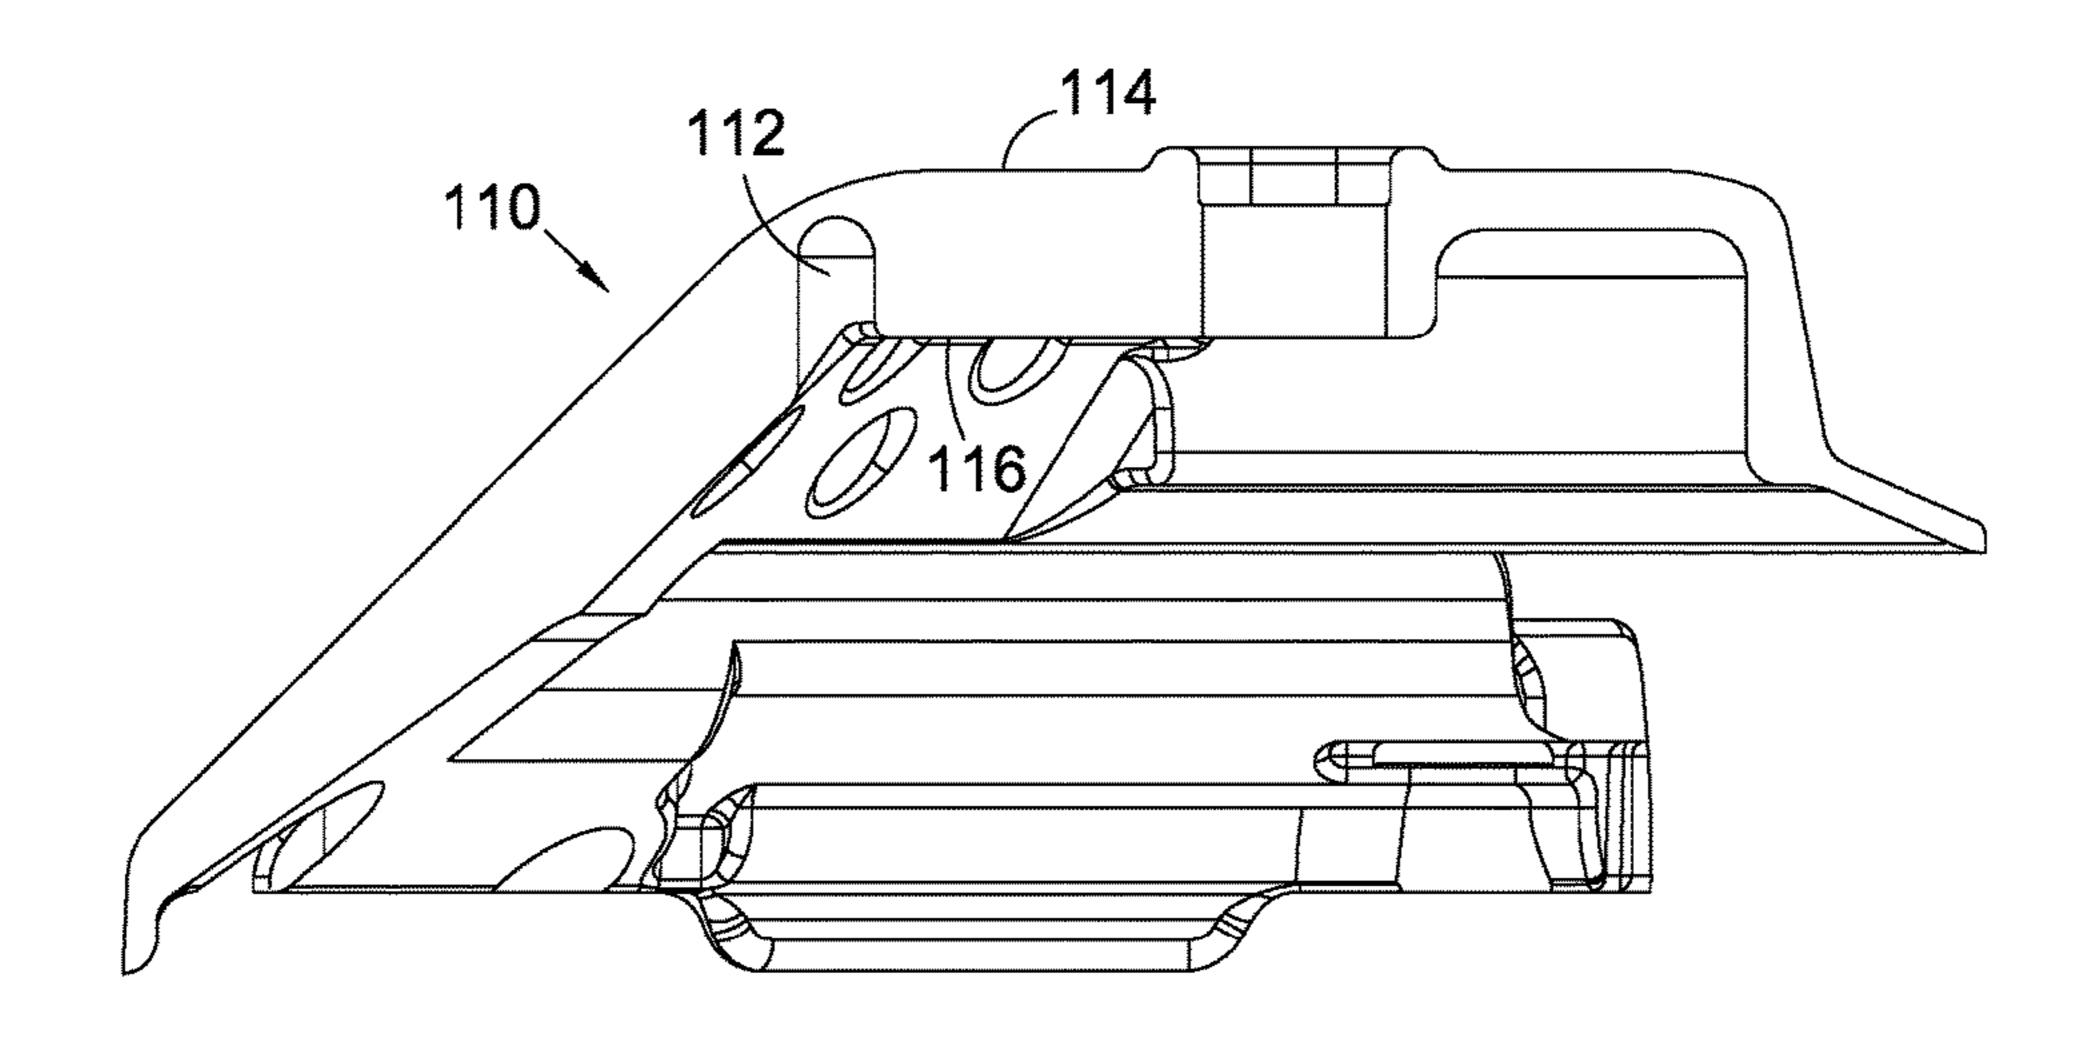
Figure 7

FIG. 7 illustrates a cross-sectional view of the secondary engine cover 110 illustrating the depth of blind holes 112 in general and the amount of material present before the top surface 114.
