US009976477B2

(54)	SECONDARY ENGINE COVERS						
(71)	Applicant:	Lewis Banks Limited, Hertfordshire (GB)					
(72)	Inventor:	Graham Banks, Hertfordshire (GB)					
(73)	Assignee:	Lewis Banks Limited, Hertfordshire (GB)					
(*)	Notice:	Subject to any disclaimer, the term of this patent is extended or adjusted under 35 U.S.C. 154(b) by 57 days.					
(21)	Appl. No.: 15/139,944						
(22)	Filed:	Apr. 27, 2016					
(65)	Prior Publication Data						
	US 2017/0009650 A1 Jan. 12, 2017						
(30)	Foreign Application Priority Data						
Jul. 10, 2015 (GB) 1512085.0							
(51) (52)	F02B 77/08 (2006.01) B62J 27/00 (2006.01) B62J 23/00 (2006.01)						
(58)	Field of Classification Search CPC F02B 77/083; B62J 23/00; B62J 27/00 See application file for complete search history.						
(56)	References Cited

According to the present invention, there is provided a secondary engine cover formed from a polymeric material comprising a wear indicator, wherein the wear indicator comprises a region of reduced thickness of polymeric material and wherein the region of reduced thickness comprises a blind hole.

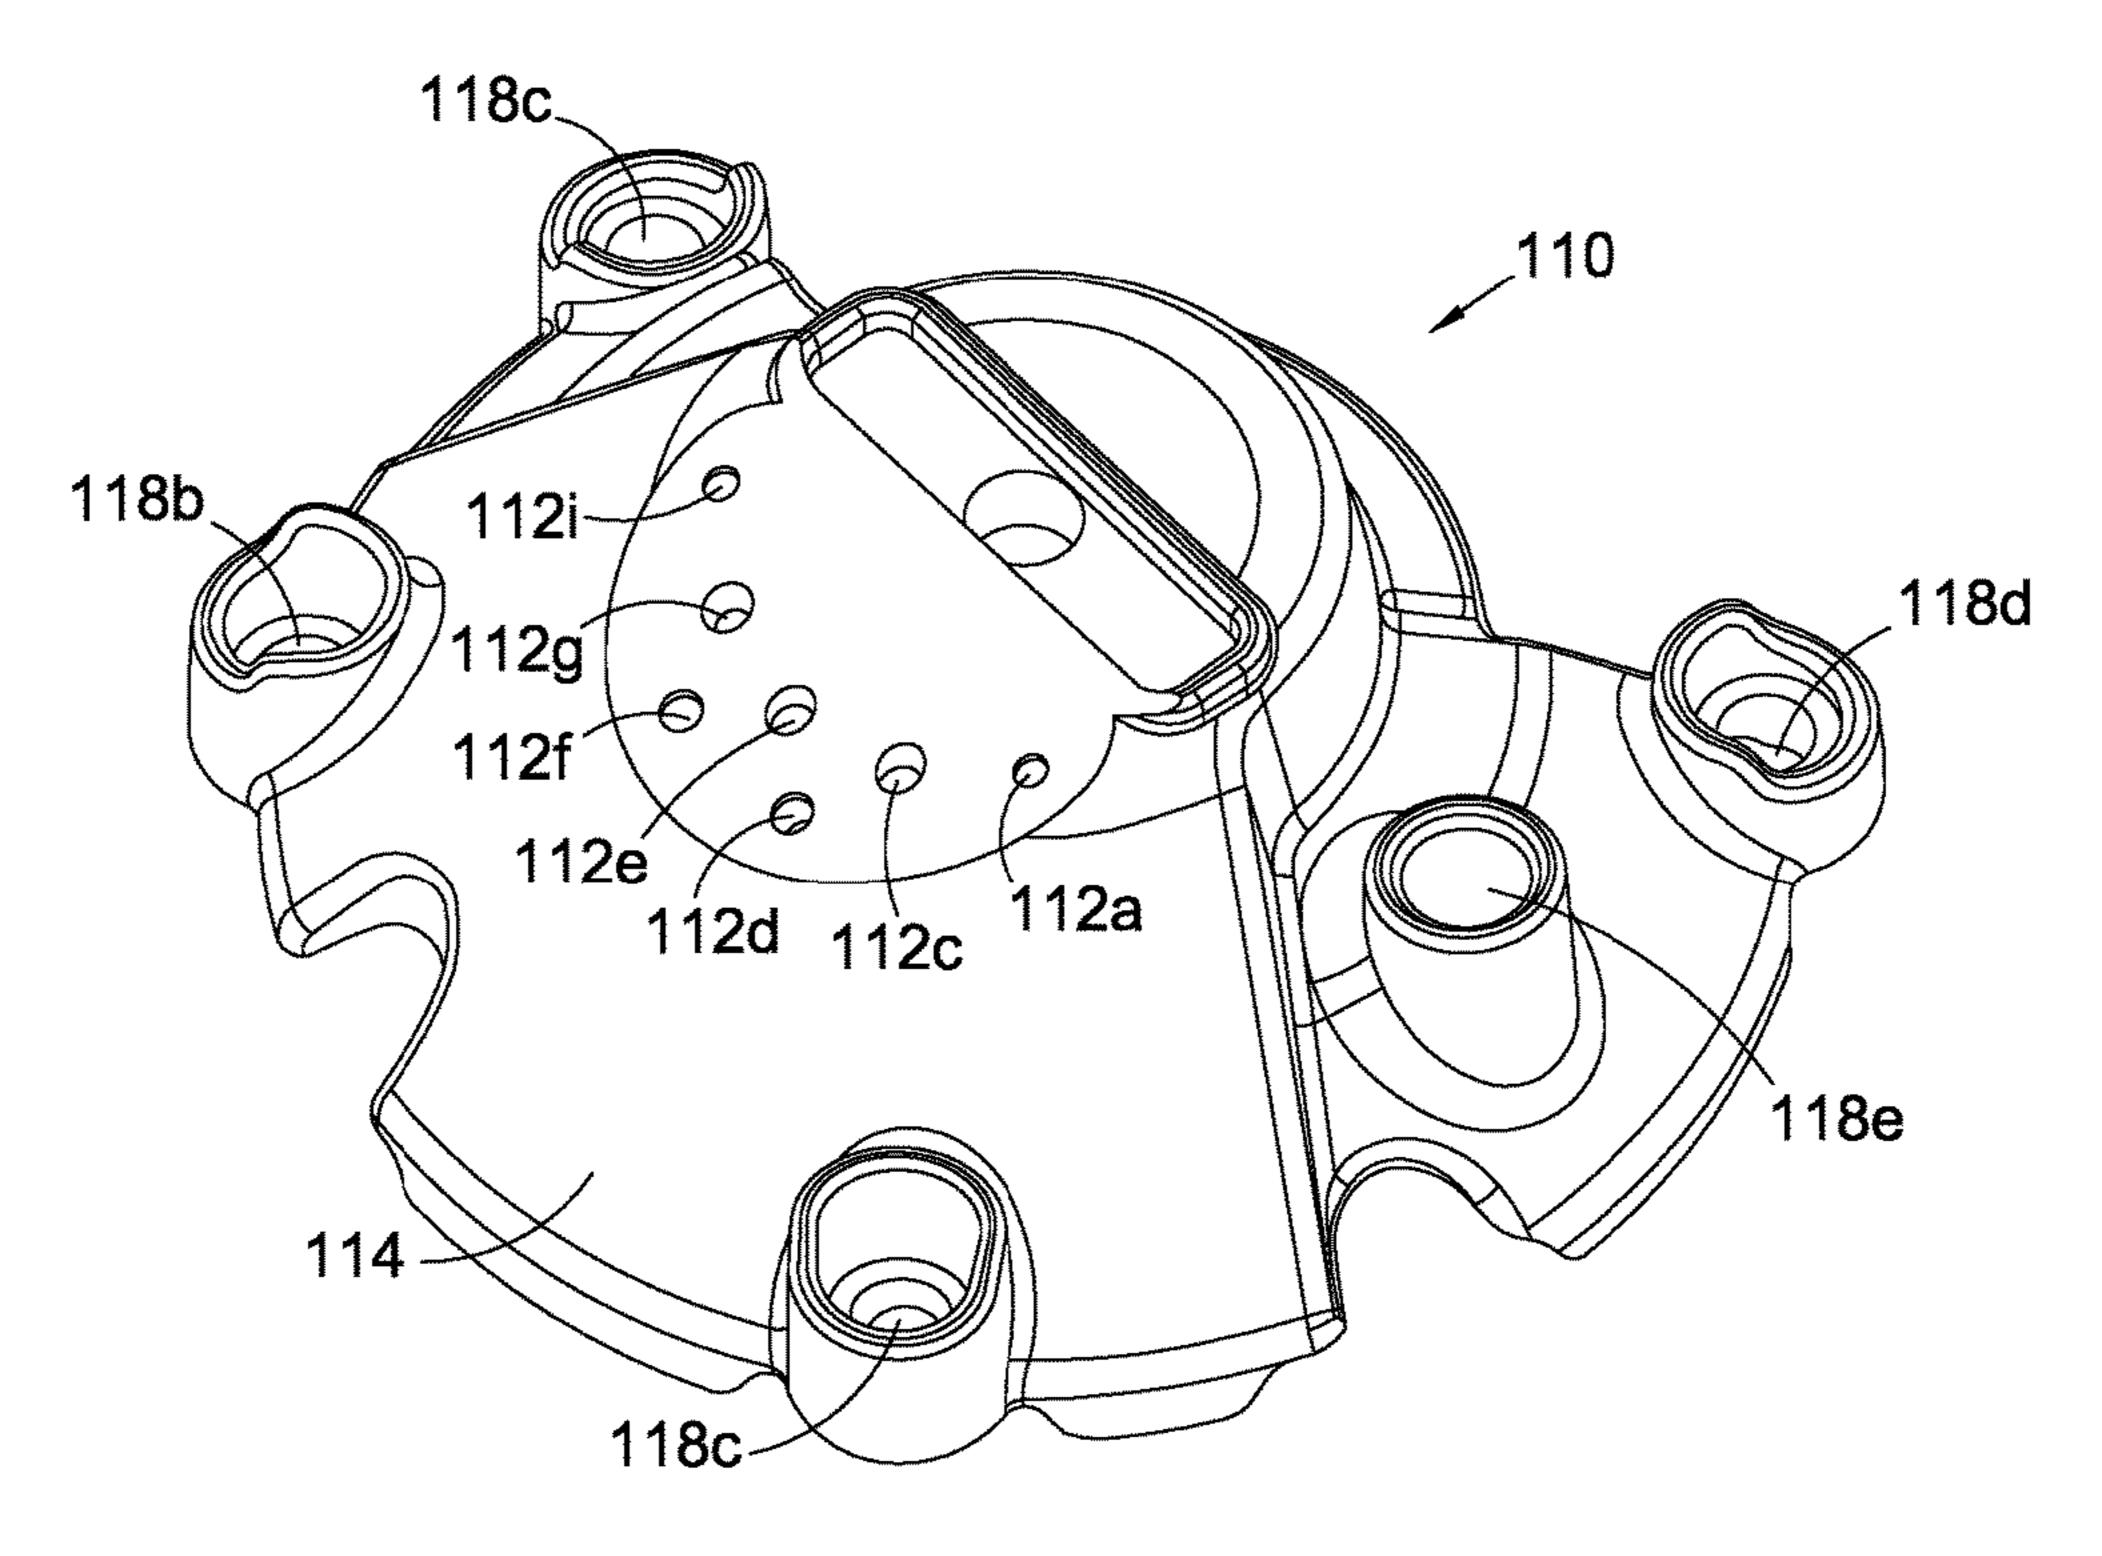
Figure 8

FIG. 8 illustrates a top cut away view of the secondary engine cover 110 in which seven of the blind holes 112a, 112c, 112d, 112e, 112f, 112g, 112i have been exposed. This view exemplifies what would happen to the secondary engine cover 110 after the top surface has become worn, such as after a fall. In the areas around exposed blind holes 112a, 112c, 112d, 112e, 112f, 112g, 112i, the top surface of the secondary engine cover 110 has become sufficiently worn for replacement as typically at least 1 mm to 2.5 mm of material (depending on the depth of material left between the end of each of the blind holes 112a to 112i and the top surface 114 of the secondary engine cover 110). As stated above in the embodiment illustrated, 1.7 mm of material is present between end of each of the blind holes 112a to 112i and the top surface 114 of the secondary engine cover 110. The visual presence of the blind holes (now holes) 112a, 112c, 112d, 112e, 112f, 112g, 112i indicates to the user that the secondary engine cover 110 needs to be replaced.

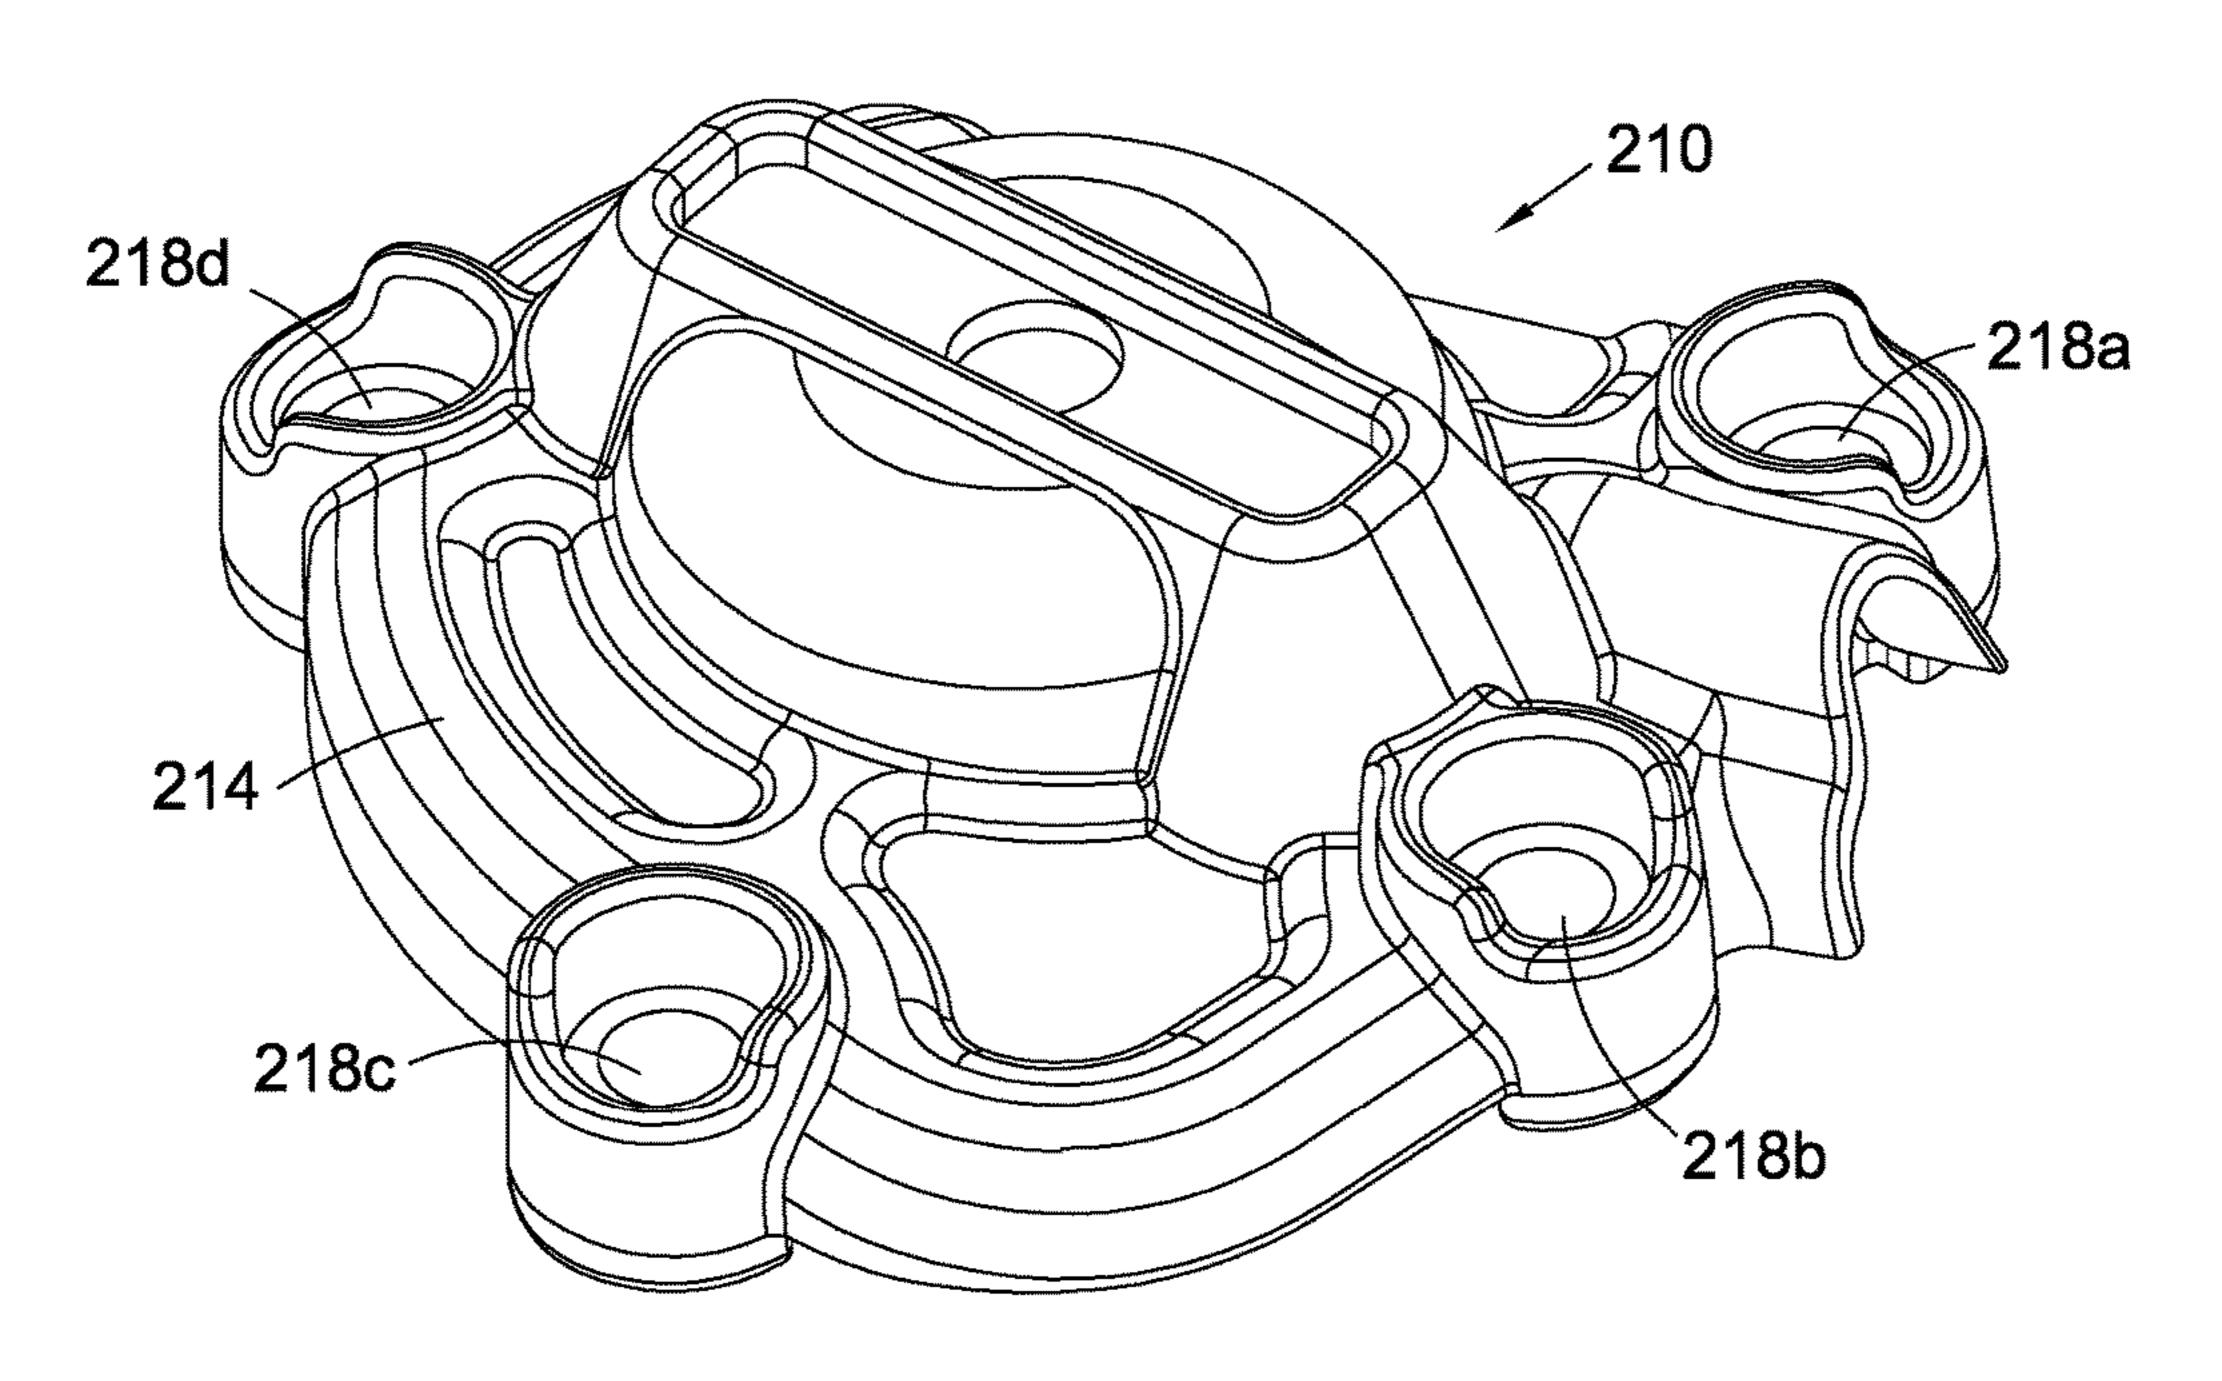
Figure 9

- FIG. 9 illustrates a top view of a secondary engine cover according to a third embodiment of the present invention;
- FIG. 10 illustrates a bottom view of a secondary engine 20 cover according to a third embodiment of the present invention;

FIGS. 9 to 12 illustrate a secondary engine cover 210 according to a second embodiment of the present invention. The secondary engine cover 210 is intended, in use, to bolt on to a motor cycle over an existing engine cover casing using bolt holes 218a to 218d. The secondary engine cover 210 has a top surface 214 and a bottom surface 216. The thickness of the secondary engine cover 210 varies depending on the wear requirements across the secondary engine cover 210, but is typically between 2 mm and 12 mm.

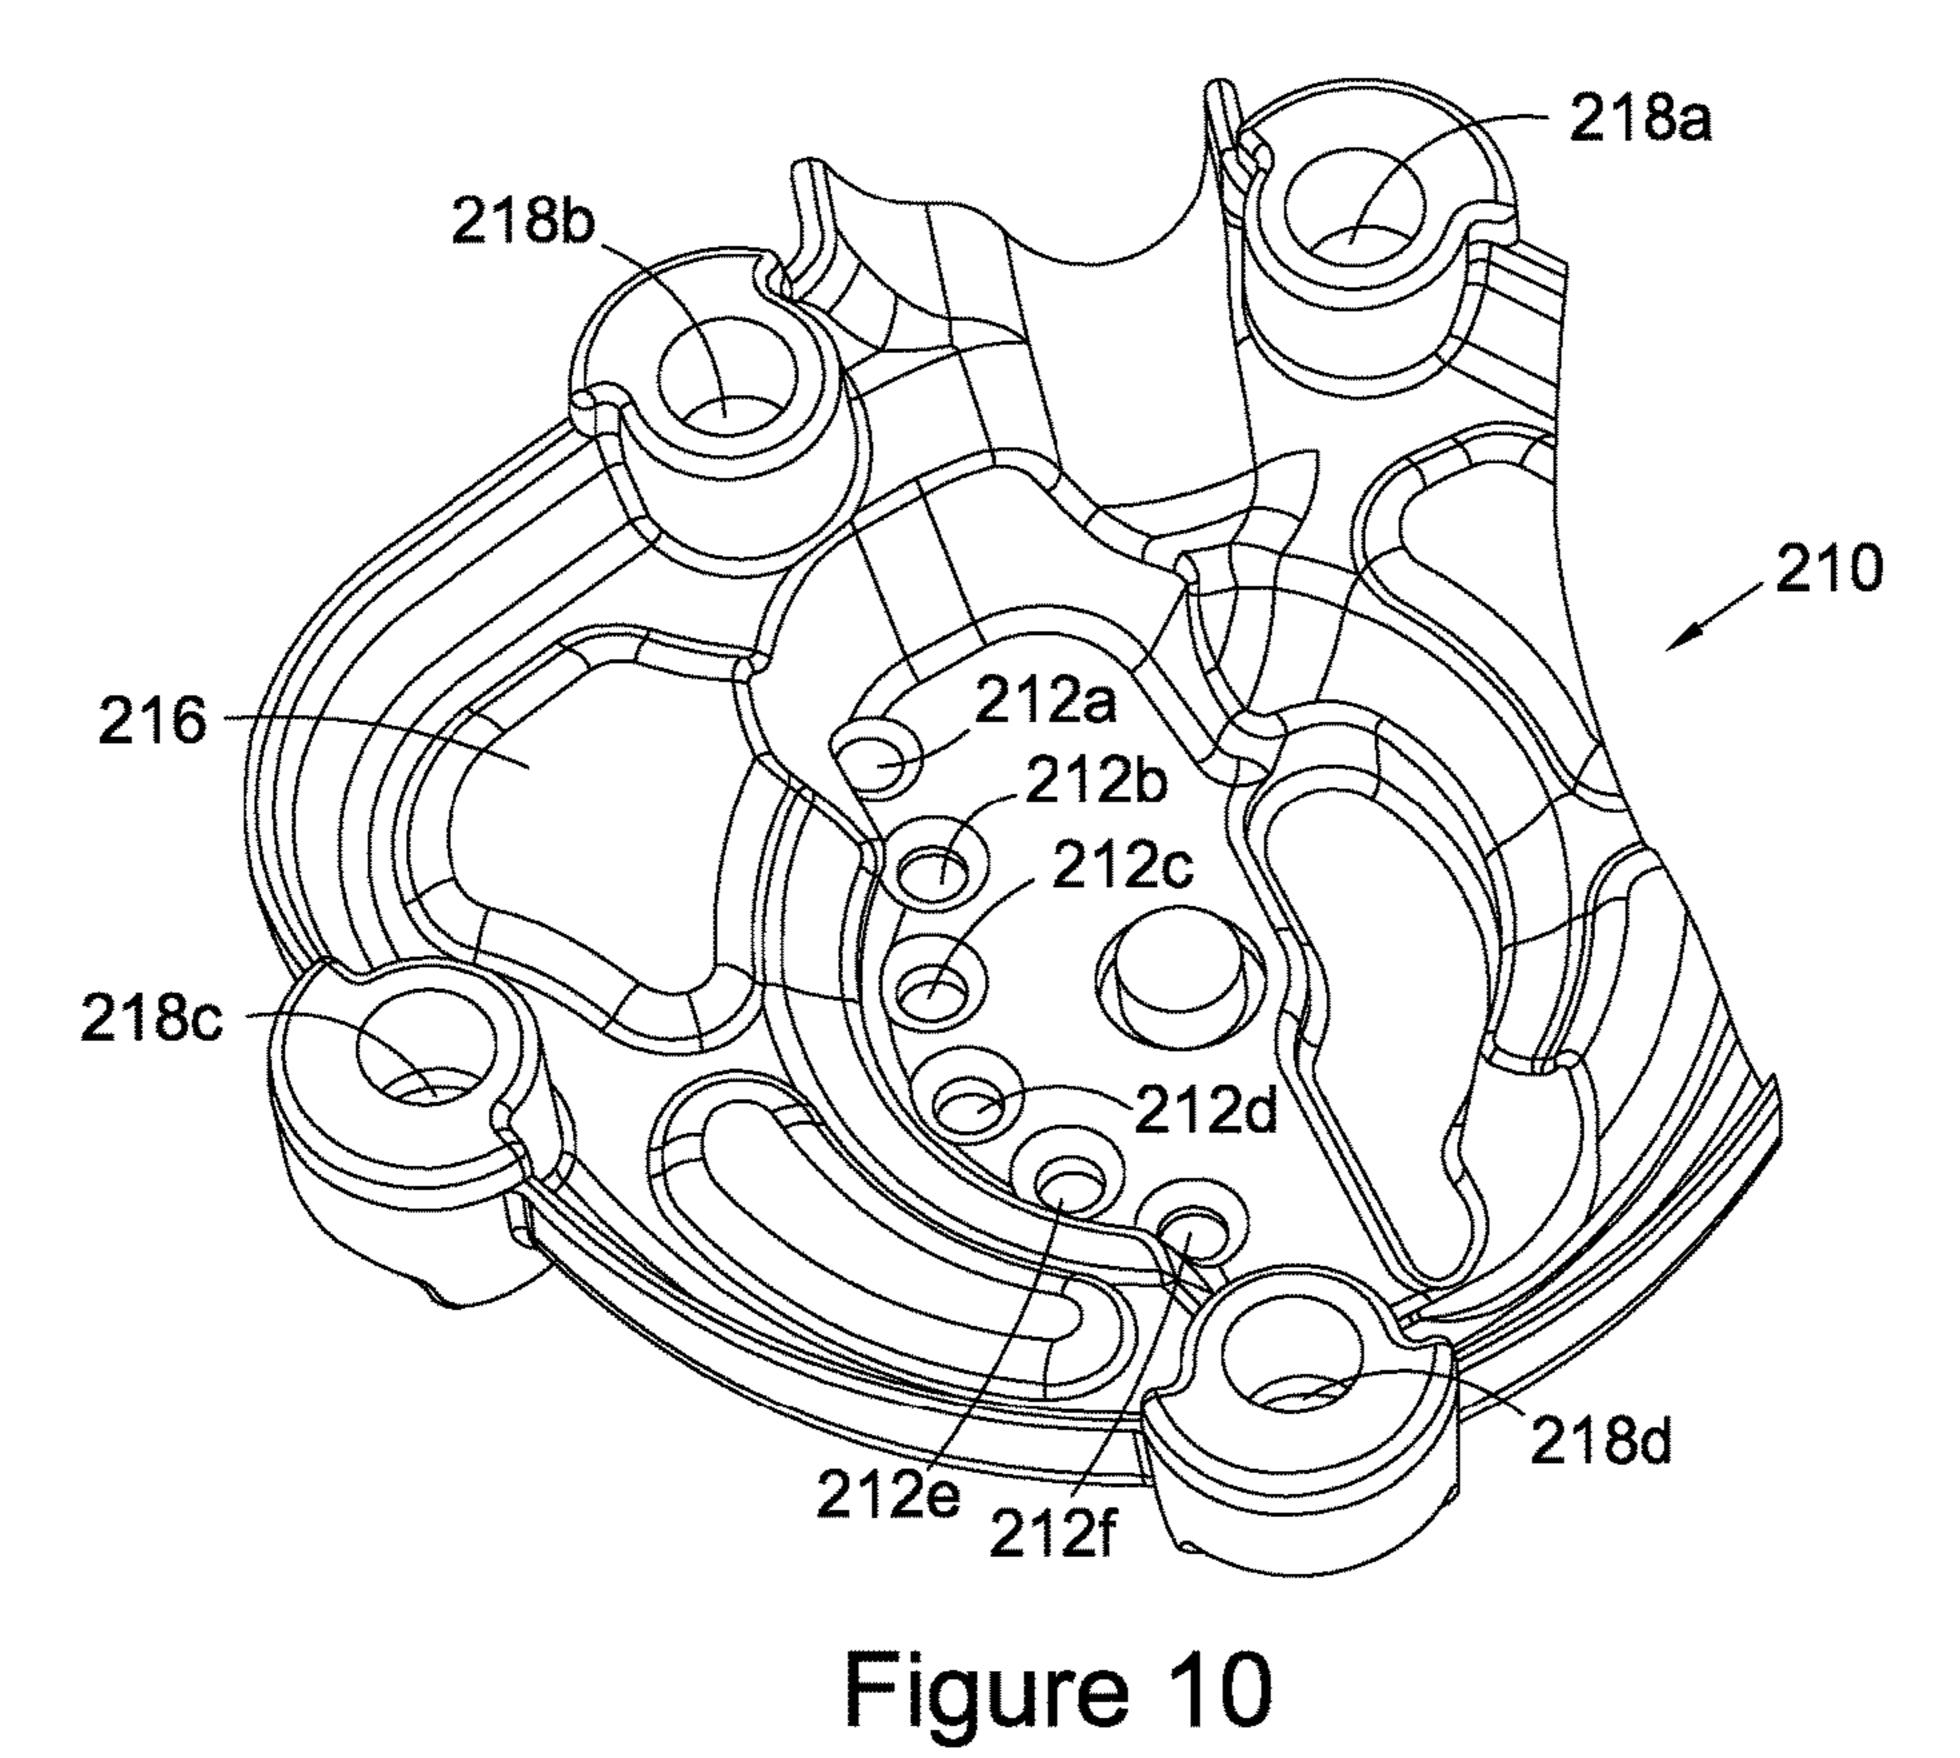
Turning to FIG. 10, which illustrates a bottom view of the secondary engine cover 210, a plurality of blind holes 212a to 212f are provided. The blind holes do not extend through to the top surface 214 of the secondary engine cover 210.

The blind holes stop short of the top surface 214 of the secondary engine cover 210. Typically, 1 mm to 2.5 mm of material is present between end of each of the blind holes 212a to 212f and the top surface 214 of the secondary engine cover 210. In the embodiment illustrated, 1.7 mm of material is present between end of each of the blind holes 212a to 212f and the top surface 214 of the secondary engine cover 210.

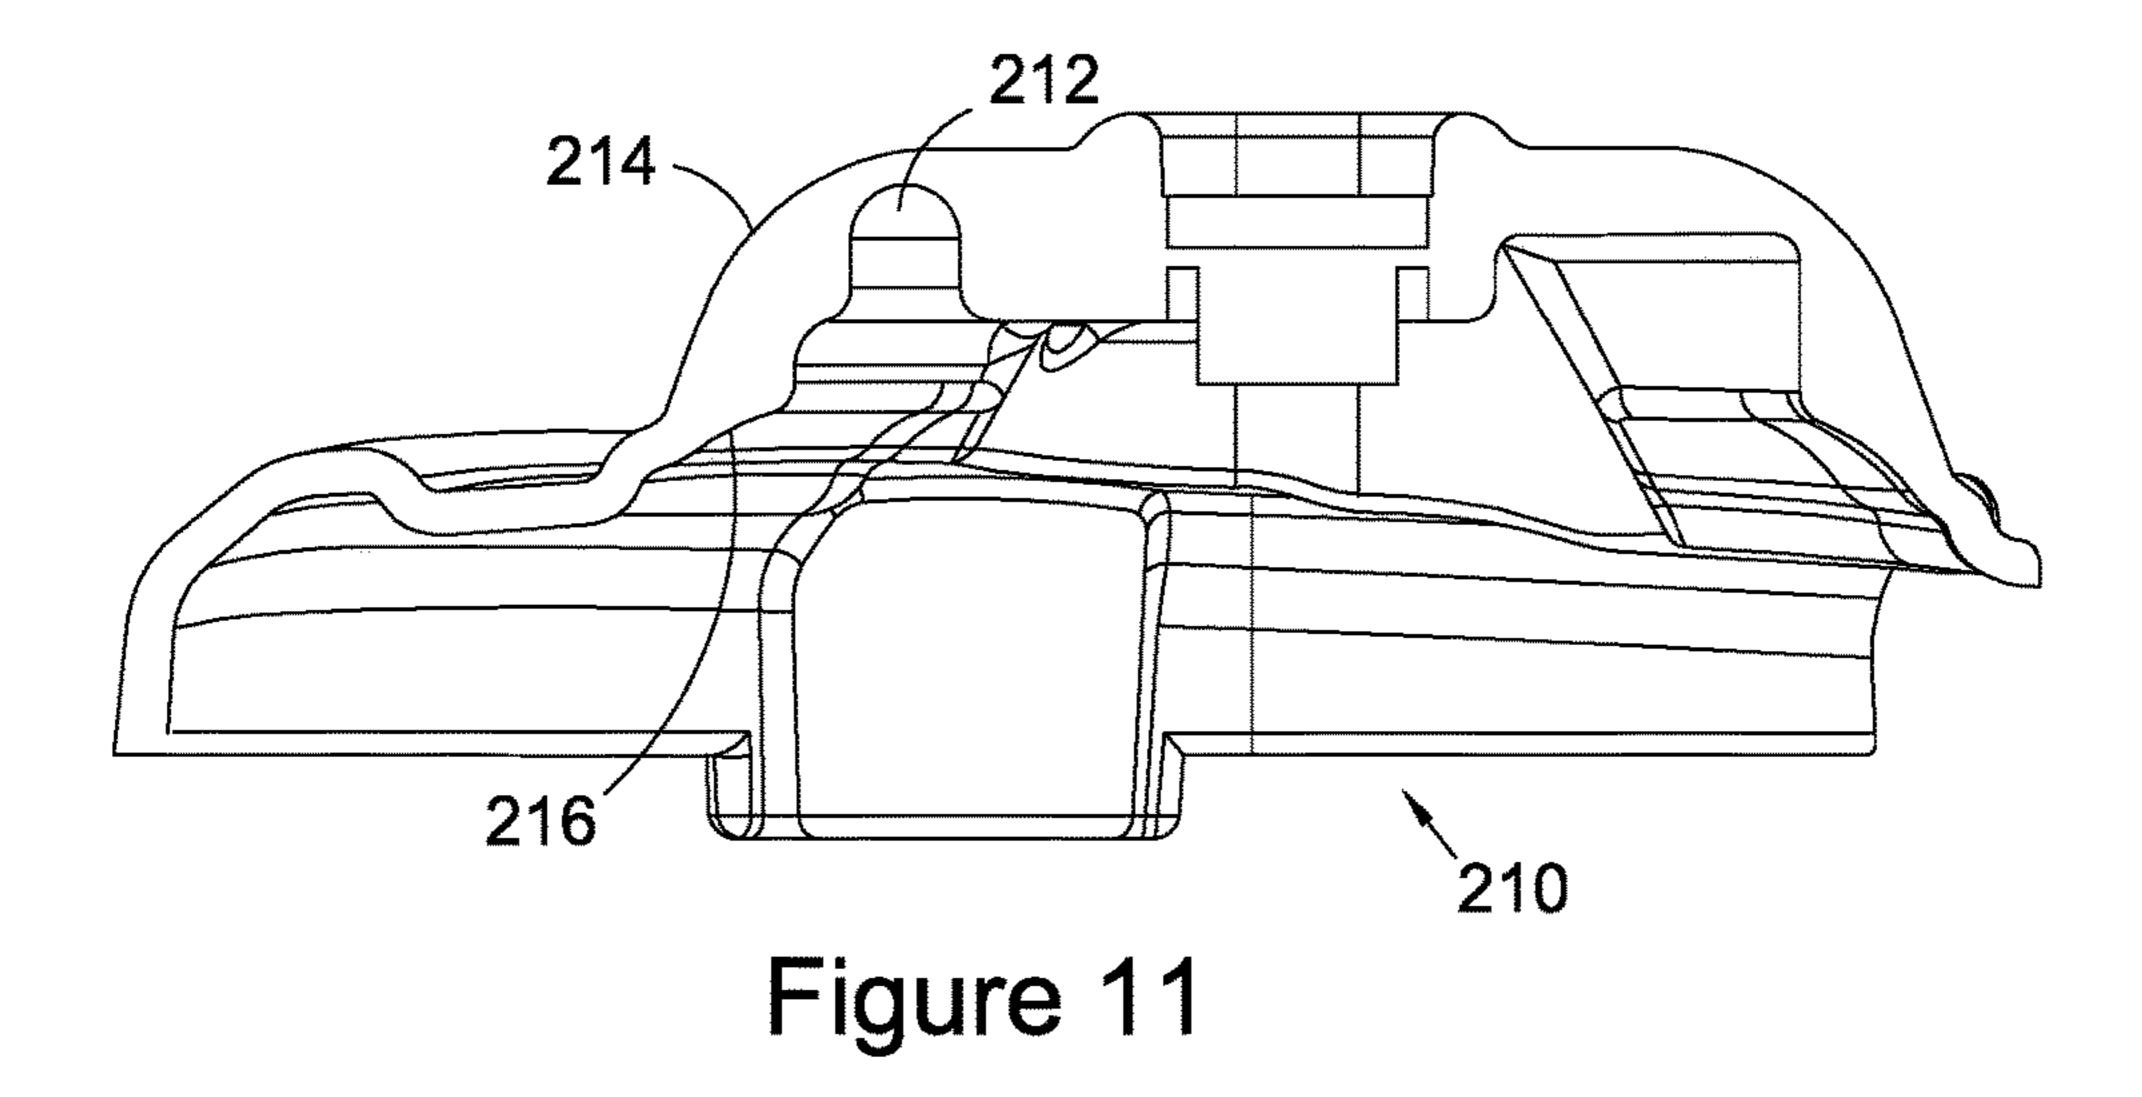
FIG. 11 illustrates a cross-sectional view of the secondary engine cover 210 illustrating the depth of blind holes 212 in general and the amount of material present before the top surface 214.

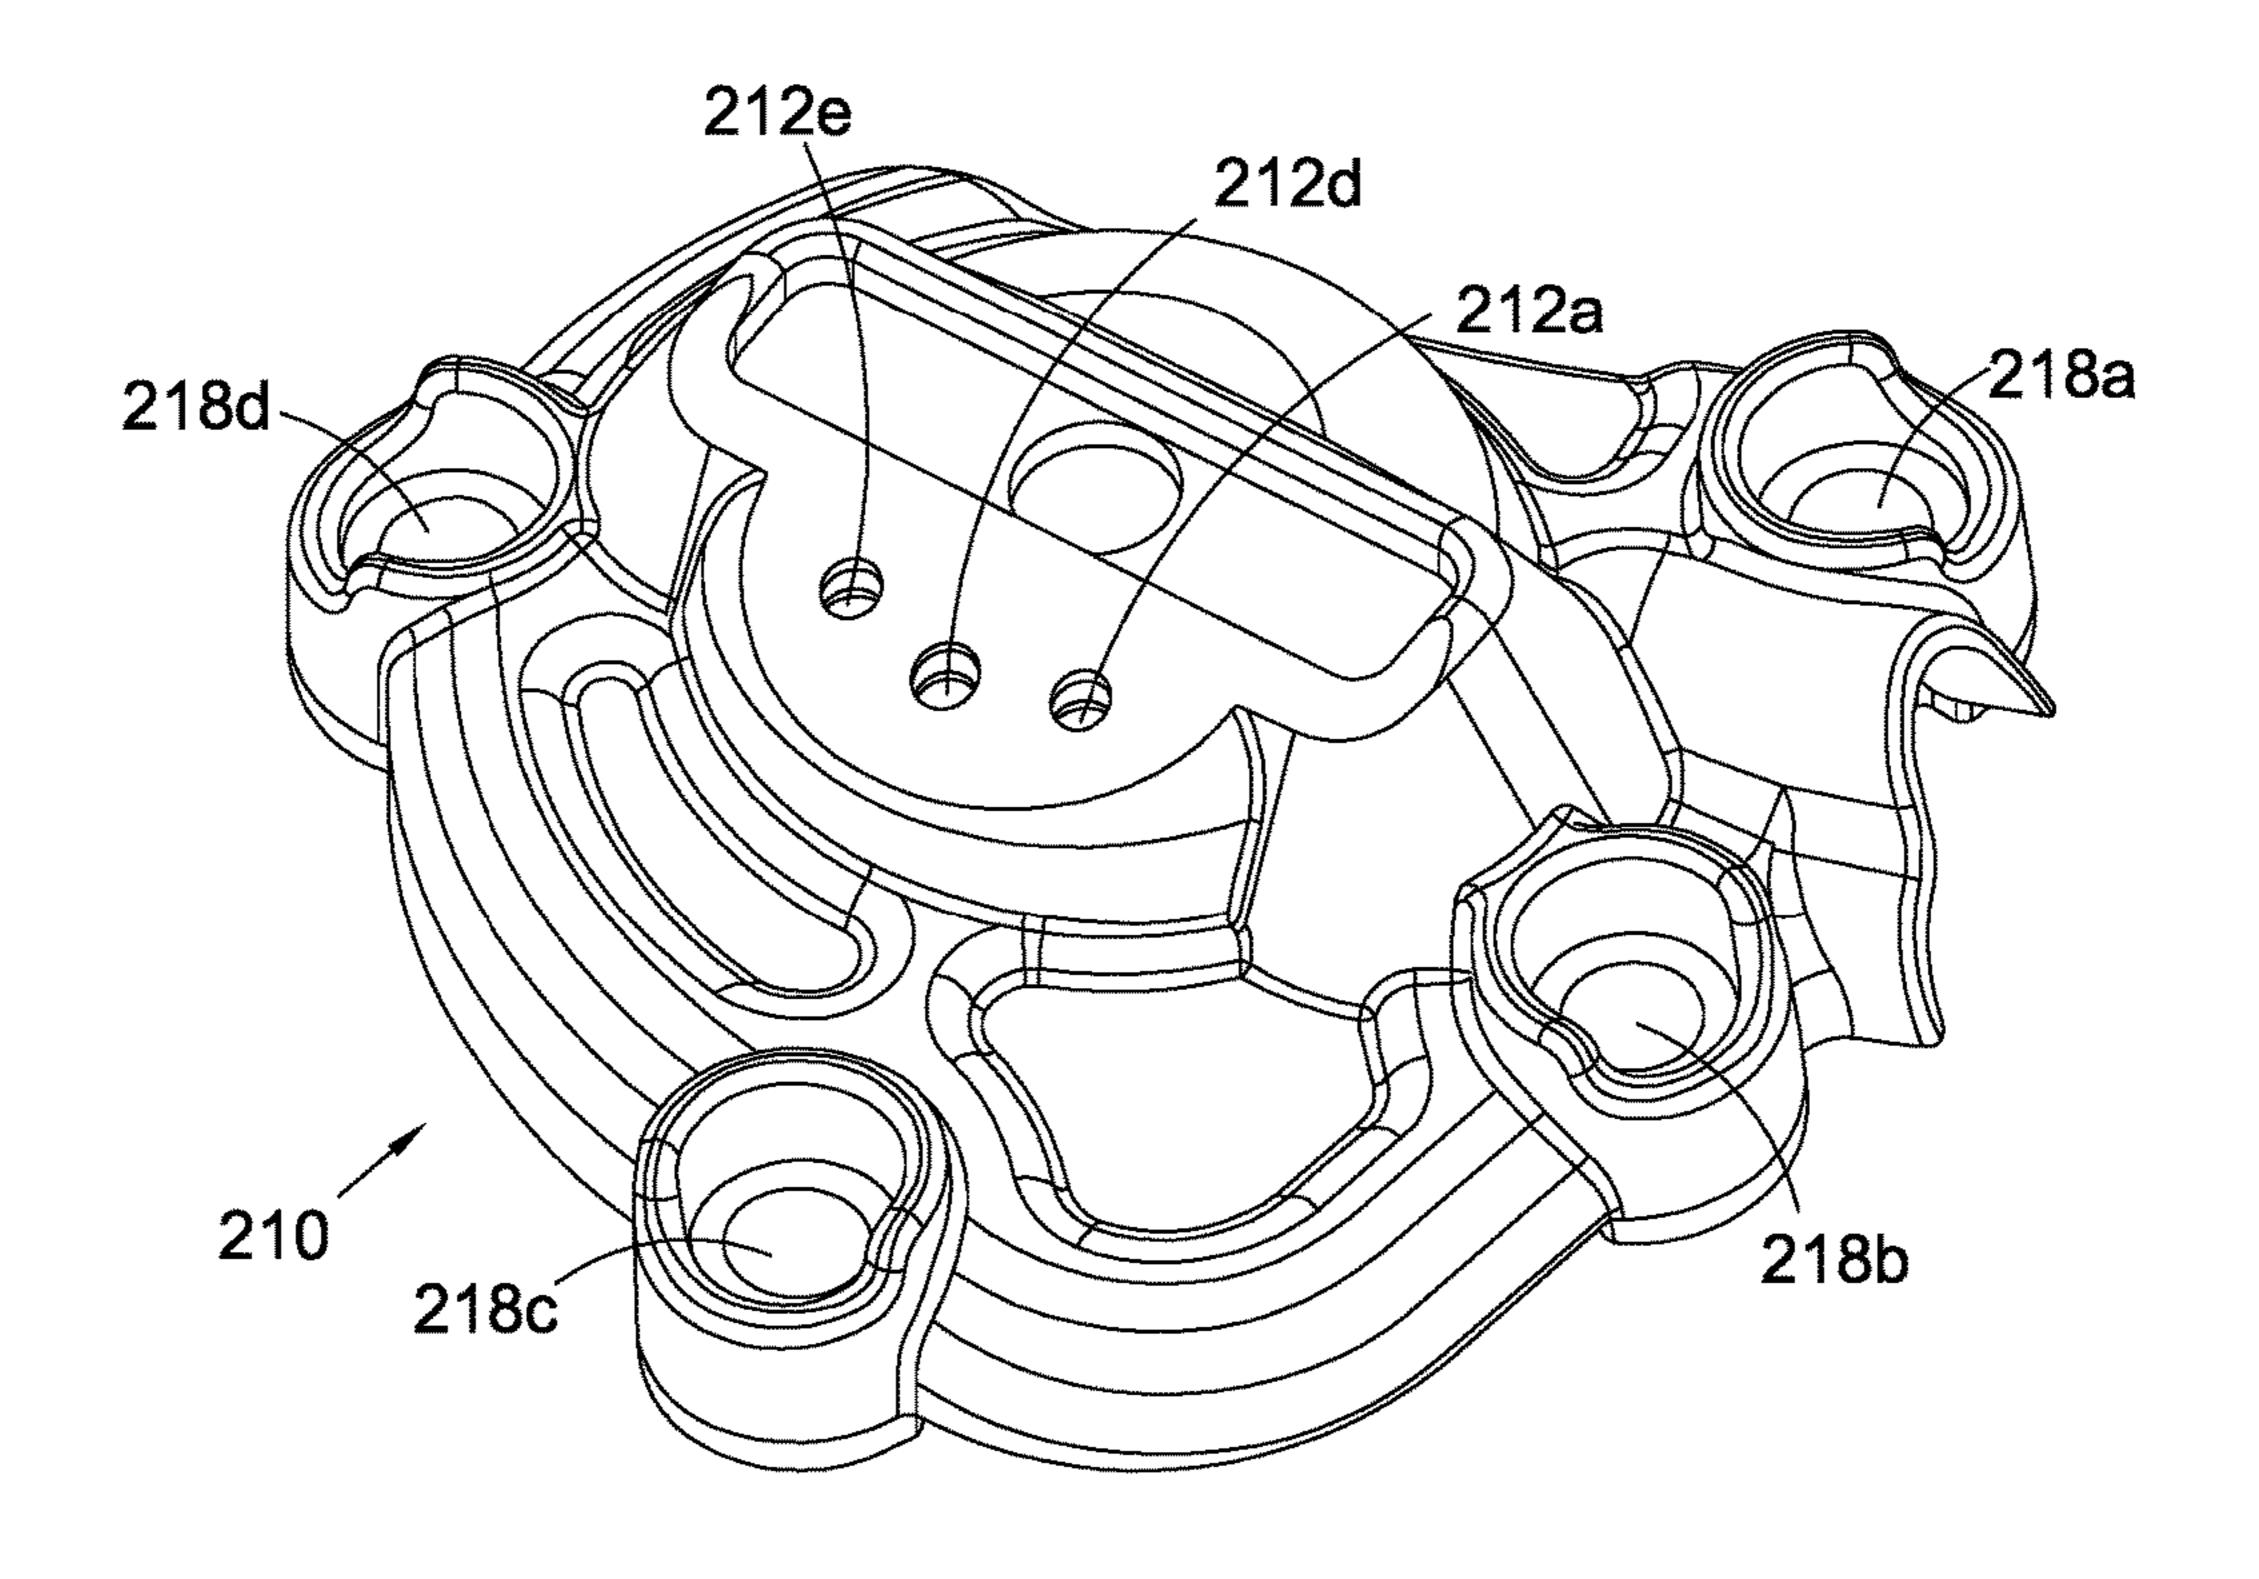
Figure 12

FIG. 12 illustrates a top cut away view of the secondary engine cover 210 in which three of the blind holes 212c, 212d, 212e have been exposed. This view exemplifies what 15 would happen to the secondary engine cover 210 after the top surface has become worn, such as after a fall. In the areas around exposed blind holes 212c, 212d, 212e, the top surface of the secondary engine cover 210 has become sufficiently worn for replacement as typically at least 1 mm 20 to 2.5 mm of material (depending on the depth of material left between the end of each of the blind holes 212a to 212f and the top surface 214 of the secondary engine cover 210). As stated above in the embodiment illustrated, 1.7 mm of material is present between end of each of the blind holes 25 212a to 212f and the top surface 214 of the secondary engine cover 210. The visual presence of the blind holes (now holes) 212c, 212d, 212e indicates to the user that the secondary engine cover 210 needs to be replaced.
