(12) **United States Patent**
Couch et al.

(10) **Patent No.:** **US 9,990,662 B2**
(45) **Date of Patent:** ***Jun. 5, 2018**

(54) **COMPUTER-BASED TECHNOLOGY FOR AIDING THE REPAIR OF MOTOR VEHICLES**

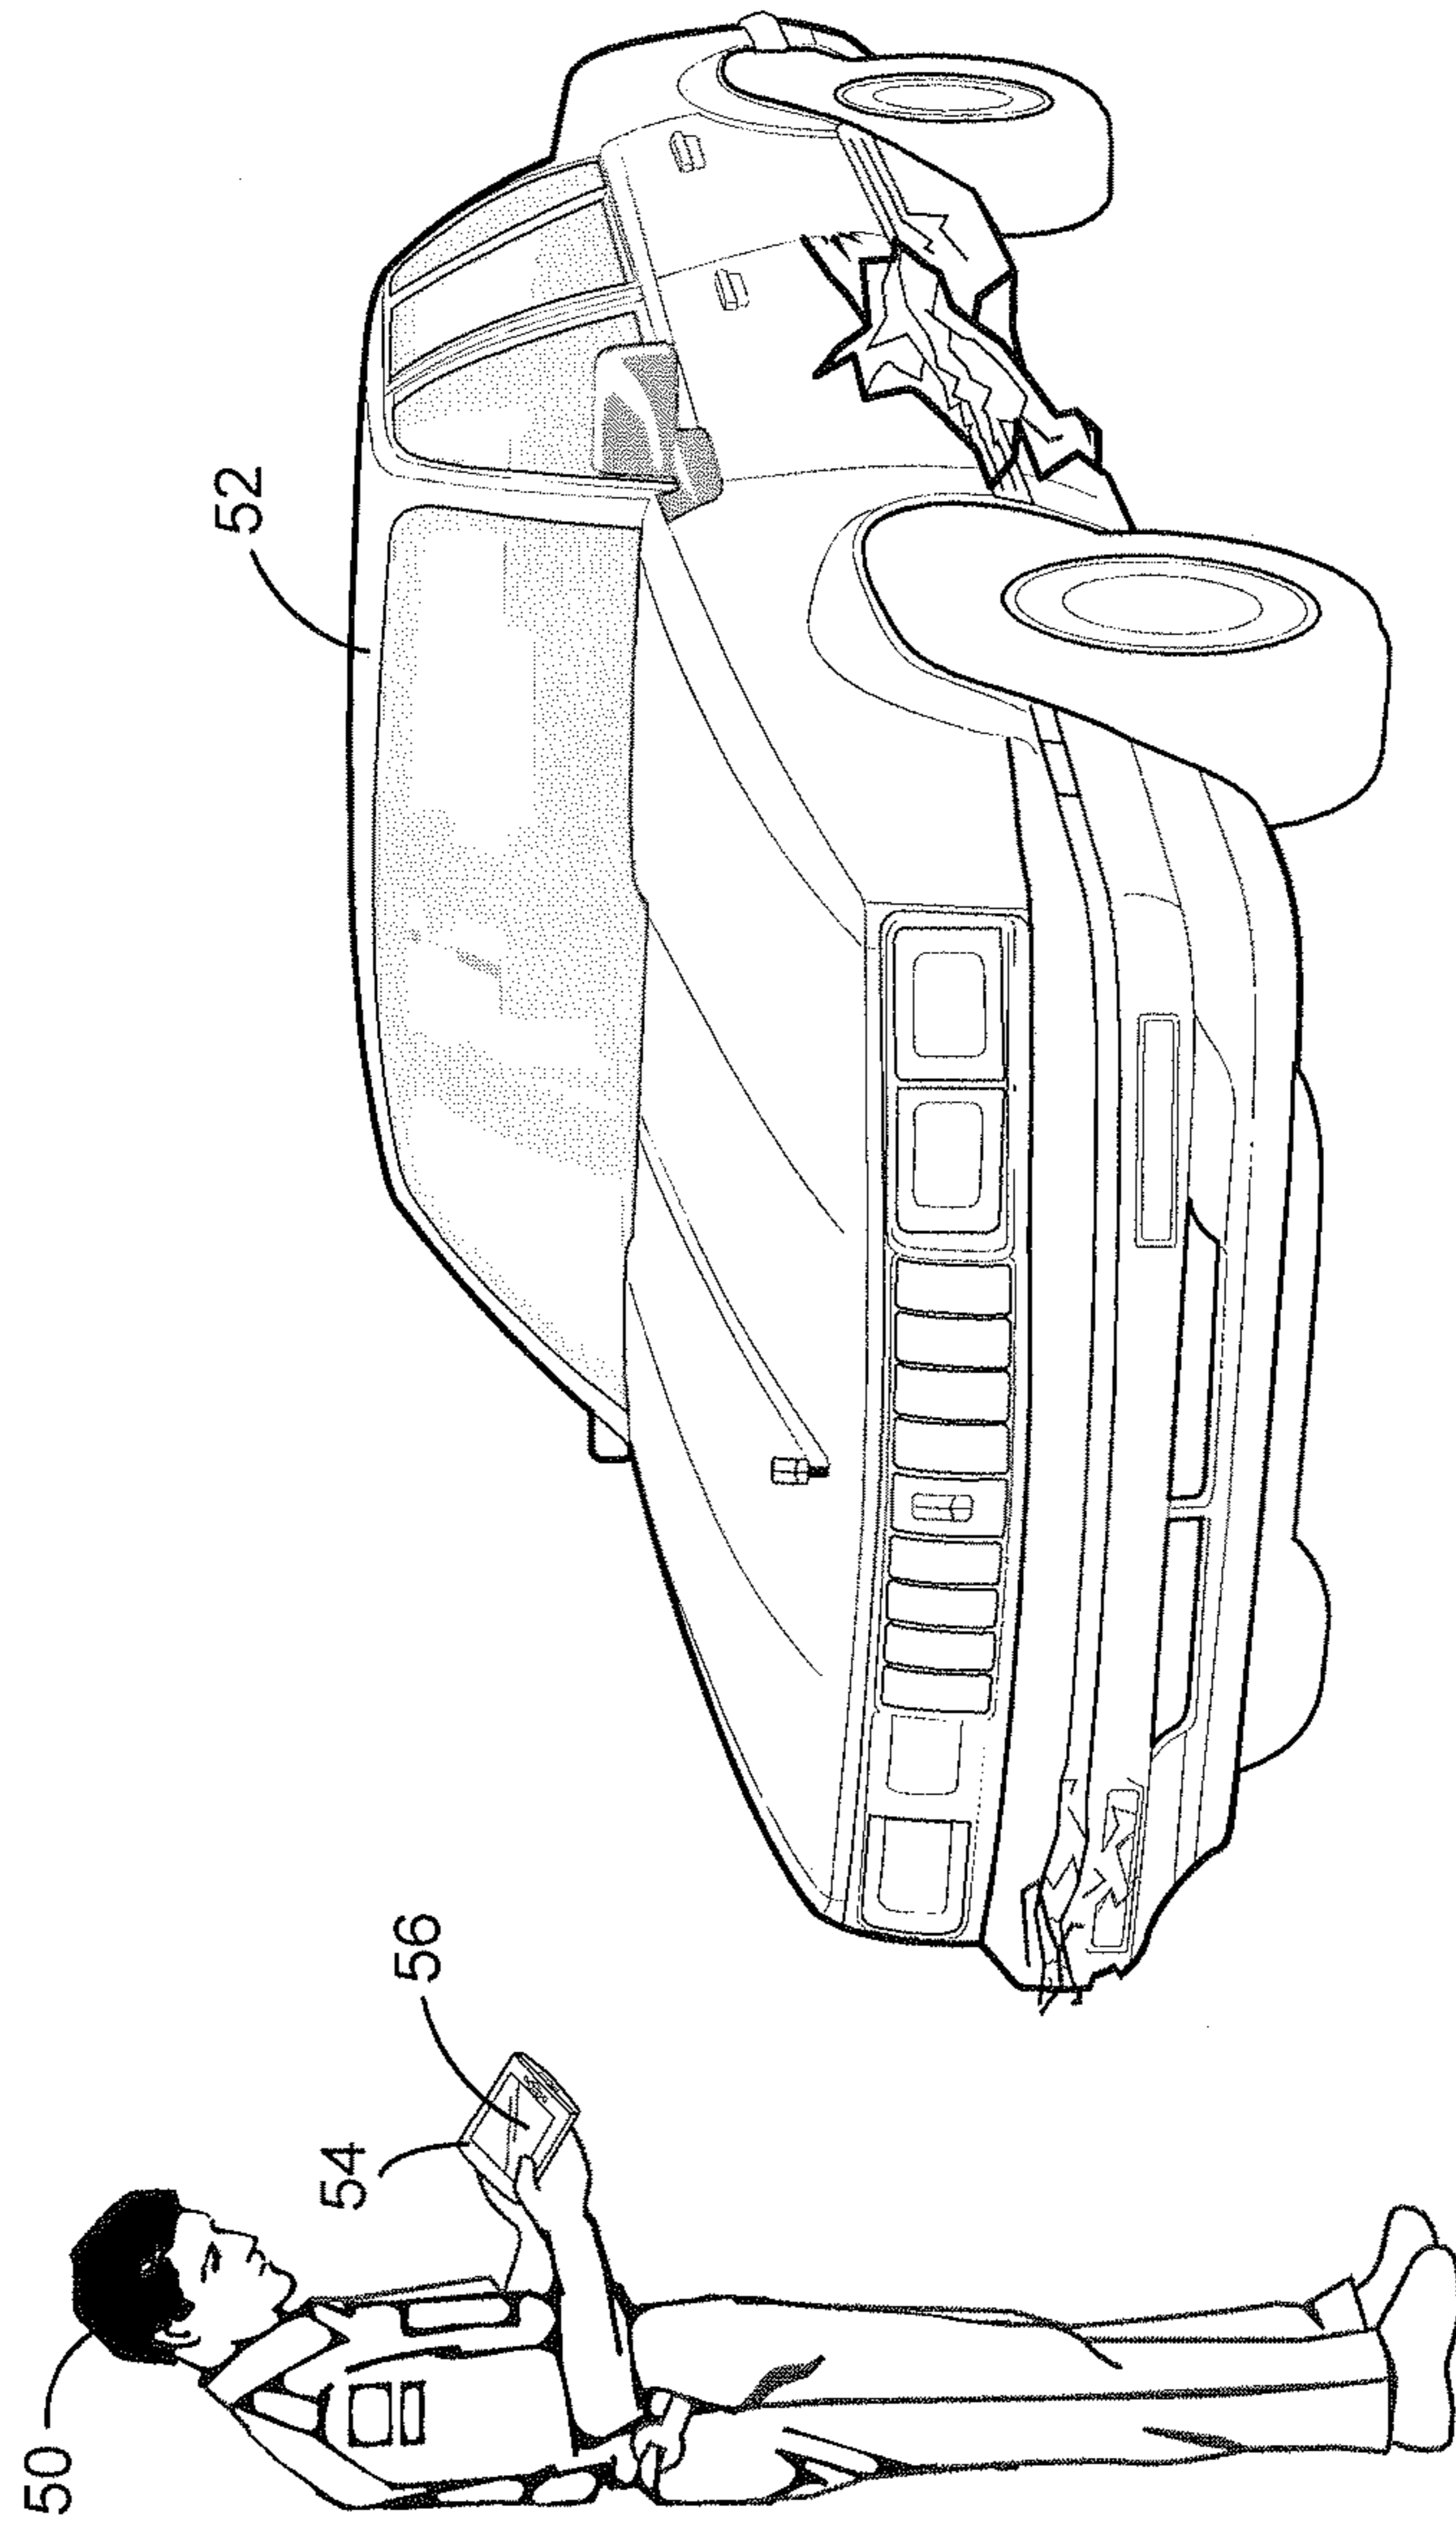
In the FIG. 1A example shown, a human inspector 50 is physically present at the site of the motor vehicle 52. The inspector 50 visually inspects the motor vehicle 52 for features and damage. Such inspection can in one non-limiting implementation be relatively comprehensive and include or provide for example information concerning any or all of the following:

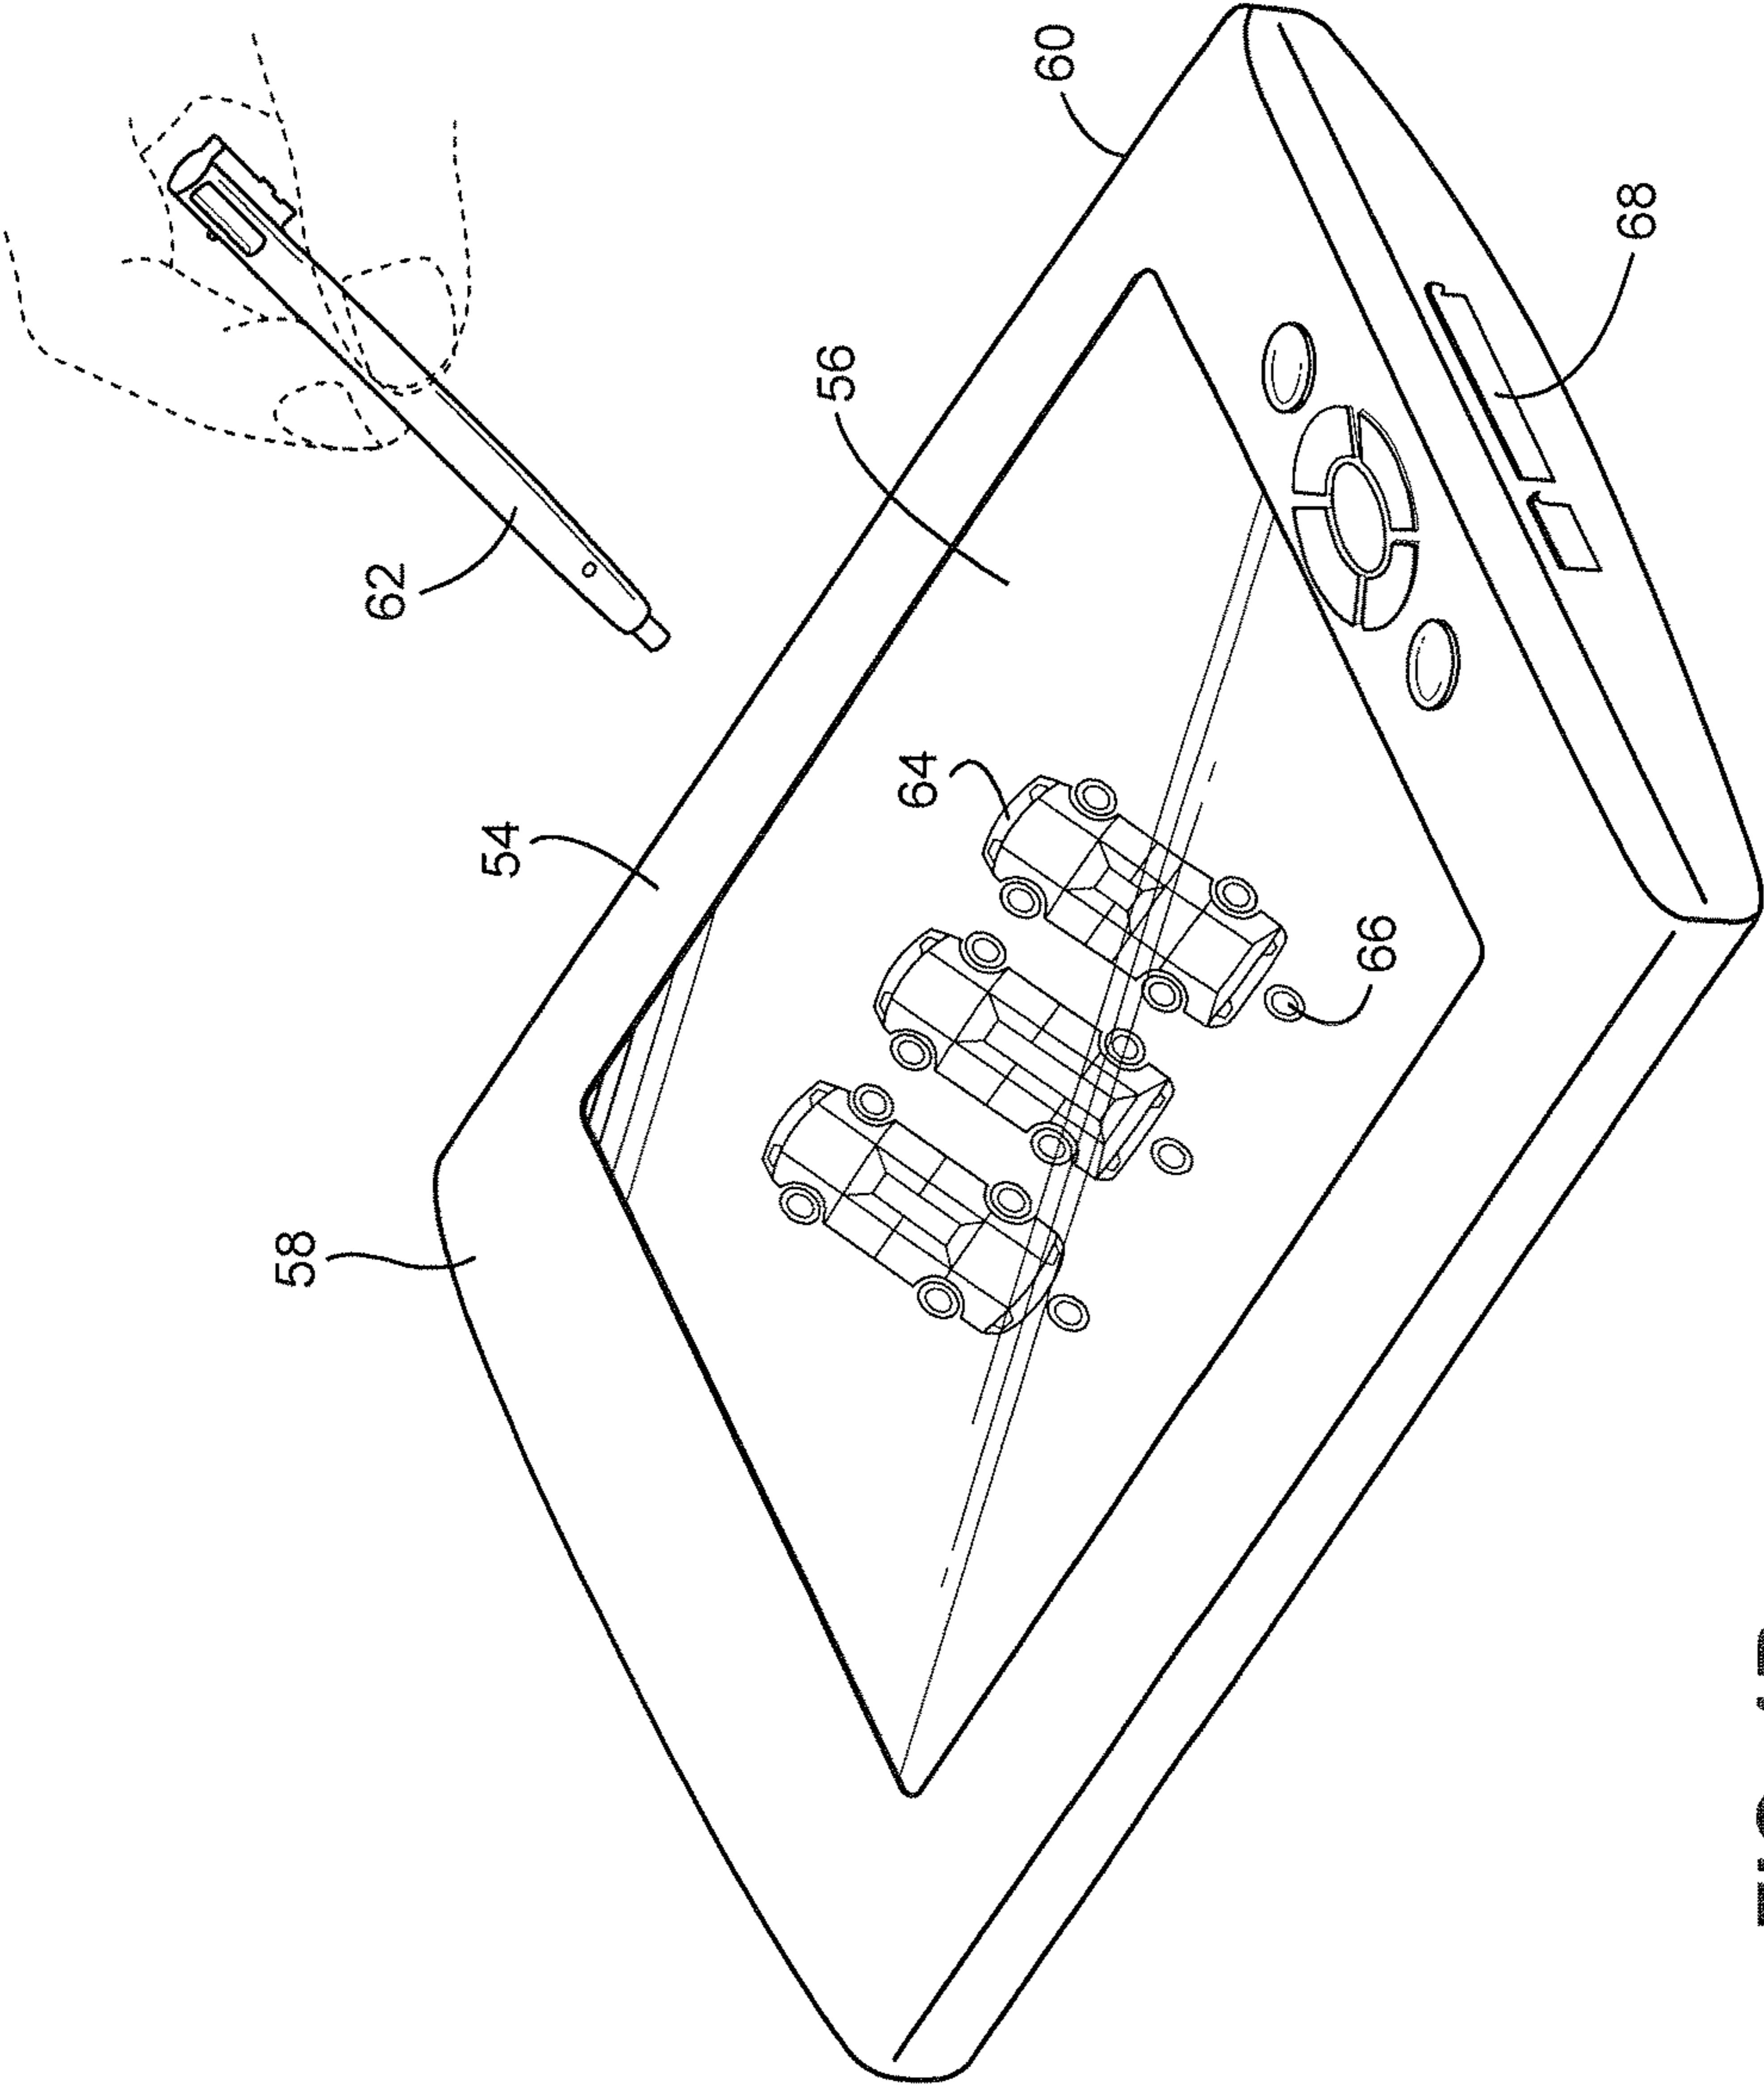
FIG. 1B shows one example illustrative non-limiting
 handheld inspection input appliance **54** including a touch
 screen **56**. Inspection appliance **54** may comprise, for
 example, a conventional commercially available tablet com-
 puter such as an iPad including a handheld, portable housing
58 containing an internal battery operated power source. The
 internal battery power source may be replaceable and/or
 rechargeable. Such a handheld portable inspection appliance
54 may include, in addition, user input controls **60** such as
 for example, buttons, knobs, keys, keyboards, directional
 controls, microphones and/or other input devices. A stylus
62 can be placed in contact with the touch screen **56** to
 indicate positional information. The inspection appliance **54**
 may provide corresponding visual feedback in response to
 stylus **62** or finger positioning including, for example, color
 changes, gesture tracing, dialogue boxes and other visual,

cally displayed based on vehicle identification number decoding (described below) or other input. Inspector 50 may also indicate location of dents, scratches and other damage by placing the tip of stylus 62 onto a corresponding location on the displayed schematic illustration 64. Inspection appliance 54 can provide visual and/or aural feedback, and may collect information in a variety of other ways including for example voice logging, image capture, automatic scanning or any other desired means.

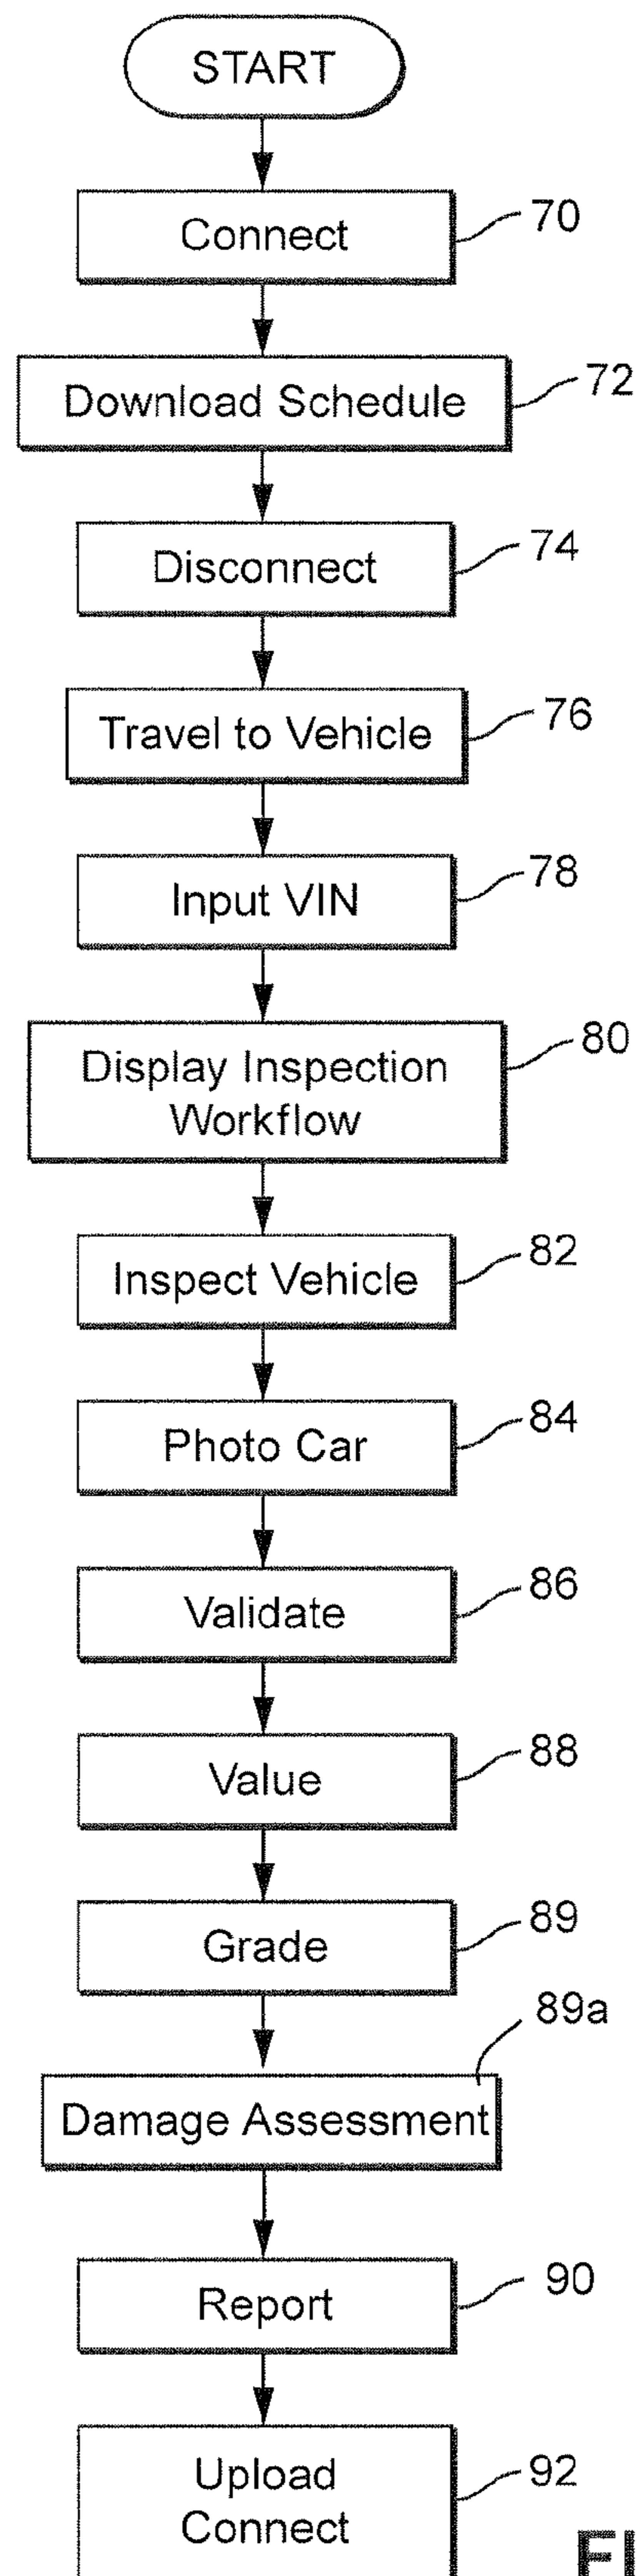
FIG. 1C

FIGS. 1C-1, 1C-2 is an example prior art condition report;

The appliance 54 may generate a condition report (see FIGS. 1C-1 and 1C-2 for an example prior art condition report) (block 90) which may be printed by an internal or external printer if desired and/or delivered electronically

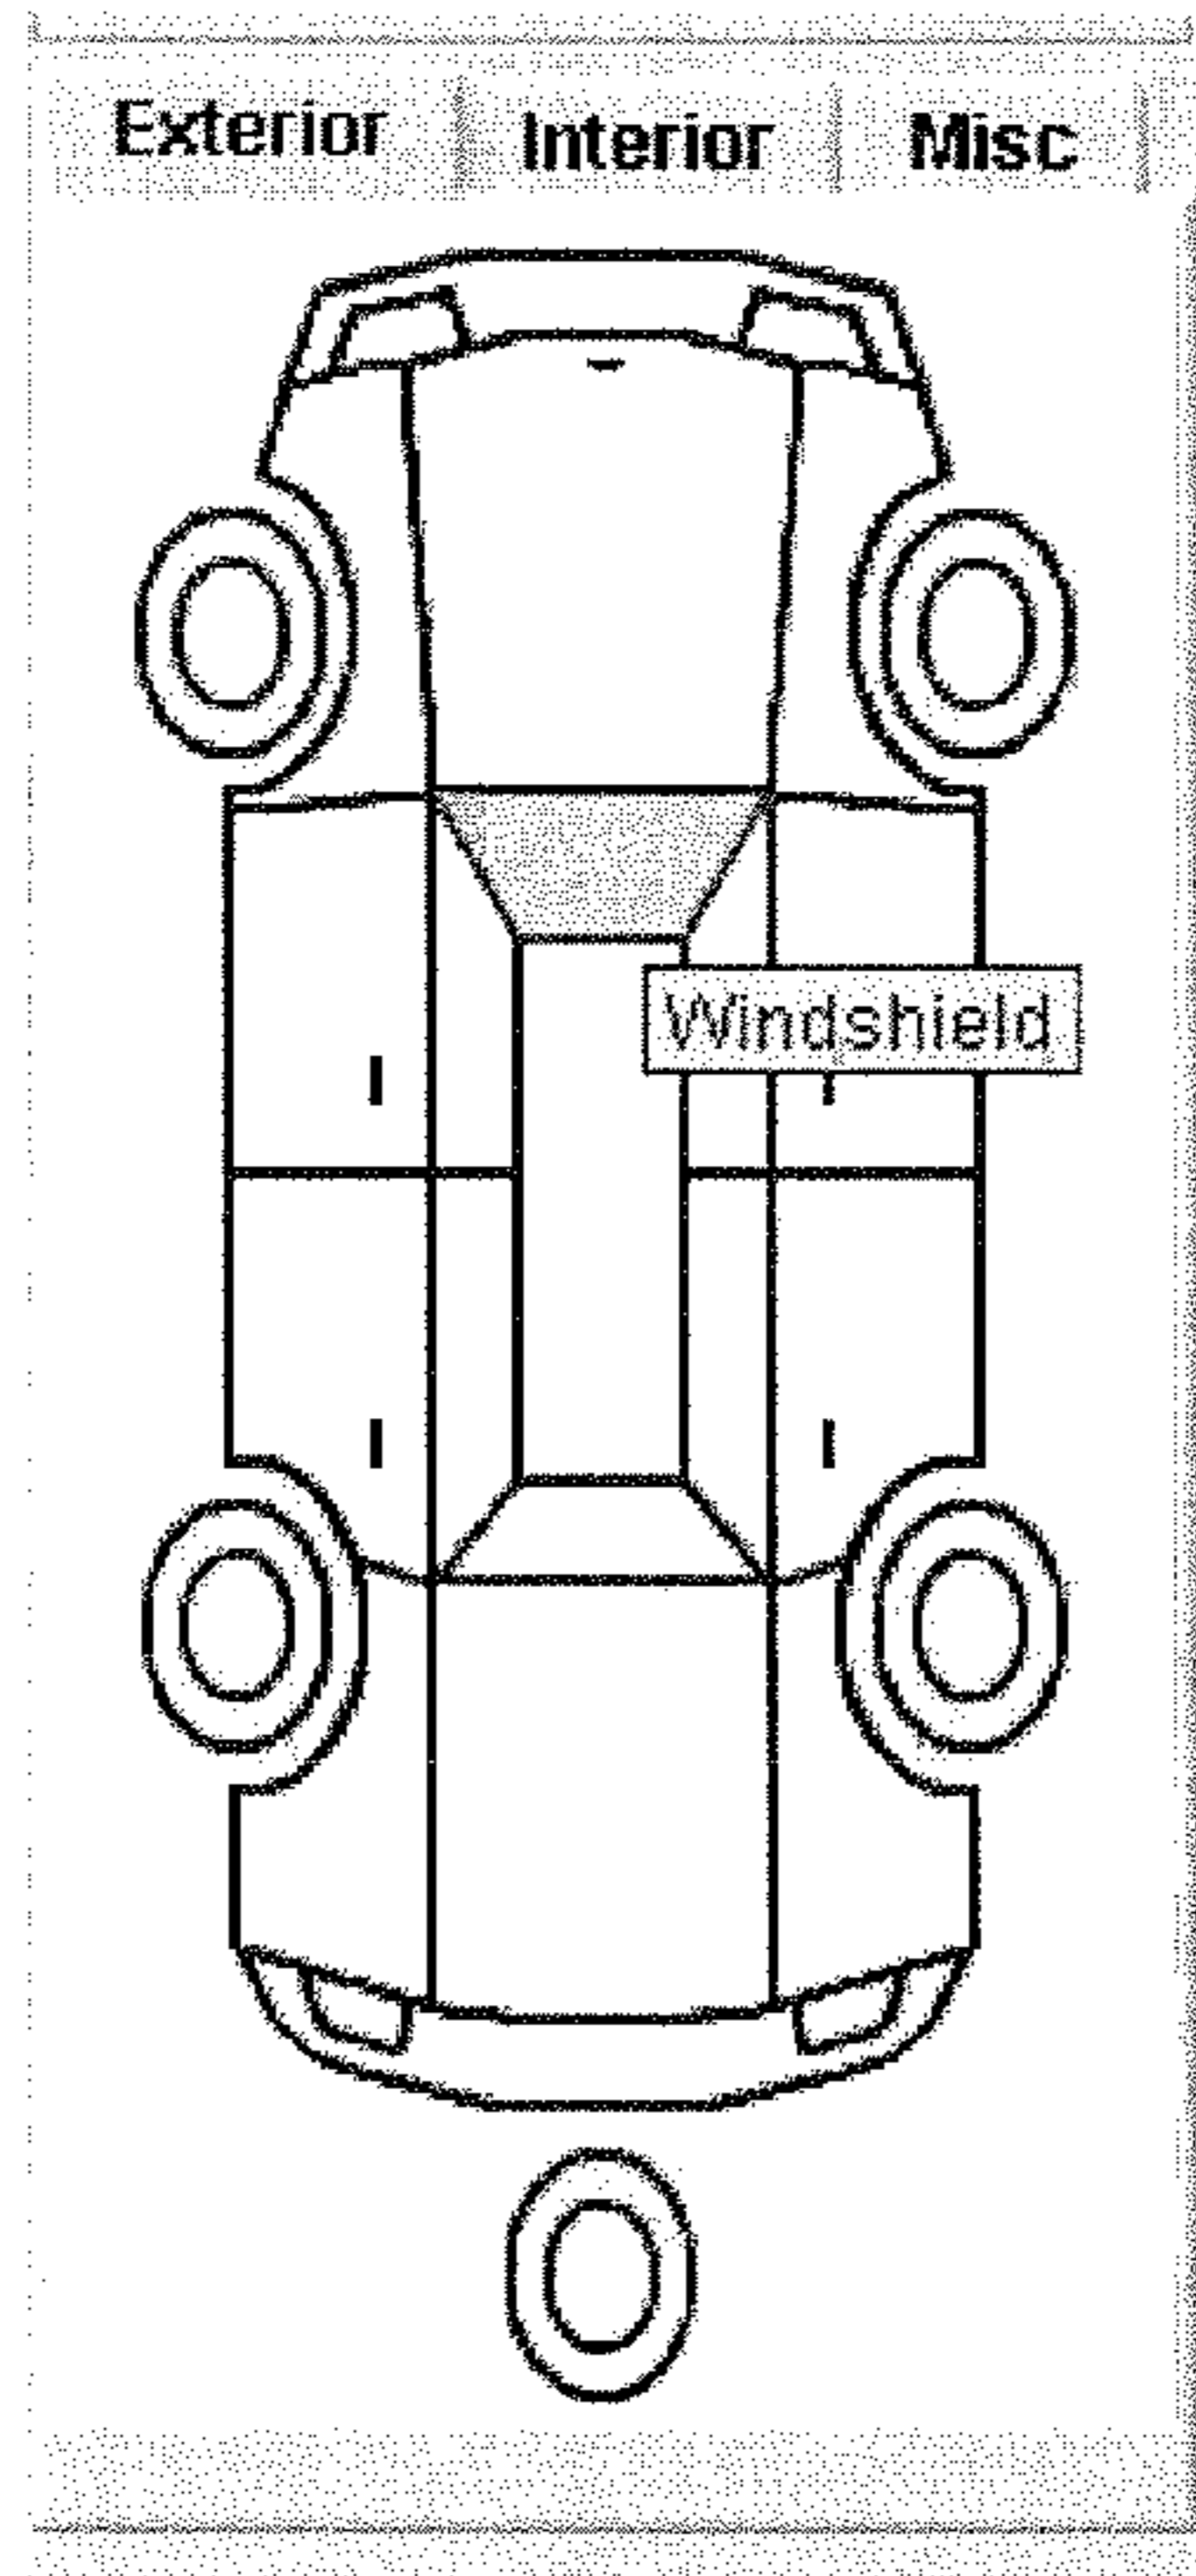
FIG. 7

FIGS. 7, 8, 9, 10 & 11 show an exemplary illustrative non-limiting sequence of user interface screen displays for use in inputting damage or other characteristic information;
