(12) **United States Patent**
Couch et al.

(10) **Patent No.:** **US 9,990,662 B2**
(45) **Date of Patent:** ***Jun. 5, 2018**

(54) **COMPUTER-BASED TECHNOLOGY FOR AIDING THE REPAIR OF MOTOR VEHICLES**

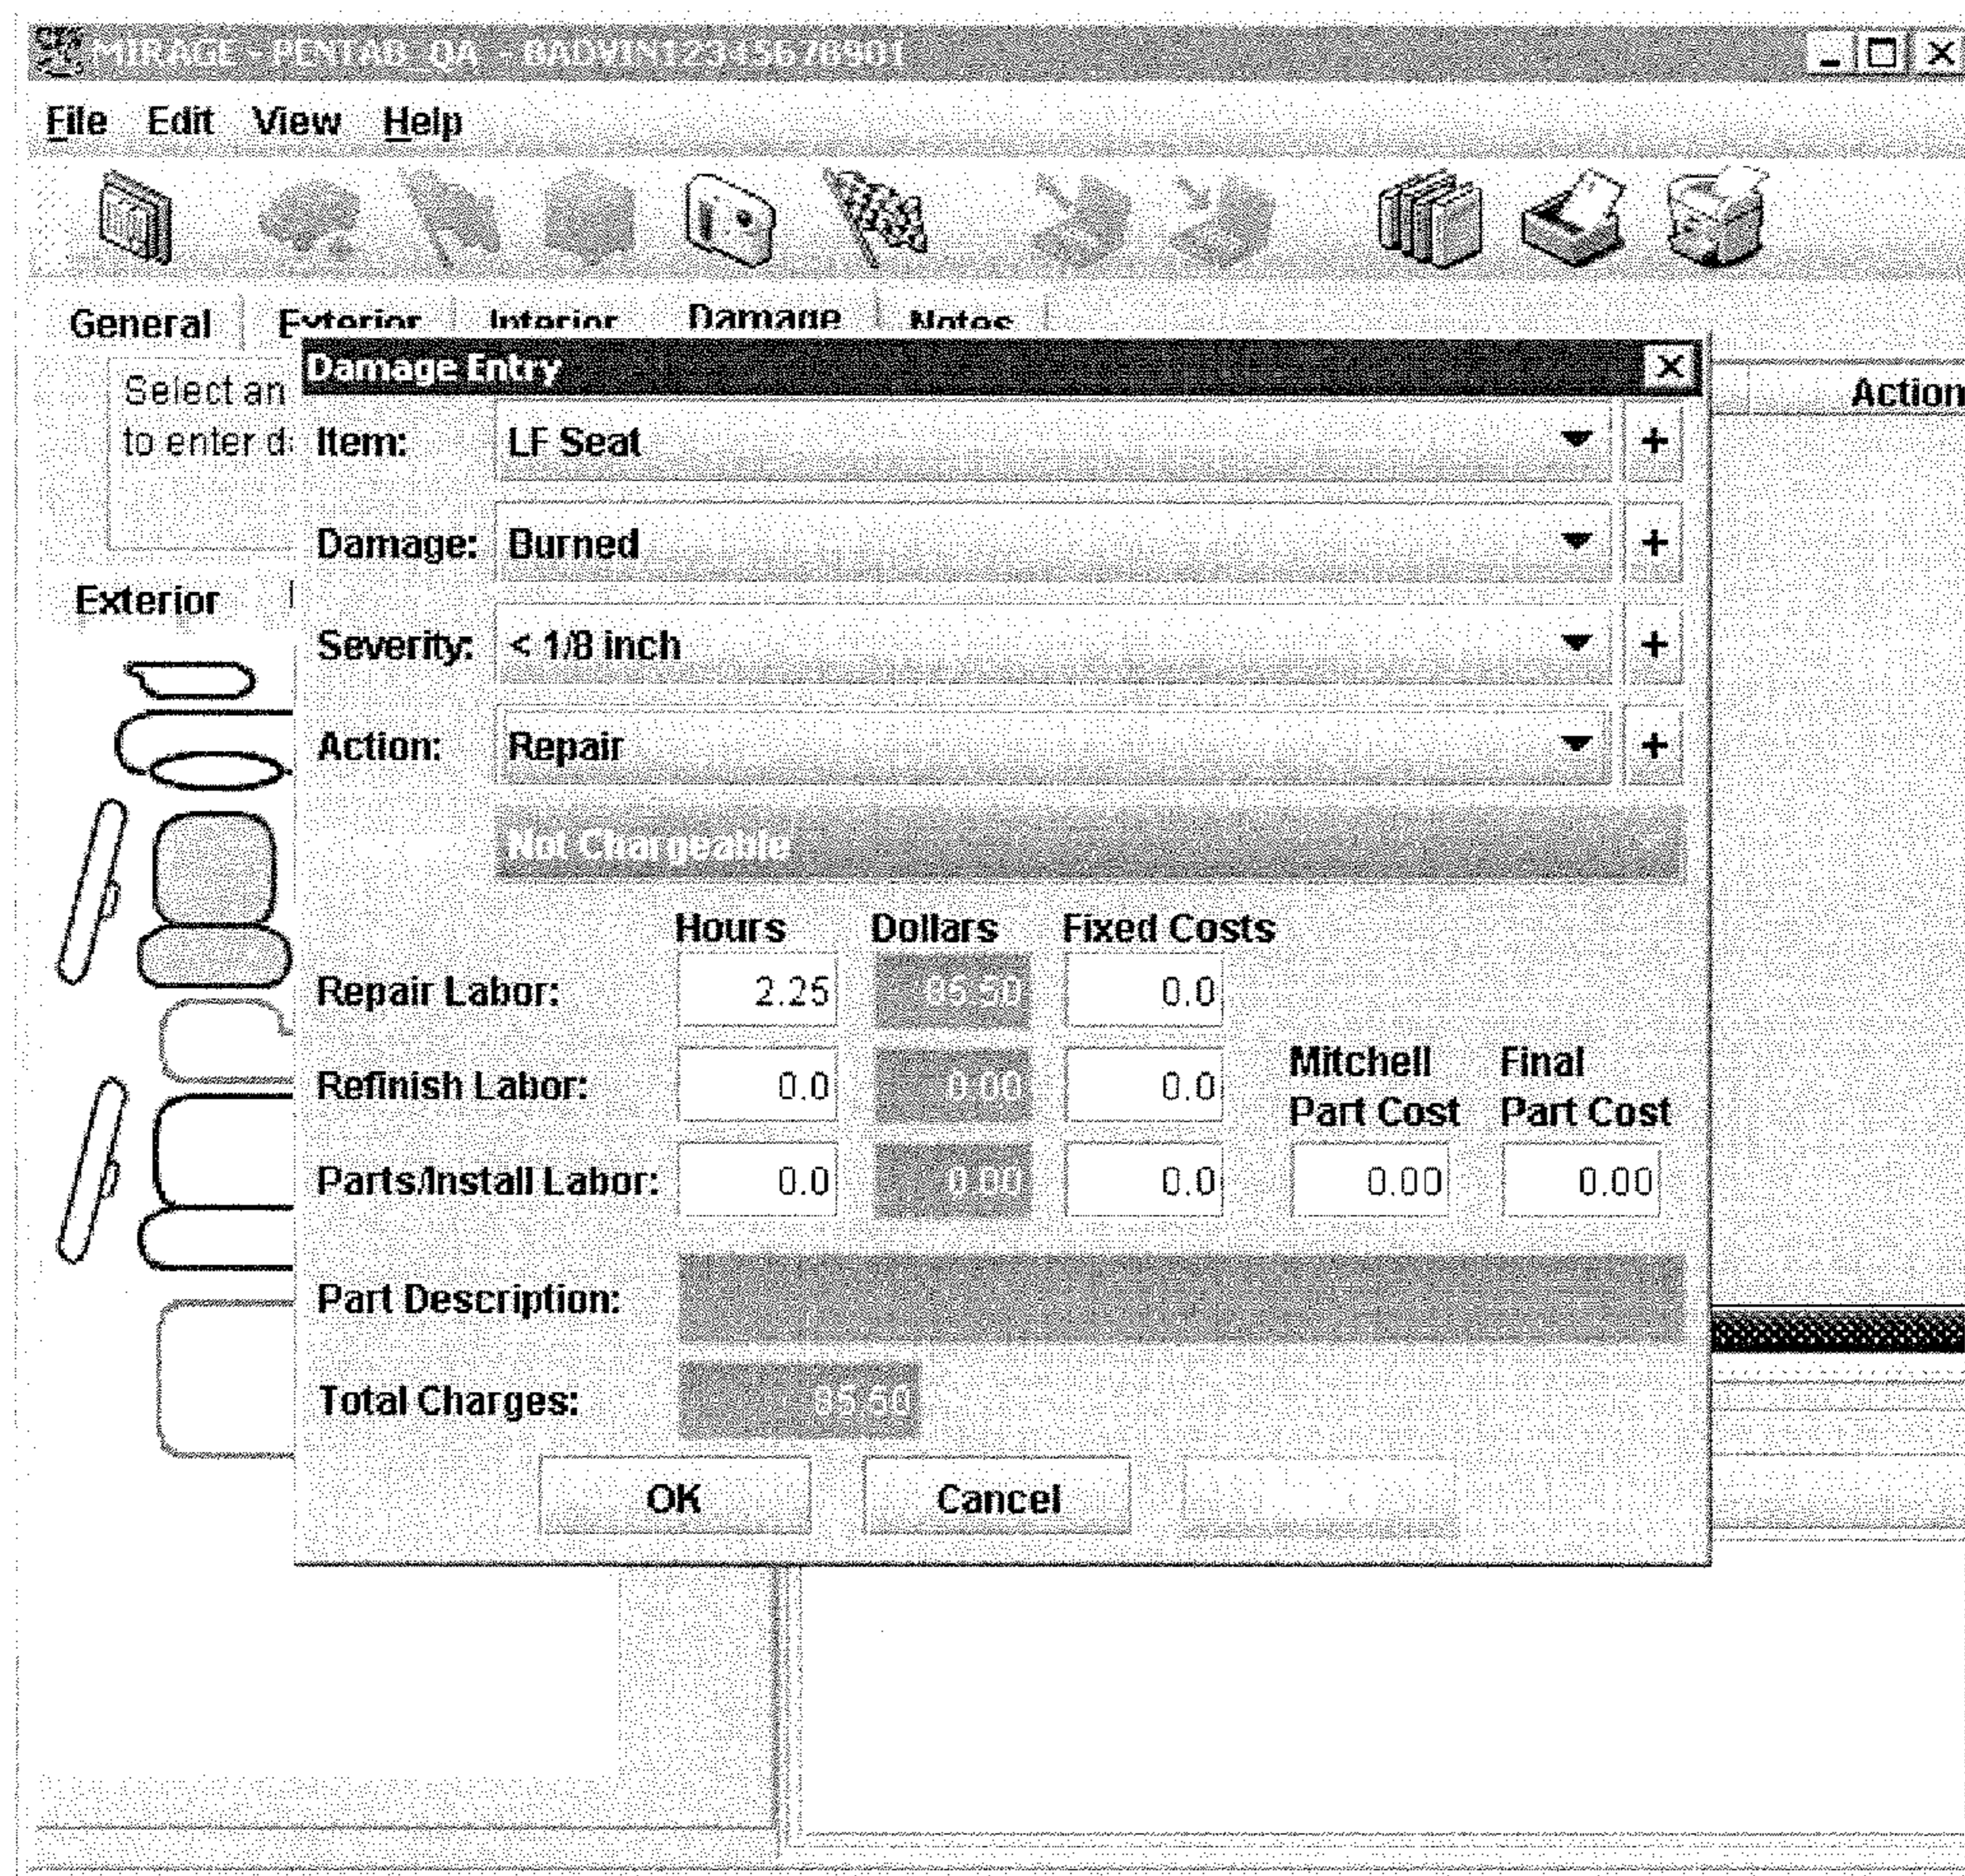
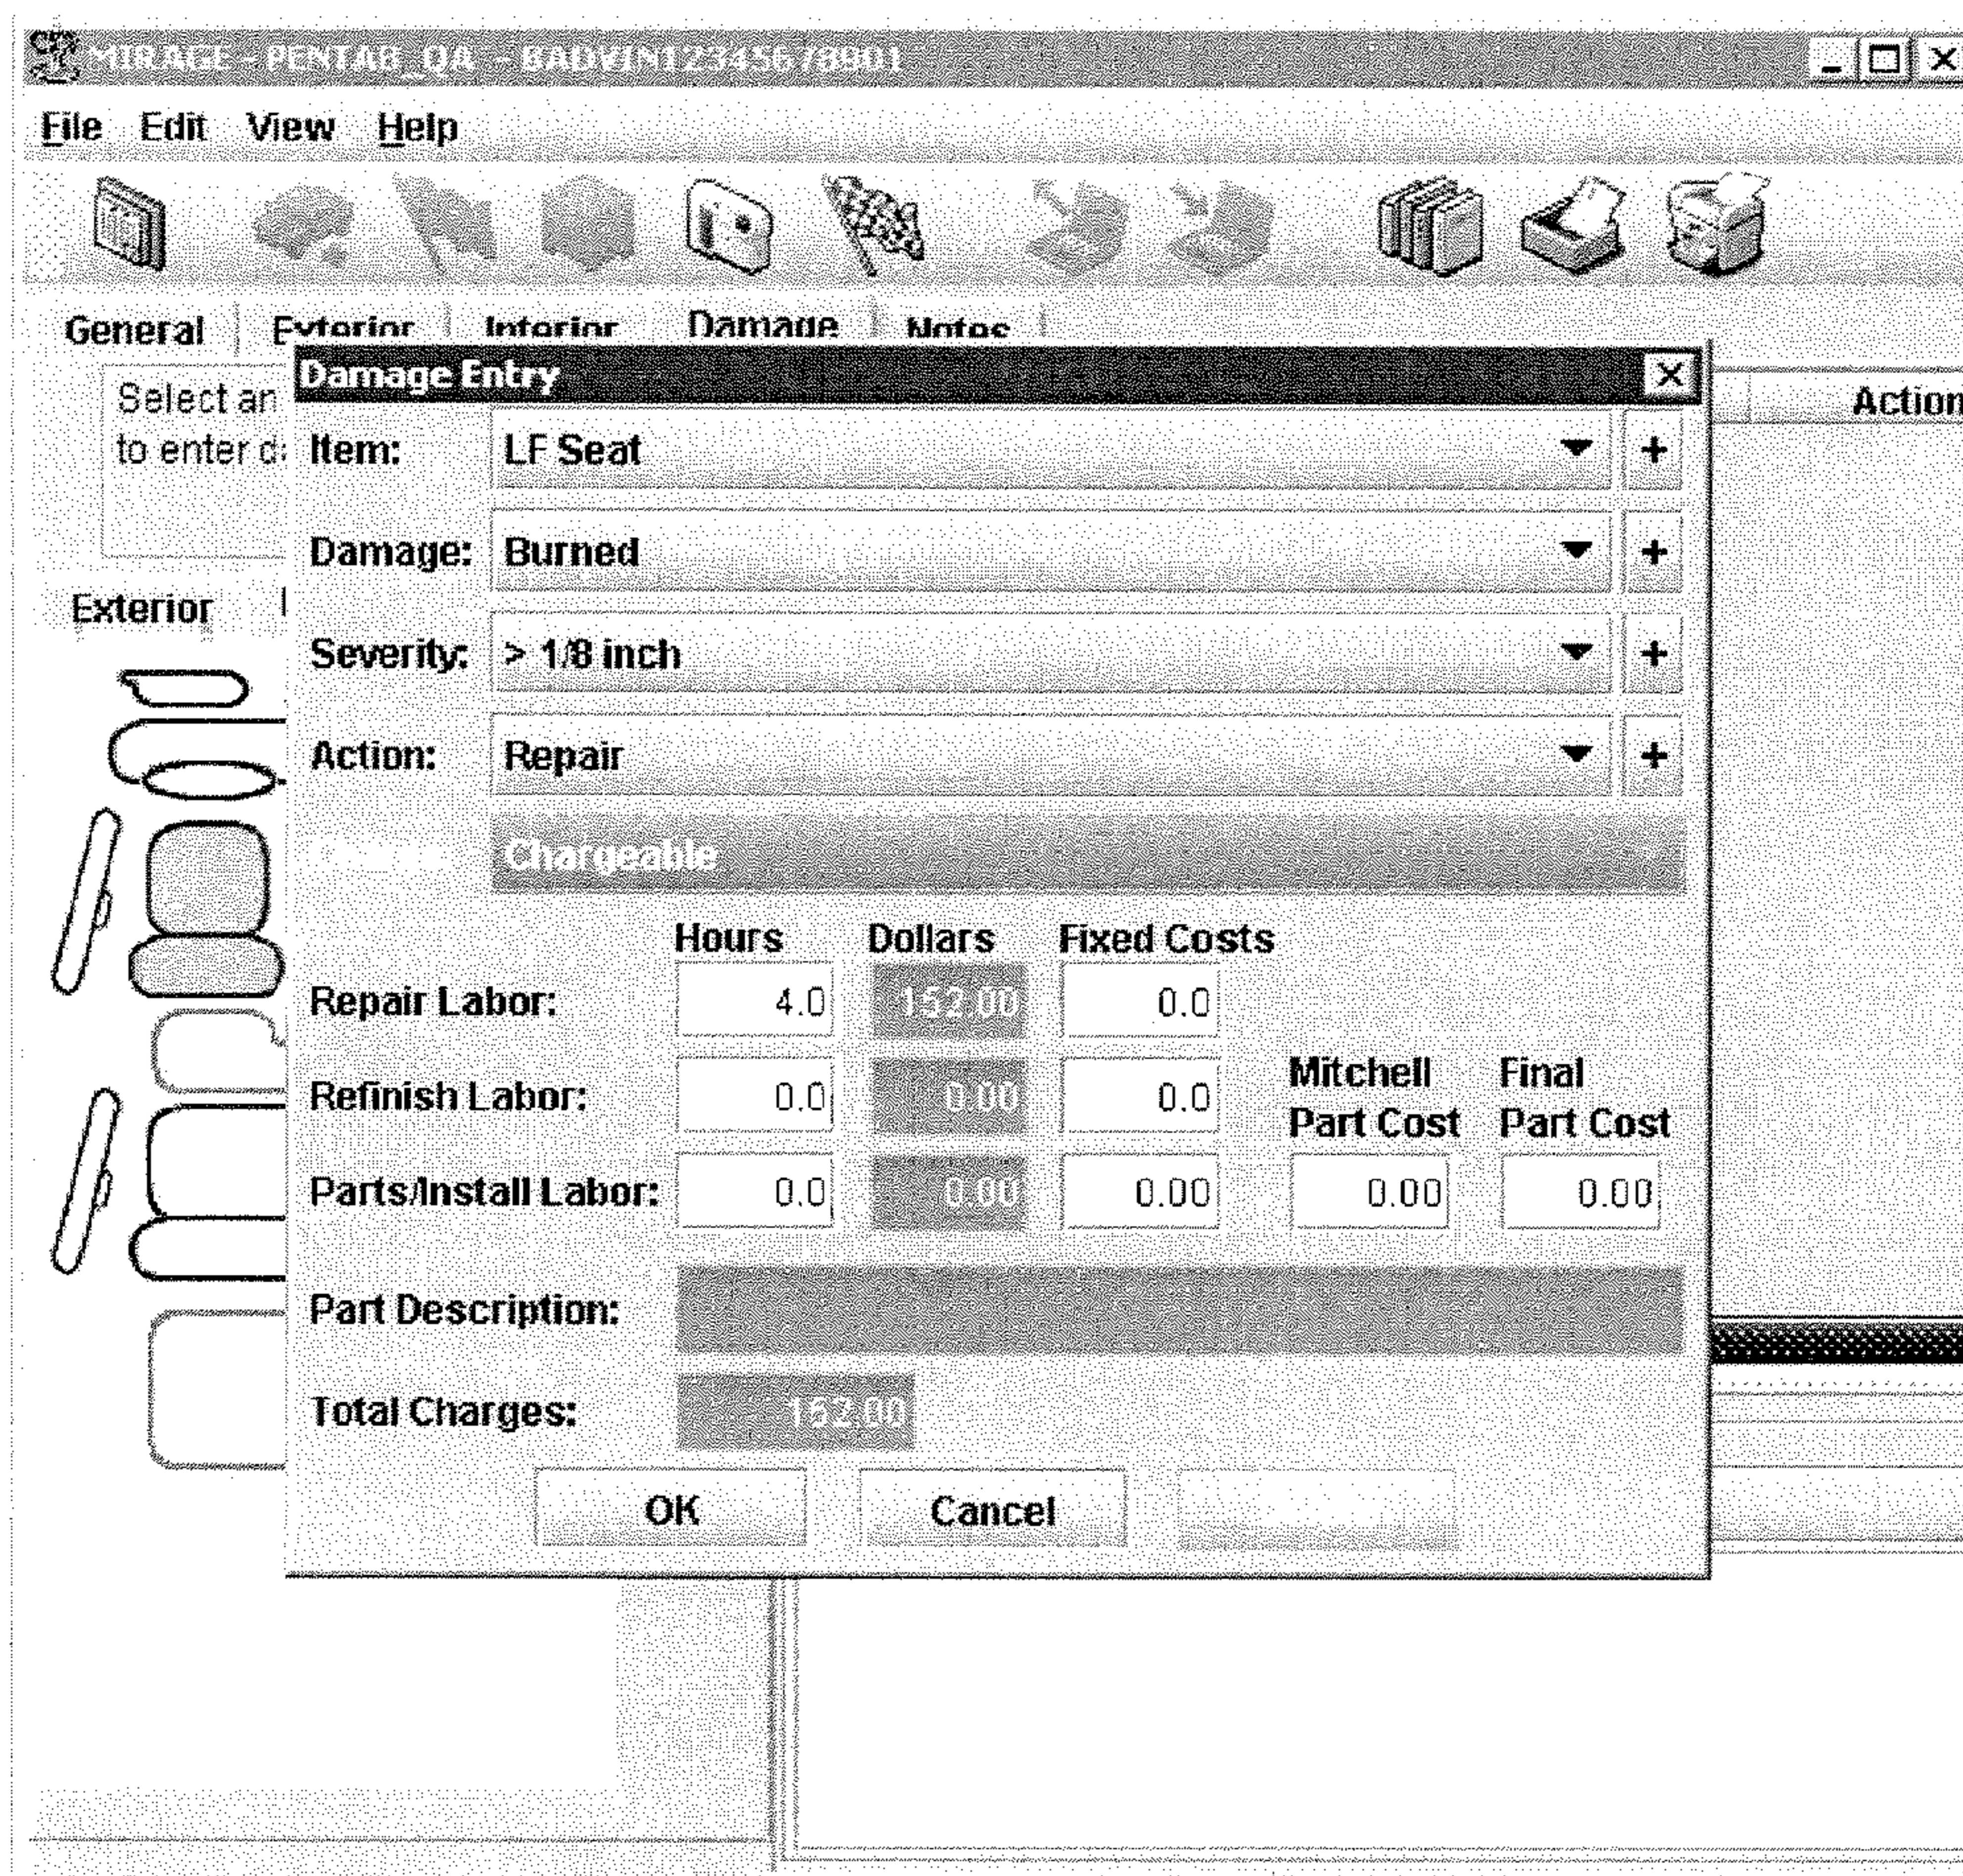
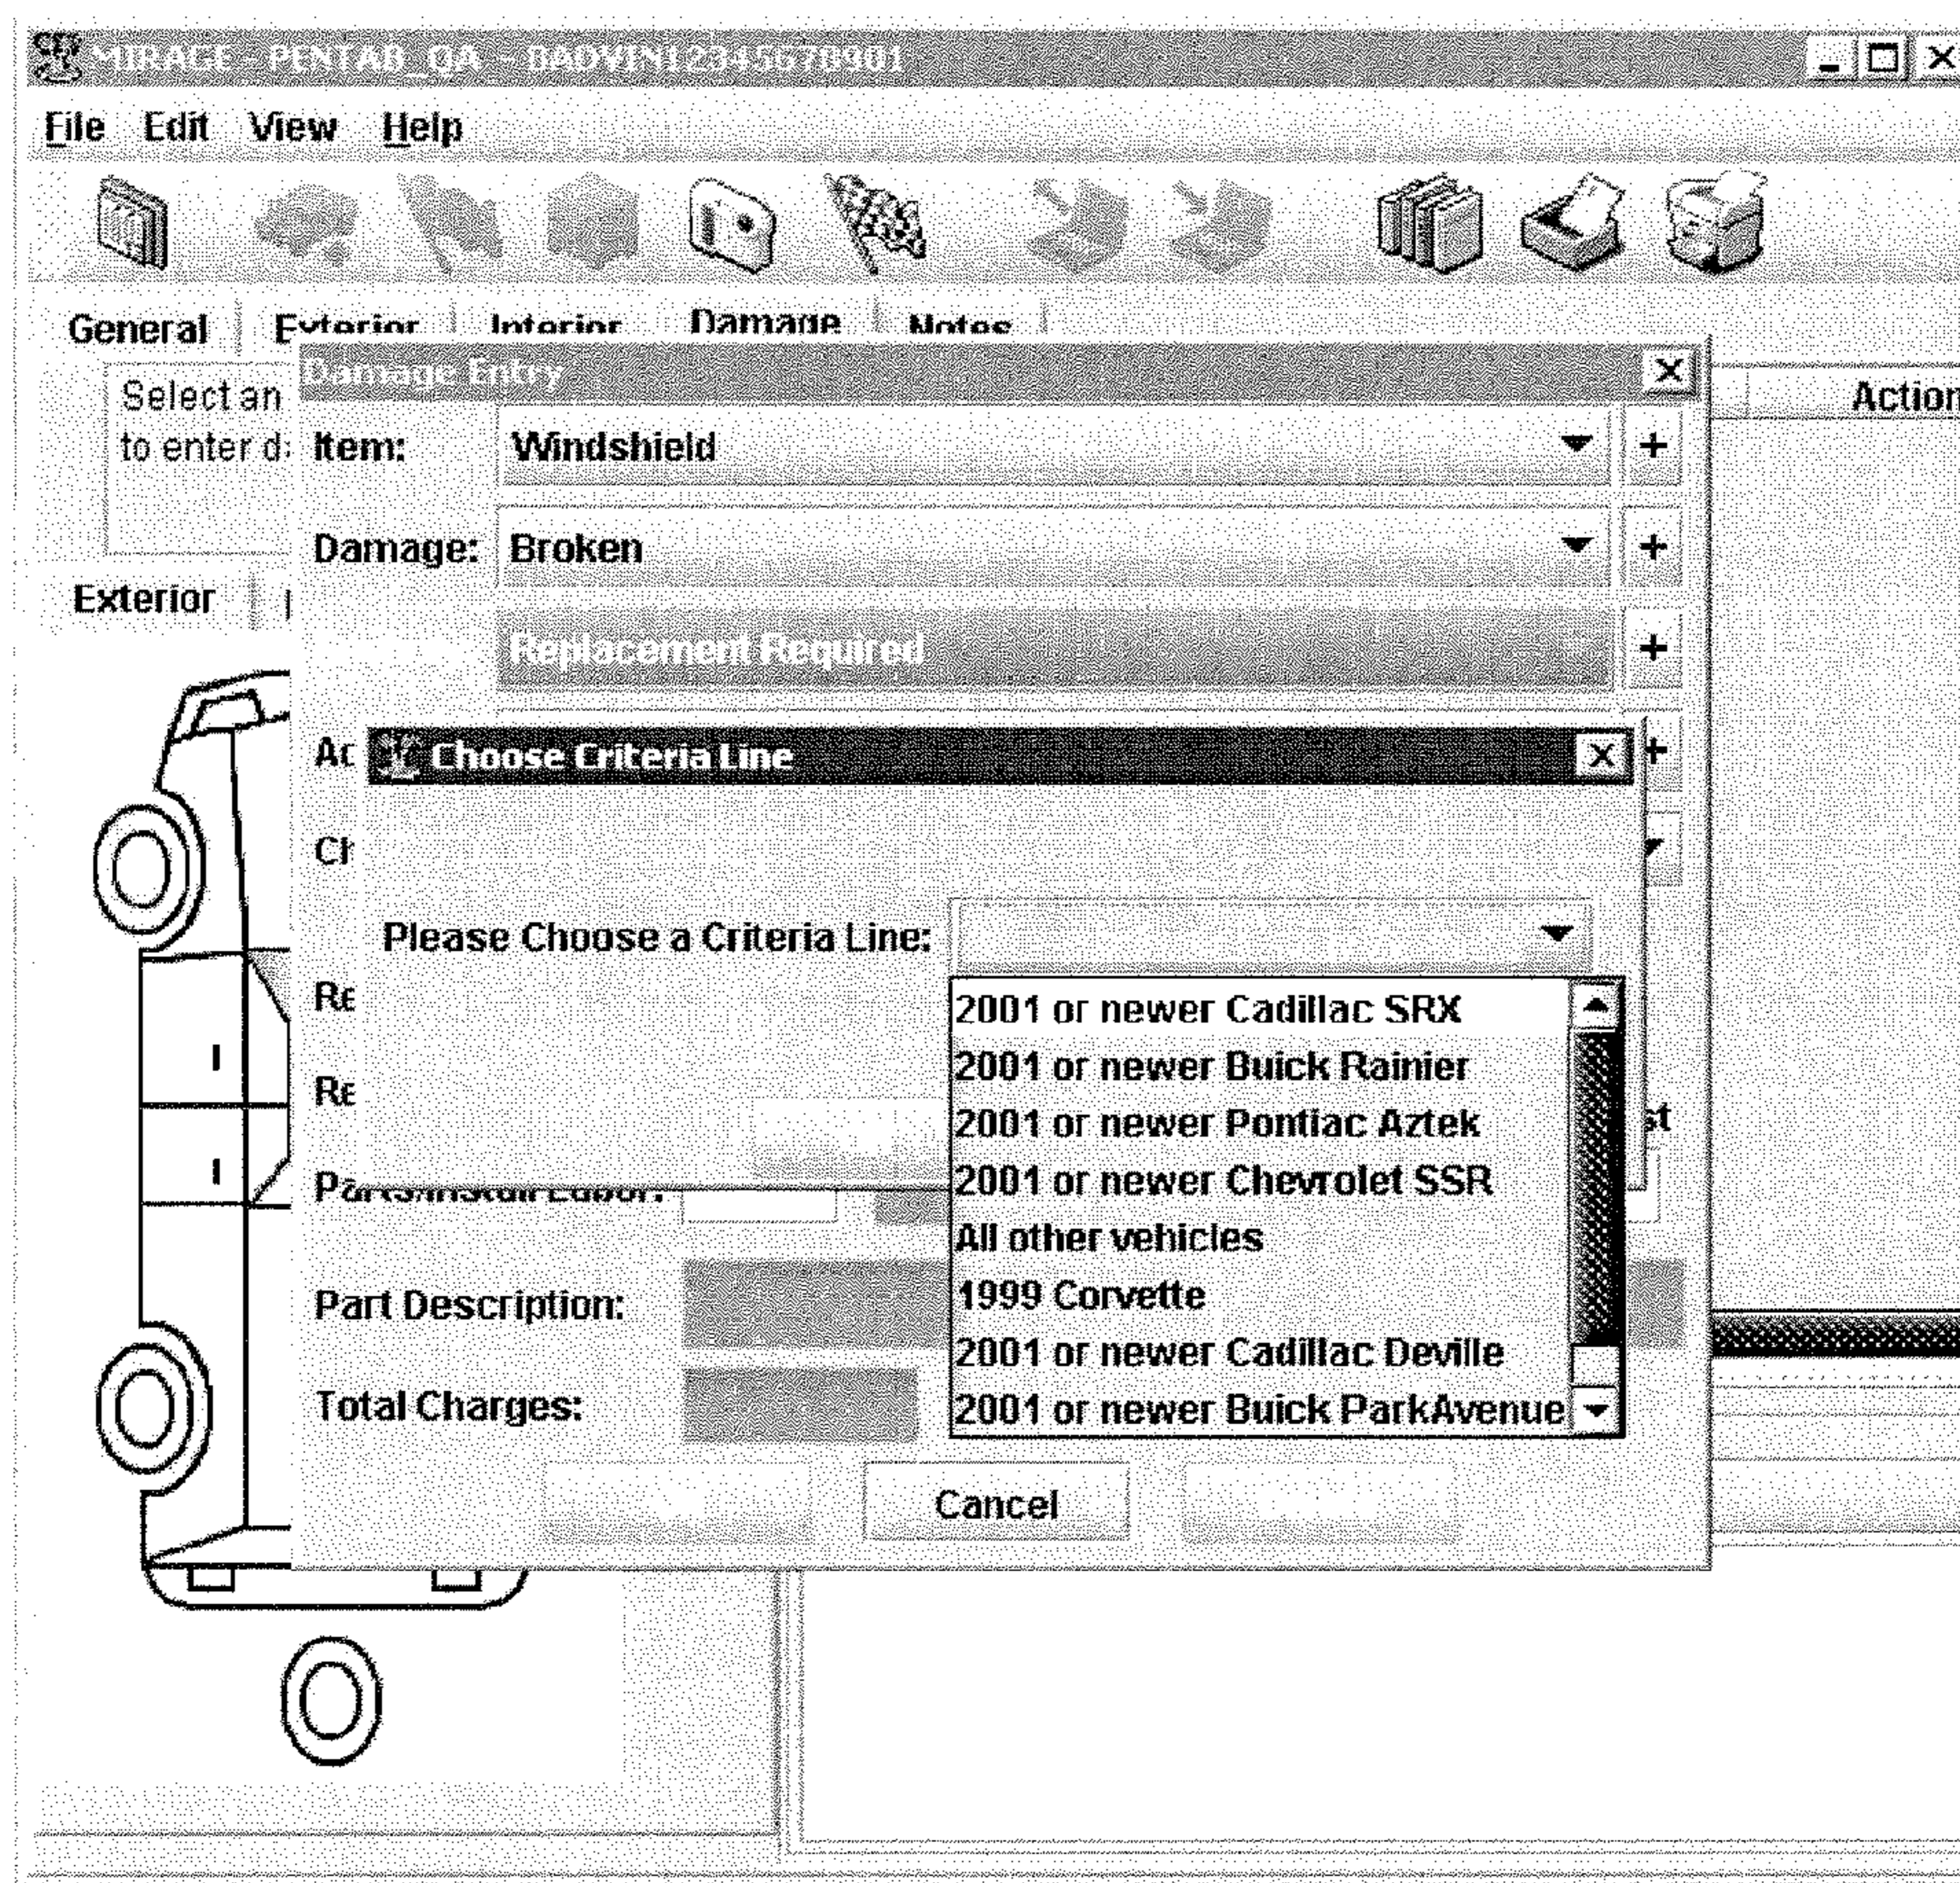
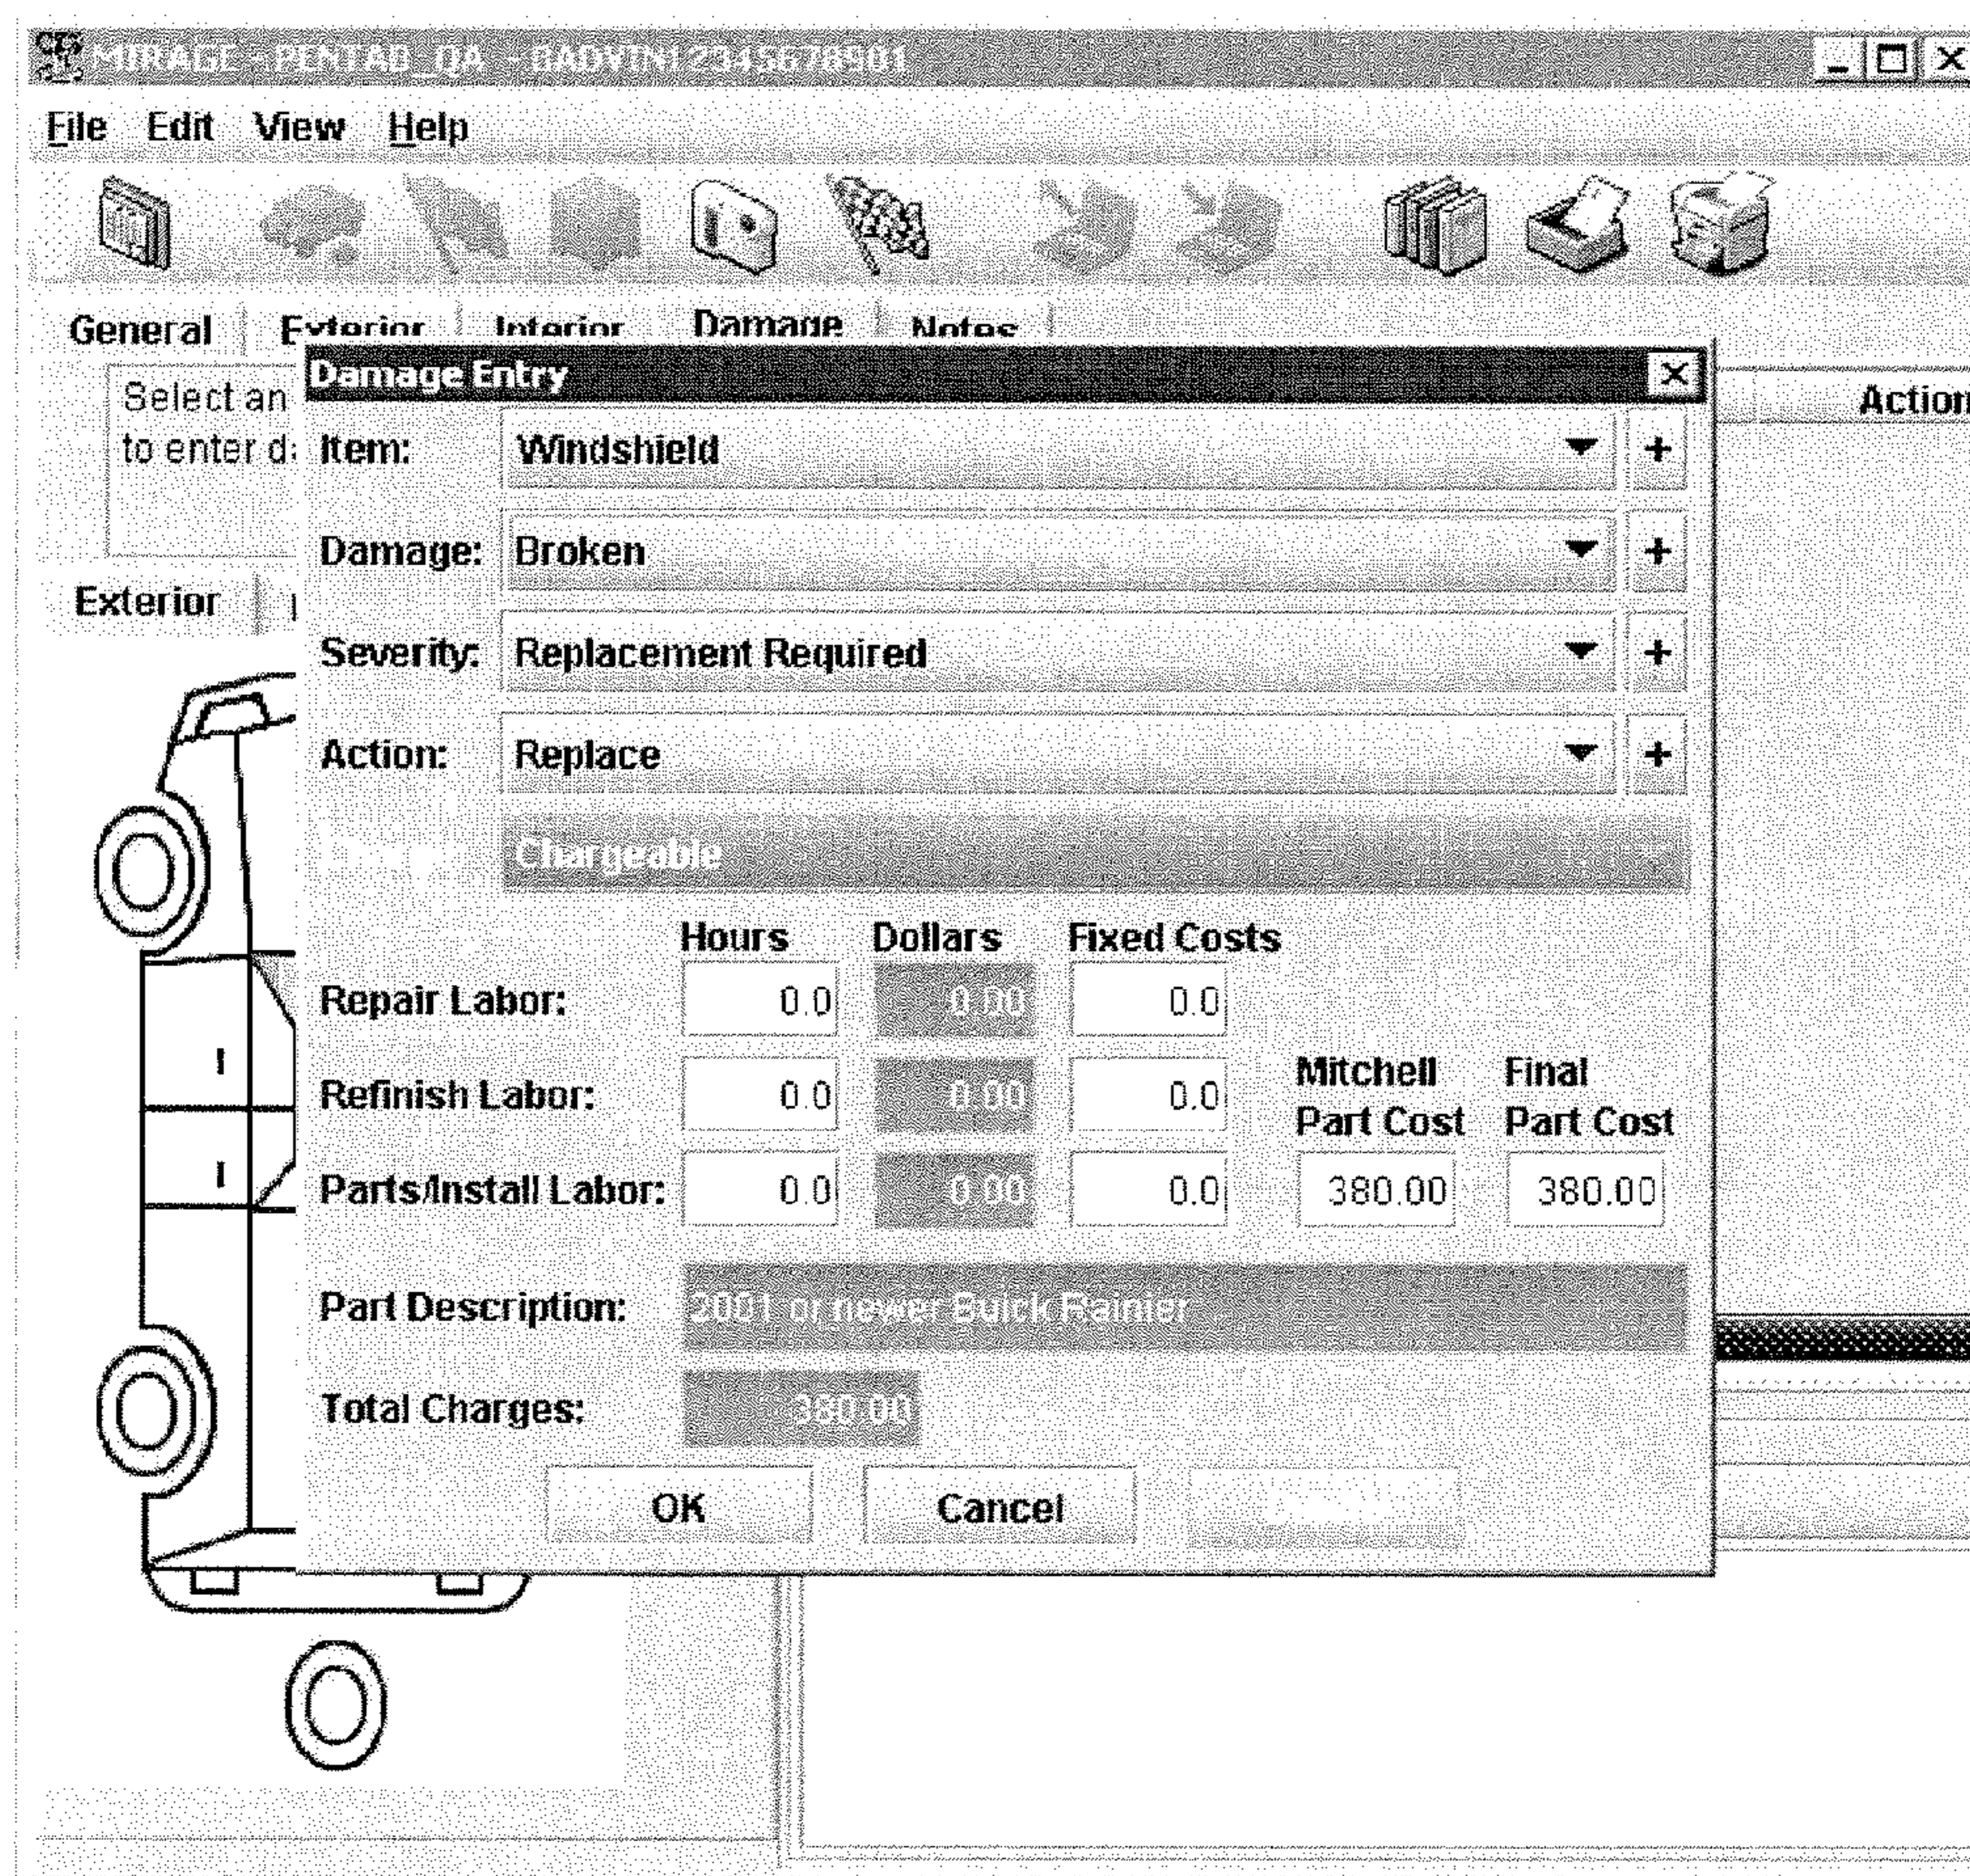
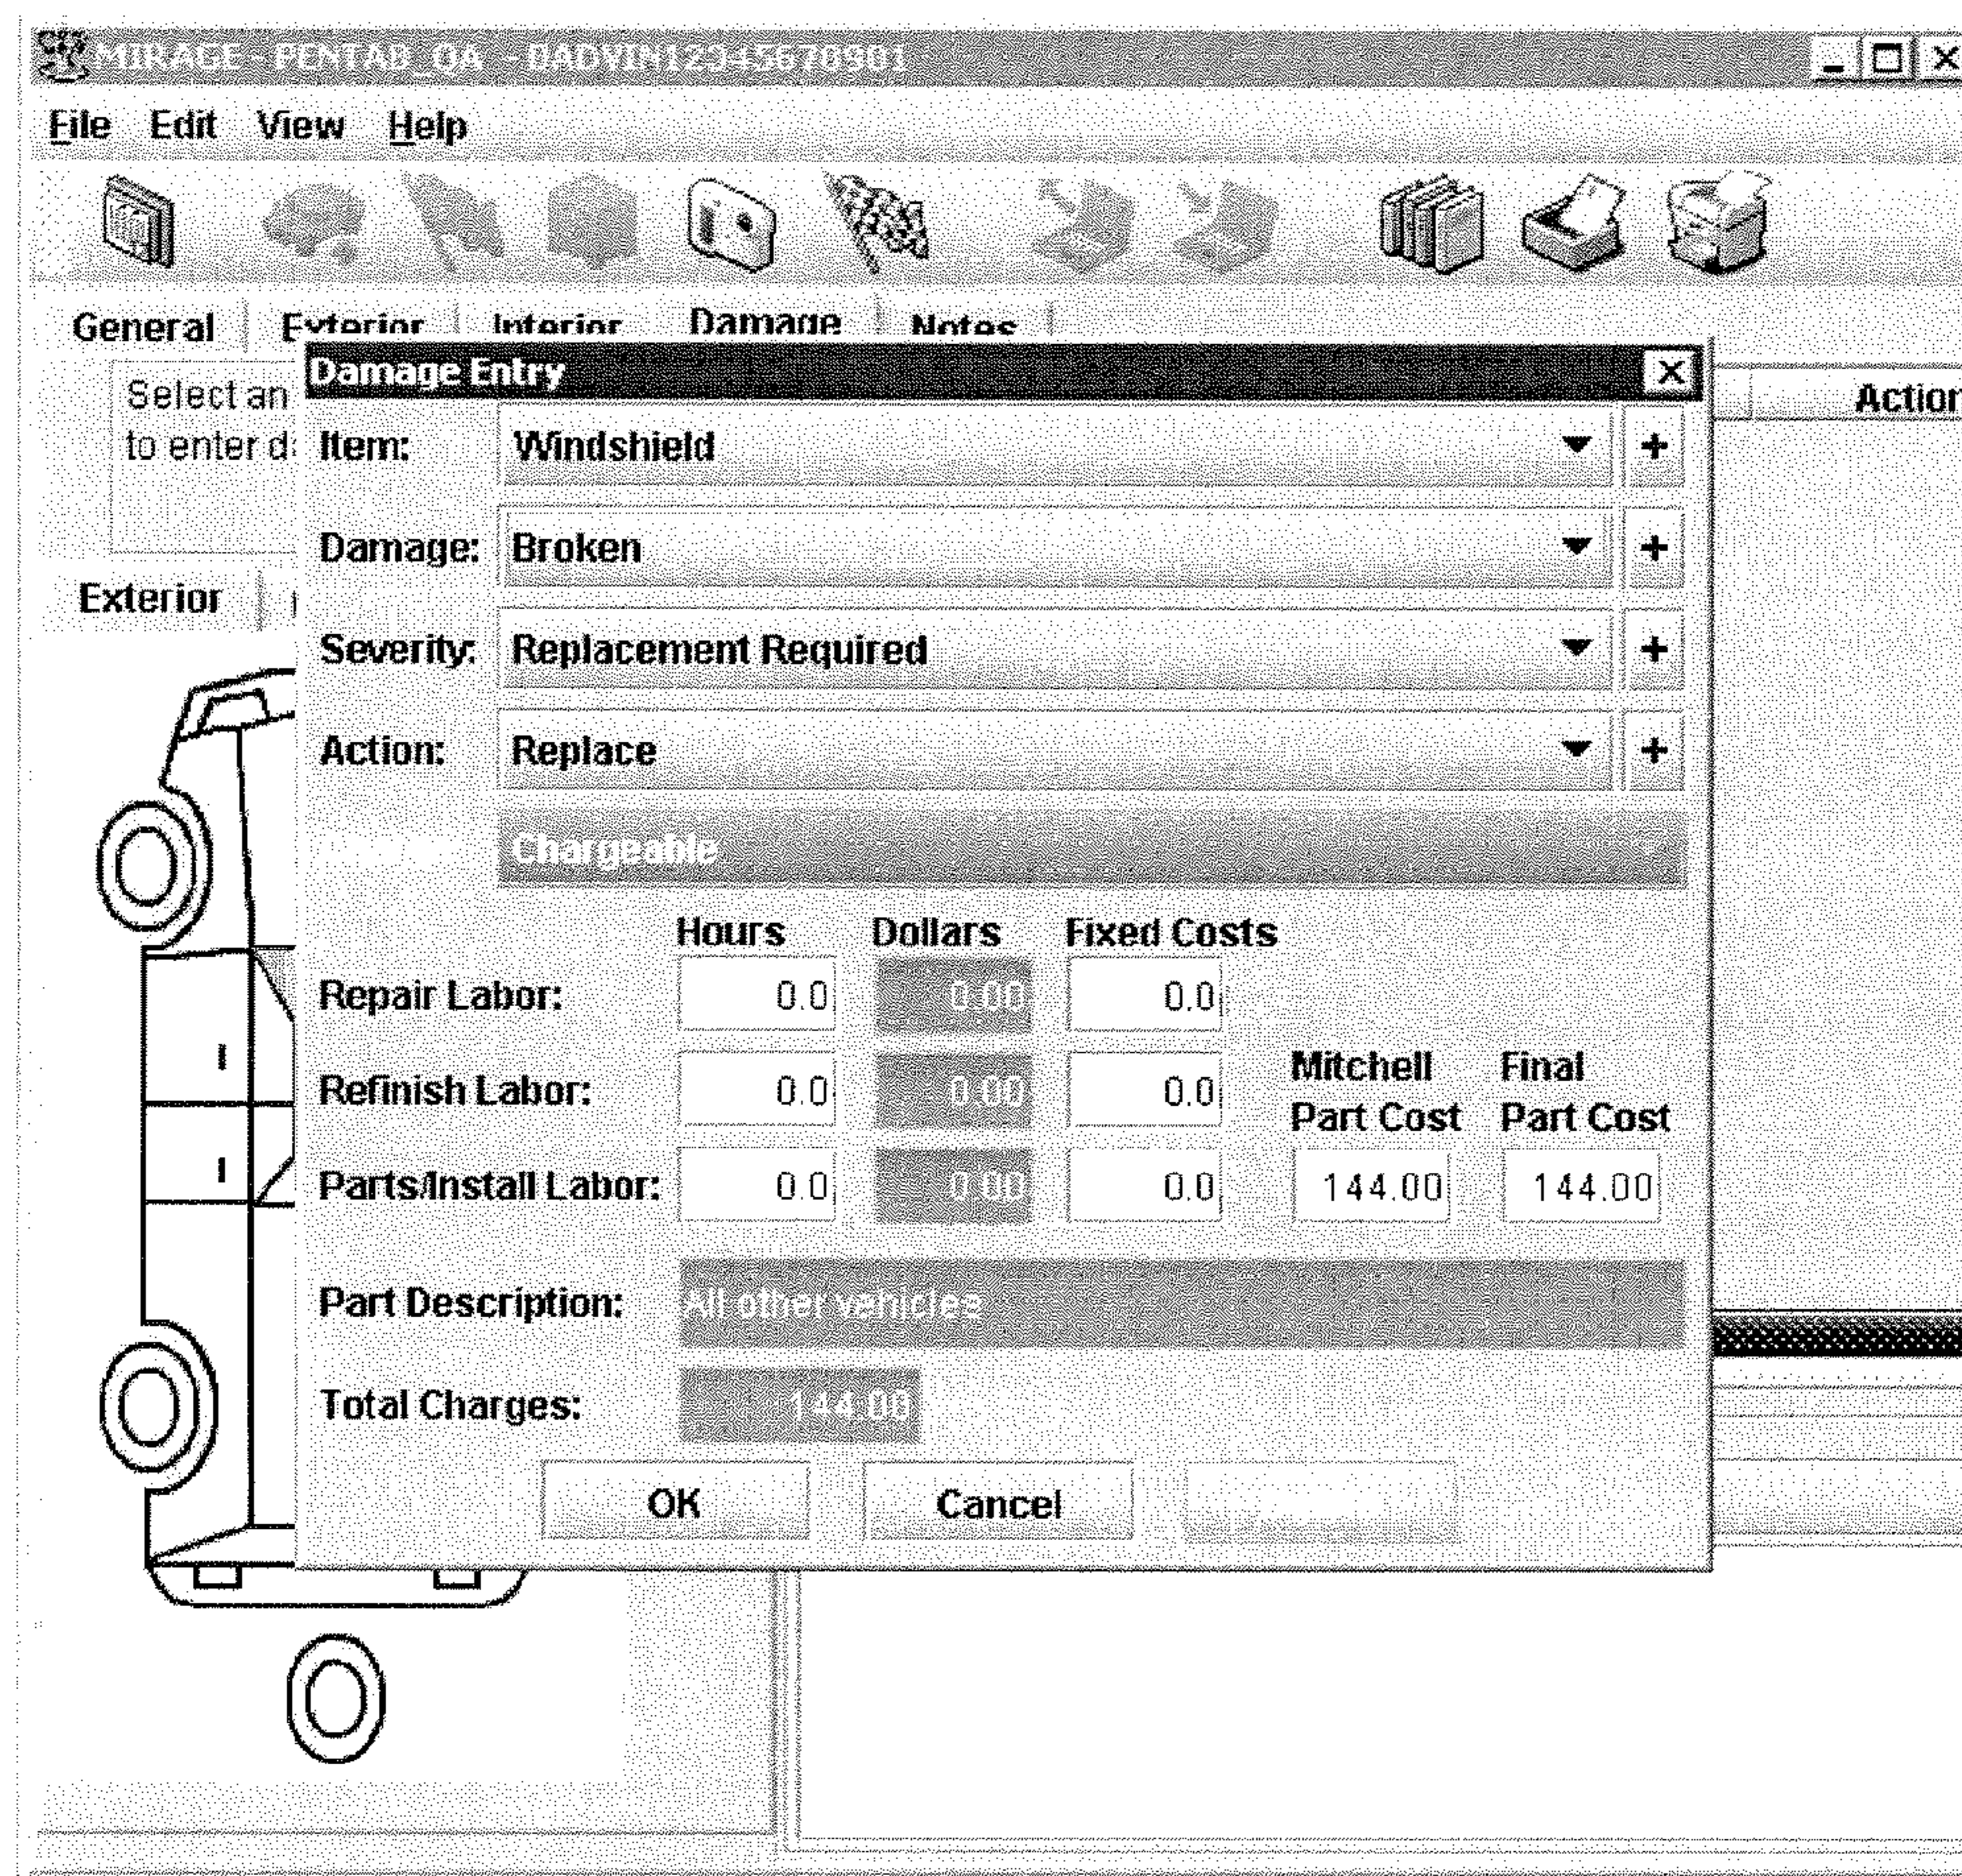
FIGS. 12A-12E are exemplary illustrative non-limiting damage entry screens;
