(12) **United States Patent**
Newman

(10) **Patent No.:** **US 9,996,747 B2**
(45) **Date of Patent:** ***Jun. 12, 2018**

(54) **SYSTEM AND METHOD FOR GROUND
BASED INSPECTION OF WIND TURBINE
BLADES**

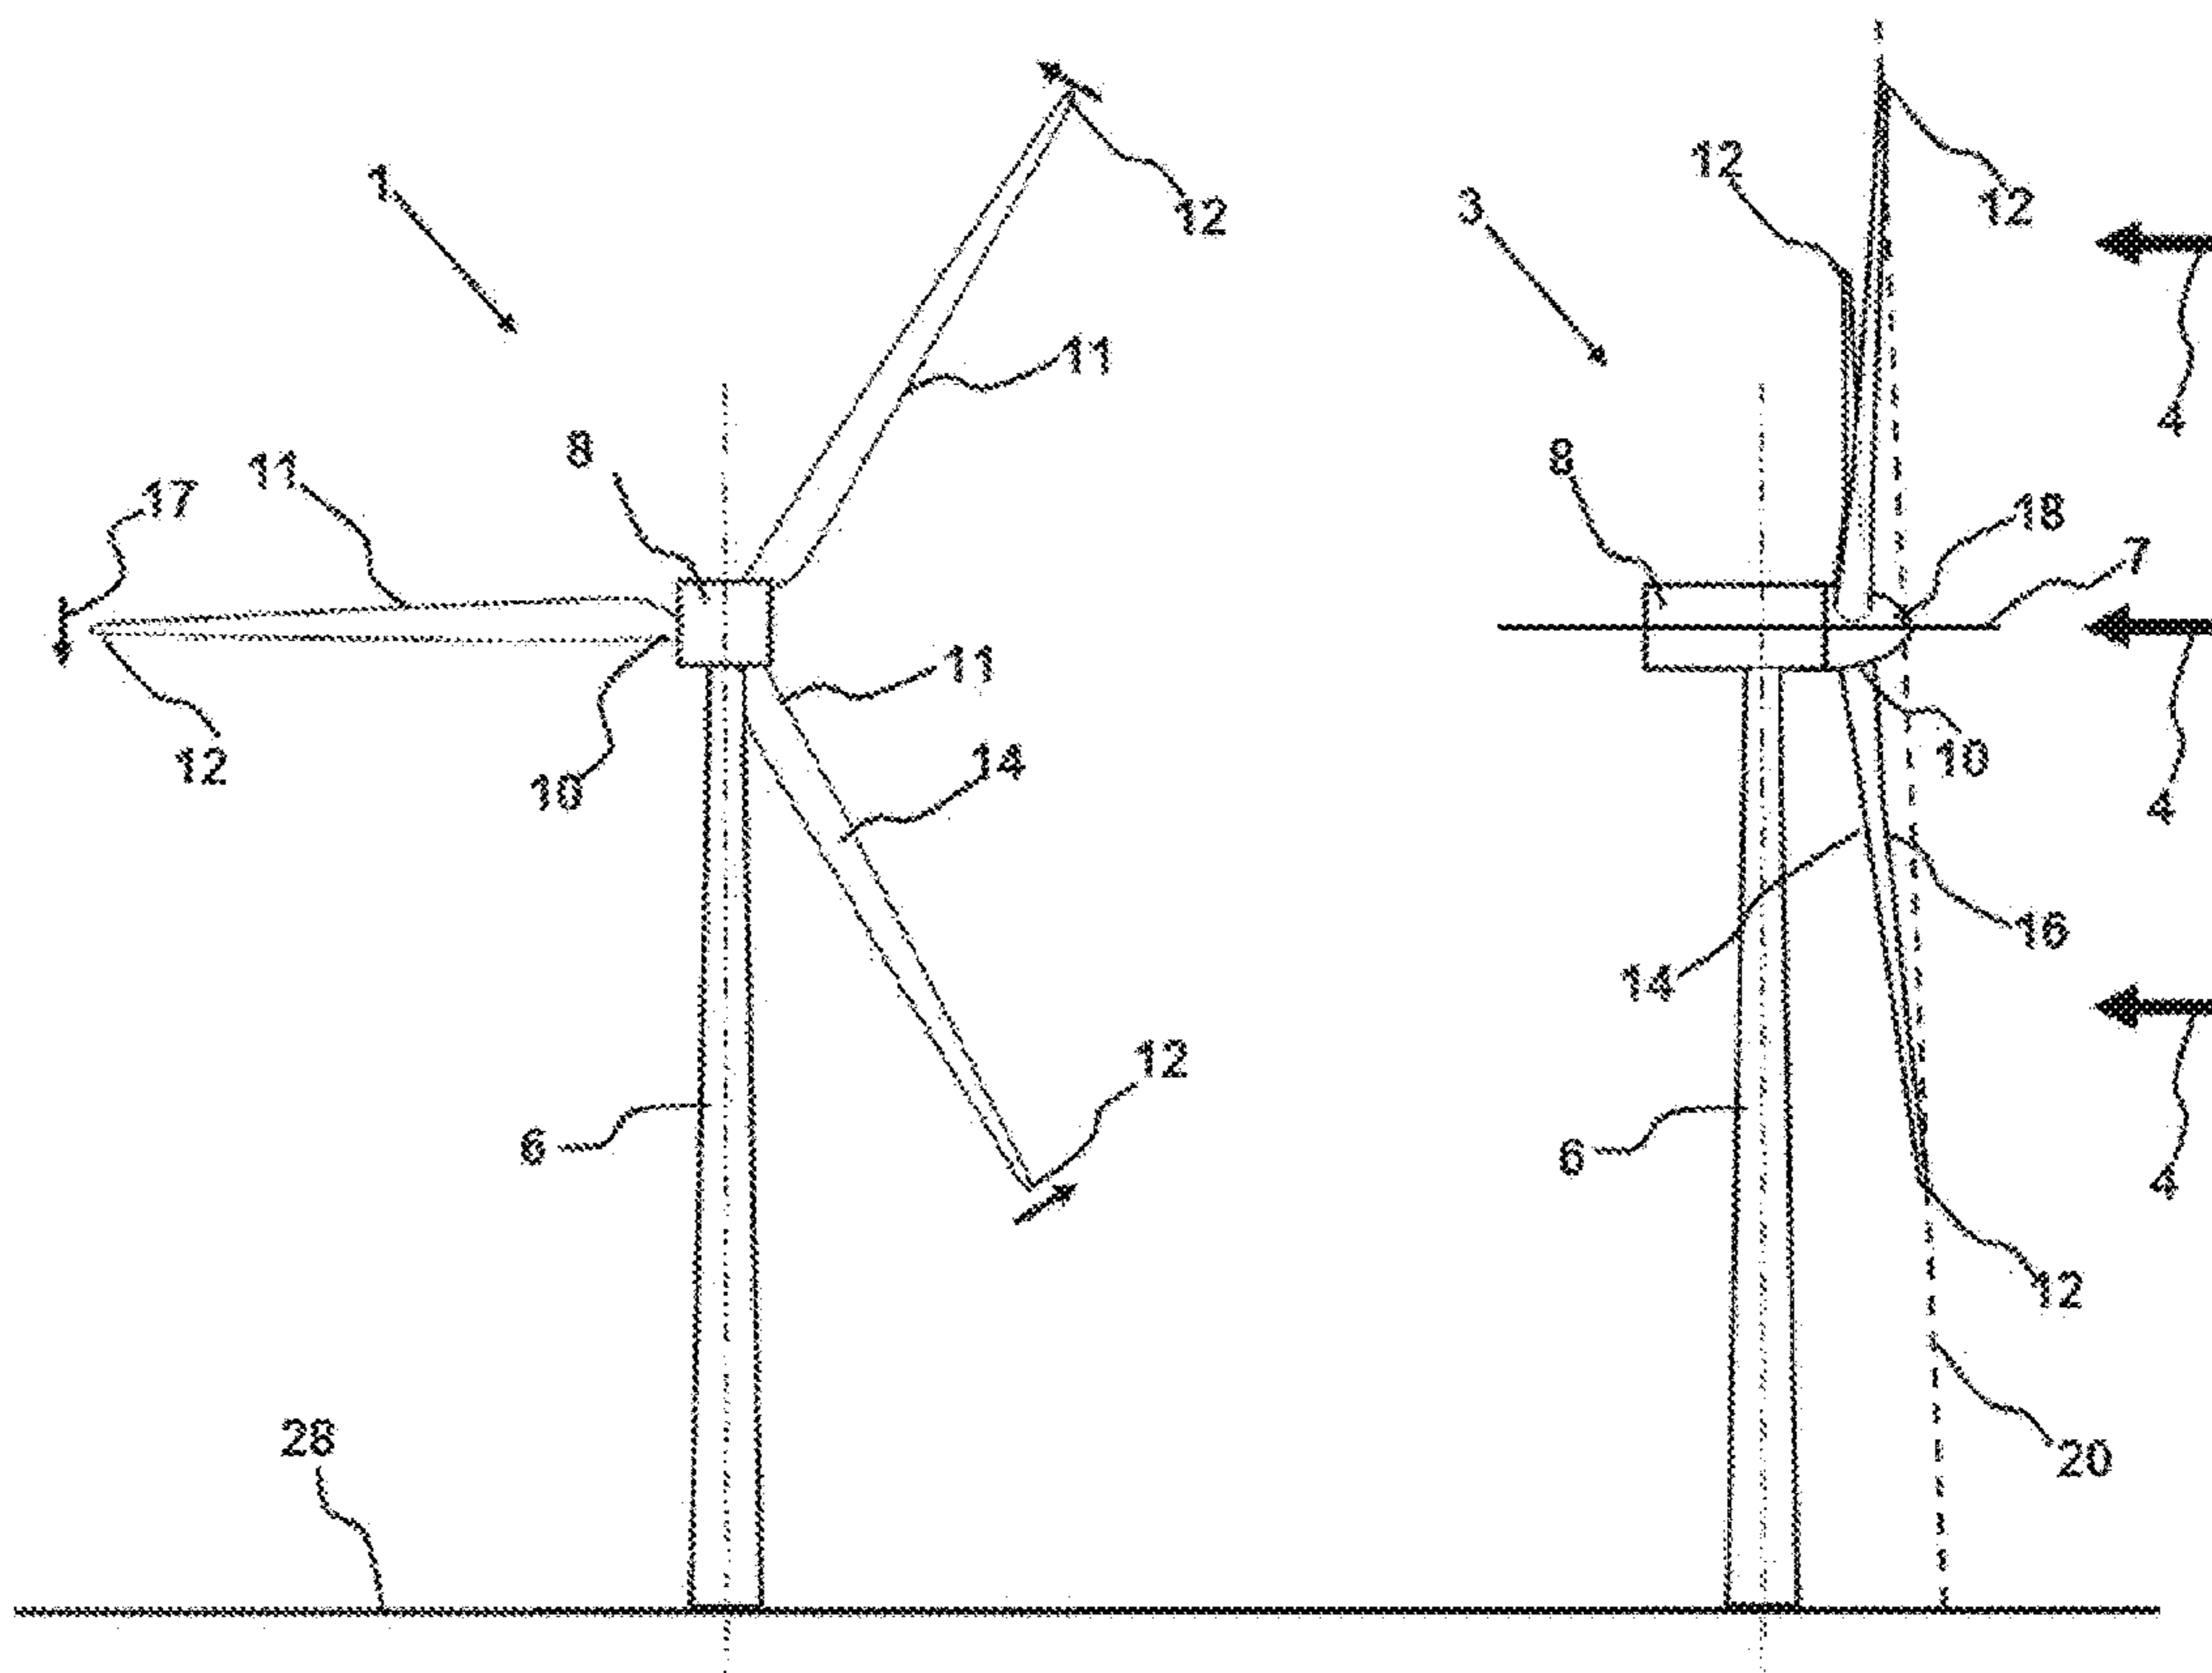
Fig. 1

FIG. 1 is a schematic representation of a utility scale, horizontal axis, wind turbine generator;

Referring now to the drawings, wherein like reference numerals indicate corresponding structure throughout the views, and referring in particular to FIG. 1, a schematic diagram of a HAWT is shown that that is typical of both land based and off-shore turbine generators. The view 1 from behind the turbine facing the wind includes tower 6 extending up from the ground or ocean surface 2 to support the nacelle 8 which contains the generator and gear reducers, unless it is a direct drive generator. There are typically three blades on a utility scale wind turbine having root ends 10 and blade tips 21. As seen from the side view 2, the blade root ends attach to the rotatable hub 18. Blade side 16 facing the wind 4 is often referred to as the high pressure side. The blade side 14, facing away from the wind is referred to as the low pressure or suction side. As the blade speed increases the blade pitch is adjusted to the optimal angle of attack to the wind to create the maximum lift and torque required to drive the electricity generator.

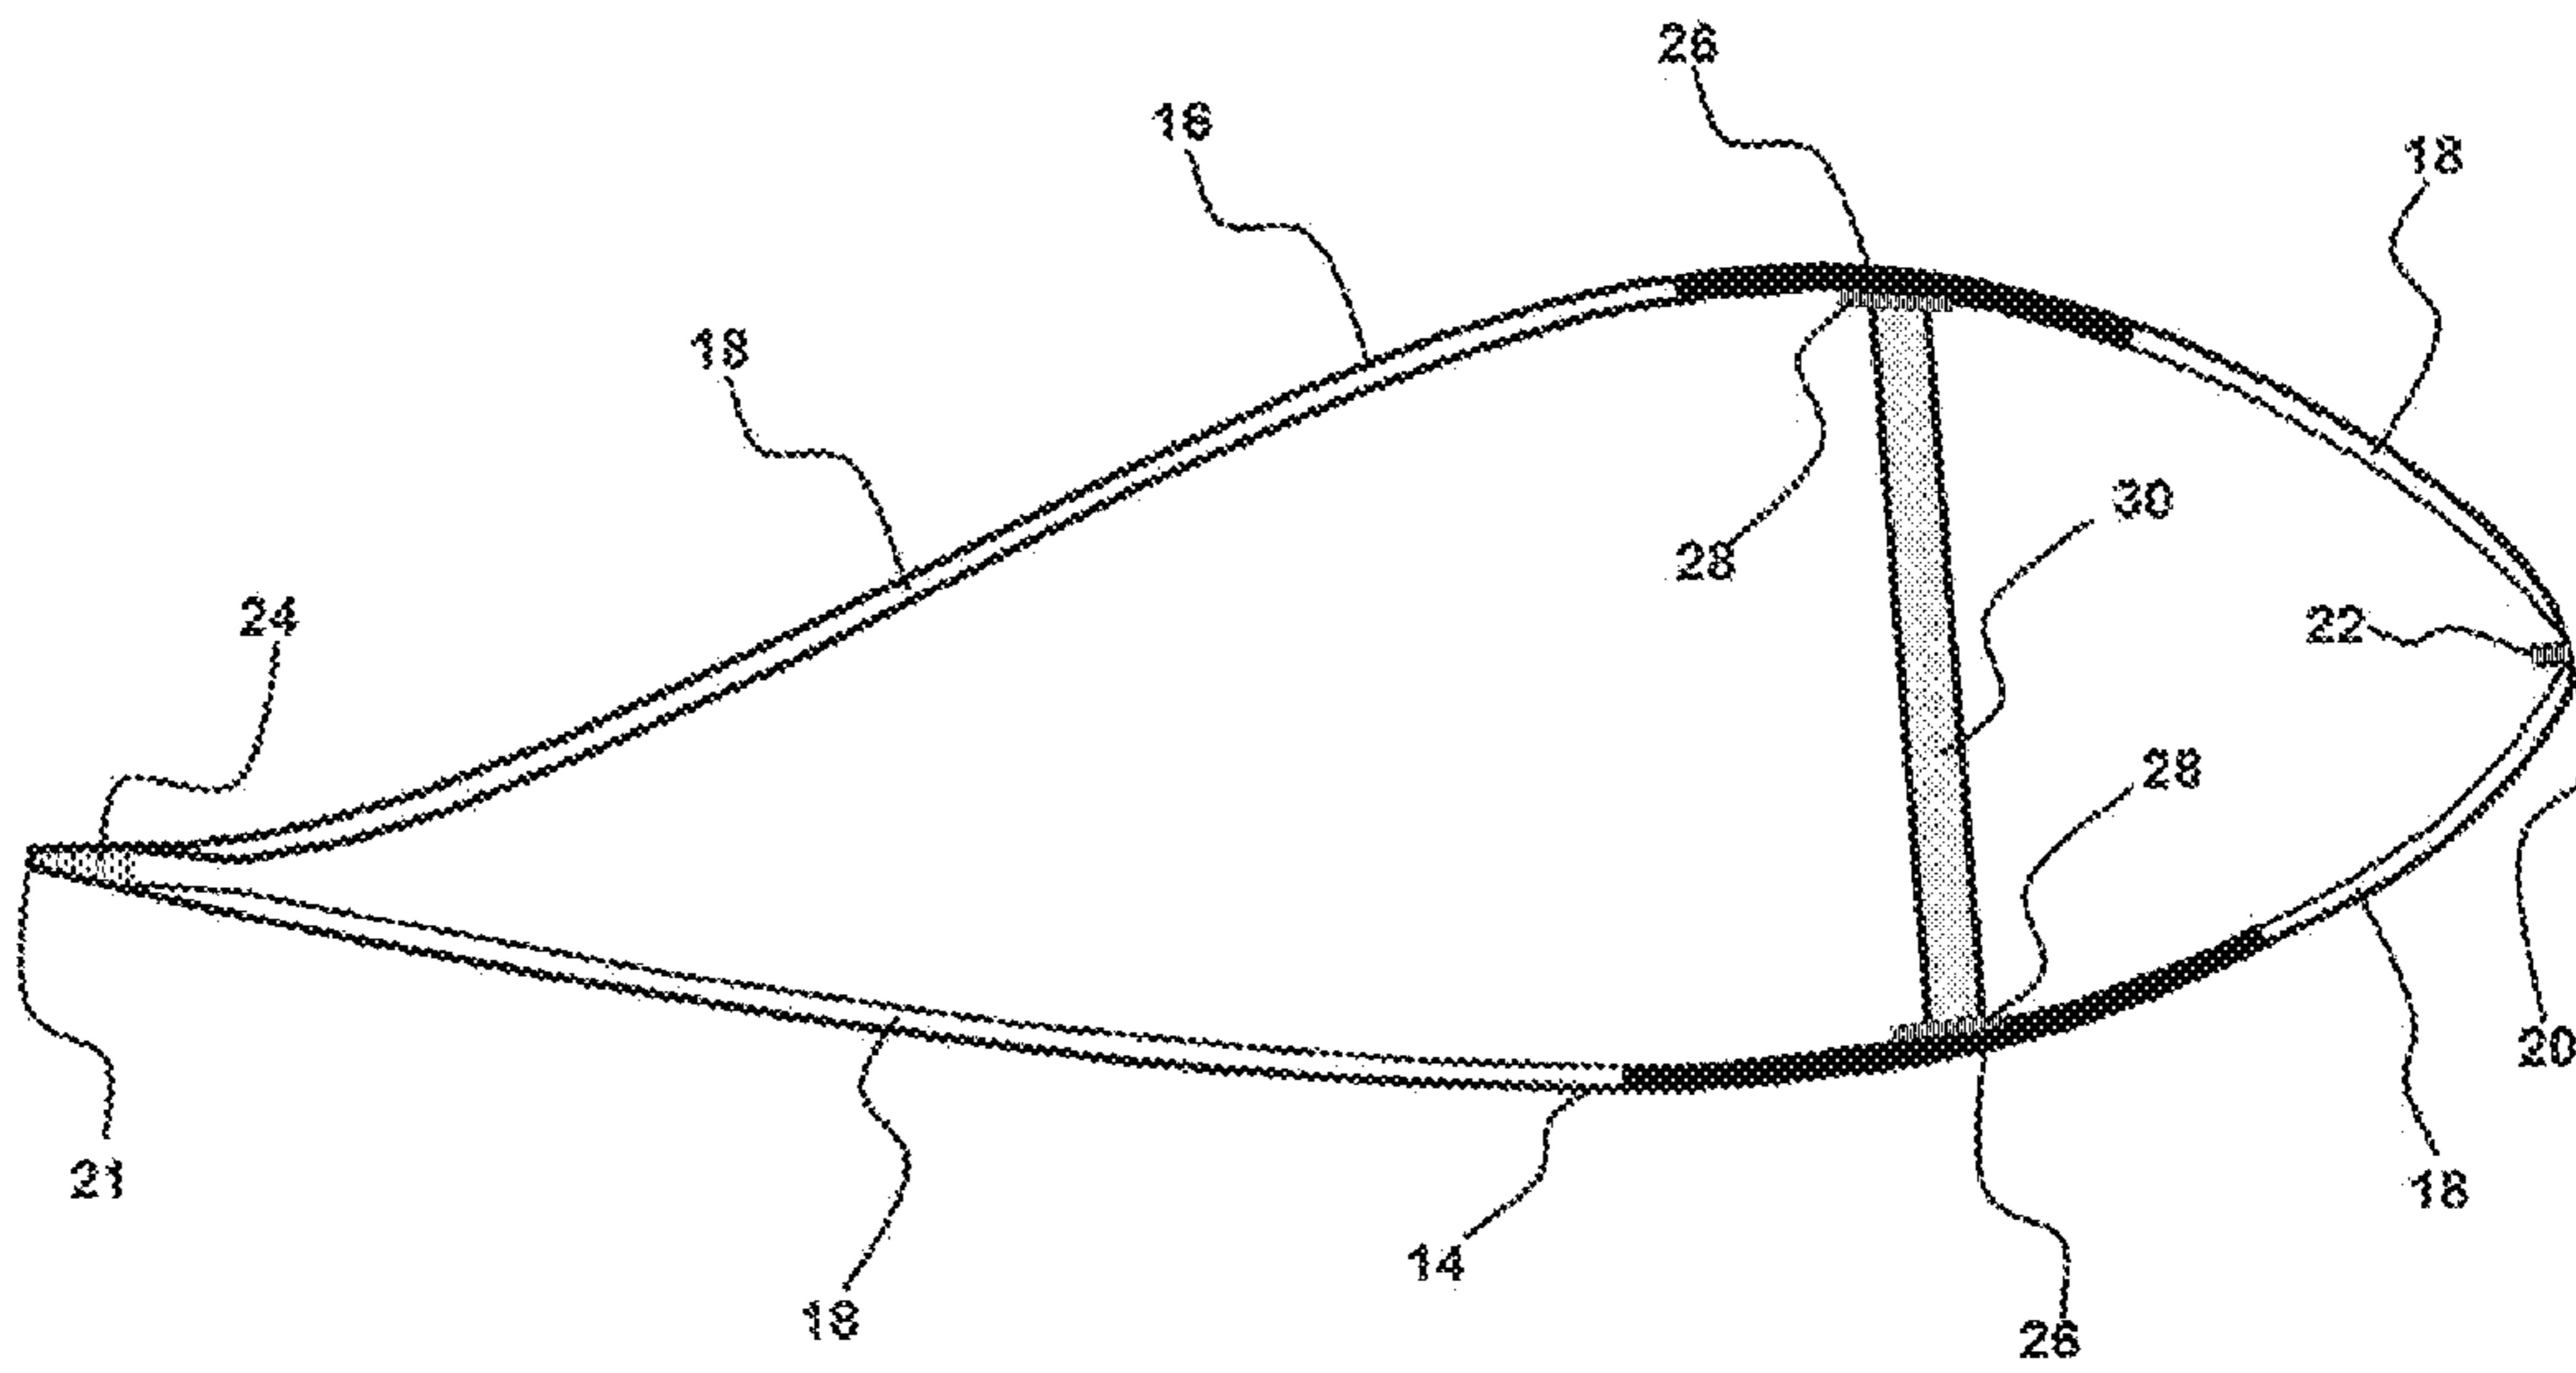
Fig. 2

FIG. 2 is a schematic representation of a wind turbine blade cross section;

FIG. 2 shows the construction cross section of a typical HAWT blade. Wind turbine blades are generally manufactured with adhesively bonded composite shells forming the high pressure side 16 and the low pressure side 14. The trailing edge 21 is adhesively bonded as is the leading edge 20, with adhesive bonding in some cases between two flanges 22 formed by the inner and outer fiberglass skins that make up sandwich panels 18. Two spar caps 26, which may be made from fiberglass or carbon fiber laminate or other like composite material are bonded to the edges of the sandwich panels 18. The blade spar web 30, which can be a solid fiberglass laminate or a sandwich construction with fiberglass or carbon fiber face sheets and a core material made with foam, balsa wood or other suitable material with high compressive strength. The spar web 30 is bonded with adhesive 28 to the spar caps 26 to form an I beam. Sometimes a second or even third spar web is present forming a box beam.

Defects such as adhesive disbonds or unbonds present at the spar cap 26 to spar web 30 adhesive bond 28 may lead to catastrophic failure of the blade in service. Fiber waves in the solid spar cap 26 laminate can also lead to cracking and ultimately to blade failure. Further, trailing edge 21 splits or cracks in the high pressure 16 and low 14 pressure side shell adhesive bond 24 may be signs or excessive blade flex during operation. The trailing edge 21 adhesive bond 24, in the area of greatest blade chord width towards the root end 10 supports blade twist loads. Cracks and breaks in the adhesive bond 24 at these locations can also lead to blade failure unless detected in time and the turbine shut down and promptly repaired. When one of the reinforcing elements such as a glass or carbon fiber breaks, it makes a distinct sound, like a stick breaking. The sound propagates throughout the structure of the wind turbine blade, and throughout the enclosed space defined by the interior surface of the outer skin of the blade. In addition, a pressure gradient develops within the enclosed space as a result of centripetal acceleration. The pressure differential between the portion of the enclosed space that is proximate the wind turbine hub and the outermost portion of the enclosed space can be on the order of 2 psi.

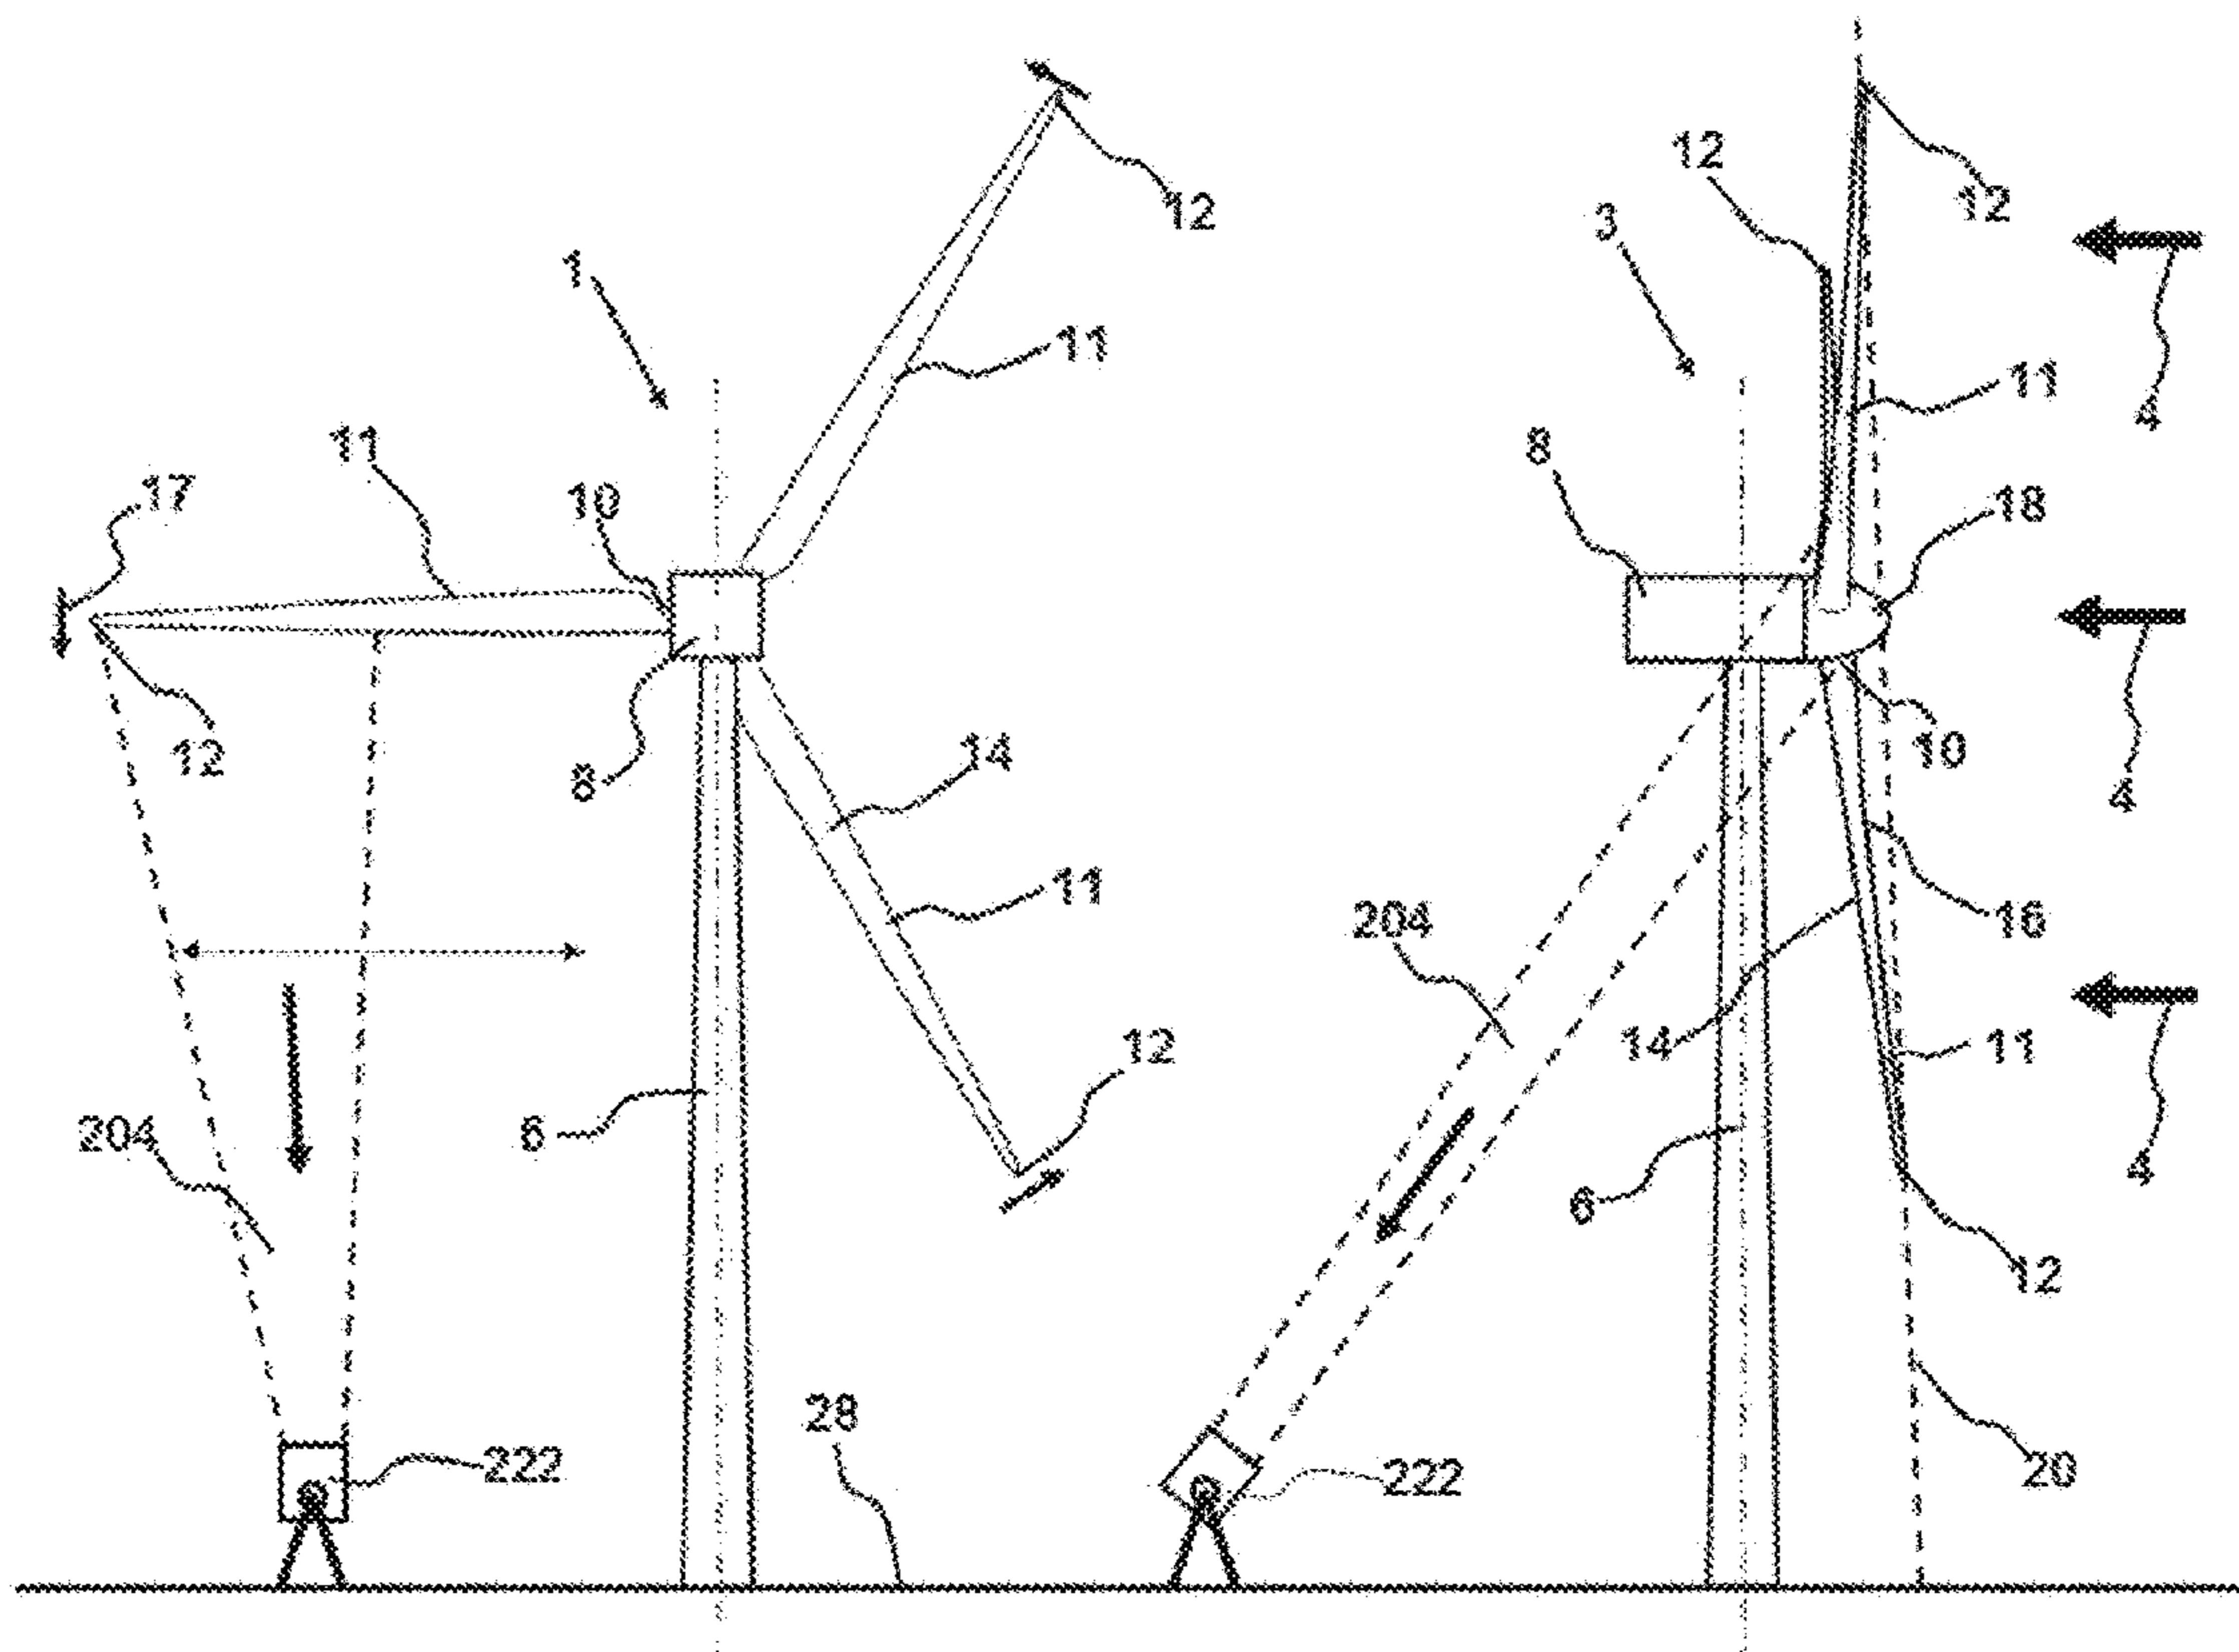
Fig. 3

FIG. 3 is a schematic diagram showing the relative location of a thermal camera for inspecting the wind turbine blades that are oriented so as to be substantially perpendicular with respect to the ground or sea level;

FIG. 3 is a schematic diagram showing the side view of thermal camera 222 at locations down wind of tower 6 for inspection of the low pressure side of the blade 11. Thermal emissions 204 from defects in the blade 11 propagating due to cyclic stress load due to gravity and wind fluctuations are detected by thermal camera 222. The side view also shows the plane 20 as a line extending to the ground or sea level 28,

containing the blade tips 12. This approximate location is a good viewing position for blade 11 leading edge 20 inspections.

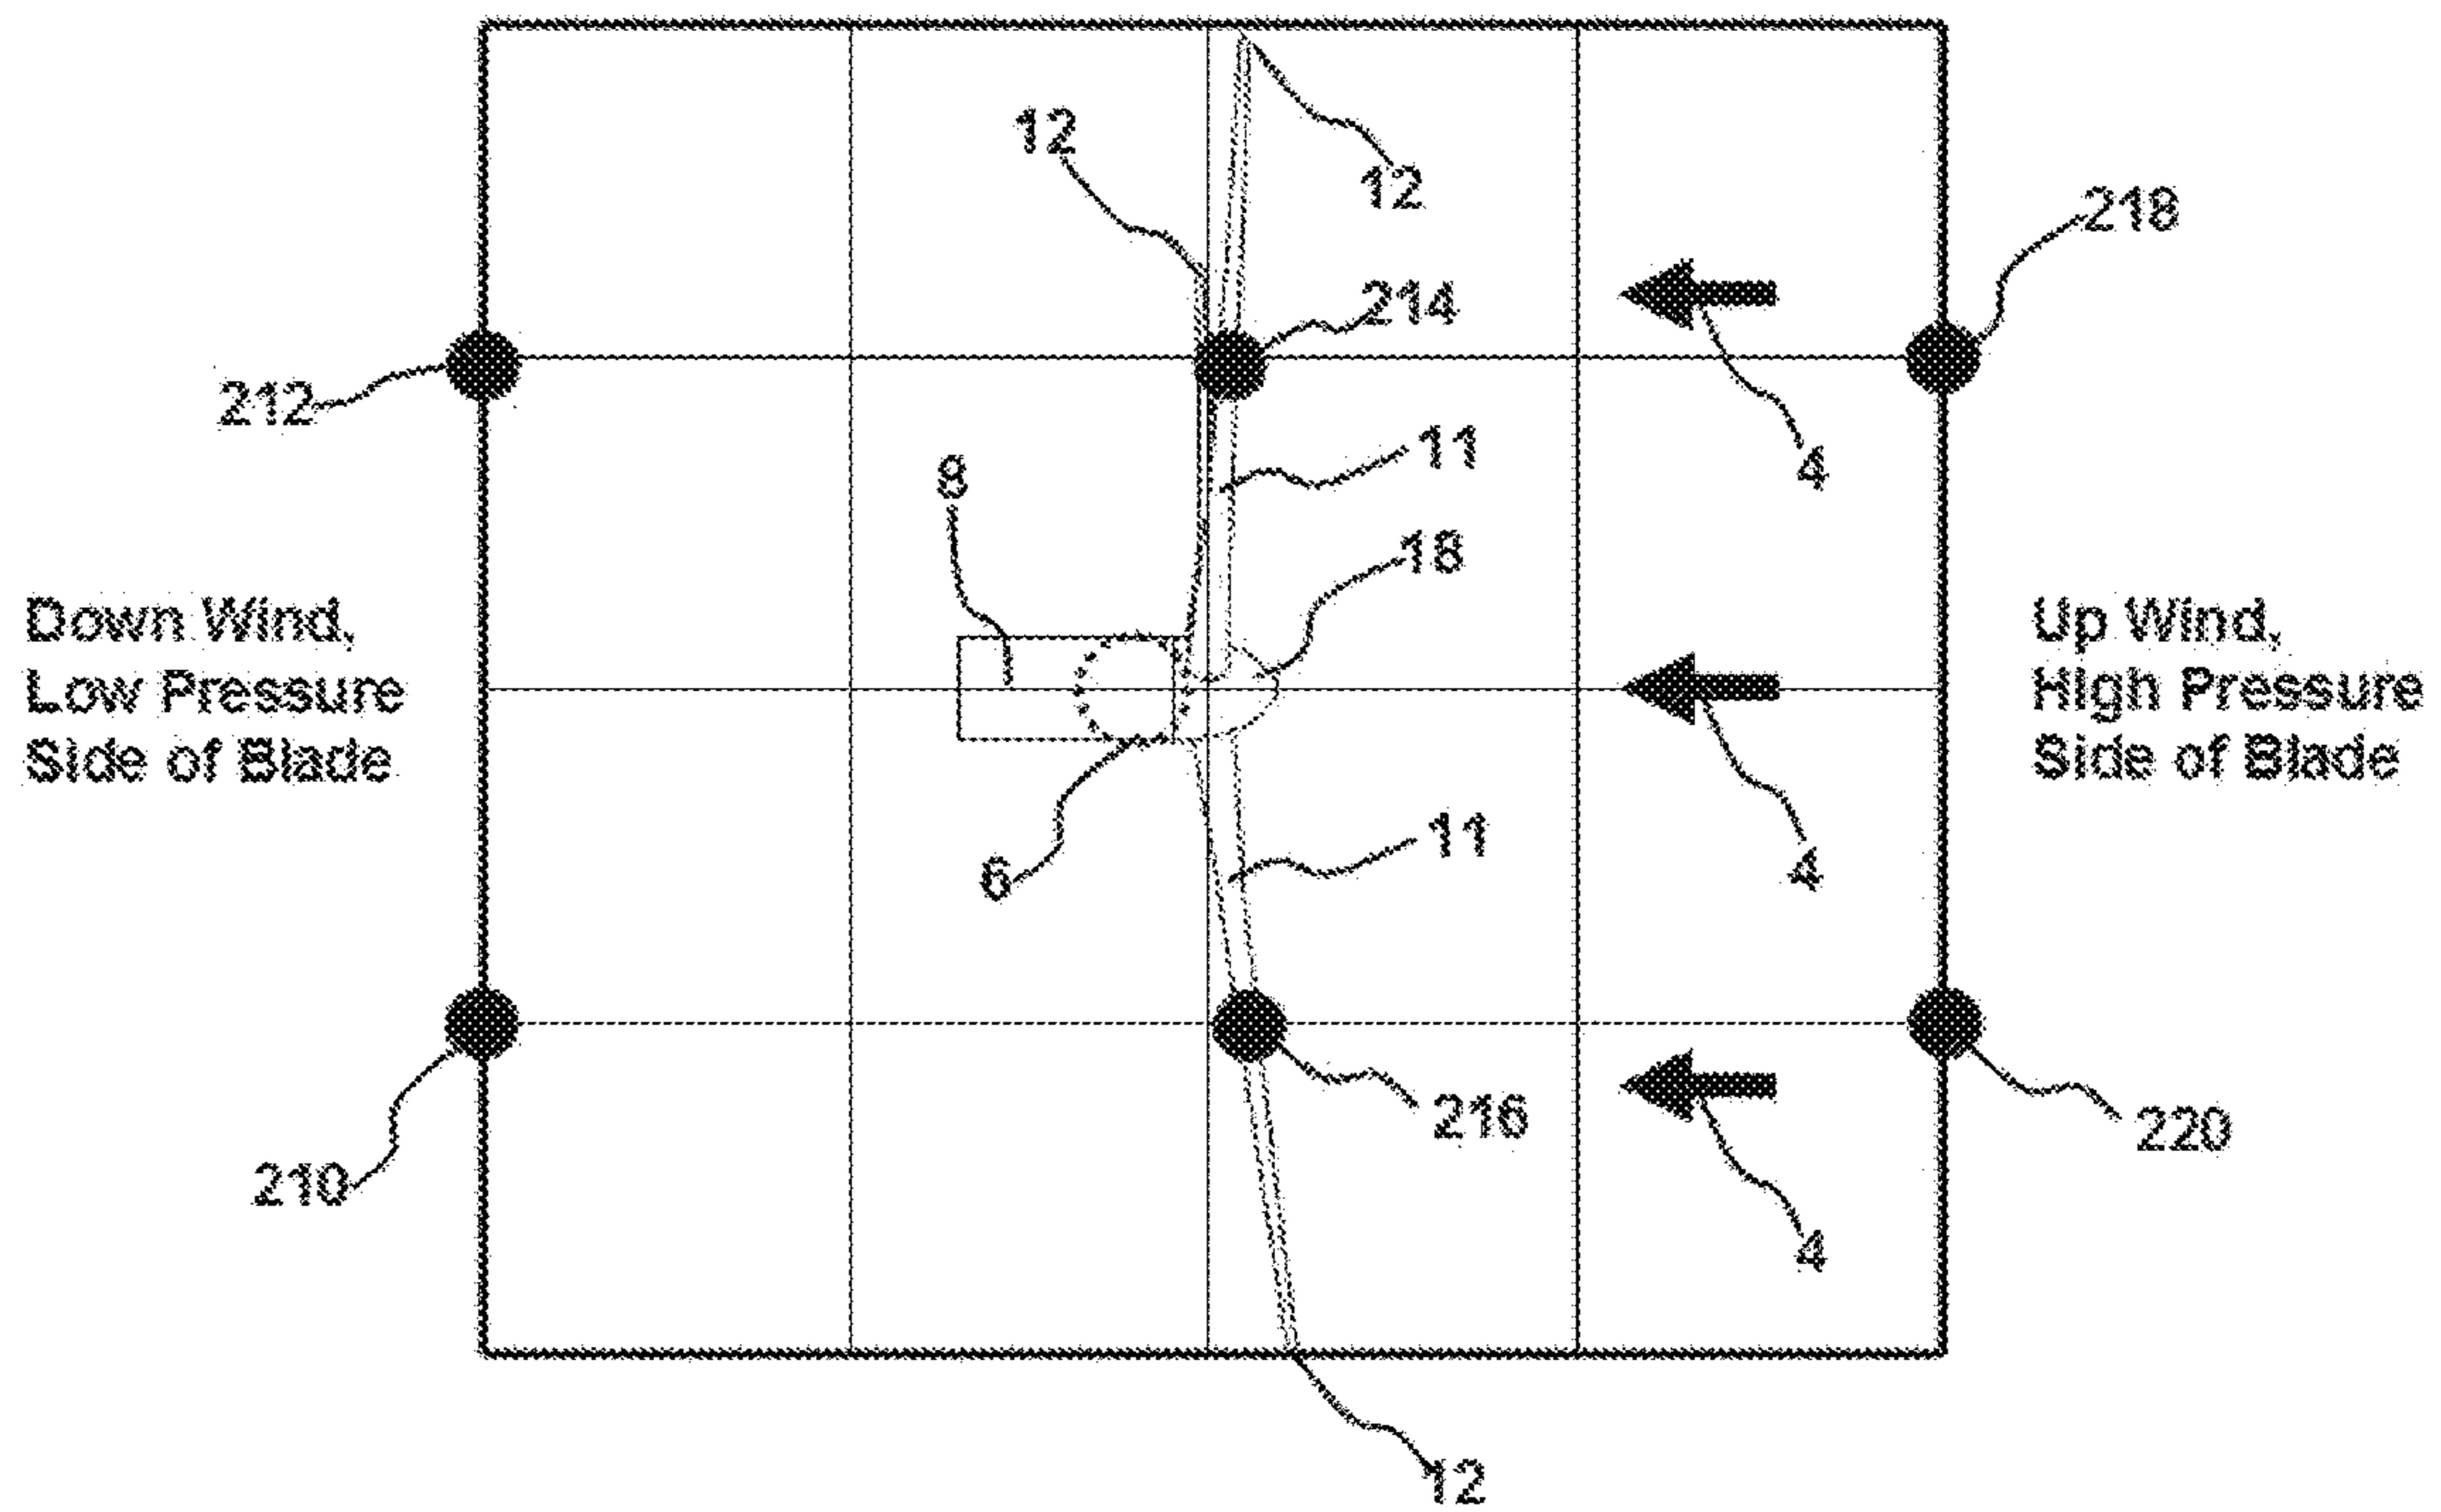
Fig. 4

FIG. 4 is a diagrammatical plan view of a wind turbine site with an indication of six placement locations for the thermal camera to view various locations on the blades;

FIG. 4 shows thermal camera 222, positioned at locations both on the up wind-high pressure side of the turbine blades, at two locations on either side of the tower in the plane of the blade disk and at a location on the down wind, low pressure or suction side of the blades to provide advantageous viewing of the entire blade surfaces during rotation. For the best view angle of the low pressure side 14 of the blades 11 is achieved with the thermal camera 222 positioned at approximately location 212, however the best results are obtained using an image stabilizer as described here in or an image peak storage unit or software due to the relatively high speed the image of the blade passes through the camera field of view. The best view of the blade leading edges 20 are at position 214, in the plane 20 of the blade tips, since the blade 11 is rotating down directly at the camera and the angles of points on the leading edge 20 are changing relatively slowly.

Moving down wind from position 214 gives good views of the forward low pressure side surfaces 14, of the blade 11 with relatively low rate of angle changes over three to four video frames. Position 216 is excellent for the trailing edge 21 of the blades and position 220 offers a full view of the high pressure side 16 of the blade 11, which is best viewed with the image stabilizer or peak storage embodiment described herein. Position 210 offers relatively poor views of the low pressure side except for the trailing edge 21 and the aft low pressure sandwich structure 18, but with fast moving angle changes and with the blade twist. Wind turbine farms are often located on hills or mountain ridges with little room to move away from the tower 6. Local conditions and land shapes often dictate where the best viewing angles can be obtained.

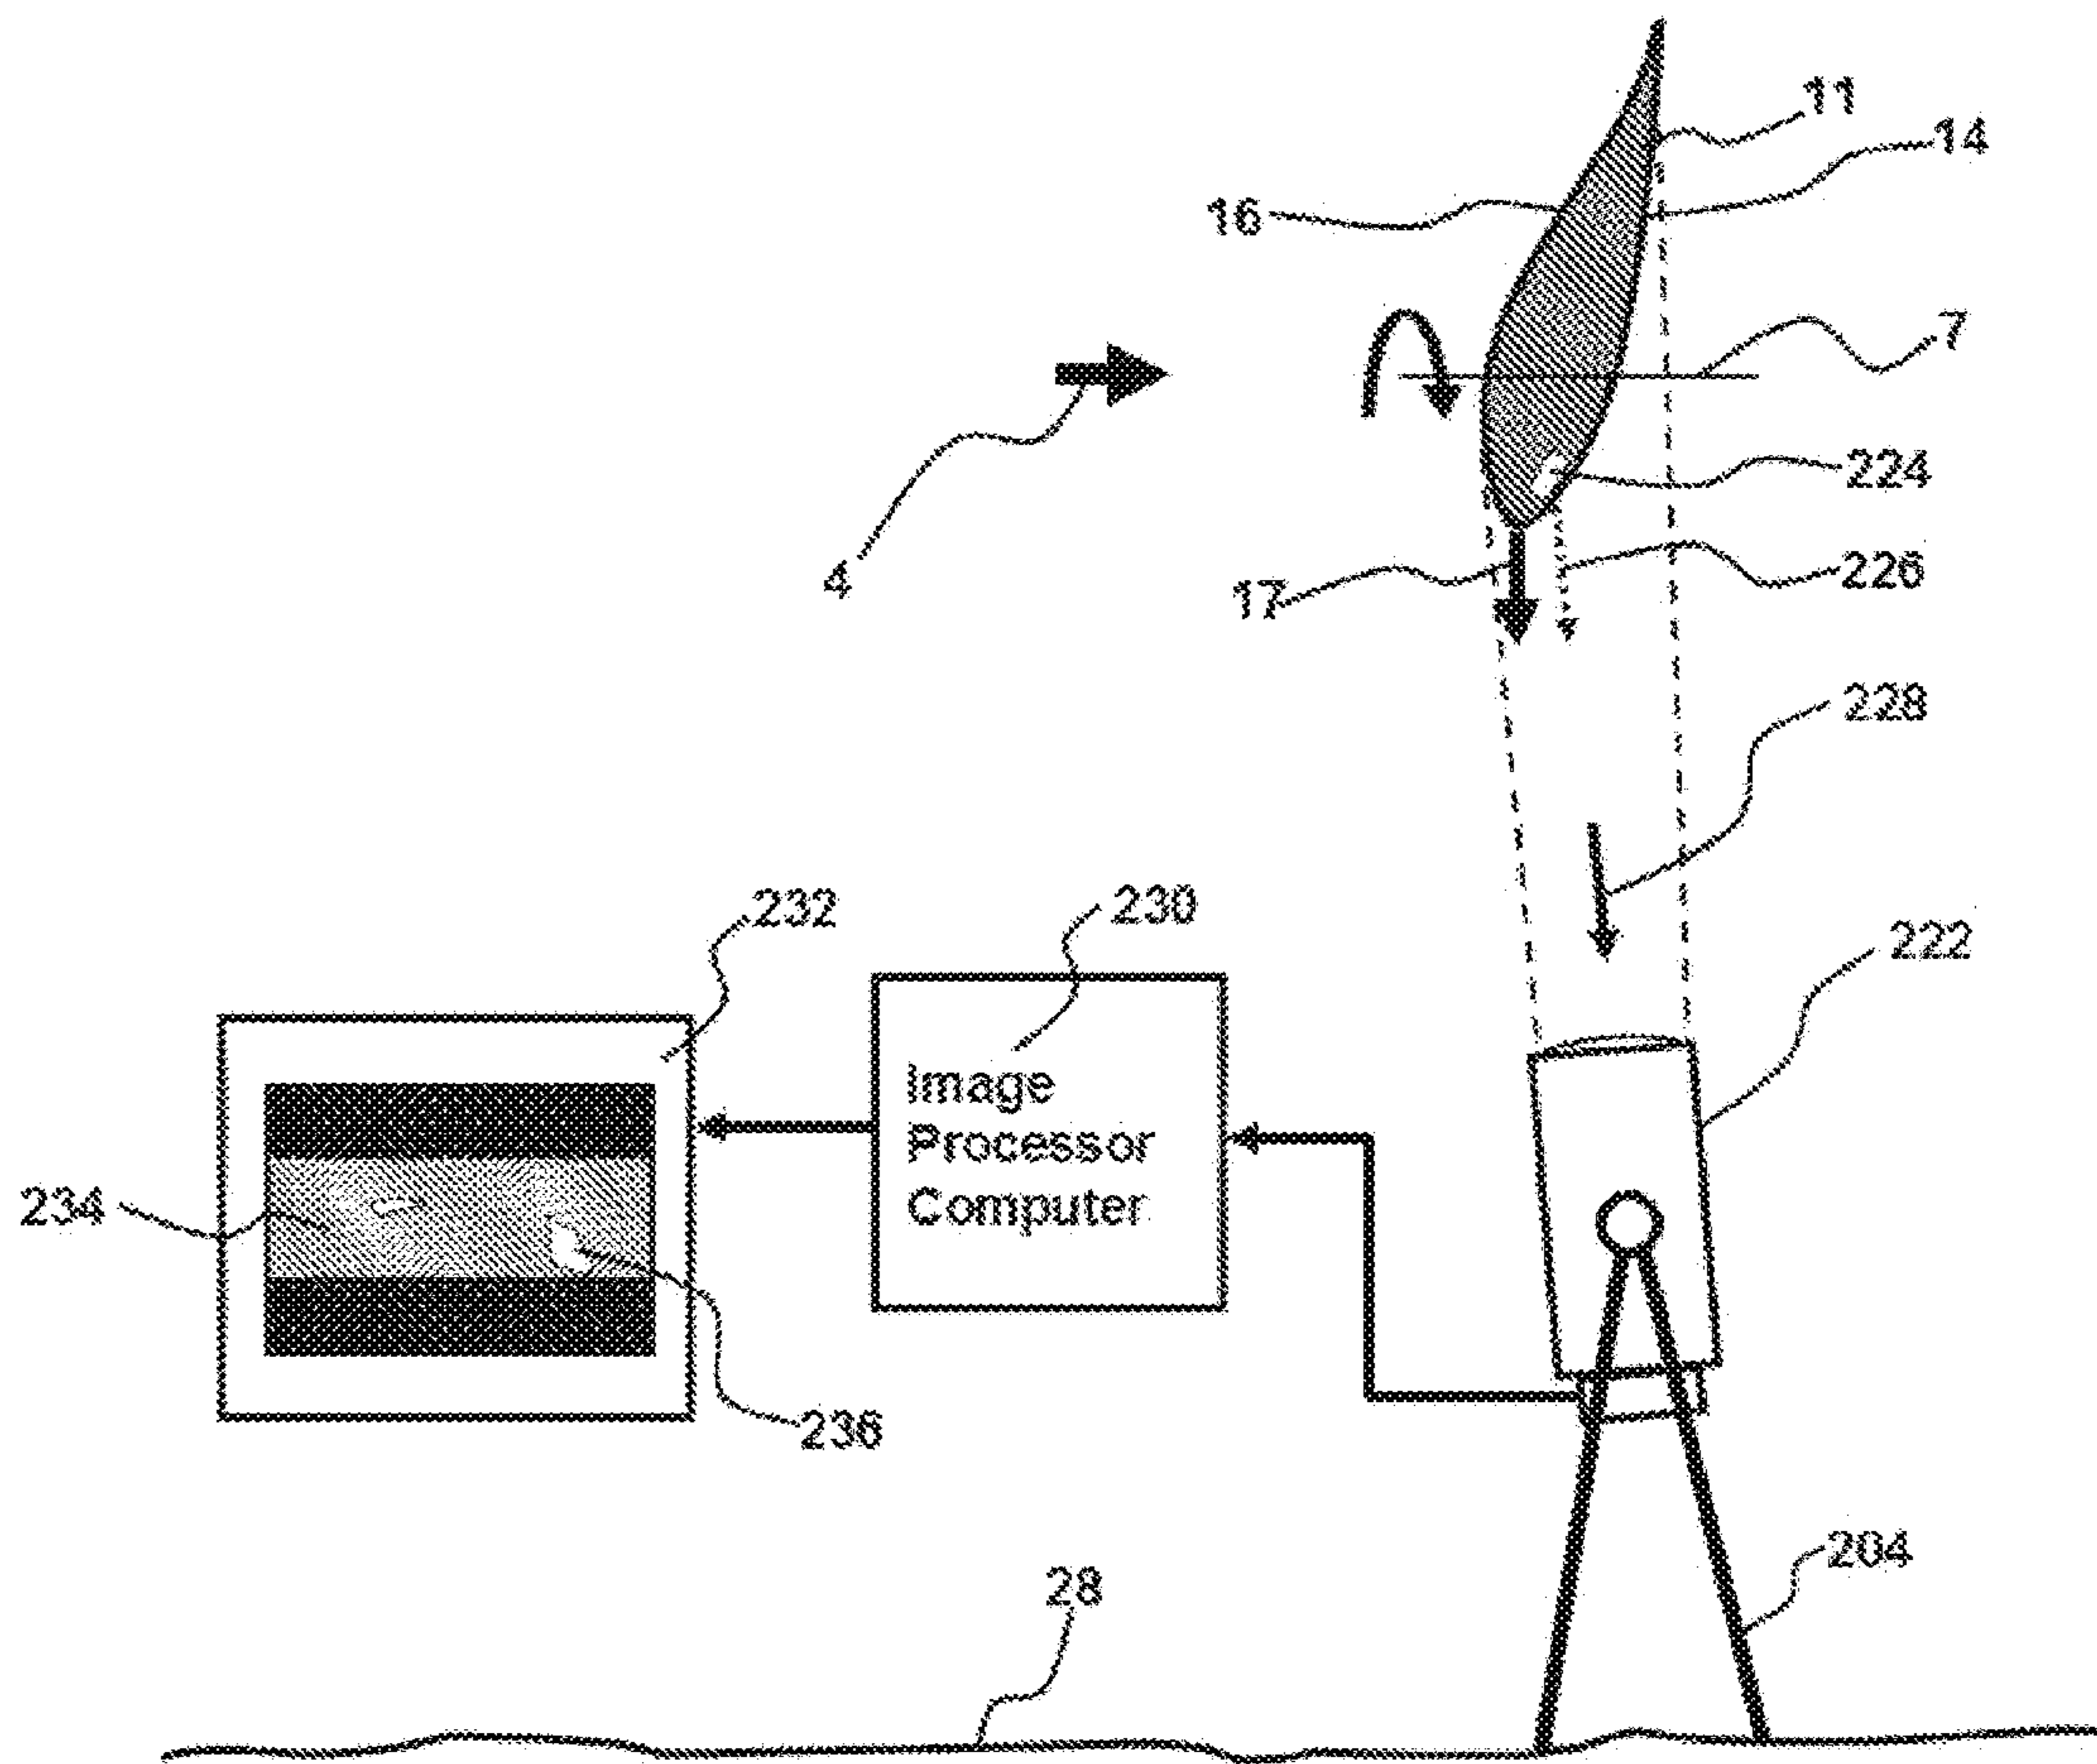
Fig. 5

FIG. 5 shows a basic thermal system including an image processing computer that is suitable for direct viewing and recording blade surfaces in or near a wind turbine site;

FIG. 5 is a schematic diagram showing a thermal camera 222, positioned to receive low level thermal radiation 228 from the blade 11 due to thermoelastic emission from the stresses acting on the blade material due to gravitational forces from the blade rotation motion 17.

Emission 226 from the mechanically stressed defect 224 appears warmer in the image produced by thermal camera 222 due to internal friction and plasticity around defect 224.

The camera 222 is positioned under the blade at position 214 to receive thermal radiation 228 from the leading edge and the forward part of the low pressure side 14. This position reduces the angular changes due to blade rotation in the image during the frame acquisition. The streamed video images from the thermal camera 222 are recorded by Image Processing computer 230, or in a memory device in the thermal camera 222 as video files, and processed presented using peak store or other image processing techniques and presented on monitor 232. Various means of processing the images including video image peak store, frame by frame analysis, histogram normalization, unsharp filters and so on to obtain good image quality and quantitative measurements of size and location comparing features of known size at the range to the target.
