(12) **United States Patent**
Newman

(10) **Patent No.:** **US 9,996,747 B2**
(45) **Date of Patent:** ***Jun. 12, 2018**

(54) **SYSTEM AND METHOD FOR GROUND
BASED INSPECTION OF WIND TURBINE
BLADES**

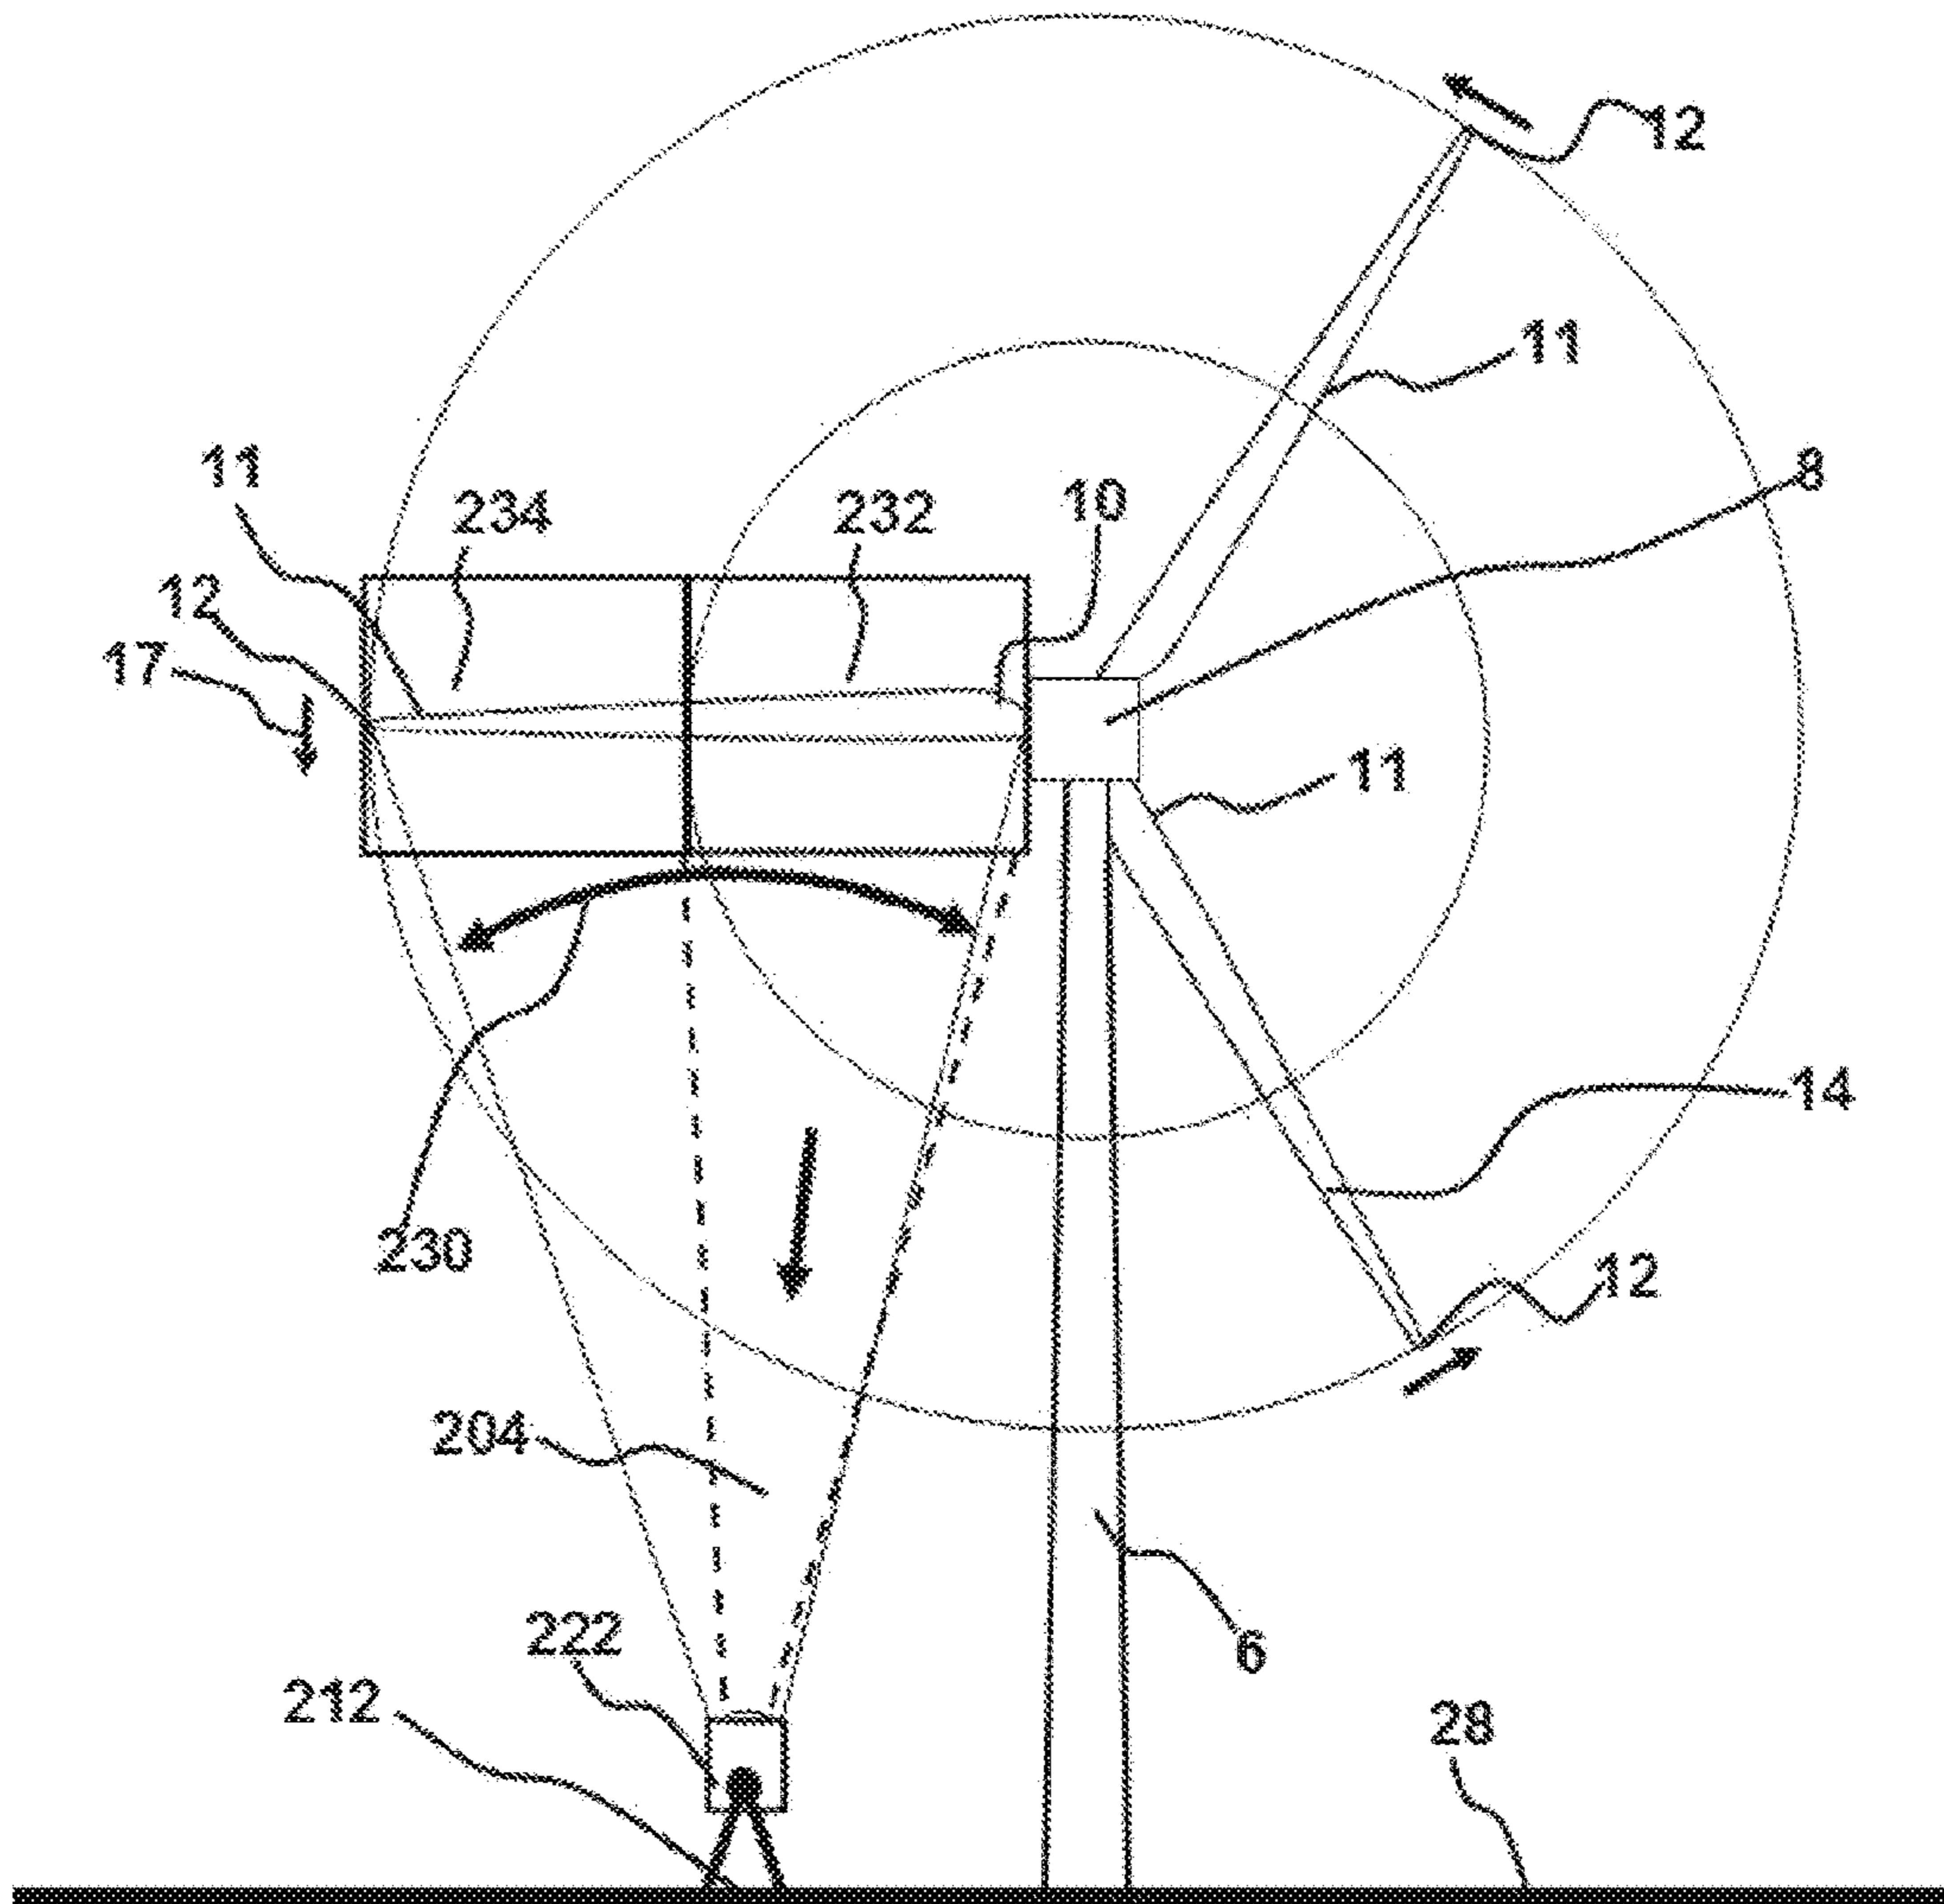
Fig. 6

FIG. 6 is a schematic showing the thermal camera viewing a low pressure, or suction side of a blade in the horizontal position;

FIG. 6 shows how a thermal camera located at position 212 that can be used to test the entire blade from one location by pointing to a blade section inboard adjacent to the generator nacelle 8 and acquiring the thermal image sequences. Moving or rotating the camera in an arc 230 outboard and overlapping the next blade section and so on until the tip is reached. The use of programmed servo or other motor drives to move the camera would allow for a fast automated test.

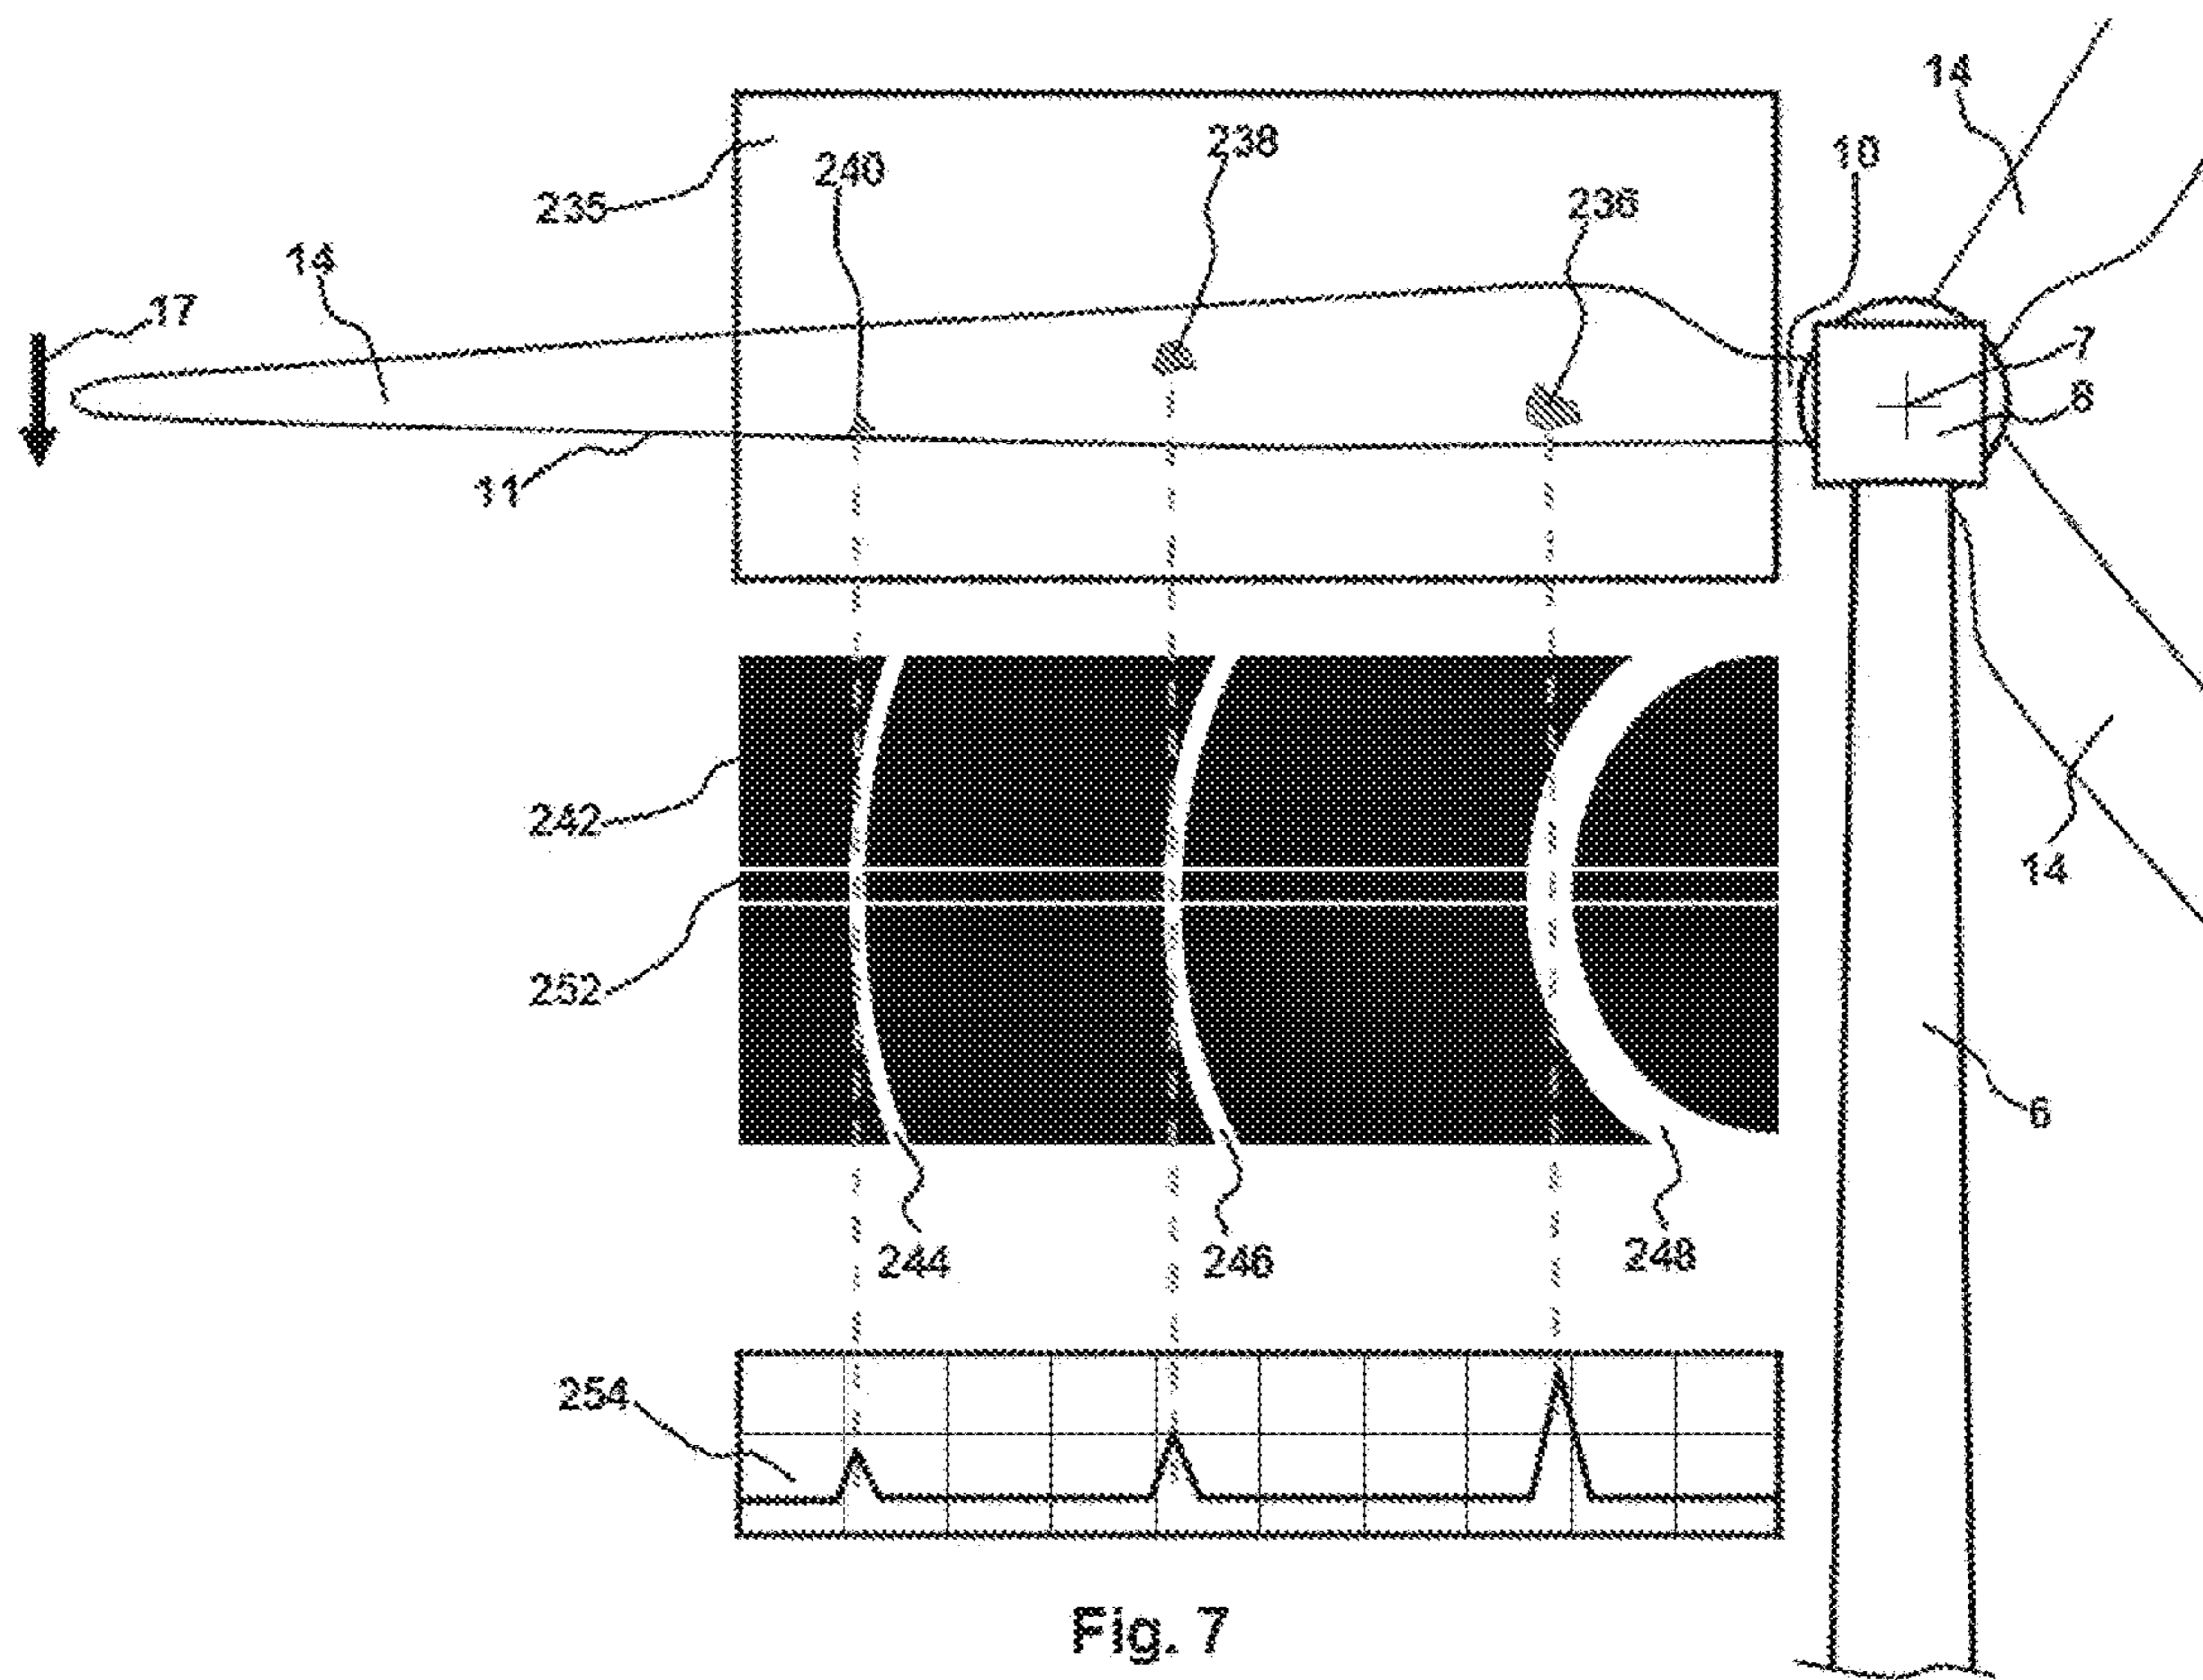
Fig. 7

FIG. 7 shows how an electronic image peak store unit captures the trajectory of thermal emitting defects as the blade passes through the thermal camera field of view;

FIG. 7 shows a representation of the video peak store function. The thermal emitting defects **236**, **238** and **240** on blade **11** as shown, rotate counter-clockwise in this view of the low pressure side **14** of blade **11**, as seen from down wind of tower **6**. The axis of rotation **7** is shown in the approximate middle of the nacelle **8**. The larger thermal emitting defect, **236**, happens to be the closest defect to the axis **7** and generates the strongest signal **248**. In a peak stored image, each pixel is locked to the highest gray level value while image data is being acquired by the post-test analysis software or in the field during the test. The result is sources of thermal emissions can be tracked through the field of view as show in defect traces **248**, **246** and **244** and as shown in FIG. 13. A thermal emitting defect has a trajectory following the blade in rotation as viewed greatly off-axis. A line scan **252**, through the peak stored image **242**, maps the gray level value for each pixel in a line from one side of the image to the other and allows a graph **254** to be plotted showing the gray level signal intensity vs. position on the blade. The distance scale is calibrated in software from the size of know features on the nacelle **8** or tower **6**. These values can be corrected mathematically for the difference in velocity for different span wise locations on the blade using a look up table (LUT) or other techniques for correcting image data based on geometric parameters well know in scientific programming and photogrametry.

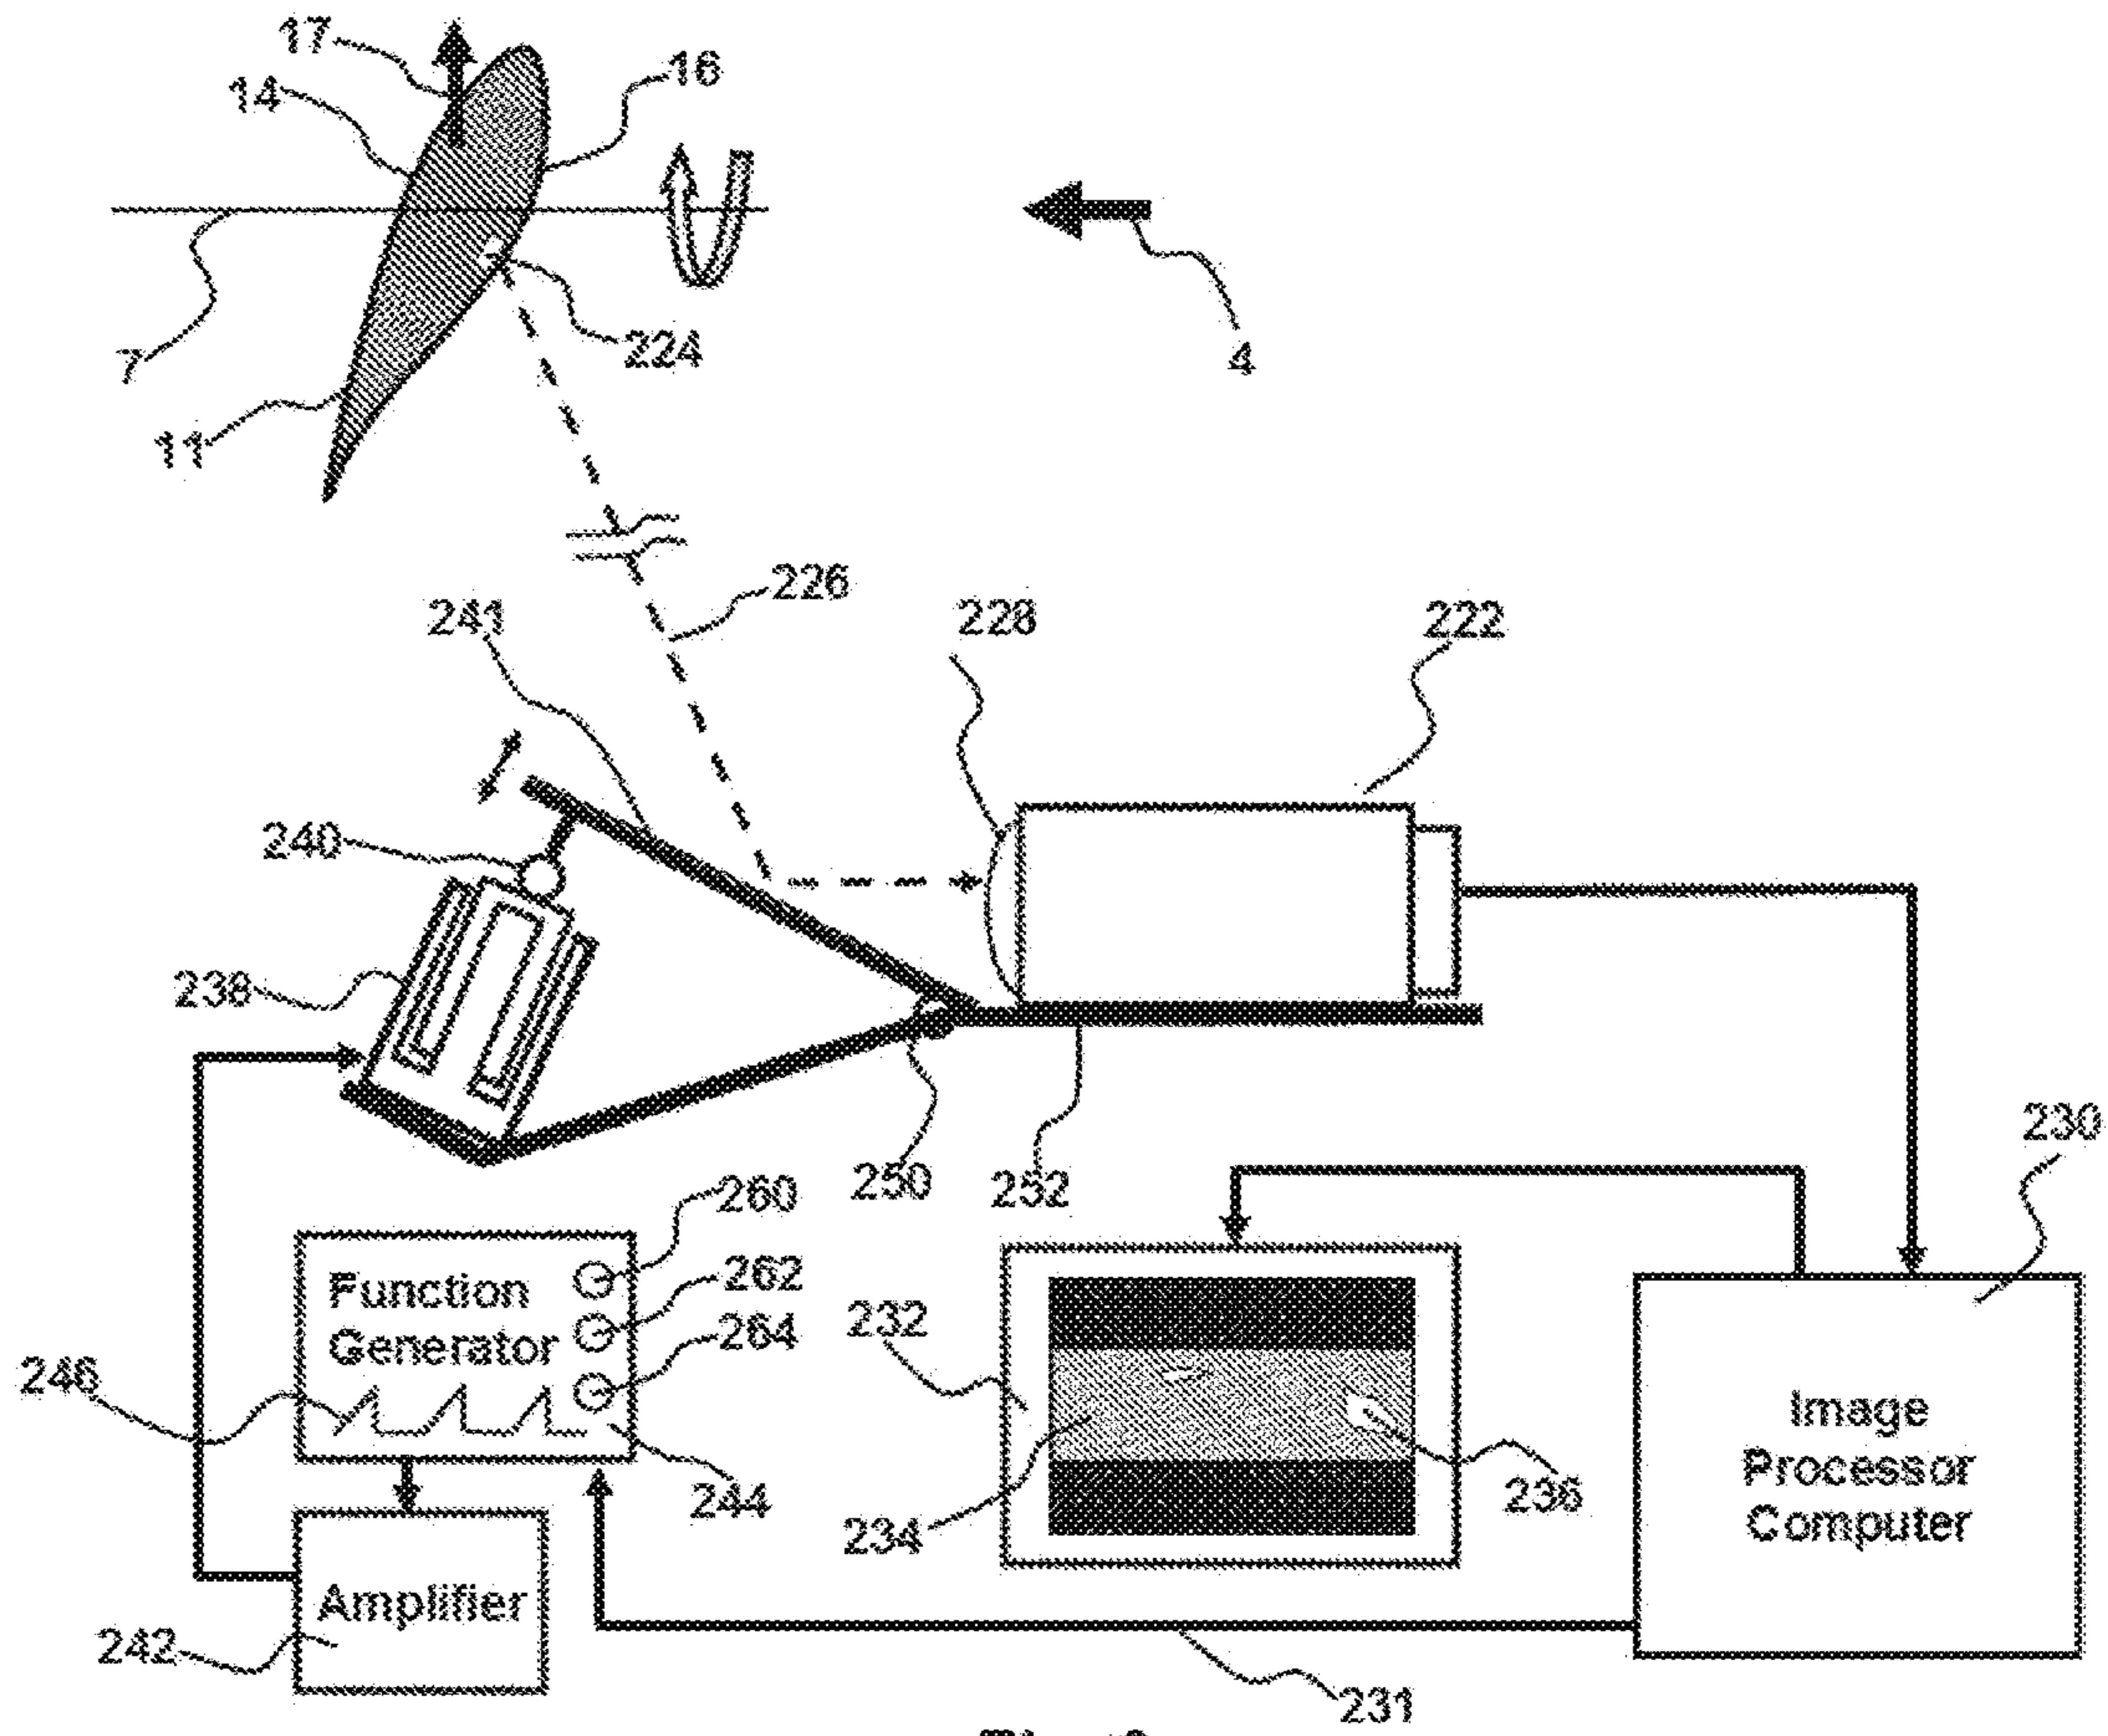
Fig. 8

FIG. 8 is a schematic diagram of a manually controlled moving mirror assembly mounted in front of the thermal camera to stabilize, or derotate, thermal images of a rotating turbine blade and suitable for use when the blade is in approximately a horizontal orientation;

FIG. 8 shows one embodiment of the thermal image de-rotator consisting of a mirror **241**, attached to a hinge **250** at one end and the opposite end is connected to a linear actuator or voice coil linear actuator **238** through a ball joint or universal joint **240**, whose cyclic motion in the direction of the blade motion can be adjusted to track the approximate motion of each blade **11** as it rotates through the field of view. The derotation will essentially stop the rotation motion for several frames. The blade appears to hang in space giving the thermal camera time to generate higher resolution images of the moving blade. The adjustments consist of amplitude of the ramp voltage **260**, which will compensate for the speed of blade rotation, the duration of the ramp function **262**, and the time **264**, between each start of the ramp function. The output of function generator **244** is amplified in amplifier **242** which then drives the linear motor actuator **238**. The motion of mirror **241** can de-rotate short sequences of images produced by thermal camera **222**. By selecting the repetition rate **262**, the user can select to image all the blades by starting the tracking motion every $\tau/3$ seconds, where τ =the period of rotation of the turbine in seconds, or by selecting a repetition rate of τ , the images of the same blade **14**, will be presented and de-rotated. A spring can be used to provide a restoring force to bring the mirror back to its start position, ready for the next blade pass. Only one or more video frames need to be tracked to substantially improve blurring of the thermal camera image due to blade rotation. The frequency of motion of the de-rotating mirror **241**, can be calculated in the following example. Assume a turbine operating @ 15 rpm, a thermal camera **222** with a 30 frames per second frame rate, and it is desired to de-rotate 4 video frames. The period, τ , of the turbine is the time required to make 1 revolution, in this case 60 seconds/15 rpm=4 seconds. In this time, the thermal camera **222** (operating at 30 frames/second) captures (4 seconds \times 30 frames/second)=120 frames. The 4 frames we wish to de-rotate are captured over a time of (4 frames/30 frames/sec.)=0.133 seconds. To de-rotate these four frames then, we start moving the mirror to track the blade starting at 0 seconds, when the blade **14** enters the field of view of the thermal camera. The mirror **241** angle is changed (increased or

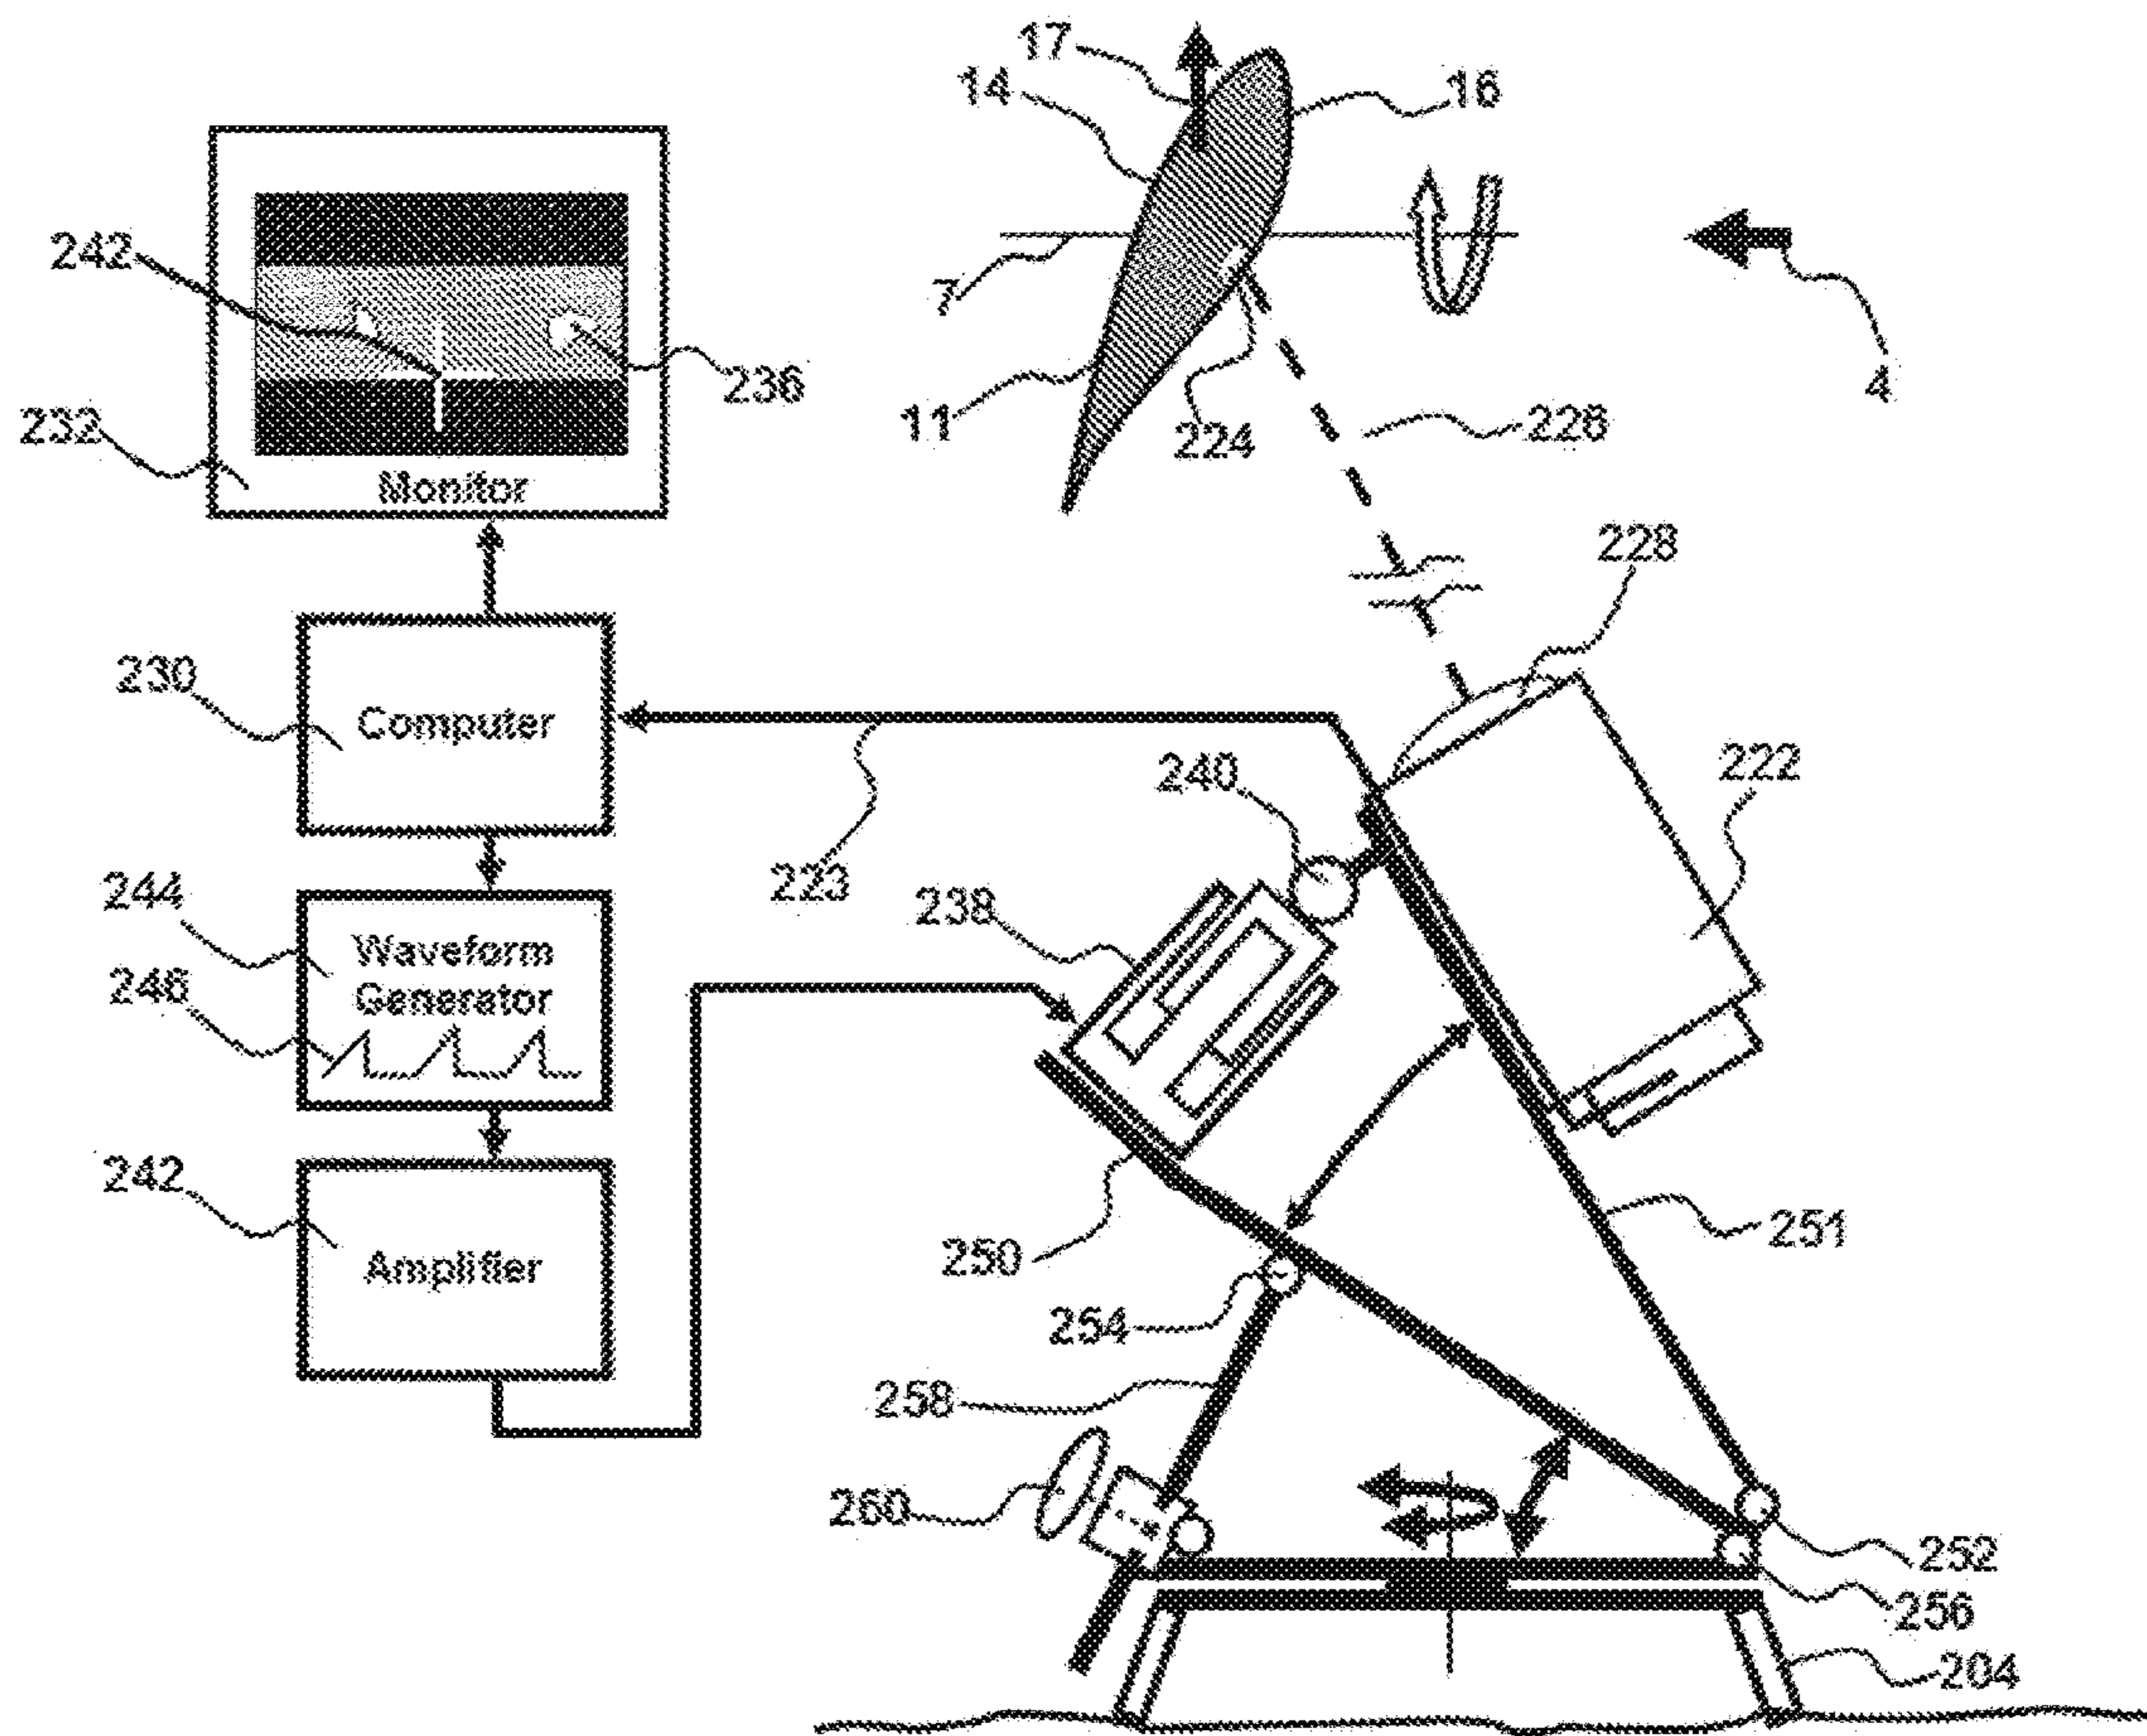
Fig. 9

FIG. 9 is a schematic of computer controlled moving camera image stabilizer for derotating a sequence of thermal images of a rotating turbine blade using the presence of the blade in the video image to trigger the start of blade tracking;

FIG. 9 shows a second embodiment where the thermal camera **222** is moved in rotation to follow the blade **11** motion around axis **7**. The thermal camera **222** is mounted on a frame or plate **251** and connected to hinge **252** which is also attached to frame member **250** which supports actuator **238**. The opposite end of plate **251** is connected to the electric actuator through a flexible joint, such as a hinge or universal joint. The movement of the actuator causes the thermal camera **222** to move up and down which when aligned with a portion of the blade here the motion is substantially the same, will tend to stabilize the blade in the field of view of the thermal camera **222**. Additional actuators can operate simultaneously to move the thermal camera in multiple directions however with additional complexity. In practice, one actuator is sufficient if a clear view of the blade **11** when it reaches the horizontal position during rotation can be attained in the field. Another option is to rotate the entire actuator **238**, support plates **250** and **251** as well as the thermal camera **222** to align the motion of the actuator with the motion of the blade during data acquisition. Reducing the driven mass reduced vibration and power requirements for the electronics and electric actuator, which may be battery operated or power from the vehicle used by the operator. The motion of the camera should be aligned approximately with the direction as the motion of the turbine blade **11** in the camera field of view during its rotation on axis **7**.

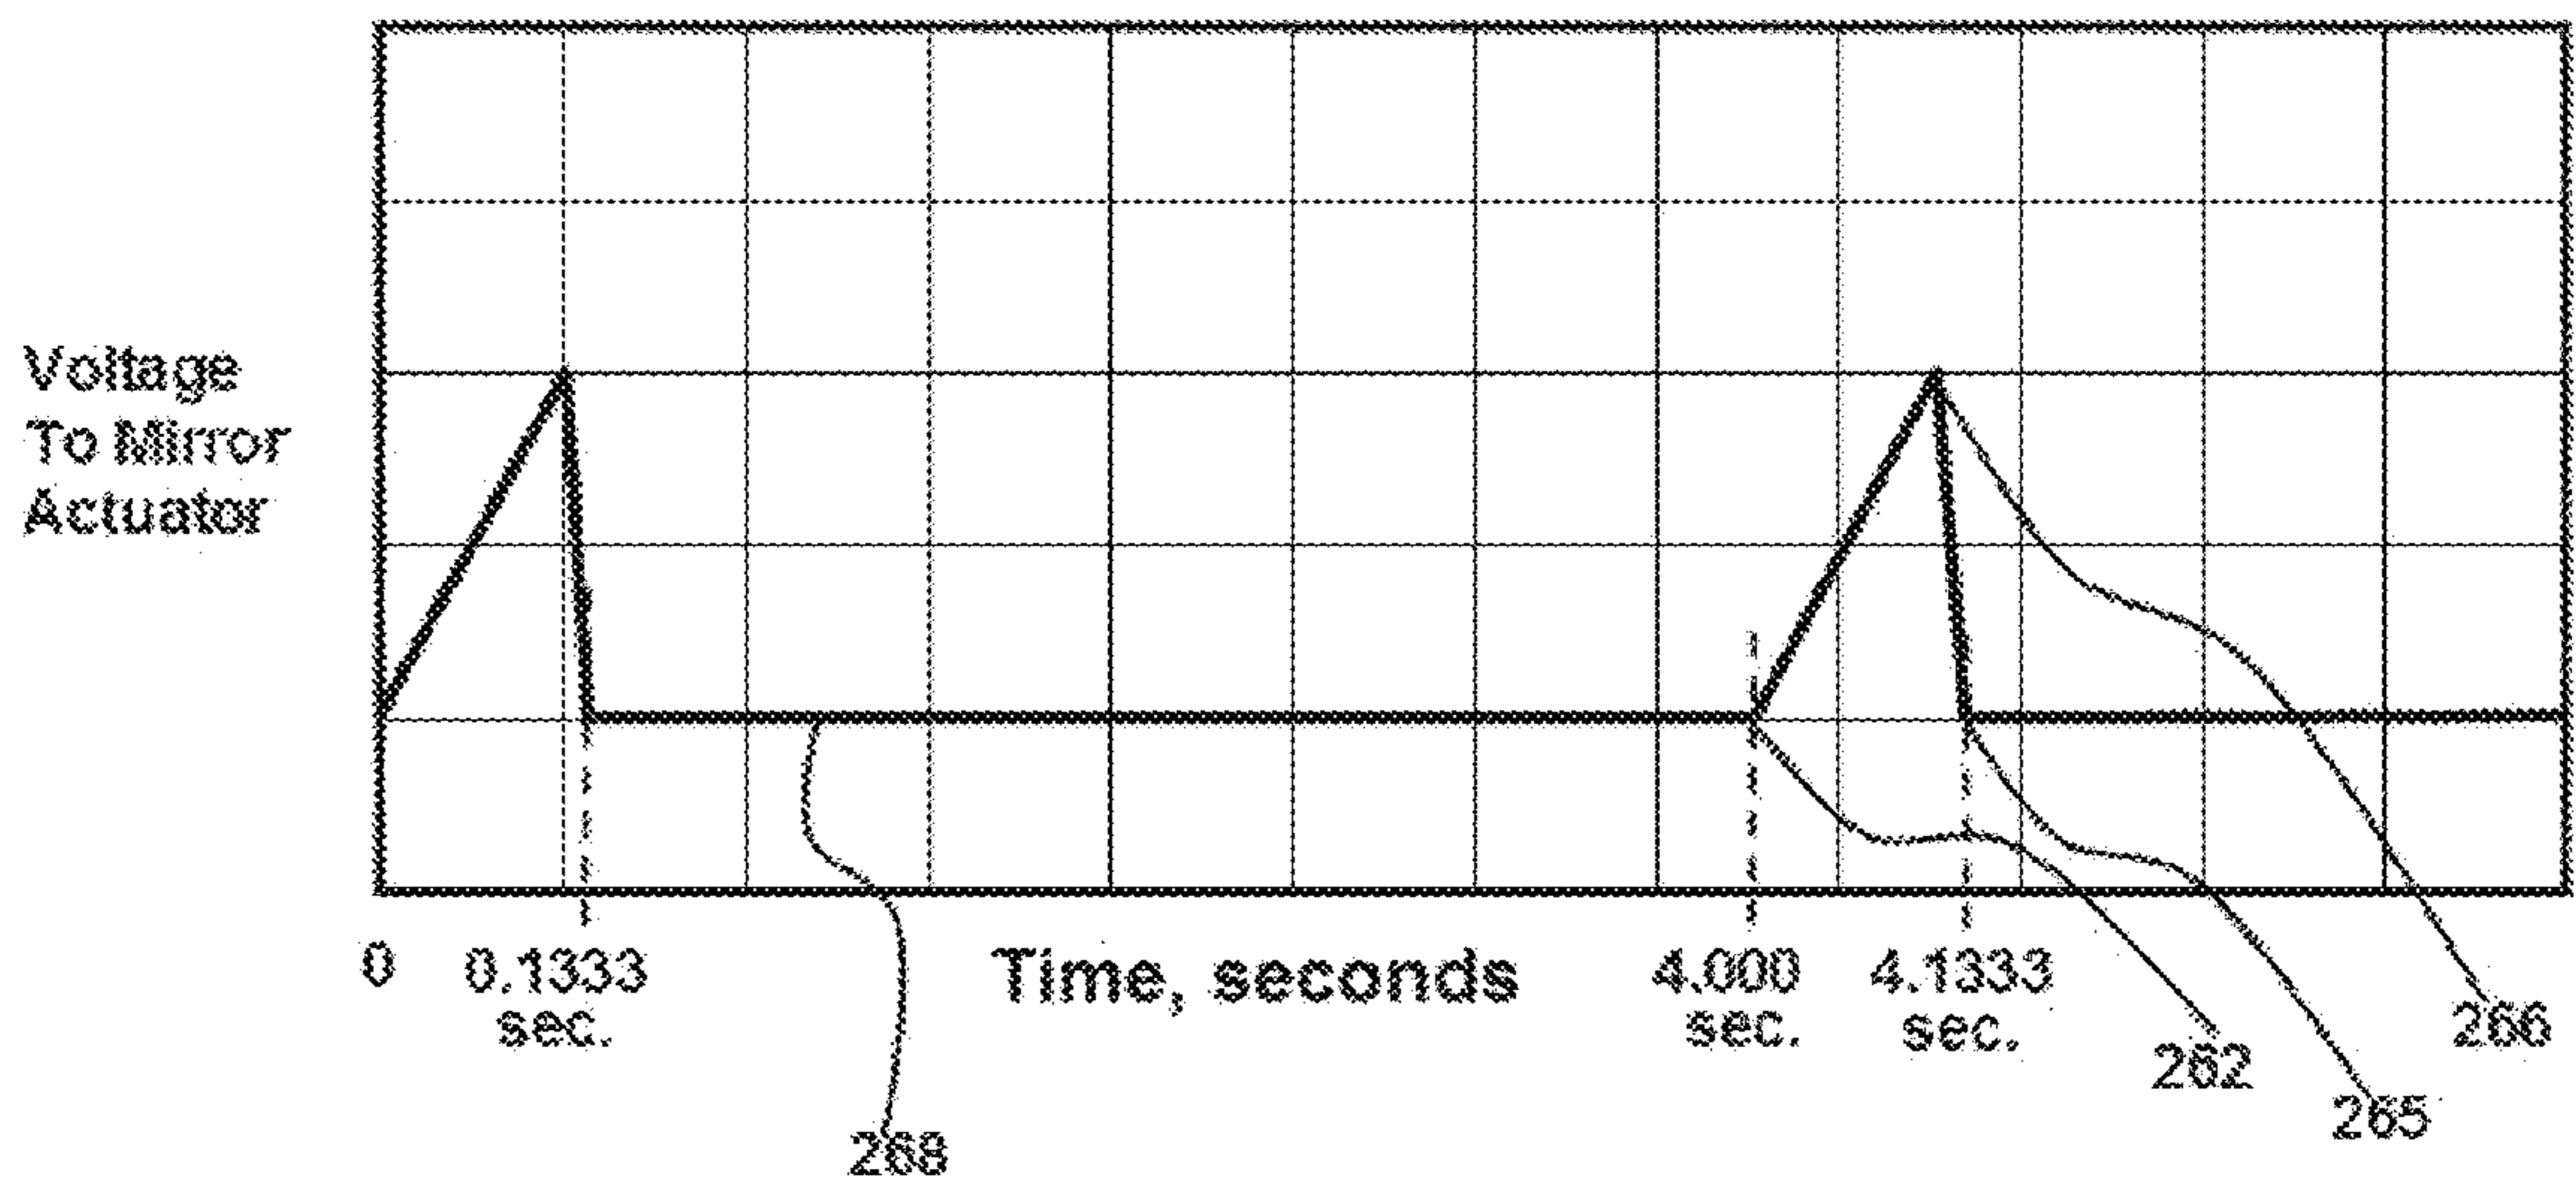
Fig. 10

FIG. 10 shows the timing of the ramp voltage waveform used to drive the linear motor to drive the hinged plate supporting the thermal camera to track one blade only turning with a period of four seconds;
