(12) **United States Patent**
Newman

(10) **Patent No.:** **US 9,996,747 B2**
(45) **Date of Patent:** ***Jun. 12, 2018**

(54) **SYSTEM AND METHOD FOR GROUND
BASED INSPECTION OF WIND TURBINE
BLADES**

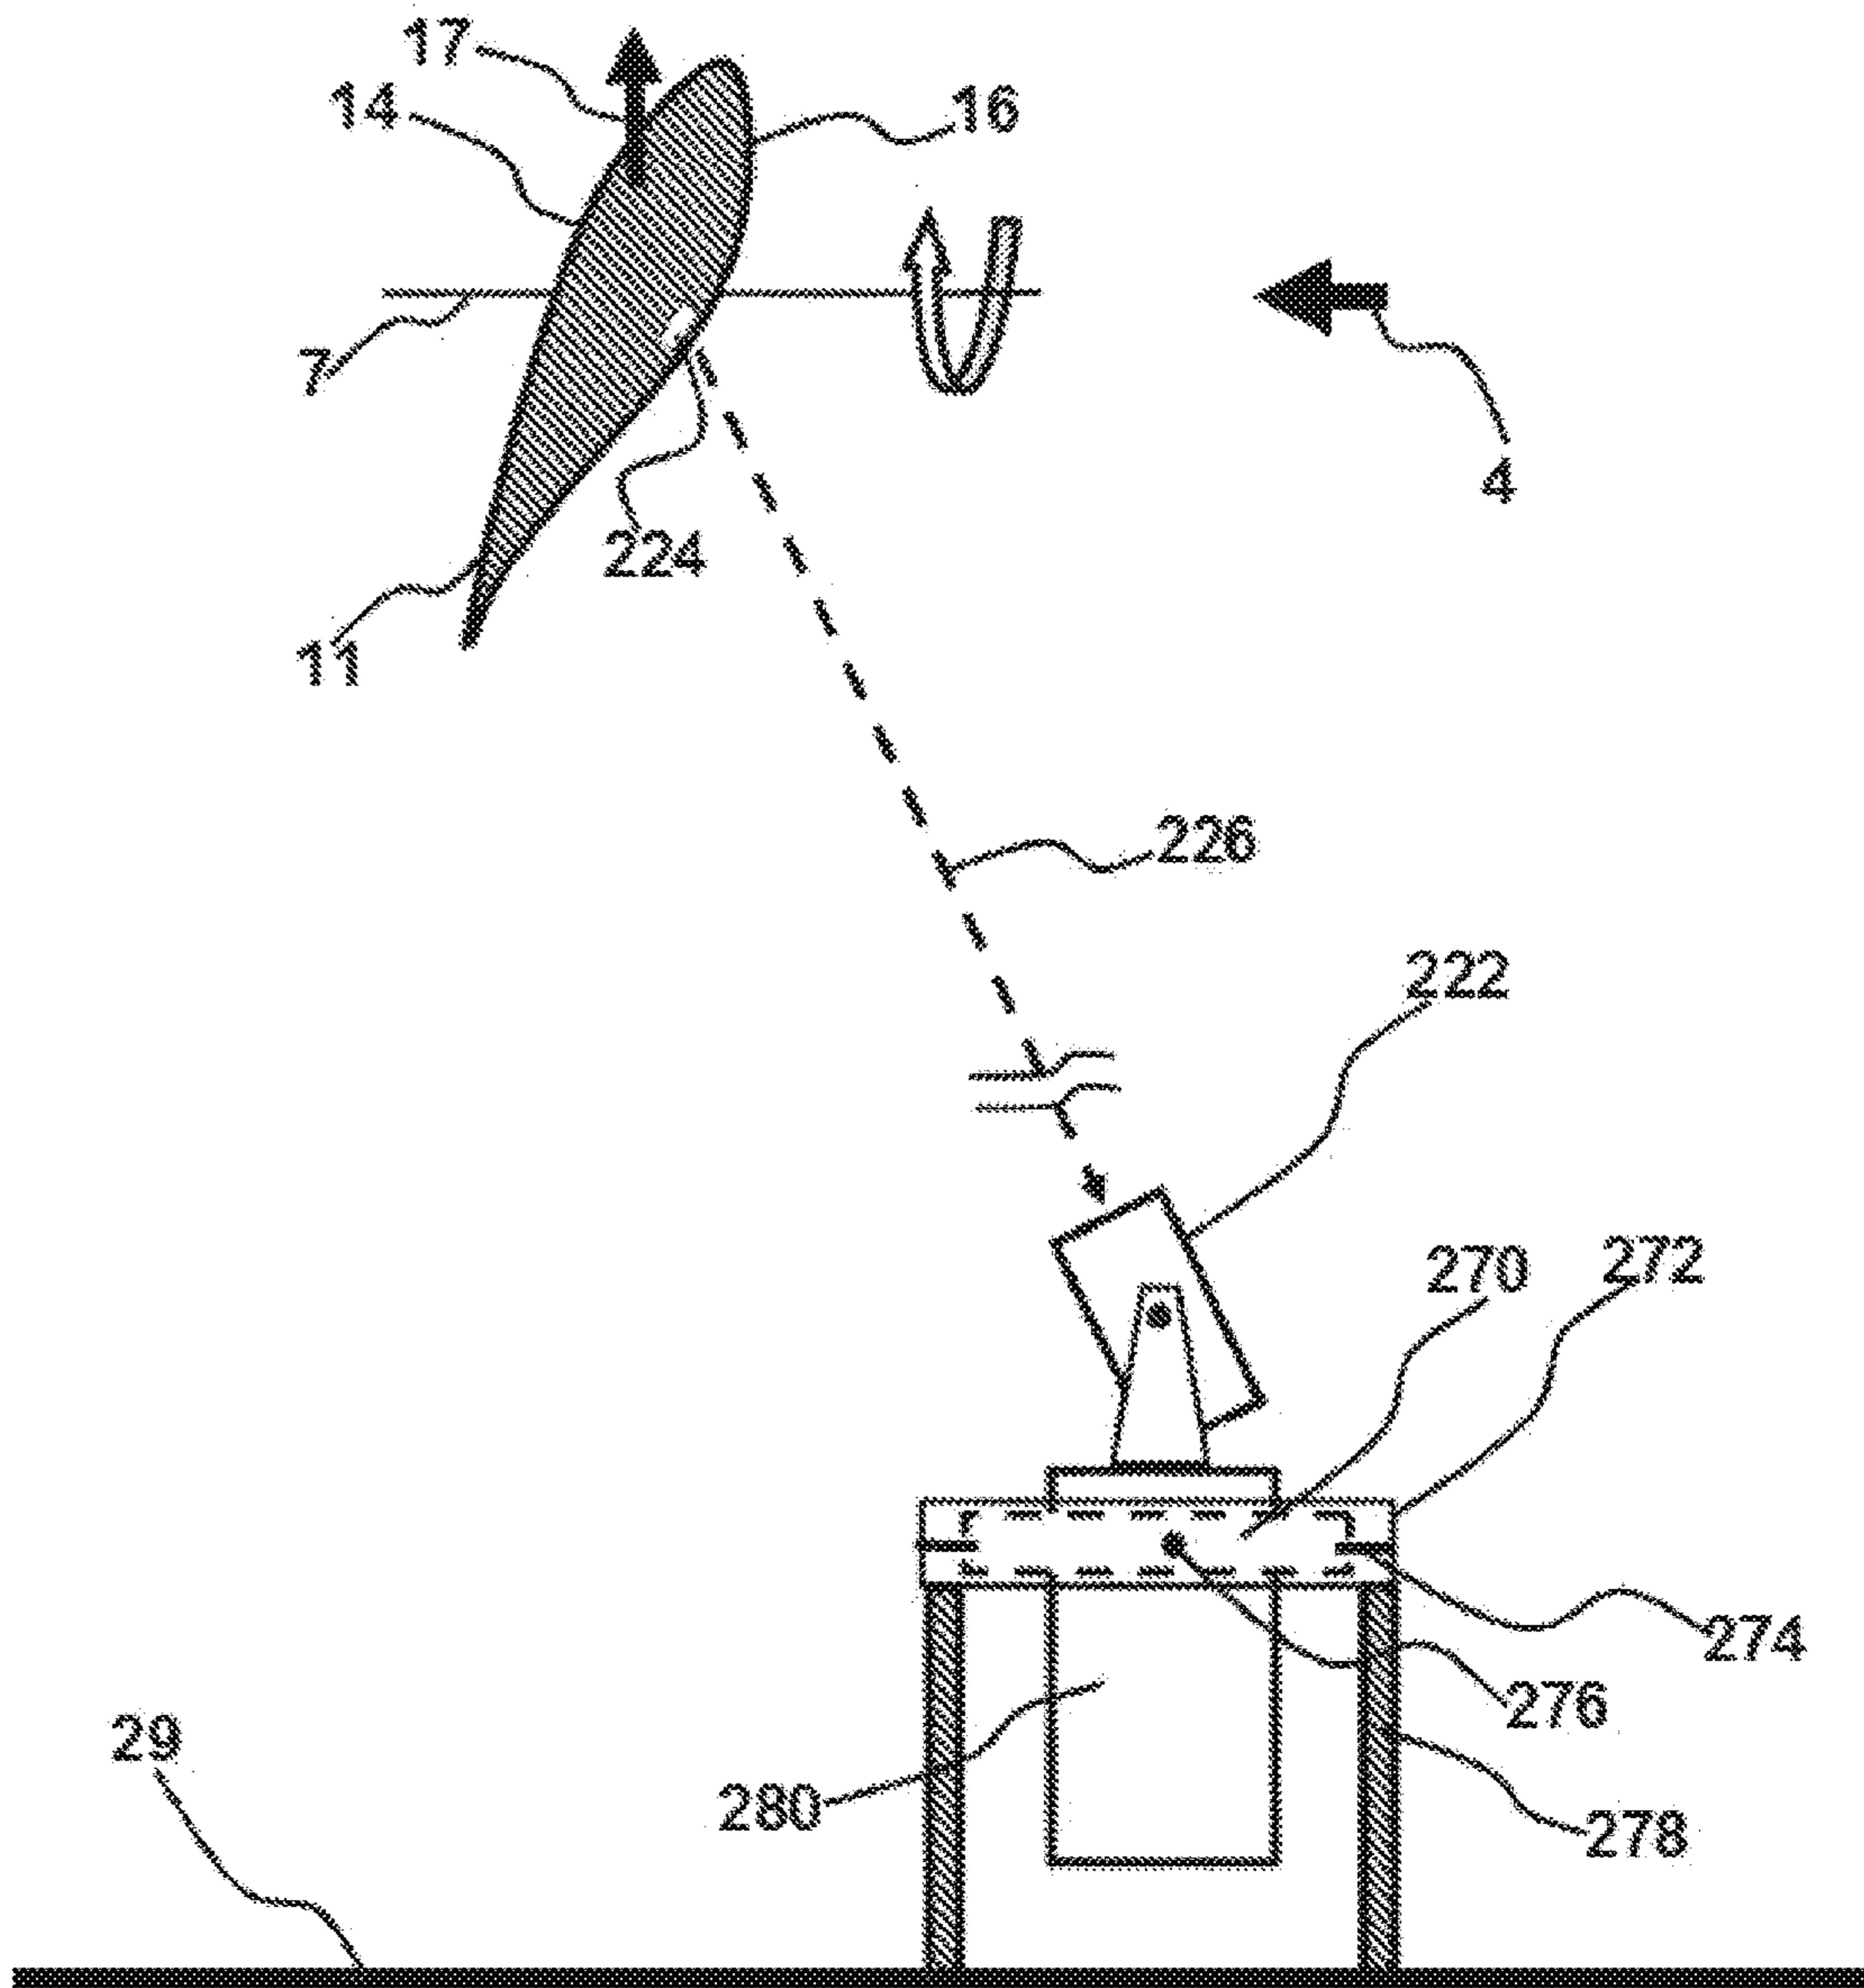
Fig. 11

FIG. 11 is a schematic diagram of a gimbal mounted thermal camera for testing off shore wind turbine blades from a boat or ship;

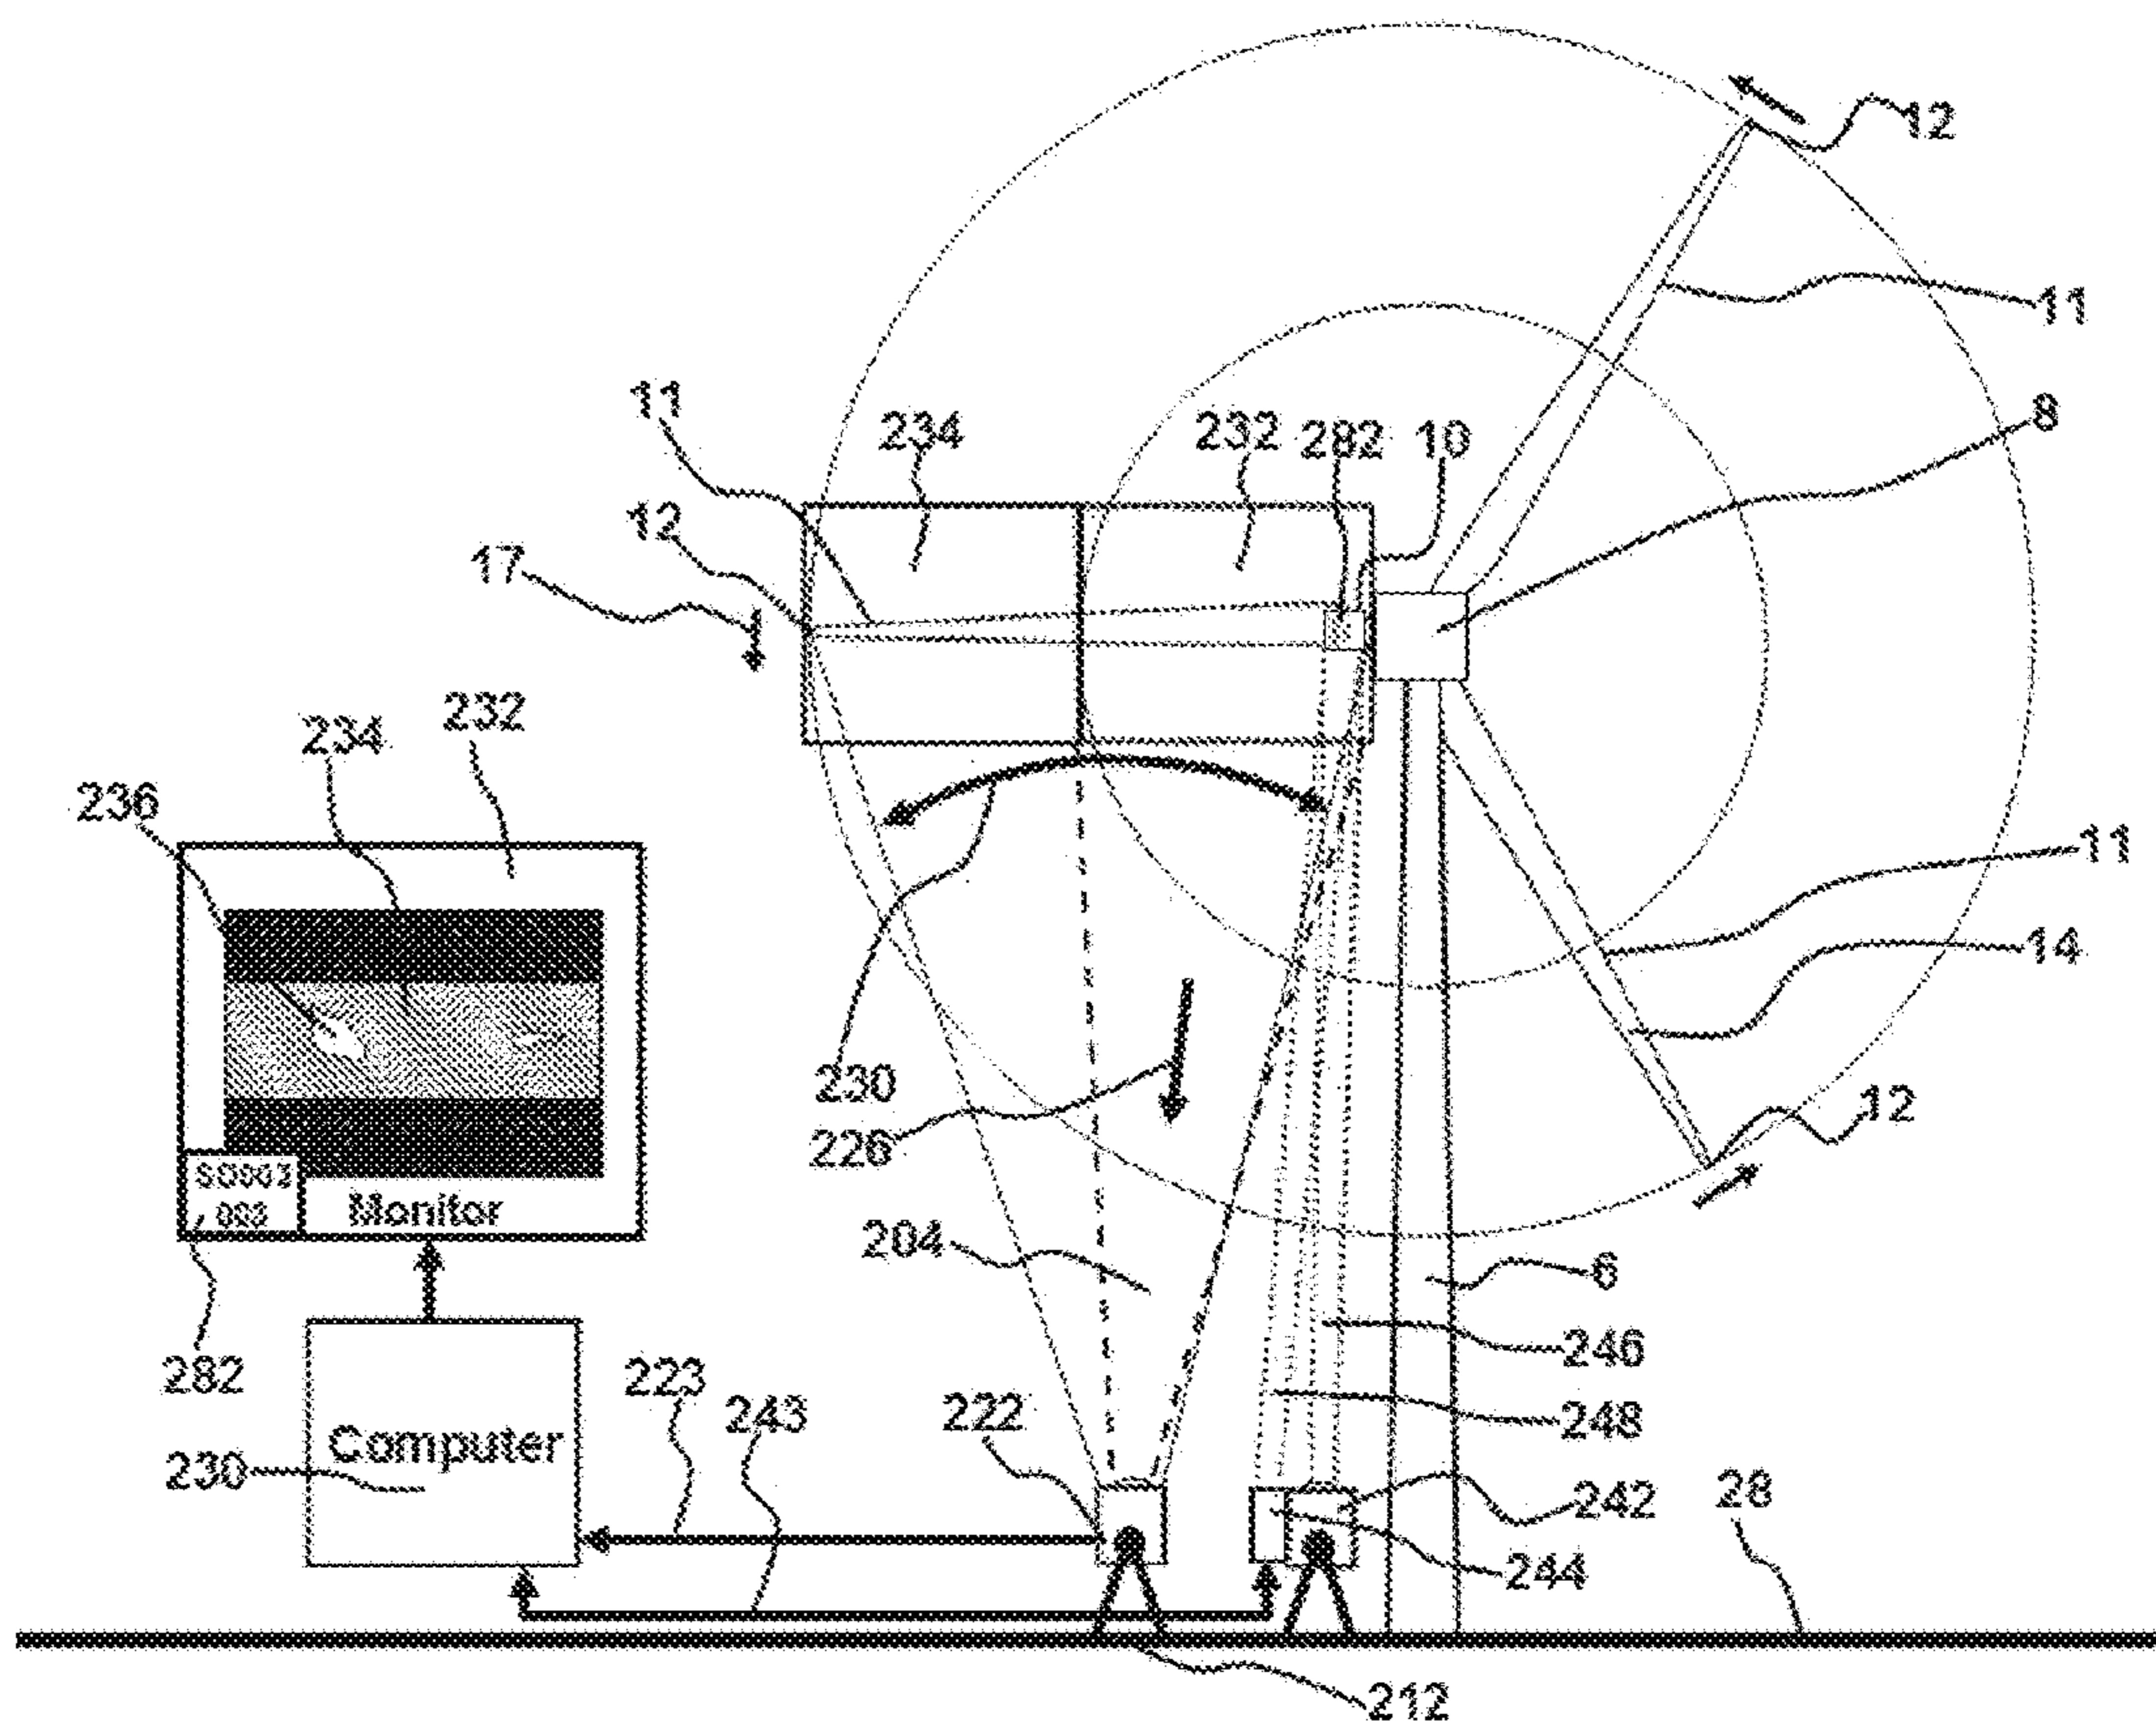
Fig. 12

FIG. 12 is a schematic diagram of a thermal camera testing a blade with a visible light camera and light source to image the serial number of the blade and showing the image of the serial number presented with the test images of the blade;

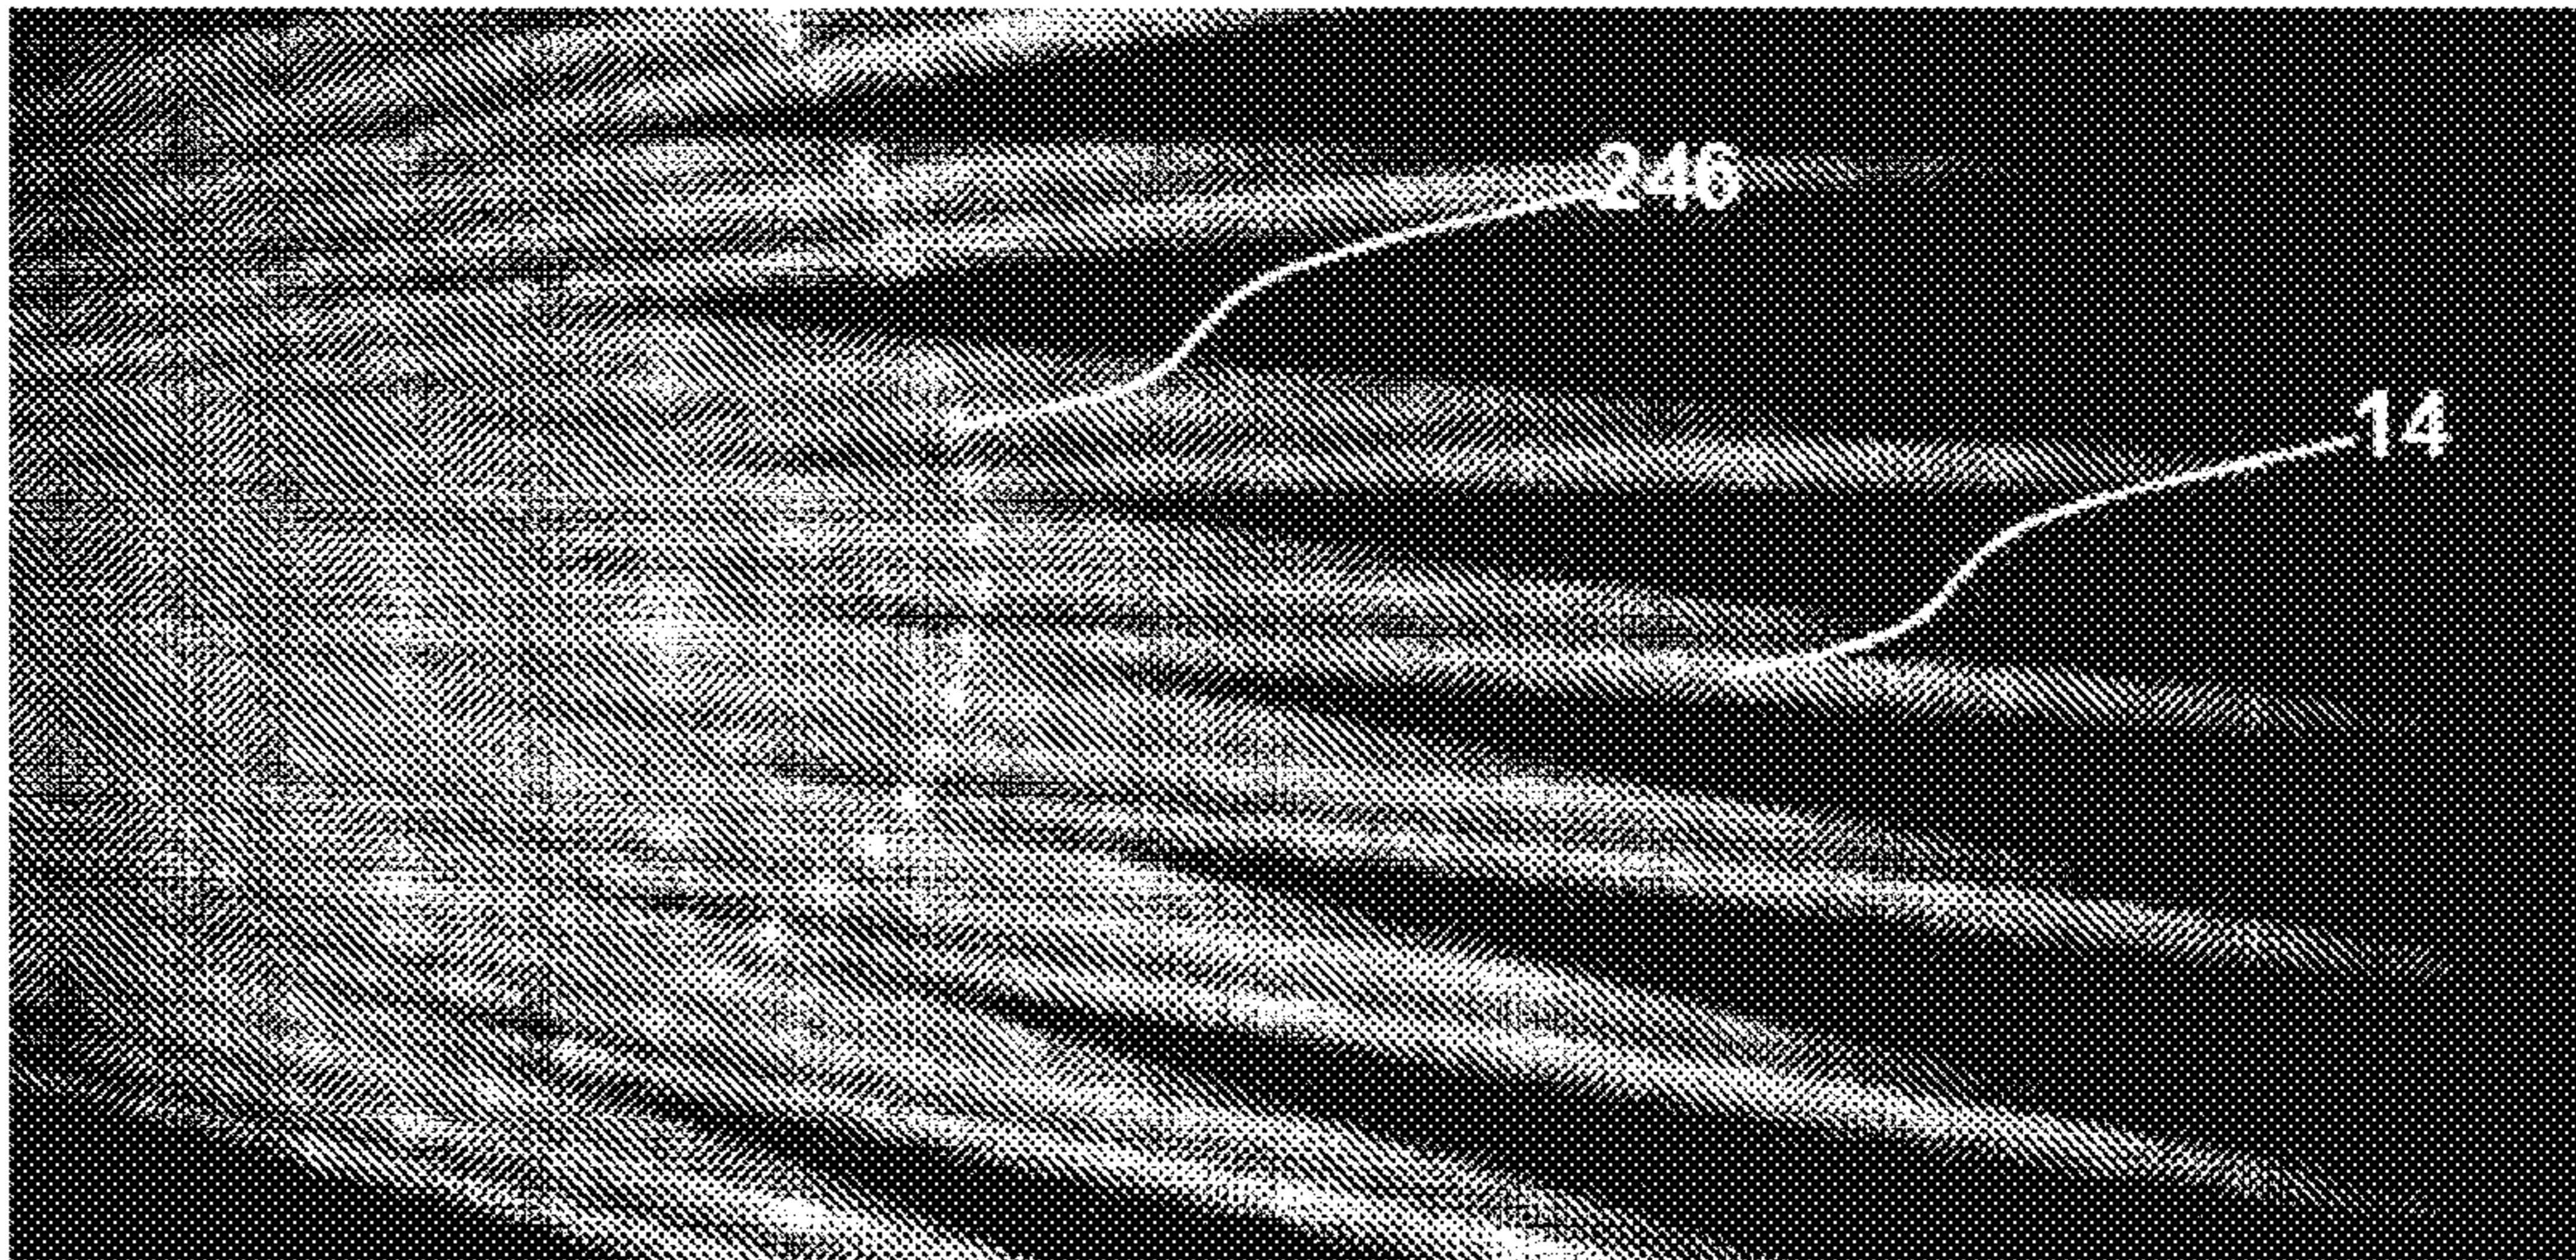
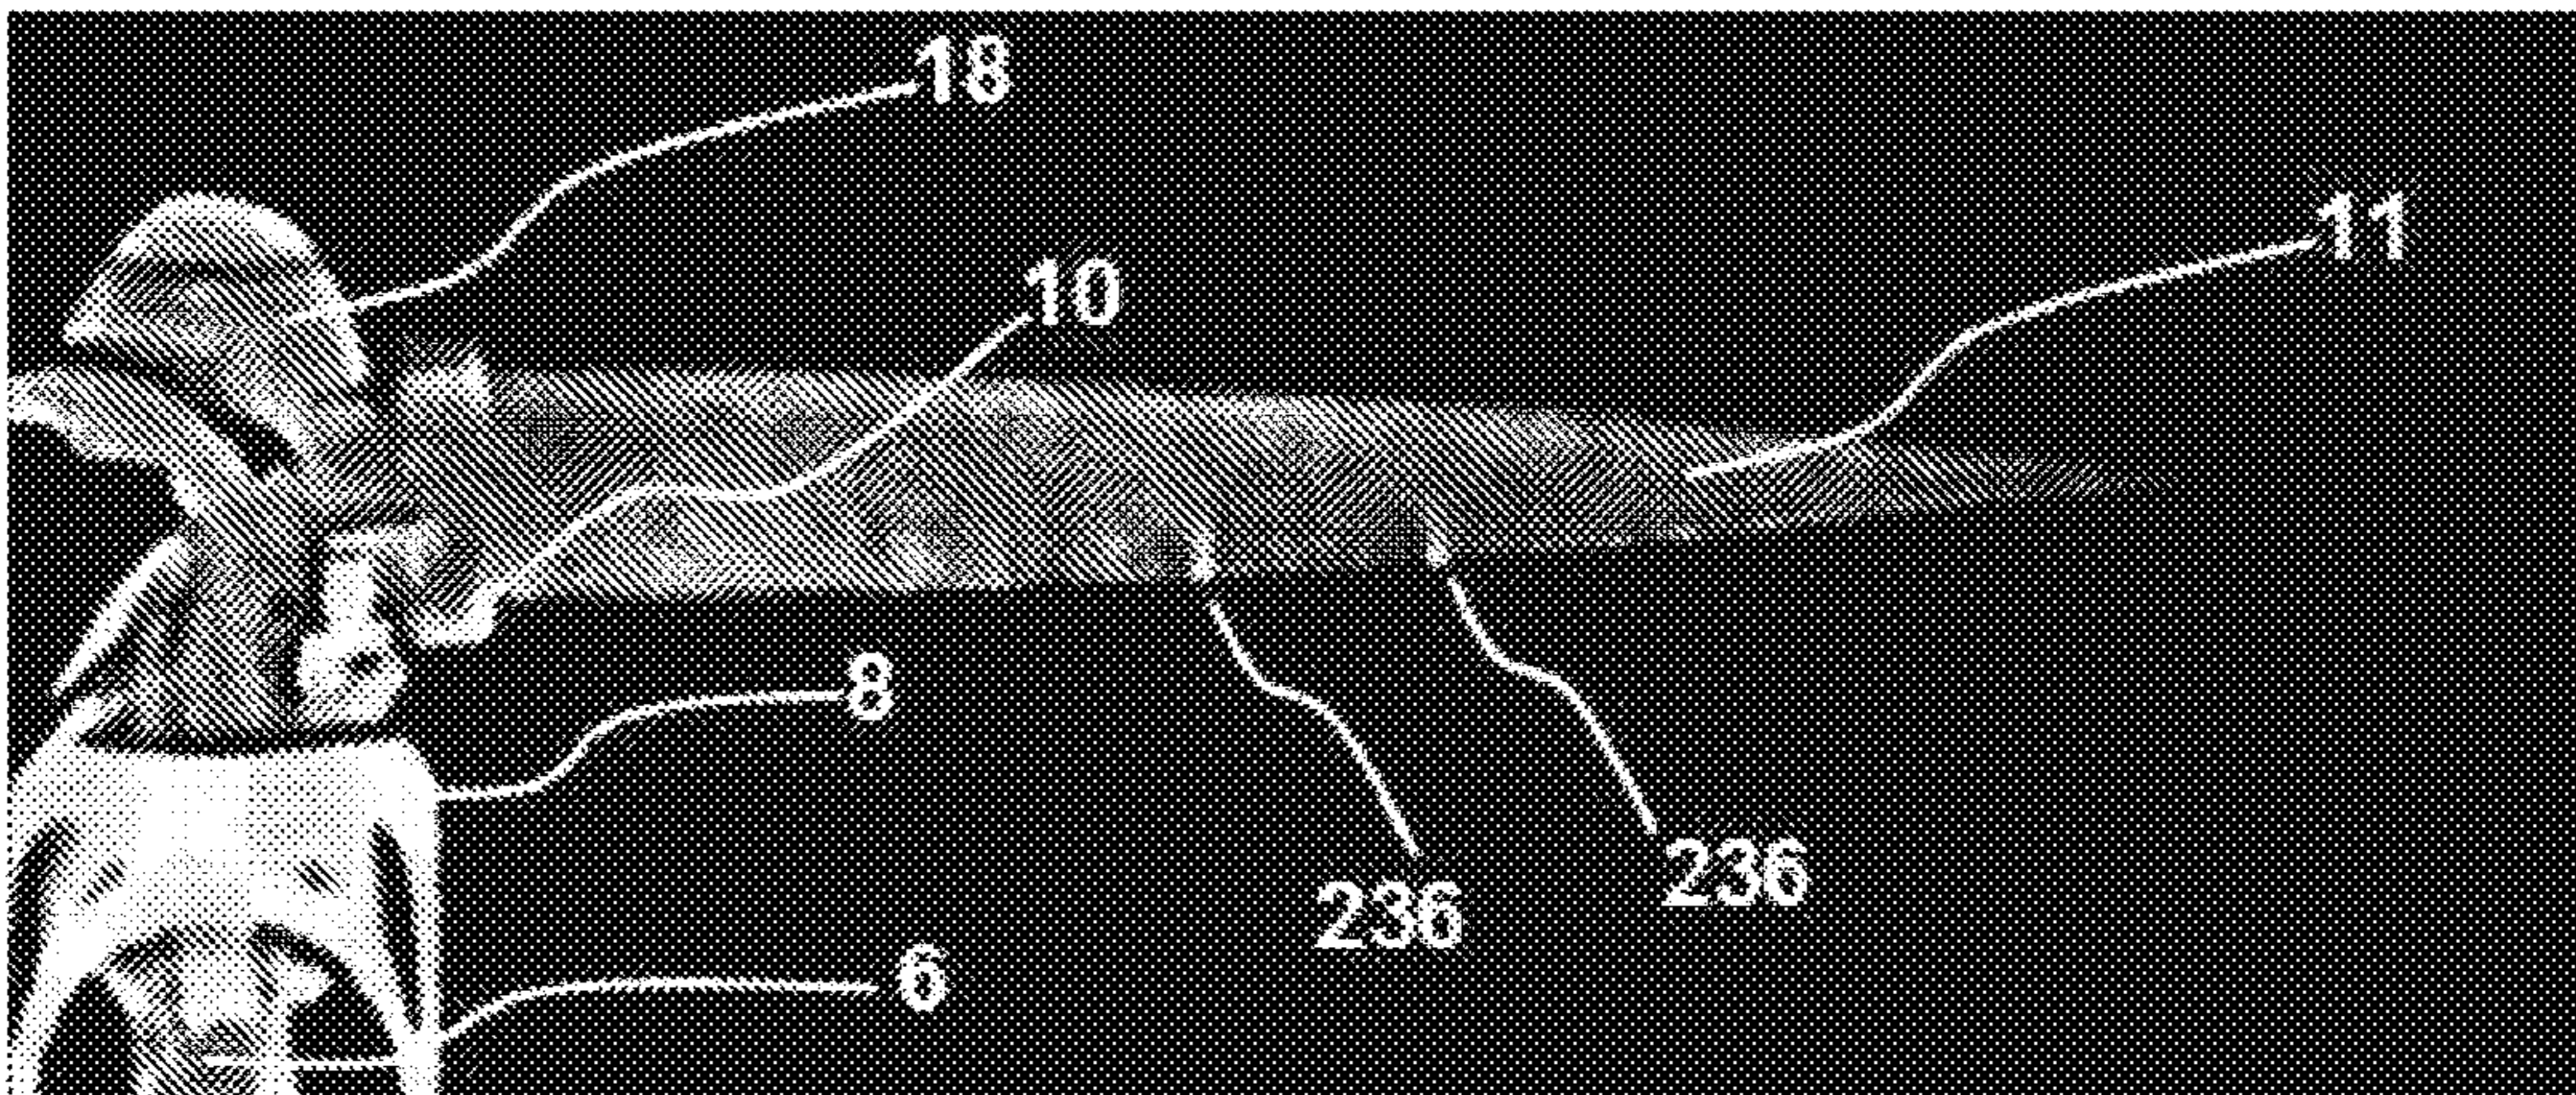
Fig. 13

FIG. 13 includes two images of a wind turbine blade exhibiting defect indications following inspection according to embodiments of the present invention;

FIG. **13** shows two test results on operating 1.5 MW utility scale wind power generators made with embodiments of this invention. The top image shows seven video frames of one blade from the high pressure side as it rotates through the thermal camera field of view. The images were recorded as a .MOV file and played back through software that generates a peak store image. The trajectory **246** of the thermal emissions from an active propagating defect is seen as the blade rotates from top to bottom clockwise. The dark lines in the image of the high pressure side **14** of this blade are thermal camera **222** artifacts due to the fast blade **11** motion. The bottom image shows a test image of a leading edge of blade **11** that includes thermal response from hub **18** nacelle **8** and tower **6**. The test was made from position **214** in FIG. **4**. Two indications of defects **236** are seen. Scaling from known features in the image, the defects are located at 7.2 and 9 meters from the root end **10**.

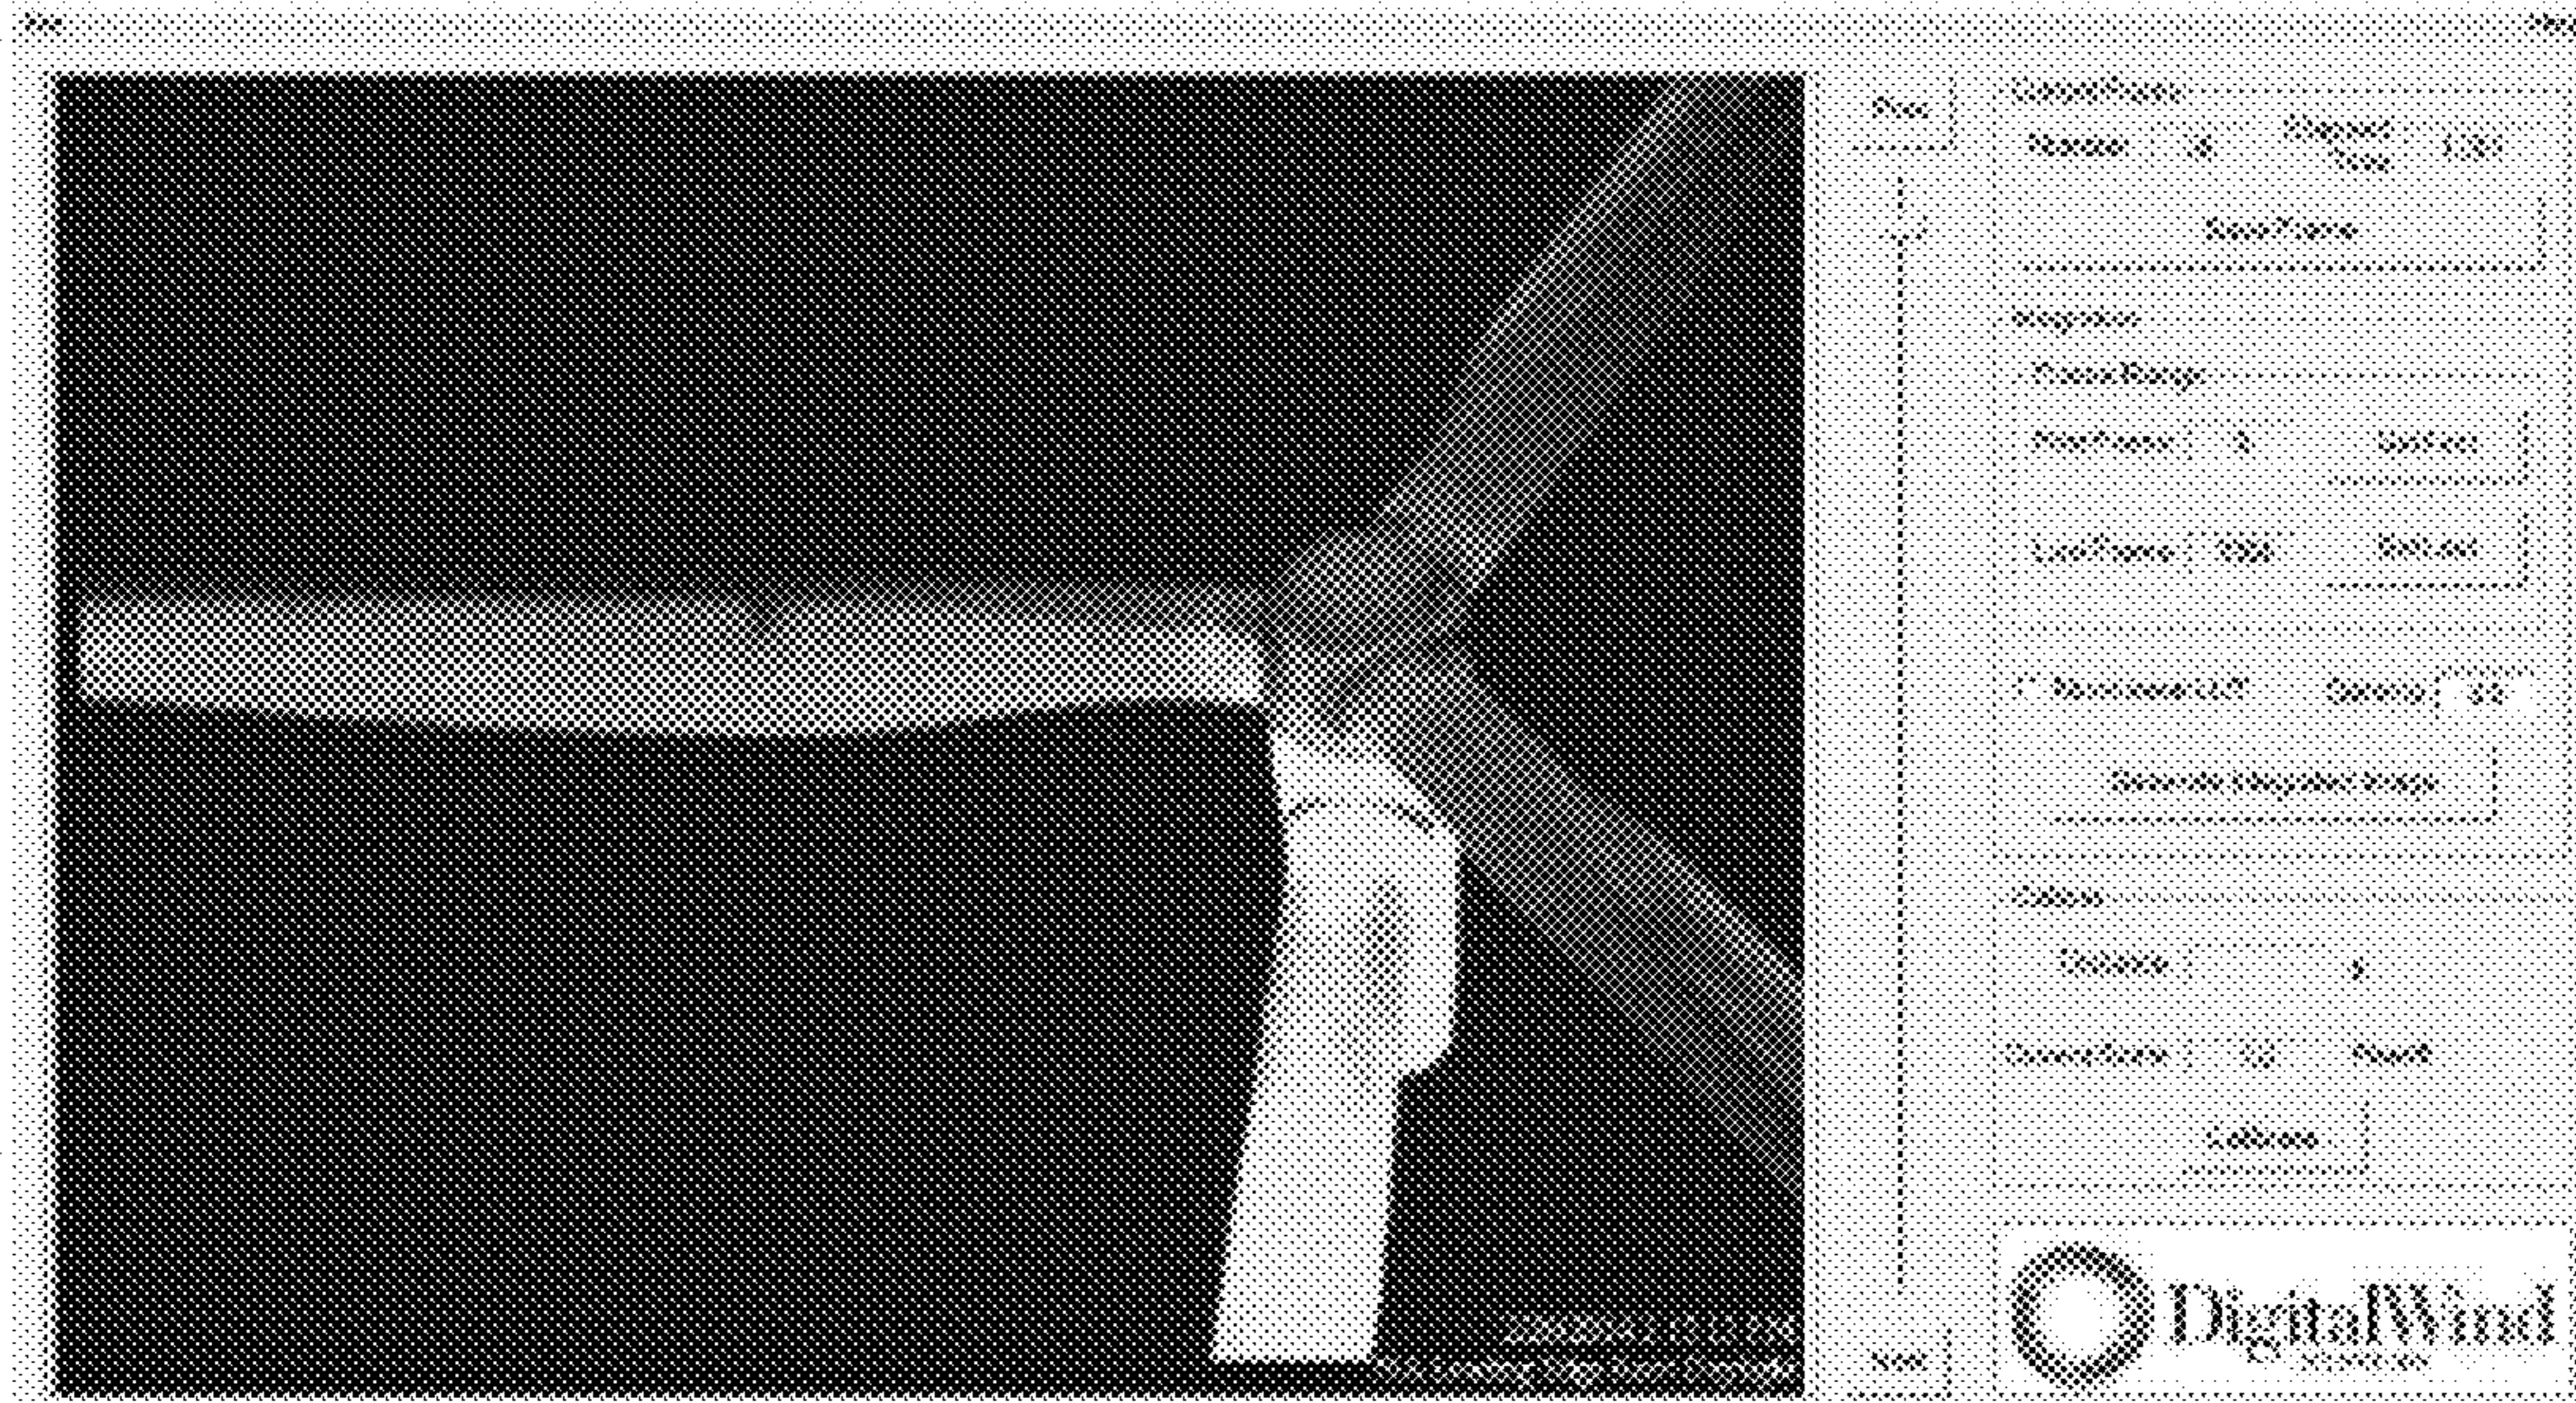
Fig. 14

FIG. 14 is a screenshot of a display image generated by the image processing computer showing a thermal image of the high pressure side of an operating wind turbine rotator with a video frame selected with the blade positioned horizontally blade showing a dark defect during nighttime;

FIG. **14** is a screenshot of a display image generated by the image processing computer showing a thermal image of the high pressure side of an operating wind turbine rotator with a video frame selected with the blade positioned horizontally blade showing a dark defect. This image was taken at night after the blade has come to thermal equilibrium from the effects of solar heating during the day. This delamination type defect is blocking the heat generated deeper in the blade and preventing it from reaching the surface. The camera used to record this image has a fast integration time of 0.001 seconds. Another defect type that appears dark is a perforation of the blade shells, the two bonded halves that comprise the blade.

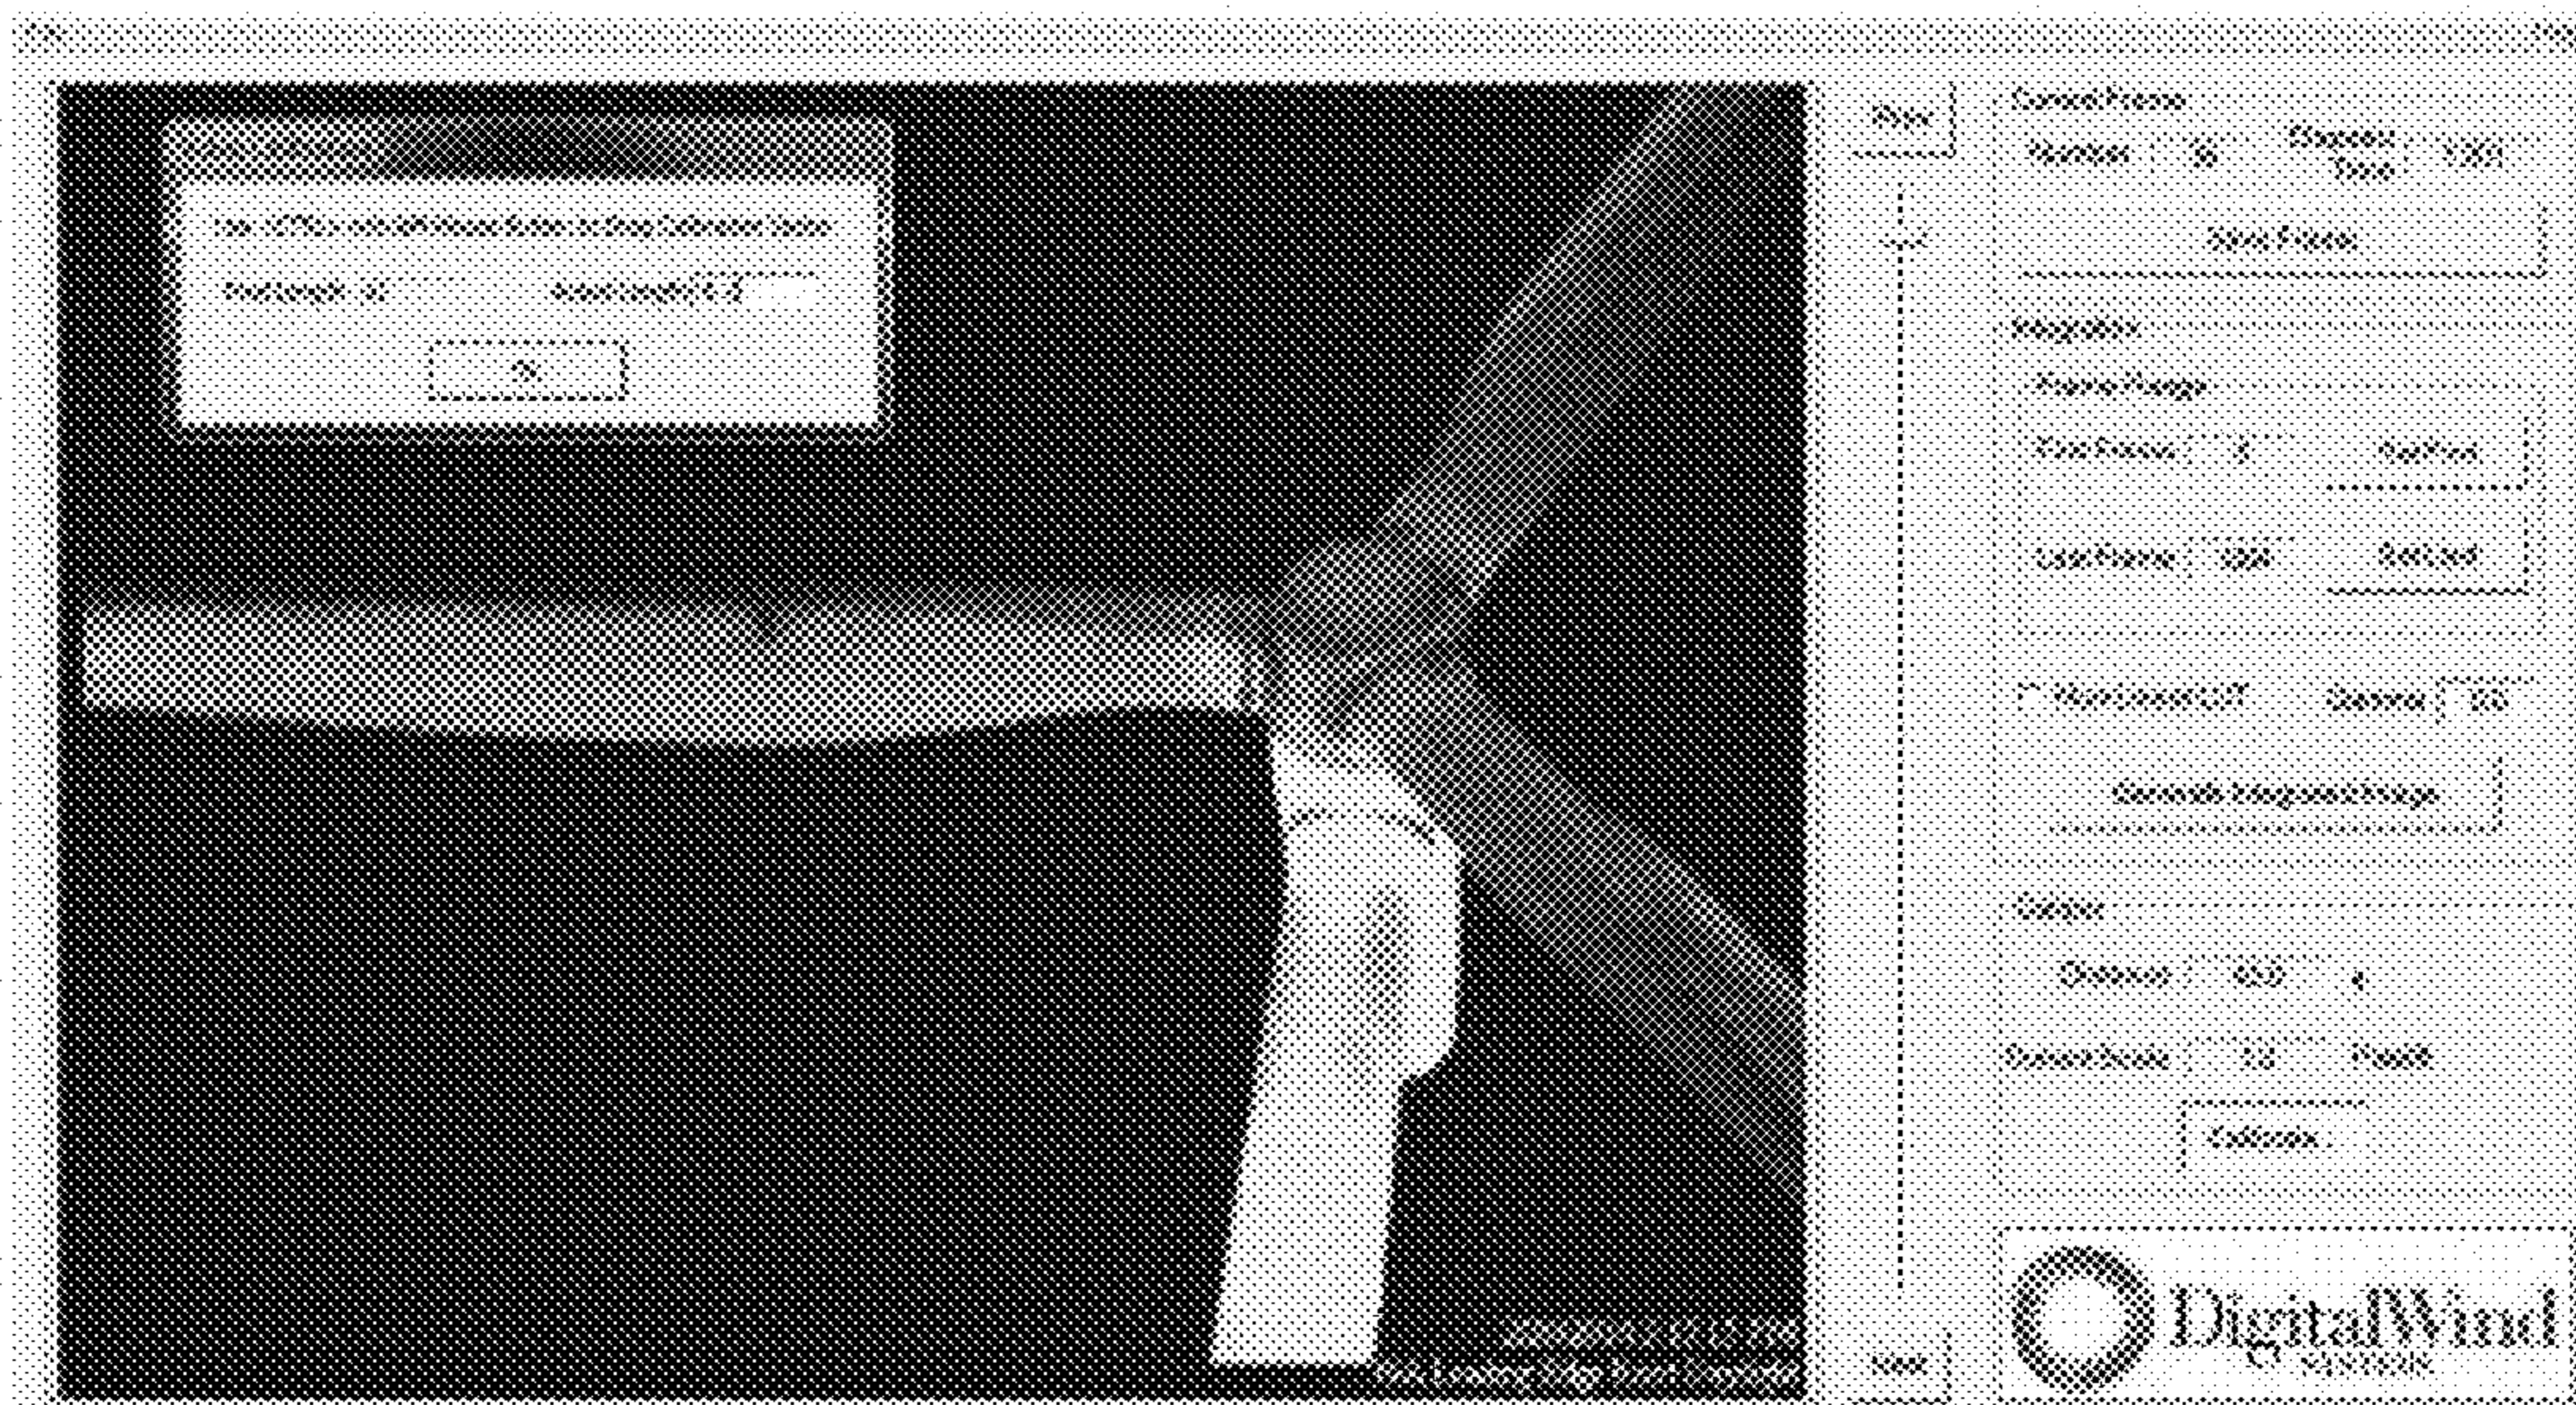
Fig. 15

FIG. 15 is a screenshot of a display image generated by the image processing computer showing the use of a caliber overlay function to mark on the digital image the width or diameter of the cylindrical root end of a blade;

The dimensions and location of this defect indication need to be determined to allow proper evaluation and maintenance decisions. FIG. 15 shows how a known distance can be defined on a still IR image of the blade. Here the diameter of the blade root end, known to be 6.2 feet, is defined by clicking on one side of the blade root and dragging the measurement line across the image to the opposite side of the blade root, hence defining the diameter of the blade root or a reference line.

The number of pixels in the image that comprise this line are counted to determine the image scale in unites of pixels per unit distance on the image of the blade. The image scale is accurate for all areas of the image of the blade at the same distance from the IR camera as the line segment defining the blade root diameter. The location of the defect with respect to a known datum such as the blade root end can then be measured as shown in FIG. 16. The computer mouse is used to move the cursor to the blade root, where a left click anchors a line at the datum which is then dragged across the image to the defects indications. So long as the line is moved across areas of the blade that are substantially equidistant from the IR camera as the defined reference line, the pixel count divided by the image scale will yield the distance of the defect to the datum.
