(12) **United States Patent**
Newman

(10) **Patent No.:** **US 9,996,747 B2**
(45) **Date of Patent:** ***Jun. 12, 2018**

(54) **SYSTEM AND METHOD FOR GROUND
BASED INSPECTION OF WIND TURBINE
BLADES**

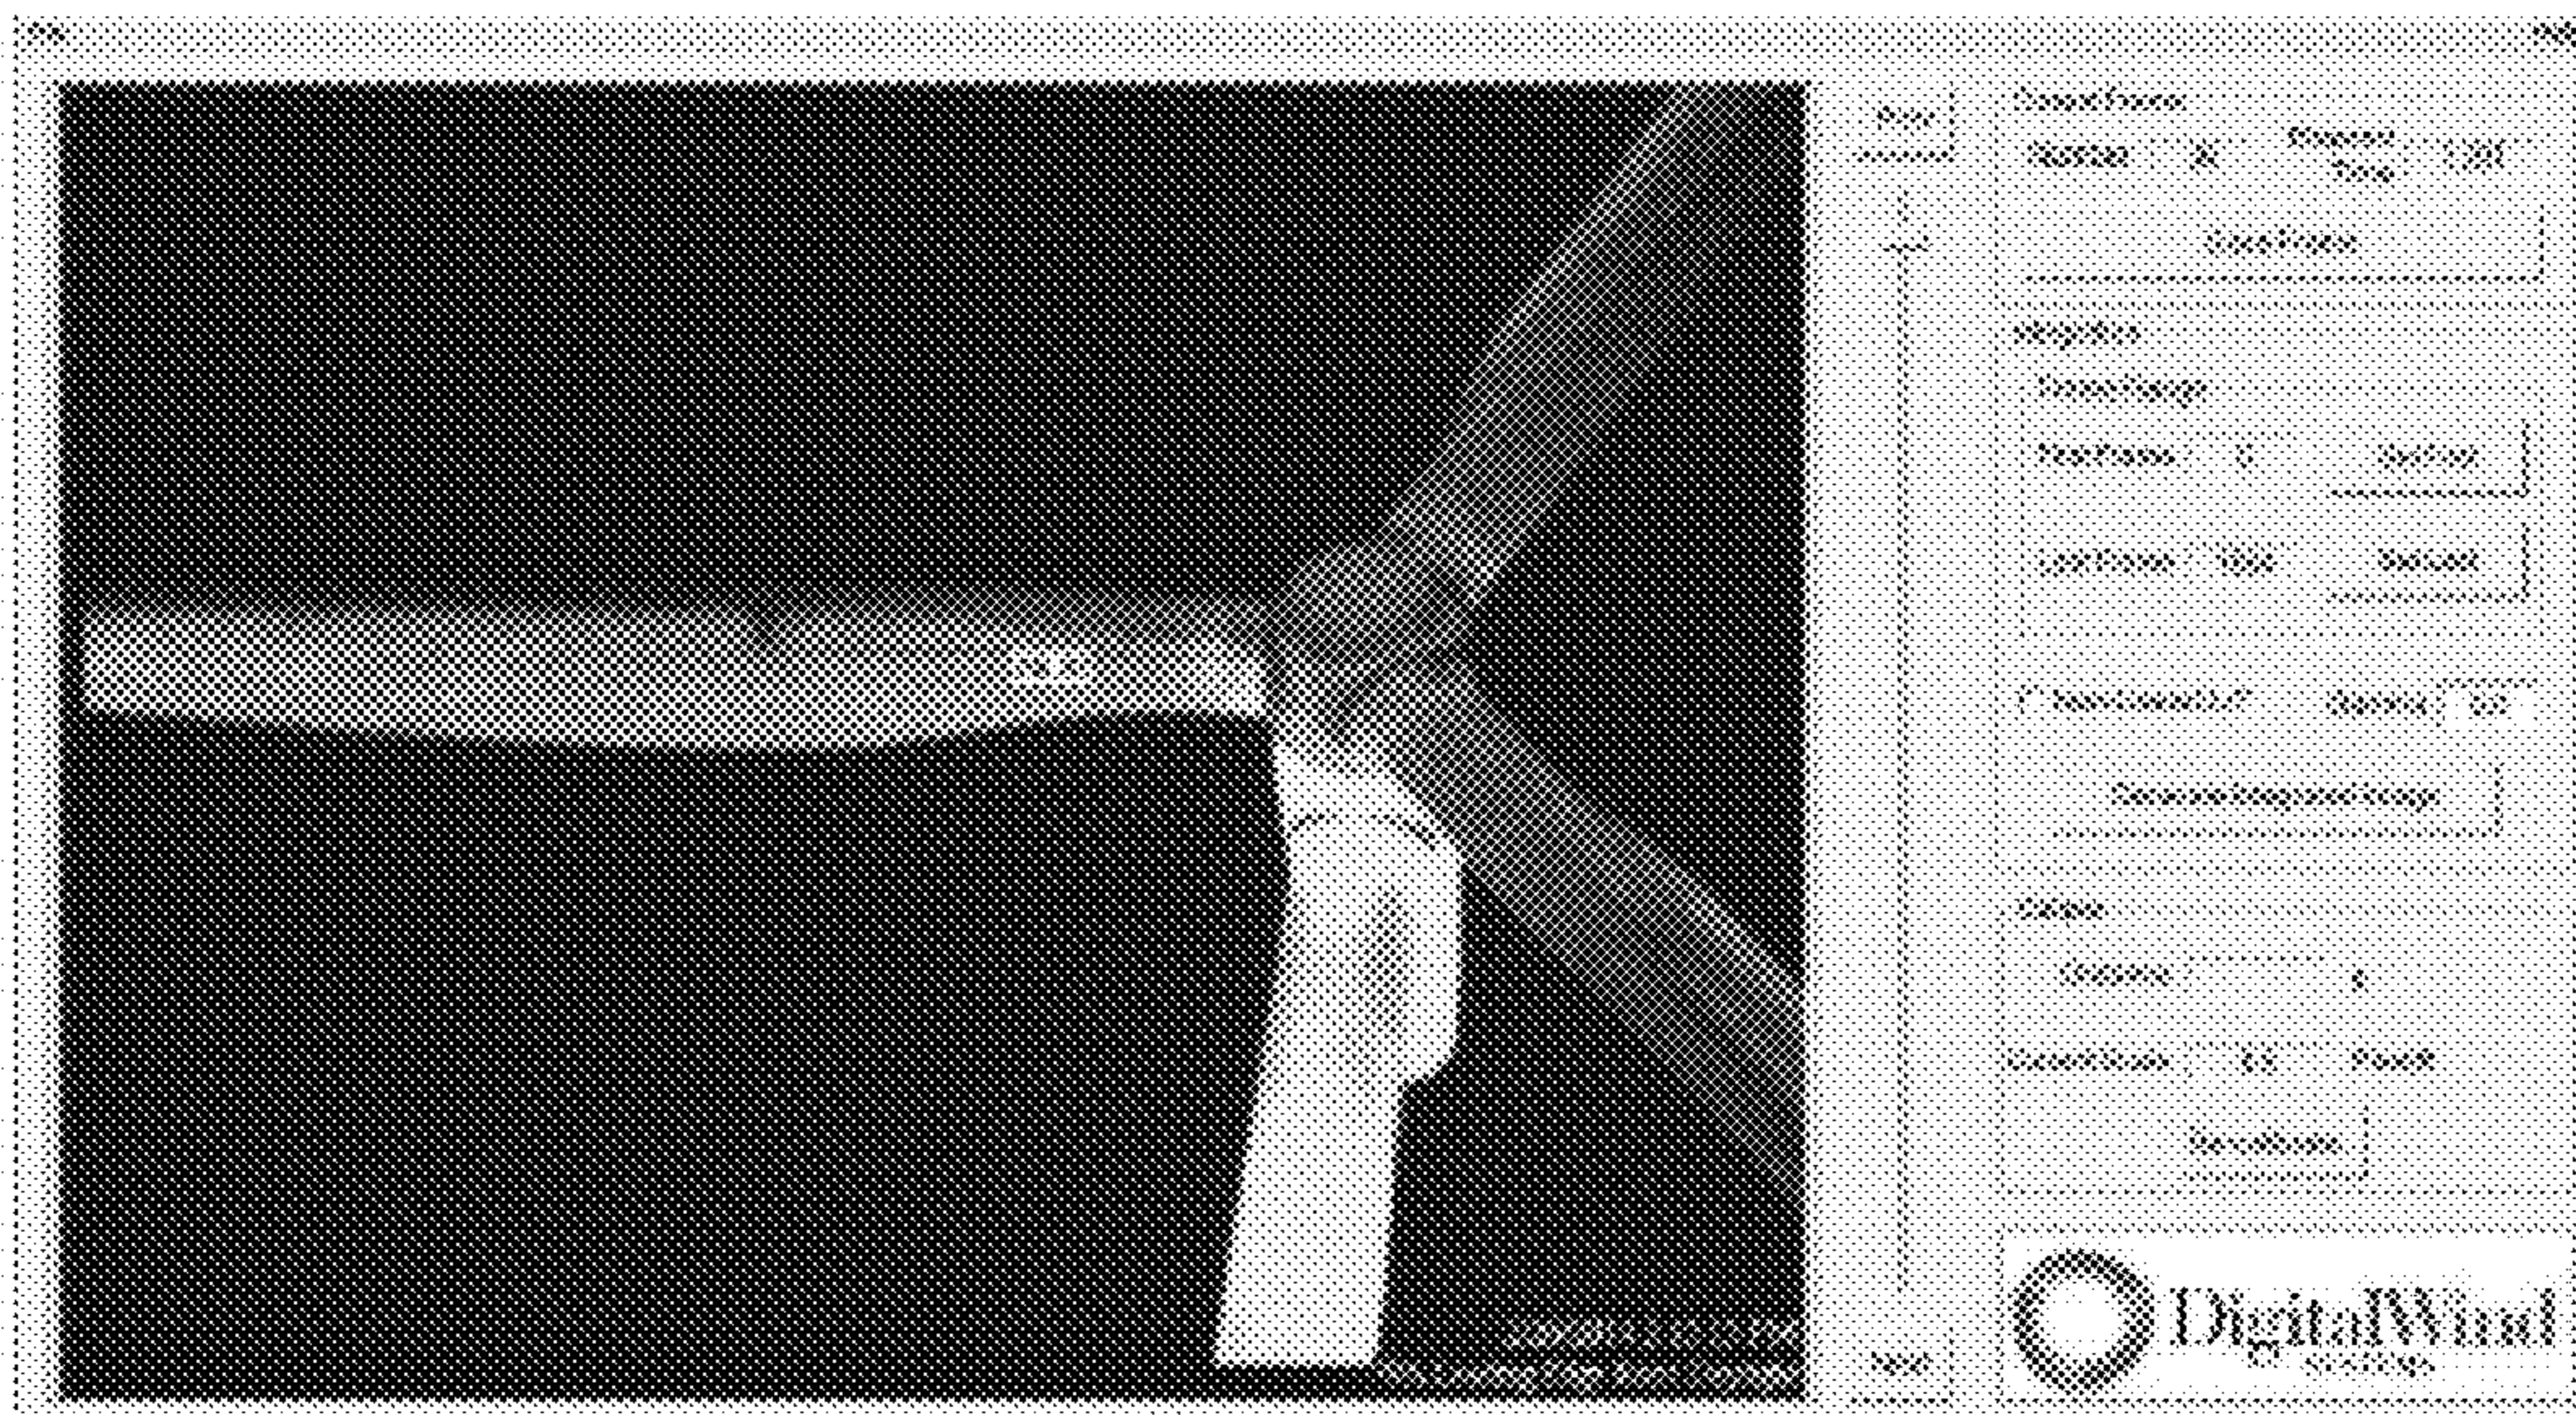
Fig. 16

FIG. 16 is a screenshot of a display image generated by the image processing computer showing the use of the caliper overlay function to determine a distance between the blade root end and the black indication of a defect in a wind turbine blade;

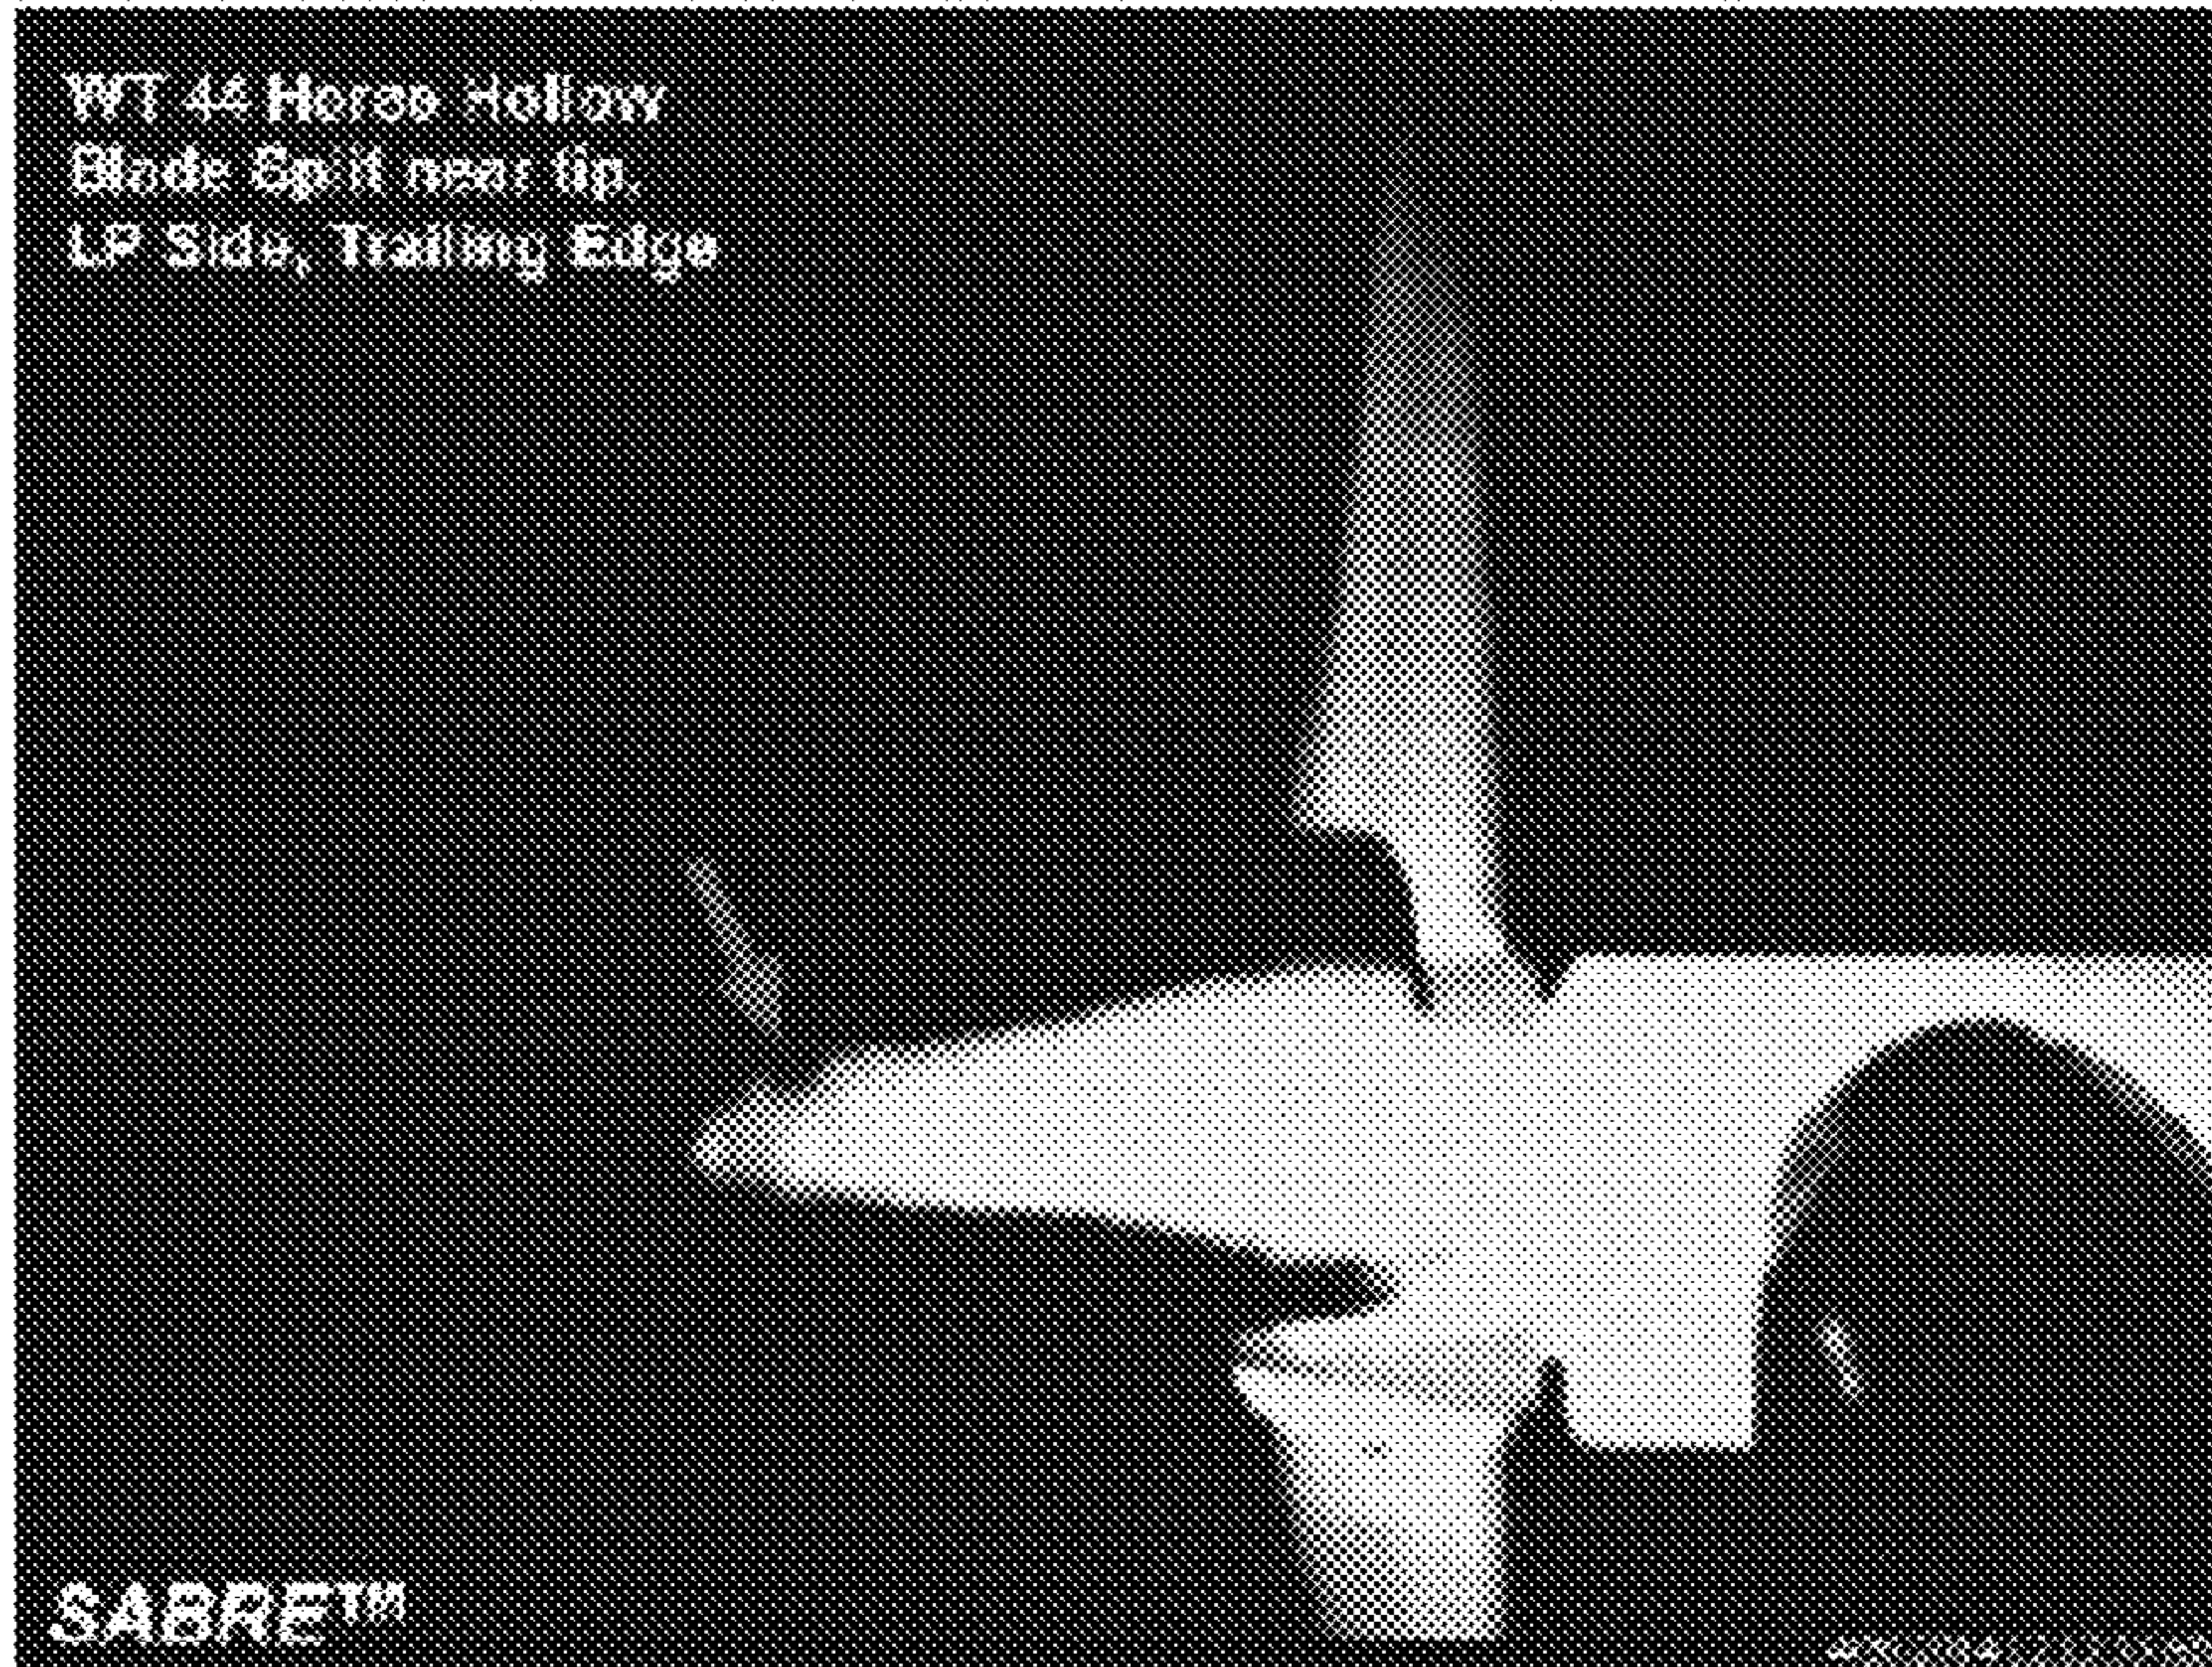
Fig. 17

FIG. 17 is an infrared image showing a flaw in a wind turbine blade near the tip of the blade;

Using the high speed IR camera images of blade tip defects, as shown in FIG. 17 are easily detected with sufficient resolution to enable sizing and determination of location, in spite of the faster than 250 ft. per second speed.

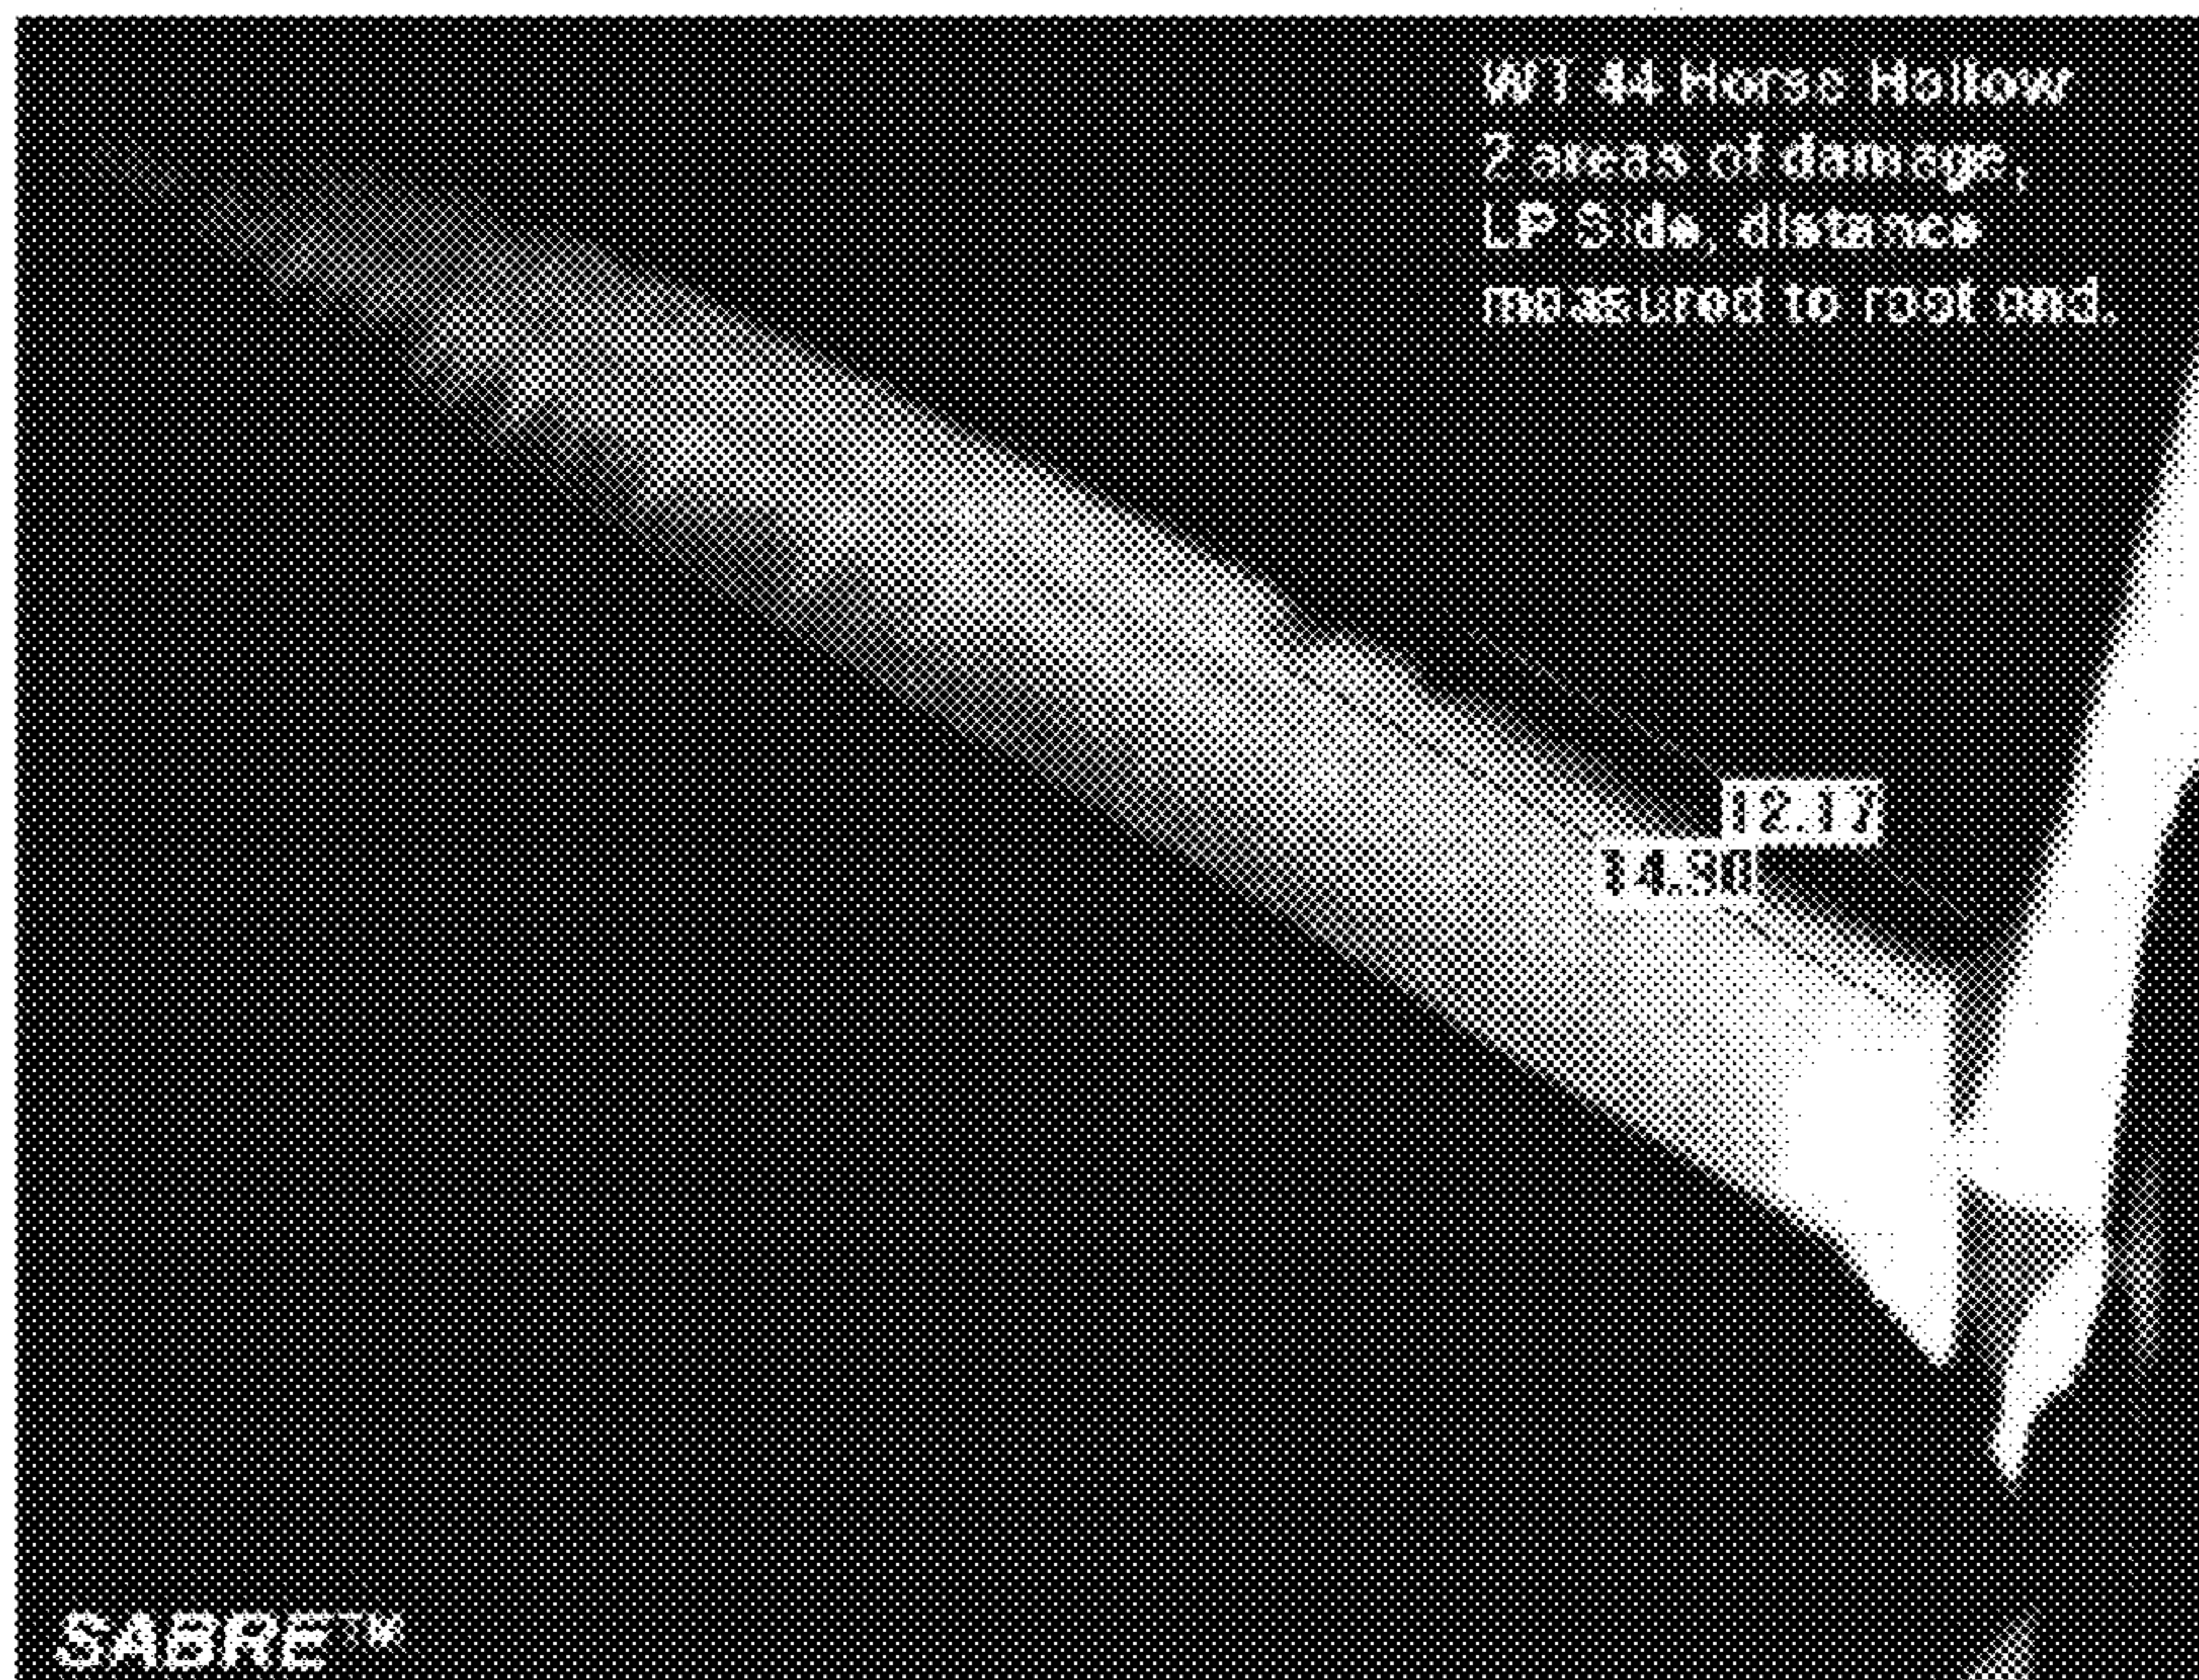
Fig. 18

FIG. 18 is an infrared image showing the caliper overlay function being used to measure the location of two areas of damage on a wind turbine blade with respect to the blade root end; and

FIG. 18 shows how two defect indications near the blade root end can be measured using a caliper overlay function.

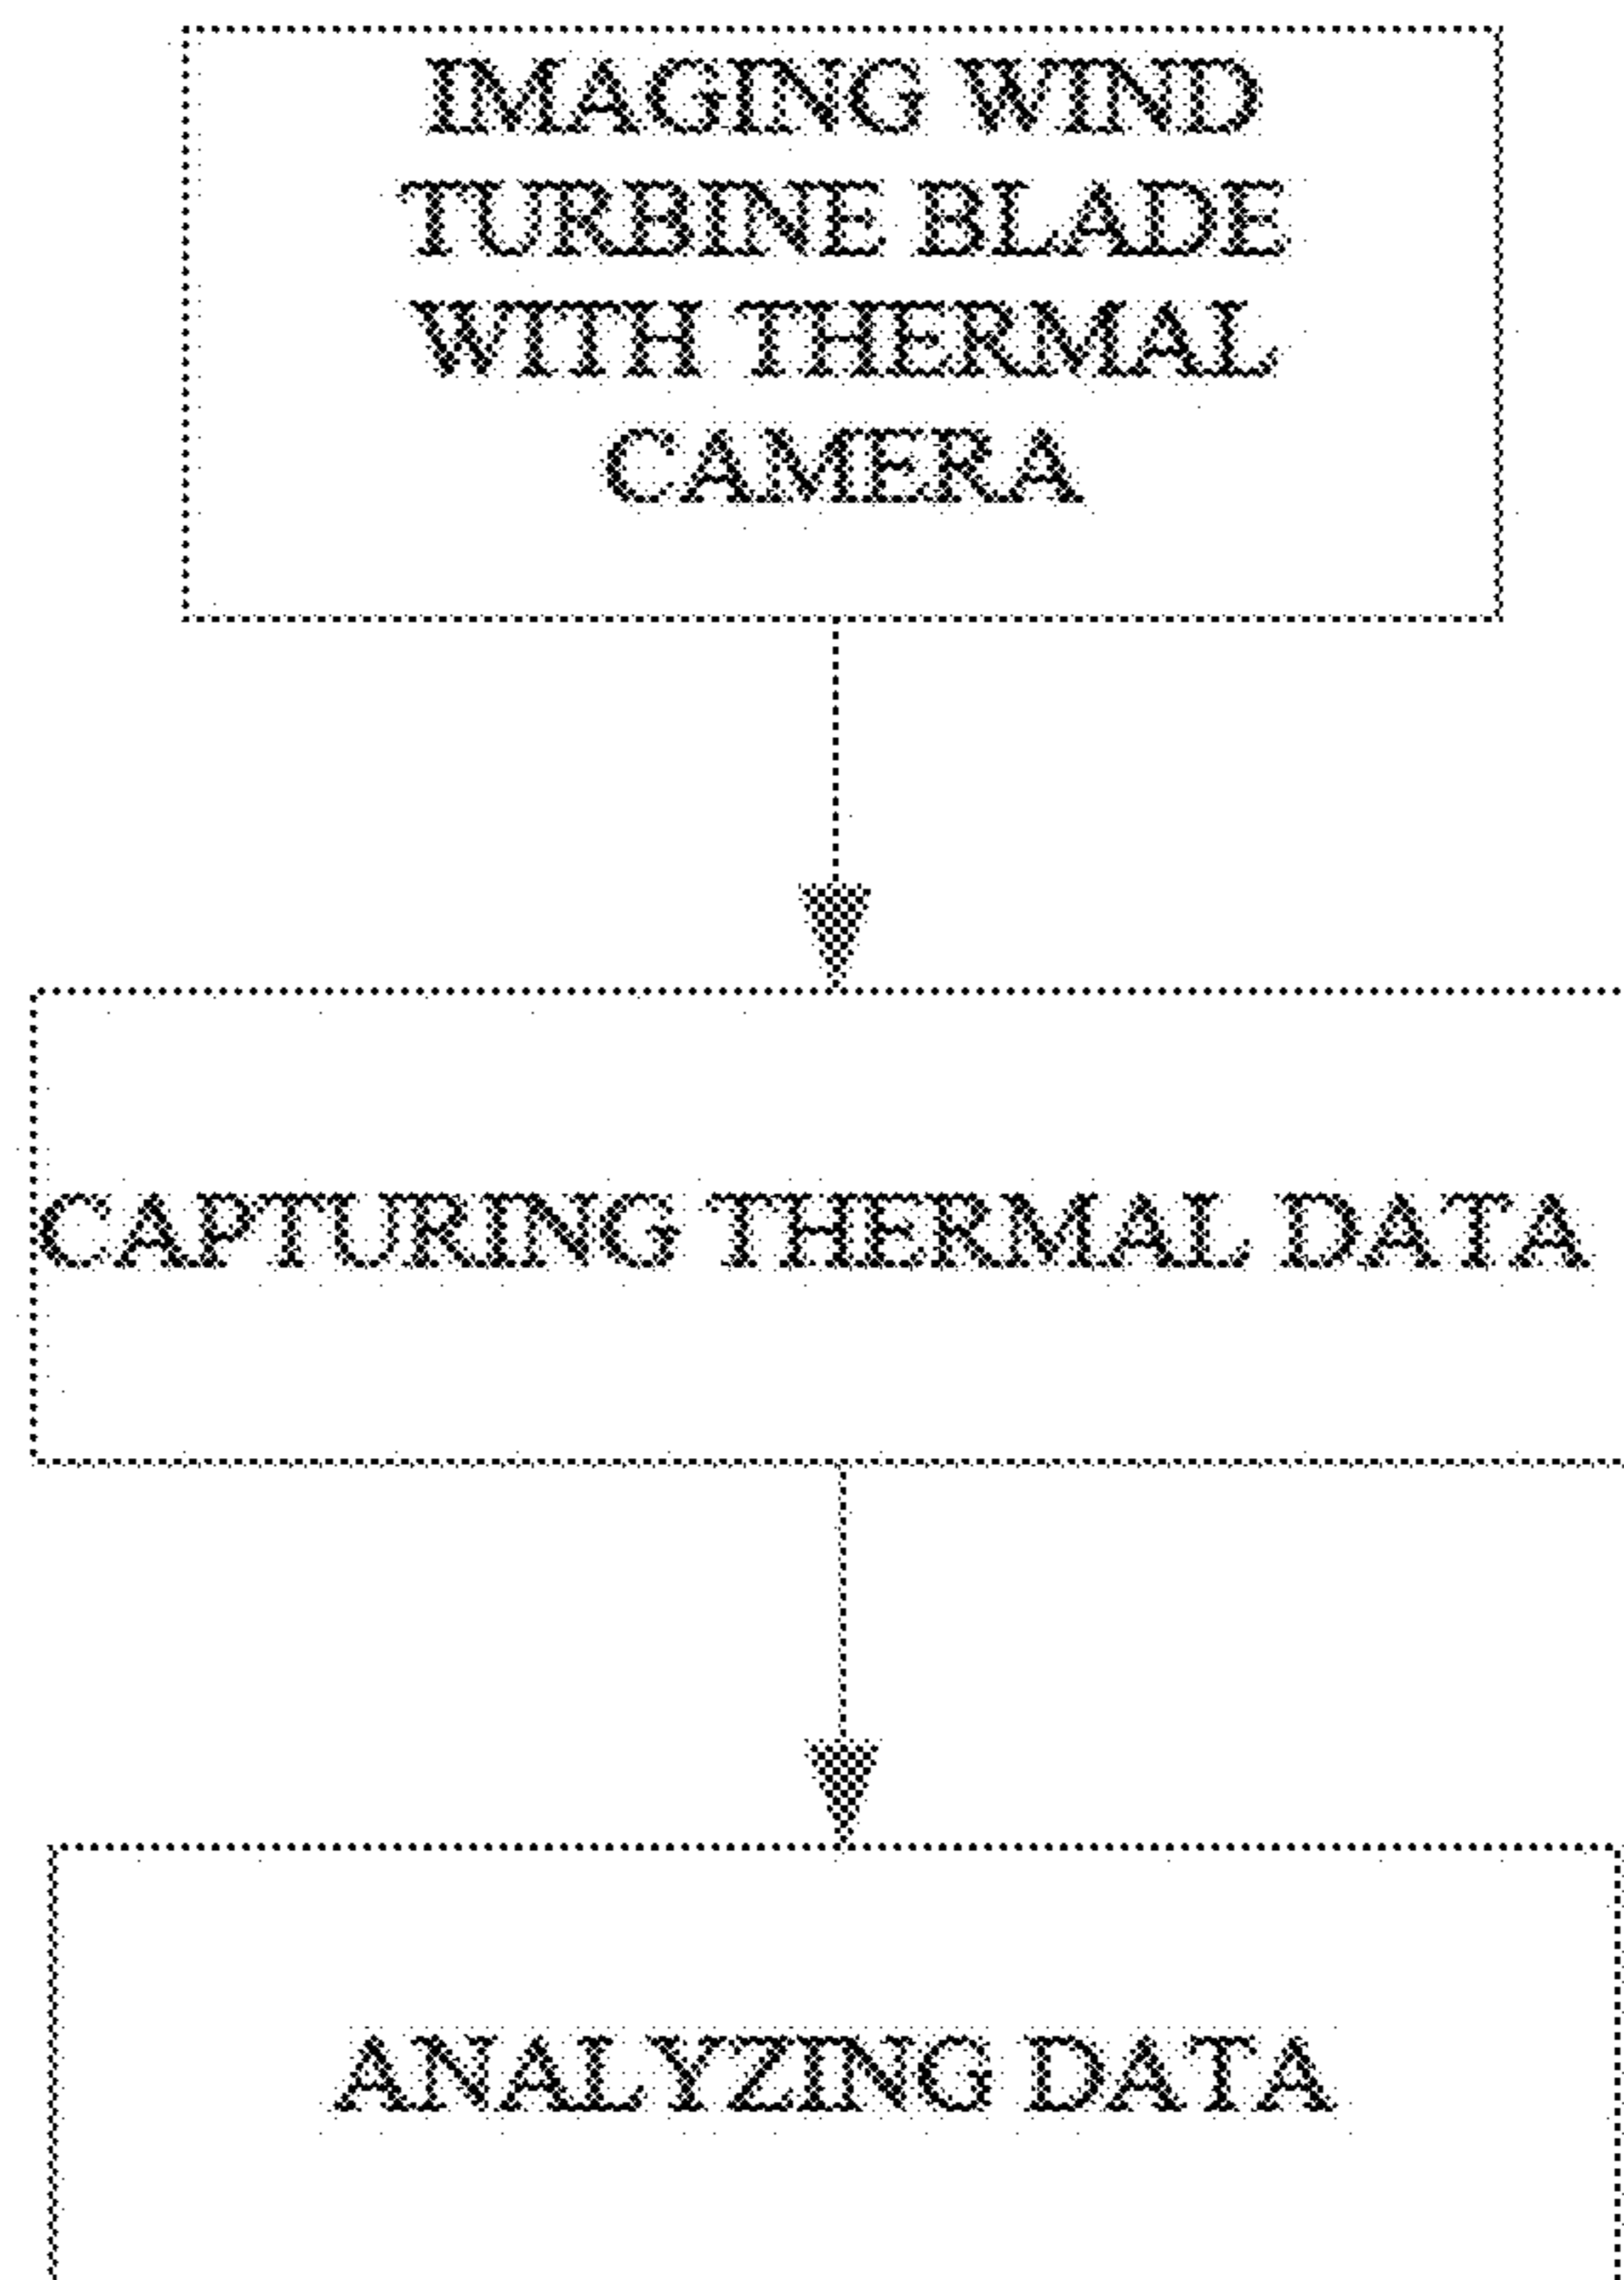
Fig. 19

FIG. 19 is a flowchart depicting a method according to a preferred embodiment of the invention.
