(12) **United States Design Patent** (10) **Patent No.:** **US D567,081 S**
Baughman et al. (45) **Date of Patent:** **** Apr. 22, 2008**

- (54) **BAIL HANDLE FOR A CLOSING CAP**
(75) Inventors: **Gary M. Baughman**, Fremond, IN (US); **Lynn A. Brooks**, Auburn, IN (US)
(73) Assignee: **Rieke Corporation**, Auburn, IN (US)
(**) Term: **14 Years**
(21) Appl. No.: **29/288,159**
(22) Filed: **May 31, 2007**
(51) **LOC (8) Cl.** **09-07**
(52) **U.S. Cl.** **D9/434**
(58) **Field of Classification Search** D9/435, D9/436, 438, 439, 440, 447, 449, 453, 454, D9/516, 539, 763, 780; D34/39; D7/392; 137/844, 845; 215/341, 358; 220/257.1; 222/185.1, 464.1, 547, 569, 570
See application file for complete search history.

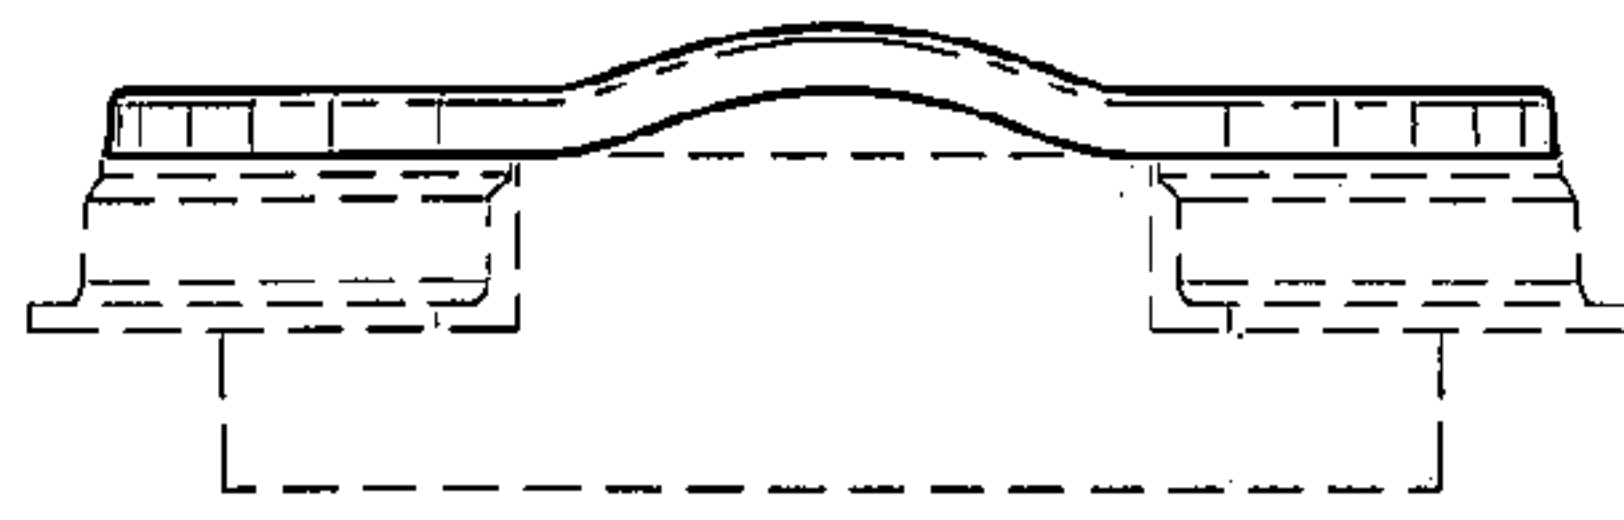
Fig. 1

FIG. 1 is a front elevational view of a curved lifting handle showing a bail handle for a closing cap, the rear elevational view being identical thereto;

In FIG. 1, the broken lines consisting of two short dashes followed by a long dash show surface shading indicating an edge with a slight radius. The broken lines under the elevational view of the claimed design depict environmental subject matter and form no part of the claimed design.
