(10) **Patent No.:** **US D957,004 S**
(45) **Date of Patent:** **** Jul. 5, 2022**

(54) **ELEVATOR WALL SURFACE HAVING
DECORATIVE MIRRORS**

(71) Applicant: **KONE Corporation**, Helsinki (FI)

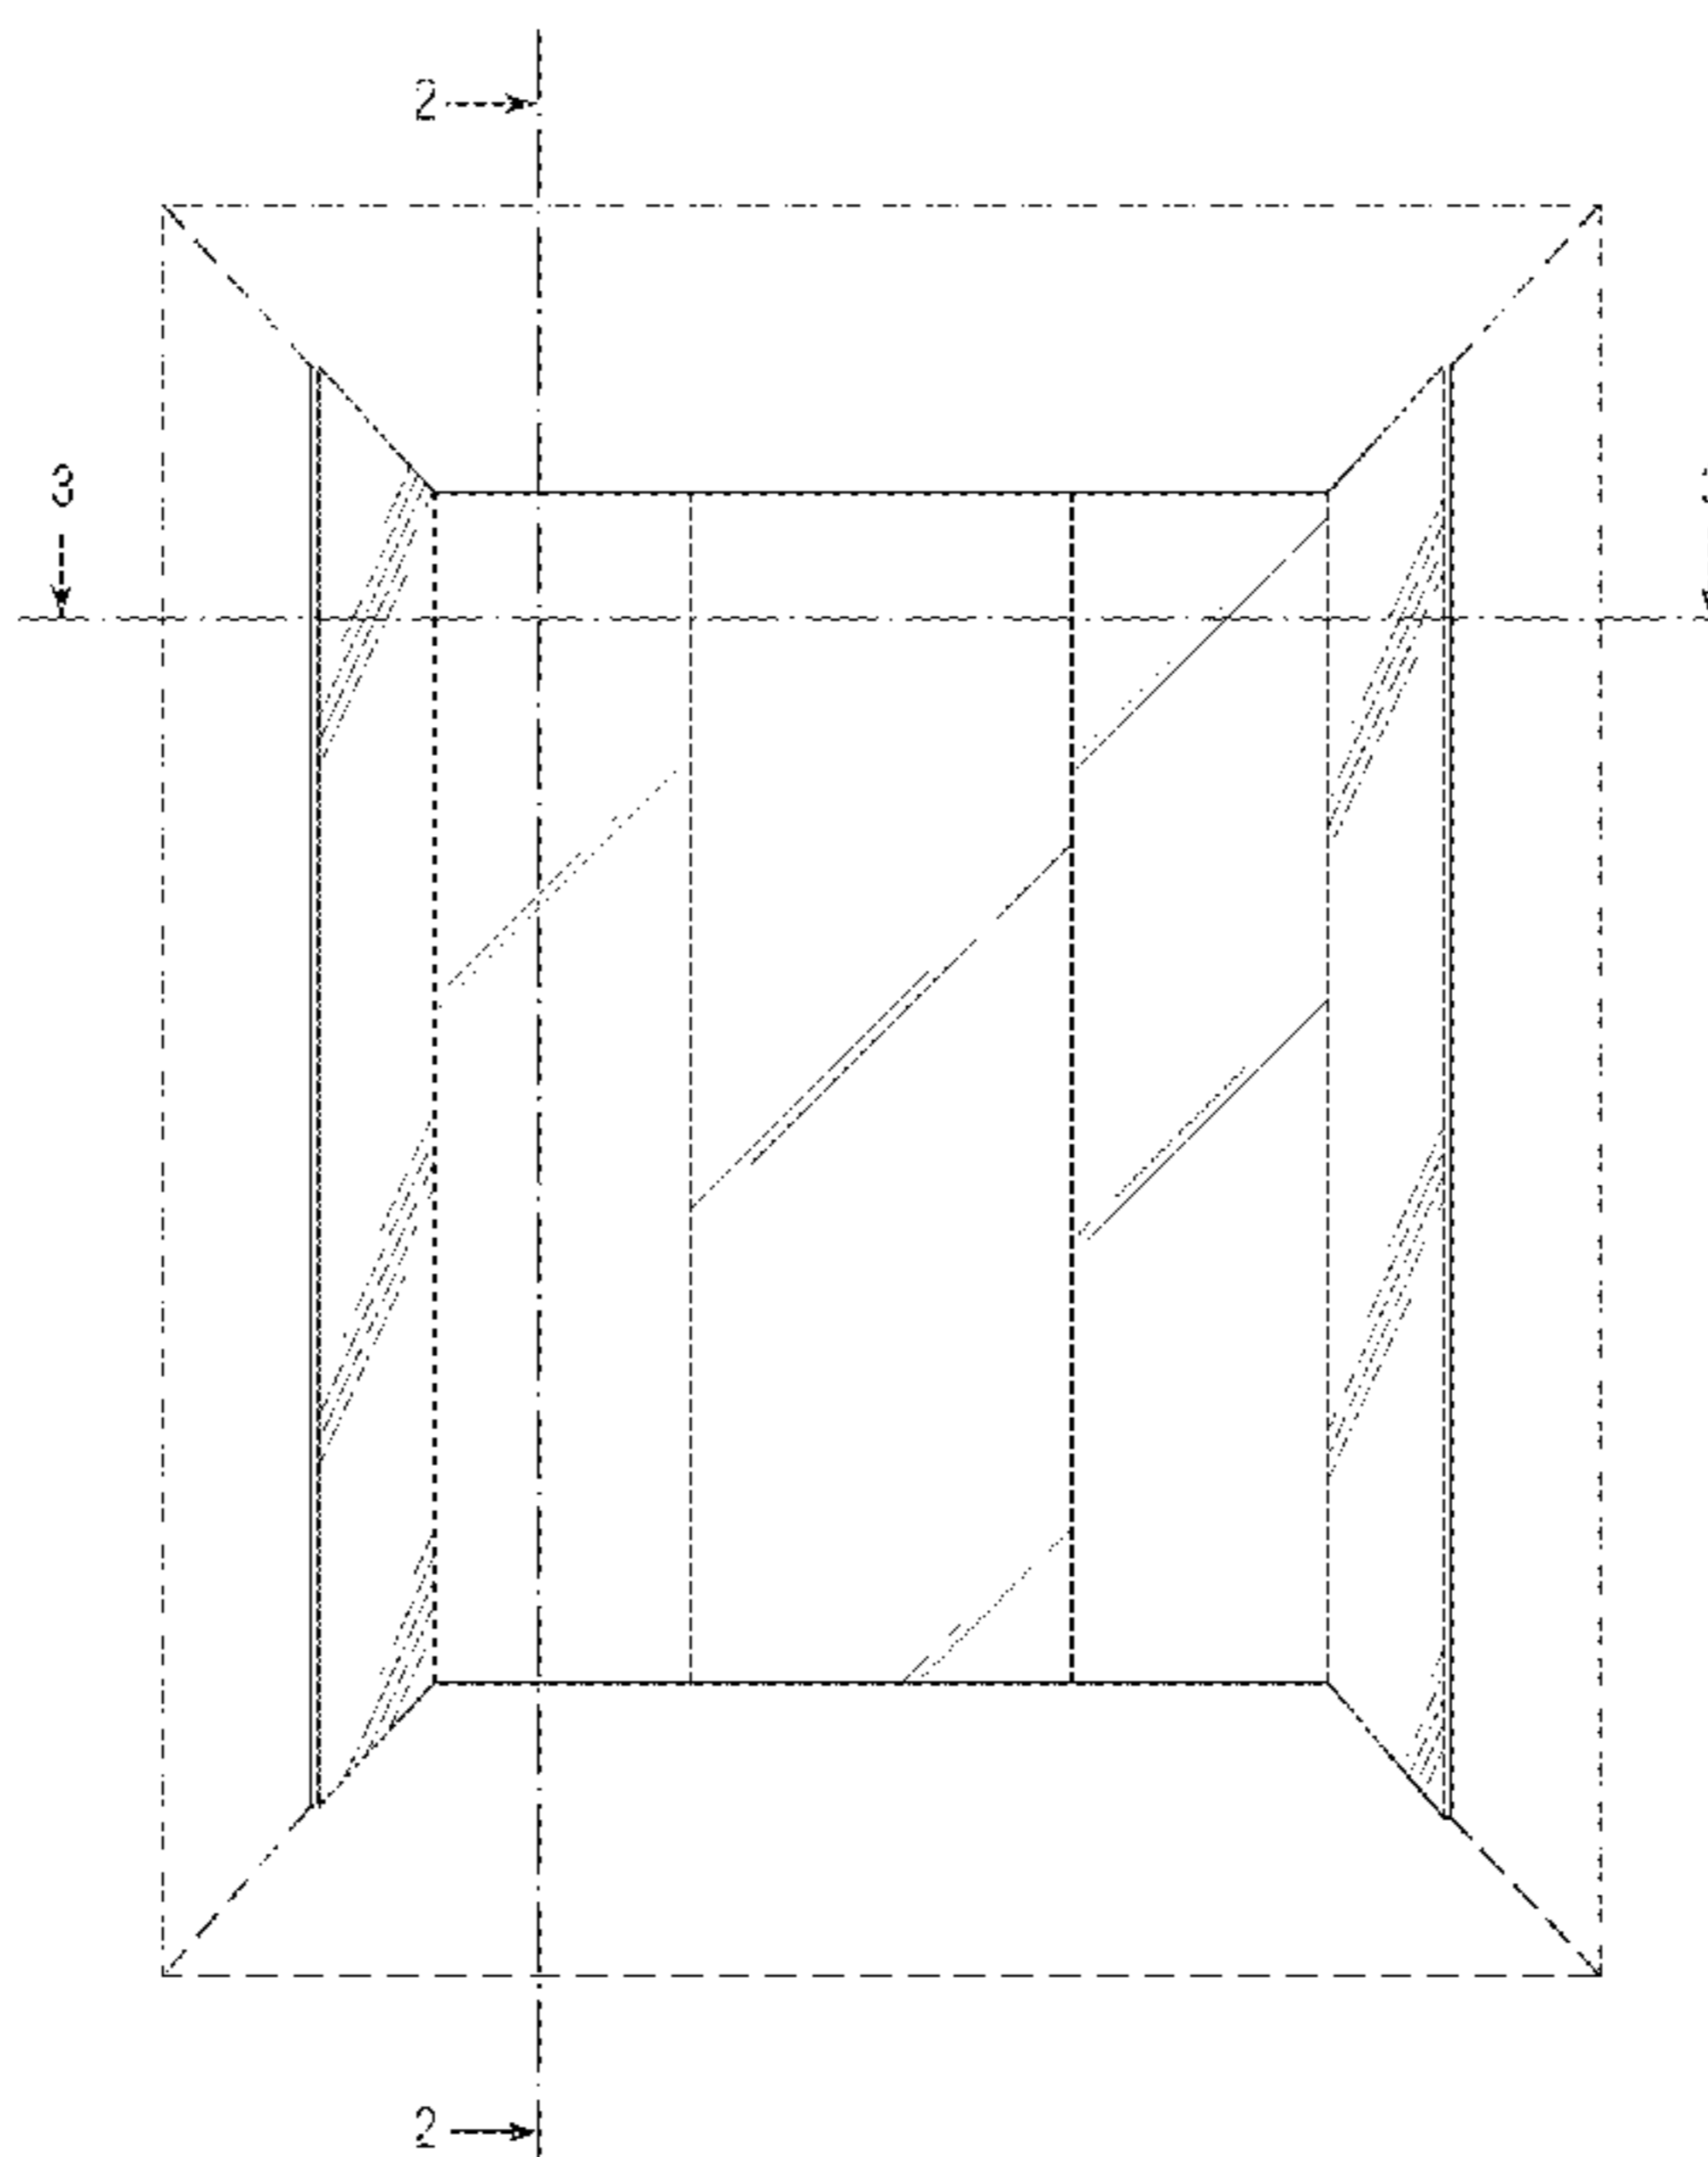
Fig. 1

FIG. 1 is an orthographic view of an elevator wall surface having decorative mirrors;
FIG. 2 is a sectional view thereof taken along line 2-2 of FIG. 1; and,
FIG. 3 is a sectional view thereof taken along line 3-3 of FIG. 1.

The claimed design in FIG. 1 concerns a glass rear wall and mirrored side wall portions flanking either side of the rear wall. The rear wall includes vertical seams dividing the panel; the seams are visible in the front view but are in the same plane as the illustrated panels, with no depth.

The broken-lines illustrate environmental structure and form no part of the claimed design.
